PARSONAGE RESIDENCE  
640 PACIFIC AVENUE  
LONG BEACH, CALIFORNIA 90813

**HISTORIC STRUCTURE REPORT**

Katie Rispoli Keotamai  
*Master of Heritage Conservation*  
on behalf of  
KEAOTAMAI, LLC  
June 6, 2018

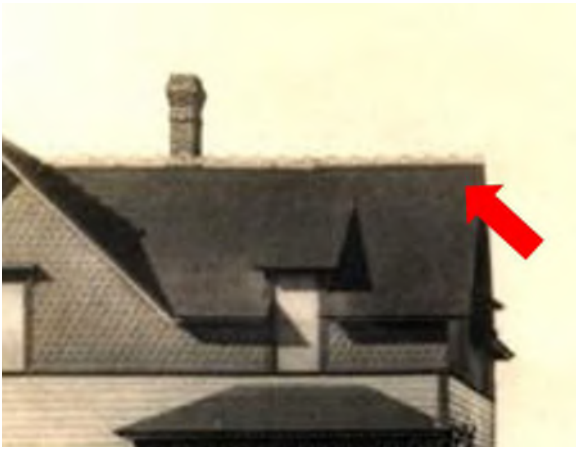
Roof Cresting in Historic Photograph, Primary Elevation	Decorative metal cresting originally existed on the building, and followed the line of the roof gables. In the above photograph, it can be seen spanning this form, and is noticeably differentiated from the brick texture of the chimney rising from the rear of the building. The edge of the cresting fronts with the asymmetrical gable on the primary elevation of the building. This cresting was removed at an unknown date.	N/A	No action recommended	N/A
<b>Roof</b>  <b>Location:</b> <ul style="list-style-type: none"> <li>Roof</li> </ul>	General Feature

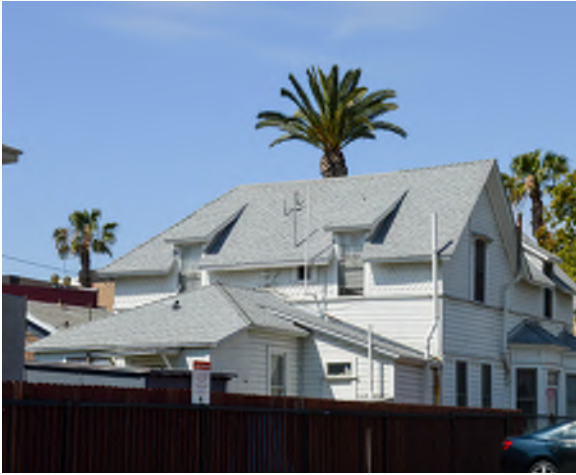
Parsonage Roof, East Elevation, View Southwest	The roof of the building is asymmetrical with a distinguished gable on the primary elevation, and cross gables on both the north and south elevations. Bracketed roof elements exist over select windows. Roof projections are observed over the grouping of three windows on the north elevation, and over the Box-Bay window on the northwest corner of the first story. In addition, there is a roof projection from the primary elevation over the entry porch. The cross gables on the north and south elevations have an open-eave roof-wall junction.	Relocation Preparation Relocation Reassembly Rehabilitation	Prior to relocation, the roof will be separated from the first floor of the residence along with the second story walls of the residence. This portion of the building will be supported with a steel beam system and lowered onto dollies for relocation. Once relocated, the roof and second story will be re-connected with the first story atop the new foundation according to the approach determined by Melvyn Green & Associates (Attachment B.) During rehabilitation, damaged interior roof framing will be removed and replaced with like materials. Exterior roof cladding will be replaced with new asphalt shingle cladding.	Following the Secretary's Standards for Rehabilitation, the roof form will not be altered as it is considered characteristic of the historic nature of the building. Additionally, deteriorated interior wood framing or other damaged components will be repaired rather than replaced when possible. When replaced, the new materials will match the original in design, color, texture, and (if possible) material. Asphalt roofing will be used in lieu of conjecture in choosing a period-appropriate roof material.

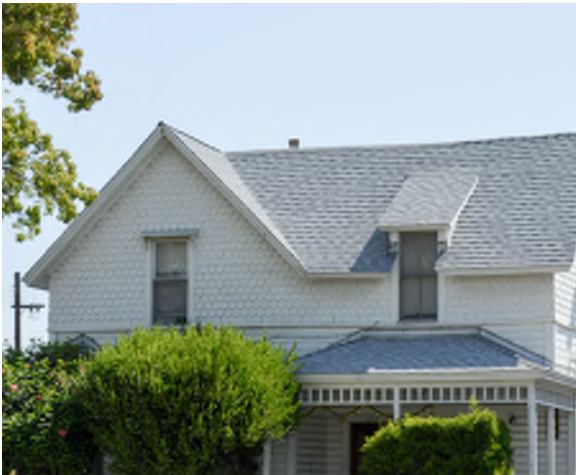
<b>Asymmetrical Roof Gable</b>  <b>Location:</b> <ul style="list-style-type: none"> <li>Roof, Primary (West) Elevation</li> </ul>	Historic Character-Defining Feature

Roof Gable on West Elevation, View Northeast	The use of a gabled roof in an asymmetrical fashion is consistent with roof typologies of the Stick Style. The gable only slightly projects from the wall of the building, and has an open eave on its northernmost edge, which continues to a cross gable on the north elevation. A cross gable is also prominent on the south elevation.	Relocation Preparation Relocation Reassembly Rehabilitation	Prior to relocation, the roof will be separated from the first floor of the residence along with the second story walls of the residence. This portion of the building will be supported with a steel beam system and lowered onto dollies for relocation. Once relocated, the roof and second story will be re-connected with the first story atop the new foundation according to the approach determined by Melvyn Green & Associates (Attachment B.) During rehabilitation, gable trim will be replaced, if damaged, with like materials and repaired where possible.	Following the Secretary's Standards for Rehabilitation, the roof form will not be altered as it is considered characteristic of the historic nature of the building. Additionally, deteriorated wood or other damaged components will be repaired rather than replaced when possible. When replaced, the new materials will match the original in design, color, texture, and (if possible) material. Asphalt roofing will be used in lieu of conjecture in choosing a period-appropriate roof material.

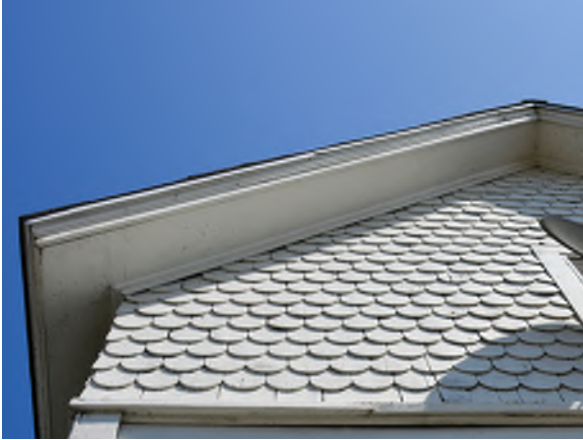
<p>Feature as Observed on South Elevation</p>	<p>Rounded (fish scale) wood shingles are found throughout the second story. On the East elevation, these shingles were replaced (most likely following relocation) with a like shingle demonstrating a squared edge. The shingles are painted, and are oriented downward, and are repeated in horizontal progressions. Their placement only on the second story is consistent with Shingle Style. Below the shingles is horizontal wood clapboard siding on the entirety of the first story. Both rounded shingles and clapboard siding are in generally good condition.</p>	<p>Relocation Preparation</p> <p>Rehabilitation</p>	<p>Shingles will not be cut during the course of building move preparations. Any shingles dislodged or damaged in the course of relocation should be replaced with like material, cut to a similar shape and placed in the same location. Squared shingles on the rear of the residence shall be preserved to demonstrate the evolution of the resource over time. Clapboard siding damaged throughout the course of the move should be replaced with like new wood siding selected to match in texture, and cut to match in arrangement, width, and orientation.</p>	<p>Following the Secretary's Standards for Rehabilitation, deteriorated wood shingles and/or clapboard siding will be repaired rather than replaced when possible. When replaced, the new materials will match the original in design, color, texture, and (if possible) material. Replaced shingles and clapboard siding will be painted to match existing.</p>

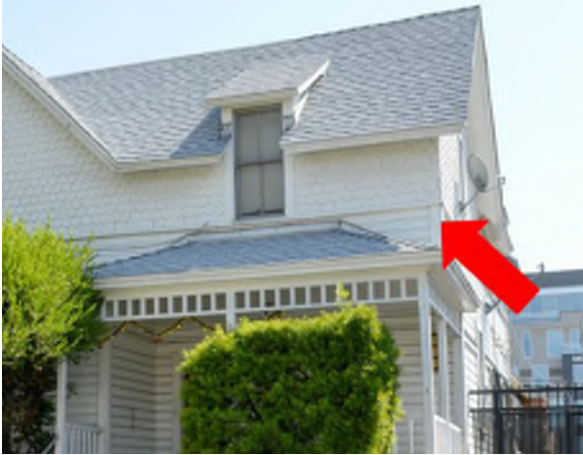
<p><b>Horizontal and Vertical Wood Bands Dividing First and Second Stories, Raised From Wall Surface for Emphasis</b></p> <p><b>Location:</b></p> <ul style="list-style-type: none"> <li>All Exterior Elevations</li> </ul>	<p>Historic Character-Defining Feature</p>

<p>Horizontal and Vertical Wood Bands</p>	<p>Narrow bands of wood ornament are located along the border between the first and second stories. These bands run both horizontally, as well as vertically at the intersection of elevations. In the period of historic significance, these bands would have been painted the same color as the building's trim or in a color noticeably different from the body color of the building for emphasis and decoration.</p>	<p>Relocation Preparation</p> <p>Rehabilitation</p>	<p>It is likely these bands will be harmed throughout the course of relocation. They are, however, simple and ornamental and are easily refitted. Damaged portions of the bands should be replaced with new, minimal wood ornamentation in like fashion. These new bands should be similar, yet easily differentiated from any existing bands that remain after the building is reassembled on its future site. New and historic bands should be painted with the original color scheme of the building (as determined as a result of this project) as part of the exterior restoration process.</p>	<p>Following the Secretary's Standards for Rehabilitation, damaged wood bands on the exterior of the building will be repaired rather than replaced when possible. When replaced, the new materials will match the original in design, color, texture, and (if possible) material. Replaced decorative features of this nature will be painted to match existing.</p>

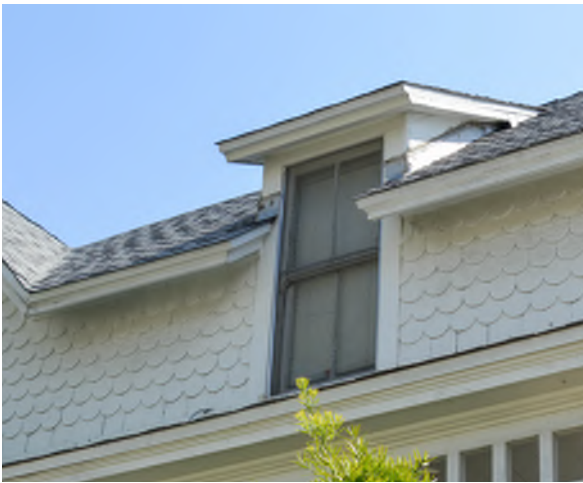
<p><b>Bracketed Rectangular Windows</b></p> <p><b>Location:</b></p> <ul style="list-style-type: none"> <li>Primary (West) Elevation</li> <li>North Elevation</li> <li>South Elevation</li> </ul>	<p>Historic Character-Defining Feature</p>

<p>Bracketed Window on West Elevation, View Northeast</p>	<p>Five windows throughout the building are sheltered by a bracketed roof form, which projects from the building wall. The roof form creates a dormer, which houses a vertically-oriented rectangular wood window.</p>	<p>Relocation Preparation</p> <p>Reassembly</p> <p>Rehabilitation</p>	<p>Windows should be removed and their openings wood-framed prior to relocation to reduce damage. Alternatively, windows may stay in place with wood bracings with the consent of the City of Long Beach. Removed windows should be numbered and recorded with orientation noted to ensure they are properly refitted. After relocation, waterproofing around window edges should be replaced with new which does not visually disrupt the features of the building, and windows should be cleaned, repainted, and re-installed. Any windows which have suffered broken glass should be fitted with contemporary tempered glass.</p>	<p>Following the Secretary's Standards for Rehabilitation, damaged portions of windows visible on the exterior of the building will be repaired rather than replaced. Extensive care and caution will be taken to ensure that windows are not damaged beyond repair in the course of this relocation. As a backup, windows in the kitchen addition (which were matched to original windows at the time of that addition's construction) will be removed and stored with original windows for use if needed.</p>

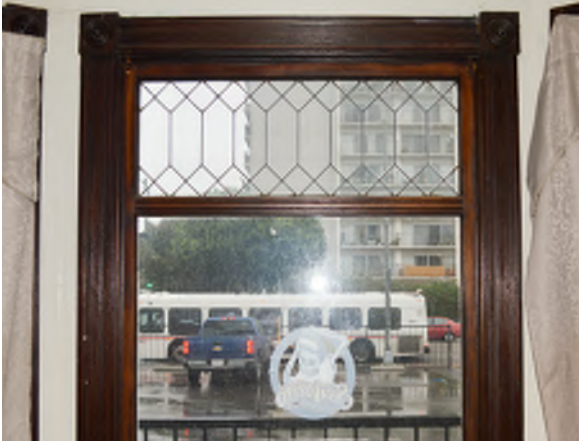
<p>Wood Window on North Elevation, View North</p>	<p>All original windows throughout the residence are wood. A number of original windows are unpainted, while some are painted.</p>	<p>Relocation Preparation</p> <p>Reassembly</p> <p>Rehabilitation</p>	<p>For treatment approach of wood windows, see the treatment for "Bracketed Rectangular Windows" in this attachment. Additionally, windows which house leaded glass must be removed prior to relocation to ensure protection of original glasswork.</p>	<p>Following Standards for Rehabilitation, damaged windows will be repaired rather than replaced. Extensive care and caution will be taken to ensure that windows are not damaged beyond repair in the course of this relocation. As a backup, windows in the kitchen addition (which were matched to original windows at the time of that addition's construction) will be removed and stored with original windows for use if needed.</p>

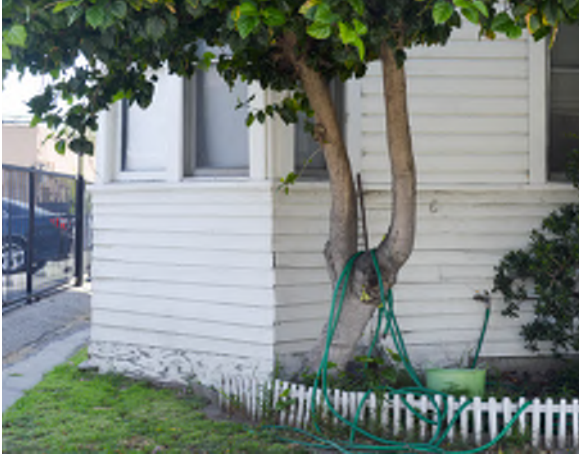
<p>Box-Bay Window on Northwest Corner, View East</p>	<p>The Box-Bay window is consistent with the Stick Style, popular during the period of historic significance. The Box-Bay window consumes the northwest corner of the first story of the building, and contains four windows which are vertically-oriented.</p>	<p>Relocation Preparation</p> <p>Rehabilitation</p>	<p>Prior to disassembly, windows within the Box-Bay window should be removed and their openings framed with wood supports to reduce risk of damage. Alternatively, windows may stay in place with wood bracings with the consent of the City of Long Beach. After relocation, waterproofing around window edges should be replaced with new which does not visually disrupt the features of the building, and window frames should be cleaned prior to installation. Any windows which have suffered broken glass should be fitted with contemporary tempered glass.</p>	<p>Following Standards for Rehabilitation, damaged windows will be repaired rather than replaced. Extensive care and caution will be taken to ensure that windows are not damaged beyond repair in the course of this relocation. As a backup, windows in the kitchen addition (which were matched to original windows at the time of that addition's construction) will be removed and stored with original windows for use if needed.</p>

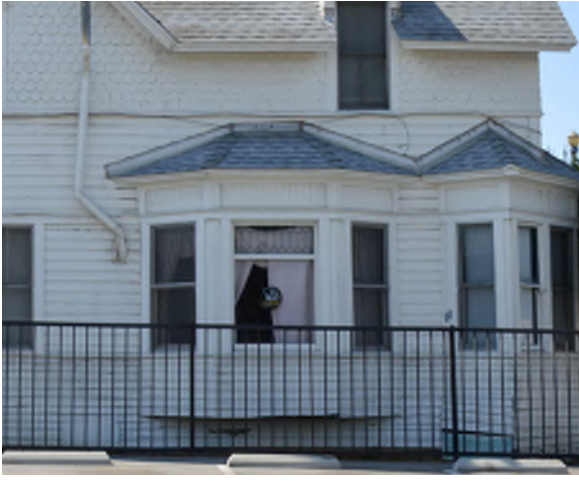
<p>Feature Observed on North Elevation, View South</p>	<p>On the North elevation of the building is a grouping of three windows. This grouping is comprised of one primary window with a decorative leaded glass inlay in the upper portion, flanked on either side by a vertically-oriented rectangular window. Above this grouping of windows are ornamental wood panels.</p>	<p>Relocation Preparation</p> <p>Reassembly</p> <p>Rehabilitation</p>	<p>All ornamental wood panels on the exterior, including those above the Box-Bay window, should be retained. Damaged wood portions within the panels should be replaced by new, compatible in size and material. The panels and their surrounds should be repainted to match the building's original color scheme. Treatment direction for this window bay should follow the direction for treatment regarding the Box-Bay window.</p>	<p>Following the Secretary's Standards for Rehabilitation, damaged wood panels and wood elements of this feature will be repaired rather than replaced when possible. When replaced, the new materials will match the original in design, color, texture, and (if possible) material. Replaced shingles and clapboard siding will be painted to match existing.</p>

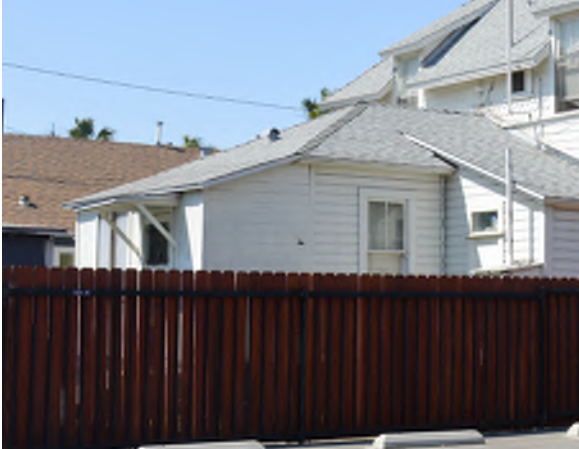
<p>Addition on East Elevation, View Southwest</p>	<p>The addition was added to the building on its current site, and is believed to have been constructed in 1921 when the residence was divided into separate units. The addition has consistent cladding to ensure it is visually compatible with the main body of the residence. This included the use of windows consistent in size and design with those observed throughout the residence. This effort is purely on the exterior, however, as interior detailing in the kitchen is simplistic and does not draw from historic features observed throughout other interior spaces.</p>	<p>Relocation Preparation</p>	<p>The proposed project will involve the demolition of this addition on the present site prior to relocation. The addition will be separated from the main body of the residence. Windows will be removed and other cladding and materials will be removed for reuse during rehabilitation if needed. Following relocation of the main body of the residence, the addition will be demolished along with the existing foundation at the present site. The void in the building's main body will be filled with compatible construction as illustrated in Attachment F.</p>	<p>The Secretary's Standards for Rehabilitation state that additions and which have gained historic significance in their own right should be preserved. However, extensive research has not yielded reason to believe this addition has gained historic significance, beyond age alone. Its relocation will require an additional move and will be costly. Due to its lack of significance and already tenuous project constraints, the project team has elected not to pursue its relocation.</p>

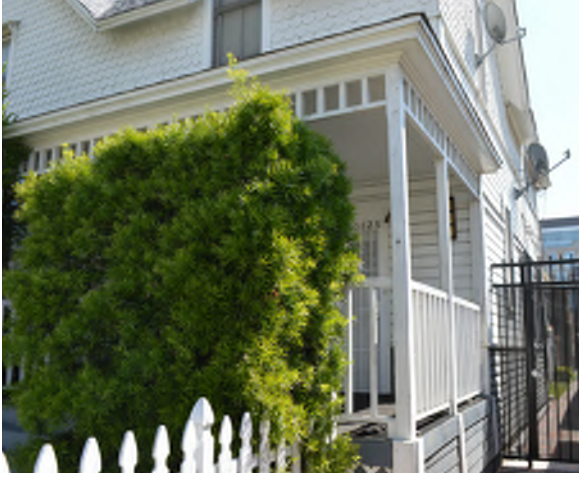
<p>Porch on West Elevation, View Northeast</p>	<p>The wood porch on the primary elevation is simplistic, following plain aesthetics popular of Single Style around the date of construction. The porch is comprised of minimal posts with a simplistic fence, as well as a simplistic frieze comprised of rectangular wood components which line the roof above.</p>	<p>Relocation Preparation</p> <p>Relocation</p> <p>Reassembly</p> <p>Rehabilitation</p>	<p>Prior to relocation, the porch will be wood-framed vertically and with cross-beams between each post to ensure structural integrity throughout the move. In rehabilitation, damaged porch materials will be repaired where possible and replaced with like materials where necessary. A new hand railing will be constructed on the right side of the staircase, modeled after the existing railing on the left as it exists prior to relocation. As part of an exterior restoration, the porch and all of its components should be painted to match the building's original color scheme.</p>	<p>Following the Secretary's Standards for Rehabilitation, damaged wood components of this feature will be repaired rather than replaced when possible. When replaced, the new materials will match the original in design, color, texture, and (if possible) material. Replaced materials will be painted to match existing.</p>

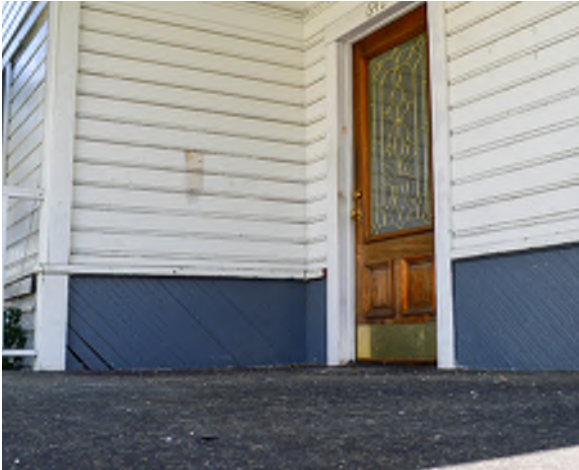
<p>Wood Paneling on Porch Interior, View Northeast</p>	<p>Diagonal wood paneling is observed throughout the porch interior. The paneling is in poor condition. It is unknown if this paneling is original to the building, or if it was installed to repair cuts to the building's lower portion after relocation to its present site.</p>	<p>Rehabilitation</p>	<p>After relocation, any portion of diagonal wood paneling which remains intact should be retained and repainted in accordance with the determined original color scheme of the building. Any material damaged beyond repair due to necessary cuts in the building or due to damage incurred during the building move may be replaced with new material cut and sized to match.</p>	<p>Following the Secretary's Standards for Rehabilitation, damaged wood components of this feature will be repaired rather than replaced when possible. When replaced, the new materials will match the original in design, color, texture, and (if possible) material. Replaced materials will be painted to match existing.</p>

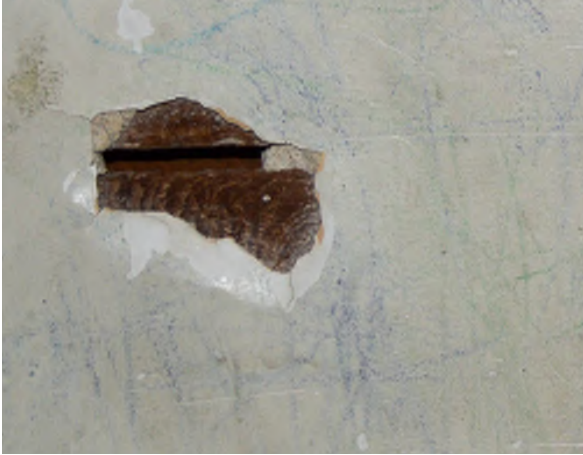
<p>Exposed Lath and Plaster on Interior</p>	<p>The interior walls are made of wood lath with plaster. Plaster is roughly 0.25 to 0.5 inches deep. The plaster is in fair condition in nearly all rooms throughout the building, and has separated from the wall where lath is exposed in some instances.</p>	<p>Relocation Preparation</p> <p>Rehabilitation</p>	<p>It is likely that lath and plaster wall structures will be severely compromised throughout the course of relocation. Restoration of these features will be costly and intensive. The replacement of these materials with in-kind is financially infeasible for the project. Though plaster repair may be performed in select areas where feasible, the majority of the building's interior will be re-clad with drywall in lieu of lath and plaster to replace damaged portions of interior walls.</p>	<p>Following the Secretary's Standards for Rehabilitation, damaged components of this feature will be repaired rather than replaced when possible. When replaced, the new materials will match the original in design and color. Replaced materials will be painted to match existing.</p>

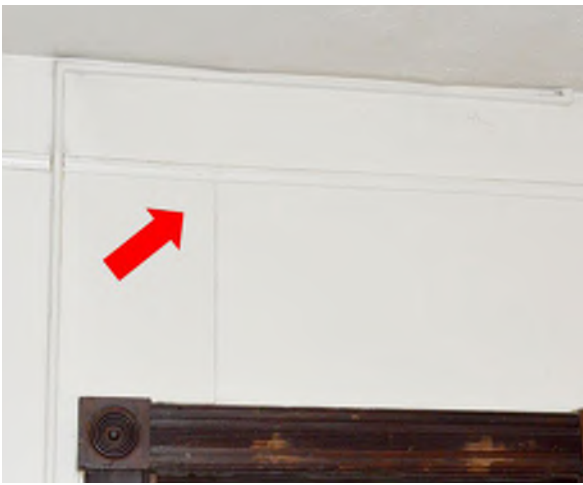
<p>Interior Picture Rail Molding</p>	<p>Roughly 1 foot from parlor room ceilings runs a narrow band of wood picture rail molding, originally used to hang artwork and portraits in lieu of damaging plaster walls. The wood band runs from the fireplace edge around the Box-Bay window, and is raised from the wall.</p>	<p>Rehabilitation</p>	<p>Picture rail molding will be retained throughout the course of rehabilitation. If plaster walls housing picture molding are damaged beyond repair as a result of relocation, new picture rail matching the original in size and shape will be installed atop new drywall to effectively continue this historic feature.</p>	<p>Following the Secretary's Standards for Rehabilitation, damaged components of this feature will be repaired rather than replaced when possible. When replaced, the new materials will match the original in design and color. Replaced materials will be painted to match existing.</p>

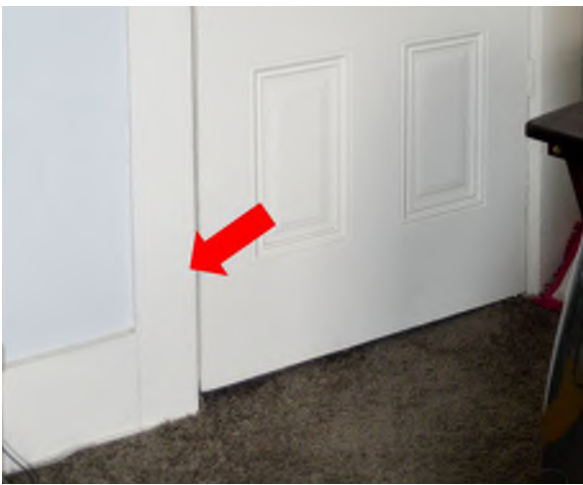
<p>Feature as Observed Throughout Interior</p>	<p>Wood baseboards, 6 inches wide, and door frames, 4 inches wide, are noted throughout upstairs and downstairs. These wood components are simplistic and in most cases bear no ornament. Many of have been painted.</p>	<p>Rehabilitation</p>	<p>Upstairs baseboards will be compromised by the act of disassembly, and will not be salvageable during the rehabilitation process. Downstairs baseboards and door frames should be cleaned and painted as appropriate following relocation.</p>	<p>Following the Secretary's Standards for Rehabilitation, damaged components of this feature will be repaired rather than replaced when possible. When replacement is chosen as the course of action, the new materials will match the original in design and color. Replaced materials will be painted to match existing.</p>

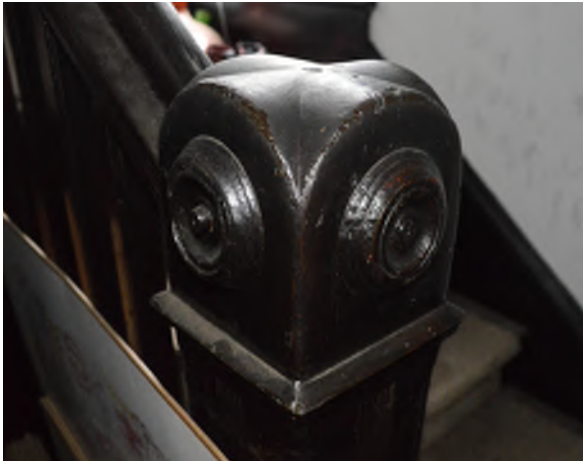
<p>Staircase Ornamentation</p>	<p>The staircase provides access to the second story of the residence, and originally would have been accessible from the foyer before division of the residence in 1921. The staircase railing is in fair condition, but stair runs are unstable. It is unpainted. The first floor stair post demonstrates dart detailing consistent with other interior details, and originally housed a decorative orb (now missing.) On the south wall of the building, opposite the stair railing, are decorative wood baseboards which also span the length of the staircase.</p>	<p>Rehabilitation</p>	<p>It is recommended that wood throughout the staircase be stripped of finishing with care not to damage historic fabric. Following removal of varnish and other elements, wood should be lightly sanded, stained, and sealed if appropriate to match current stain. Sanded portions of the stair railing should be stained and varnished to match the existing color of undamaged portions of the stair railing. New wood will be used to rebuild stairs throughout the staircase.</p>	<p>Following the Secretary's Standards for Rehabilitation, damaged wood components of this feature will be repaired rather than replaced when possible. Replaced stairs will be consistent in finish with the railing. Lost aspects of the feature, such as the decorative orb, will not be replaced using conjecture.</p>

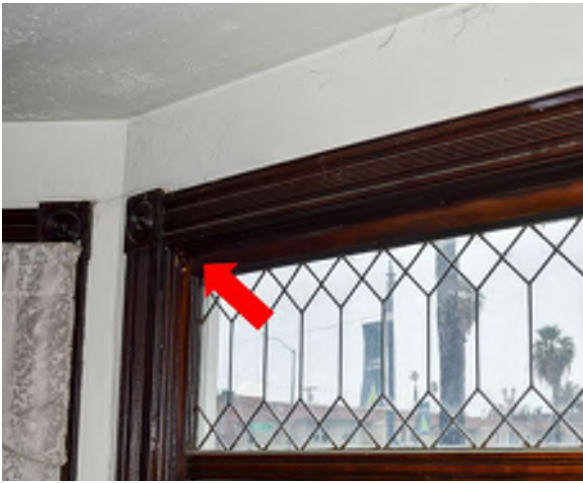
<p>Feature Observed in First Floor Entertaining Area</p>	<p>Throughout the building, dart ornamentation is observed above wood windows. While this ornamentation is painted in one instance, it is unpainted and original in the remainder of its occurrences.</p>	<p>Rehabilitation</p>	<p>Window frames and ornamentation will be stripped of finishing with care not to damage historic fabric. Following removal of varnish and other elements, holes in window ornamentation and surrounding window frame areas should be filled with suitable wood filler, and then wood should be lightly sanded, stained, and sealed if appropriate to match current stain. Painted window frames may receive a new coat of paint, and unpainted frames should be stained and varnished to match the existing color of undamaged portions of the frame.</p>	<p>Following the Secretary's Standards for Rehabilitation, any window frames damaged throughout the course of relocation will be repaired rather than replaced when possible. When replaced, the new materials will match the original in design, color, and texture. Replaced materials will be painted or treated to match existing.</p>

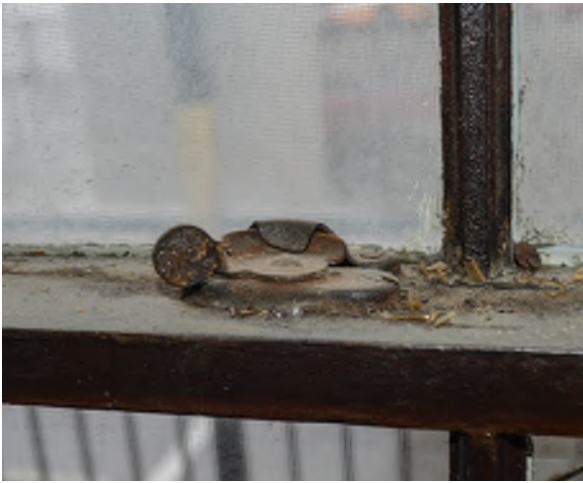
<p>Window Hardware Observed Throughout Residence</p>	<p>Bevel sash locks are used throughout the residence as a security feature on single-hung wood windows. In most cases, these locks are unpainted metal. However, some locks have been painted. Locks are generally in poor condition.</p>	<p>Rehabilitation</p>	<p>Where salvageable, existing locks should be repaired, cleaned with a non-abrasive cleaning agent, and reinstalled throughout the course of rehabilitation. If insecure and beyond repair, new production Bevel sash locks should be utilized as a replacement.</p>	<p>Following the Secretary's Standards for Rehabilitation, any window frames and their hardware damaged throughout the course of relocation will be repaired rather than replaced when possible. When repaired, abrasive agents or agents which may damage the historic material will not be used. When replaced, the new materials will match the original in design, color, and texture.</p>

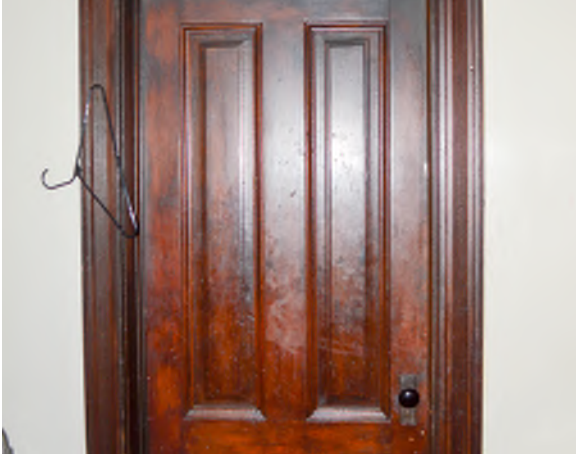
<p>Interior Wood Panel Door</p>	<p>Wood panel doors are observed throughout the interior. These doors, original to the building, are identified by the placement of two inset wood panels, rectangular in nature, which run vertical down the upper two thirds of the door surface. The lower two thirds of the door surface contains two inset wood panels of smaller rectangular nature. Several of these doors remain, however only two are unpainted.</p>	<p>Rehabilitation</p>	<p>Wood panel doors will be stripped of finishing with care not to damage historic fabric. Following removal of varnish and other elements, holes in wood panel doors should be filled with suitable wood filler, and then wood should be lightly sanded, stained, and sealed if appropriate to match current stain. Painted wood panel doors may receive a new coat of paint, and those unpainted should be stained and varnished to match the existing color.</p>	<p>Following the Secretary's Standards for Rehabilitation, any doors damaged throughout the course of relocation will be repaired rather than replaced when possible. When replaced, the new materials will match the original in design, color, and texture. Replaced materials will be painted or treated to match existing.</p>

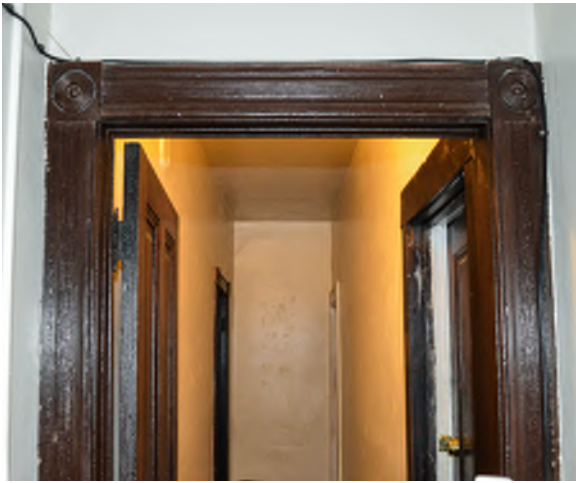
<p>Interior Door Frame Ornamentation</p>	<p>Wood door frames with ornamental dart and carvings are observed throughout the interior, and are particularly prevalent in areas that would have been used for entertaining guests in the Parsonage during its period of significance. These door frames are original to the building.</p>	<p>Rehabilitation</p>	<p>It is recommended that door frames and ornamentation be stripped of finishing with care not to damage historic fabric. Following removal of varnish and other elements, holes in ornamentation and surrounding door frame areas should be filled with suitable wood filler, and then wood should be lightly sanded, stained, and sealed if appropriate to match current stain. Painted door frames may receive a new coat of paint, and unpainted frames should be stained and varnished to match the existing color of undamaged portions of the frame.</p>	<p>Following the Secretary's Standards for Rehabilitation, any door frames damaged throughout the course of relocation will be repaired rather than replaced when possible. When replaced, the new materials will match the original in design, color, and texture. Replaced materials will be painted or treated to match existing.</p>

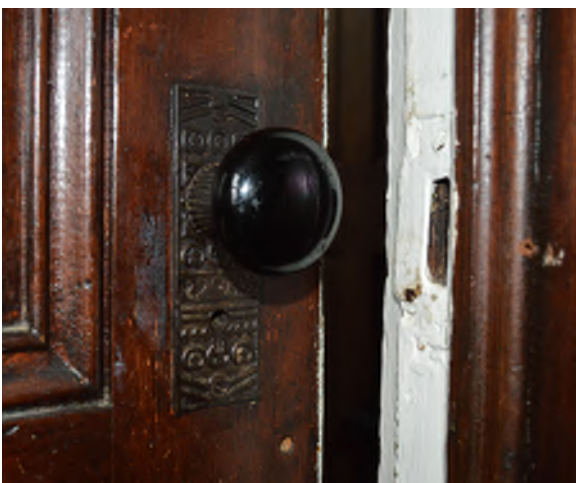
<p>Original Door Hardware</p>	<p>Original door hardware is observed on four doors throughout the residence. In the first story, this hardware is found on the entrance door to the hallway, which would have greeted guests, and on the door to a room off of the dining area, which would have been used for entertaining. This door hardware is ornate in nature and contains a decorative backplate with lock and porcelain door knob. Upstairs door hardware is observed in two instances. In both instances, door knobs have been painted and are accompanied by simplistic backplates.</p>	<p>Rehabilitation</p>	<p>Original door hardware on the first story should be retained and reused following relocation in the rehabilitation of the building. Door hardware on the second story may be reused if desired by the property owner. However, it is in poor condition. If desired, this hardware may be replaced.</p>	<p>Following the Secretary's Standards for Rehabilitation, any damaged door hardware will be repaired rather than replaced when possible. When repaired, abrasive agents or agents which may damage the historic material will not be used. When replaced, the new materials will match the original in design, color, and texture.</p>
