COLOR ANALYSIS STUDY

Exterior
of the
8TH AND PINE BUILDING
located at
118 East 8TH Street
Long Beach, California 90802

Report prepared by
Carolyn Lehne

August 17, 2015

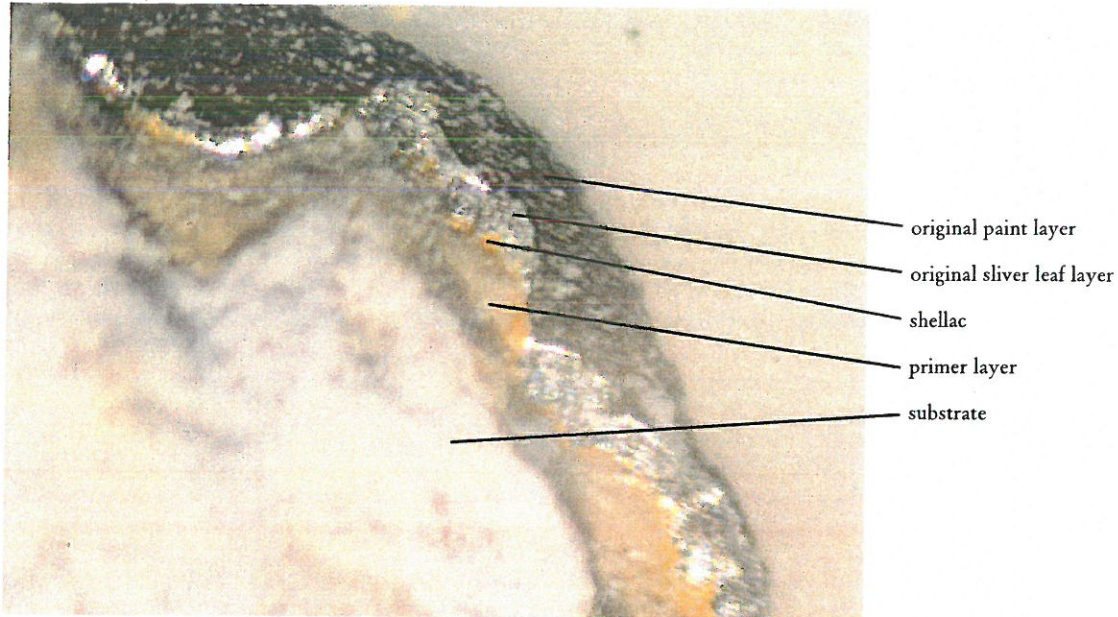
SAMPLE #1 DECORATIVE ARCH MAIN STENCIL

The first sample (SAMPLE #1) located on the decorative arch had several layers of paint. The first paint layer is a taupe/grey color followed by a shellac and a silver leaf. The black areas also have a black over the silver leaf. I found this sequence consistent in all of the samples I took.

Silver leaf was used to create the
silver details of the original finish.

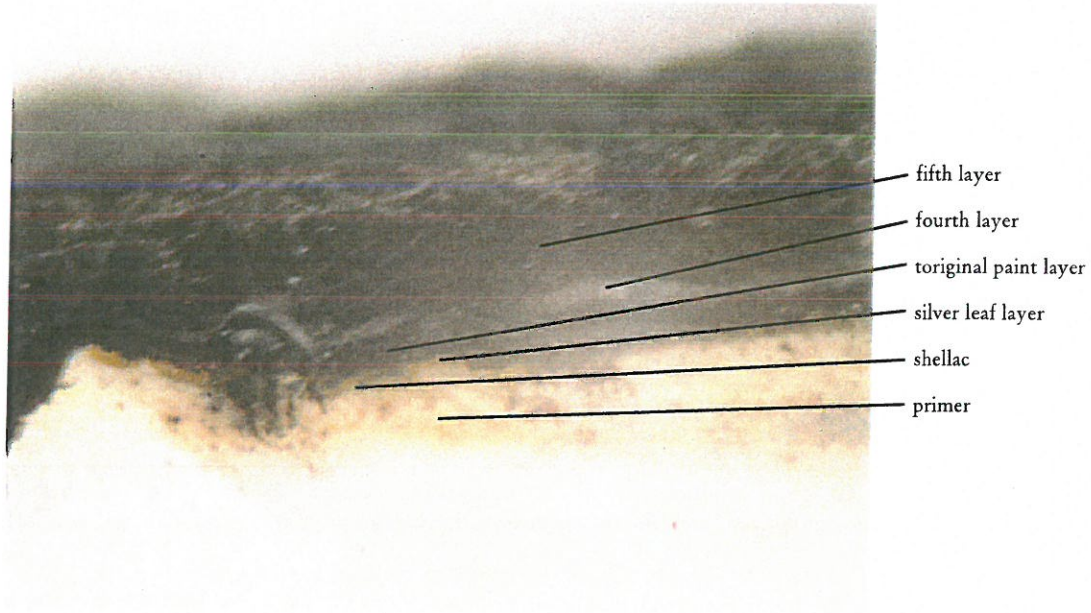
SAMPLE #1a DECORATIVE ARCH BLACK ZIGZAG

The black zig zag pattern (SAMPLE #1a) along the sides of the arch had a color sequence of taupe/grey, shellac, silver leaf, black, grey/cream and black.

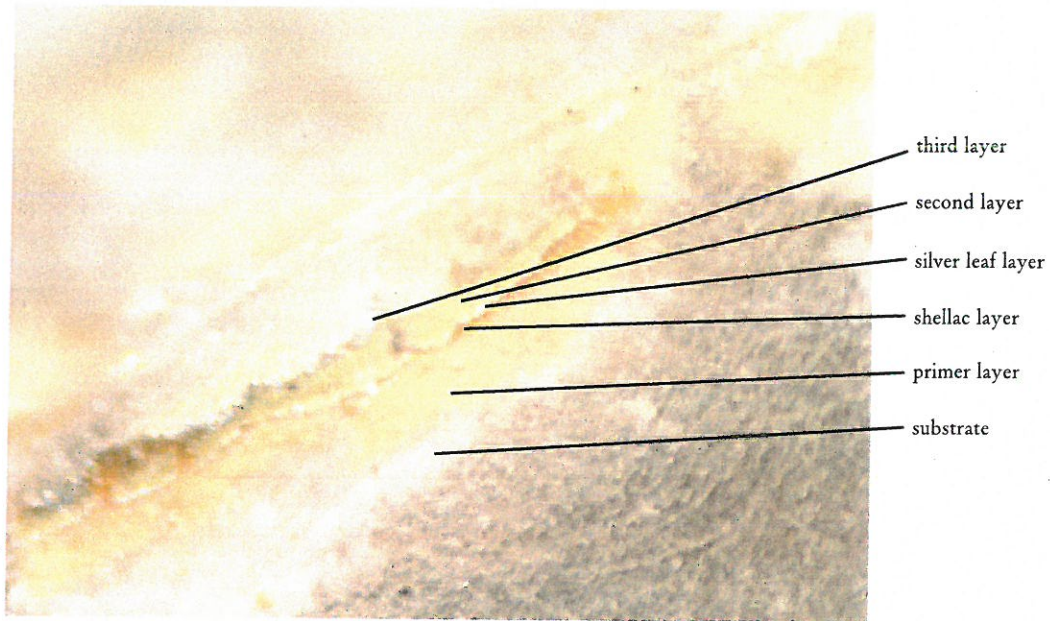
SAMPLE #1b DECORATIVE ARCH SILVER ZIGZAG

The silver of the zig zag pattern (SAMPLE #1b) in the same location has a color sequence of taupe/grey, shellac, silver leaf, grey green, and composition silver.

Silver leaf was used to create the original finish.

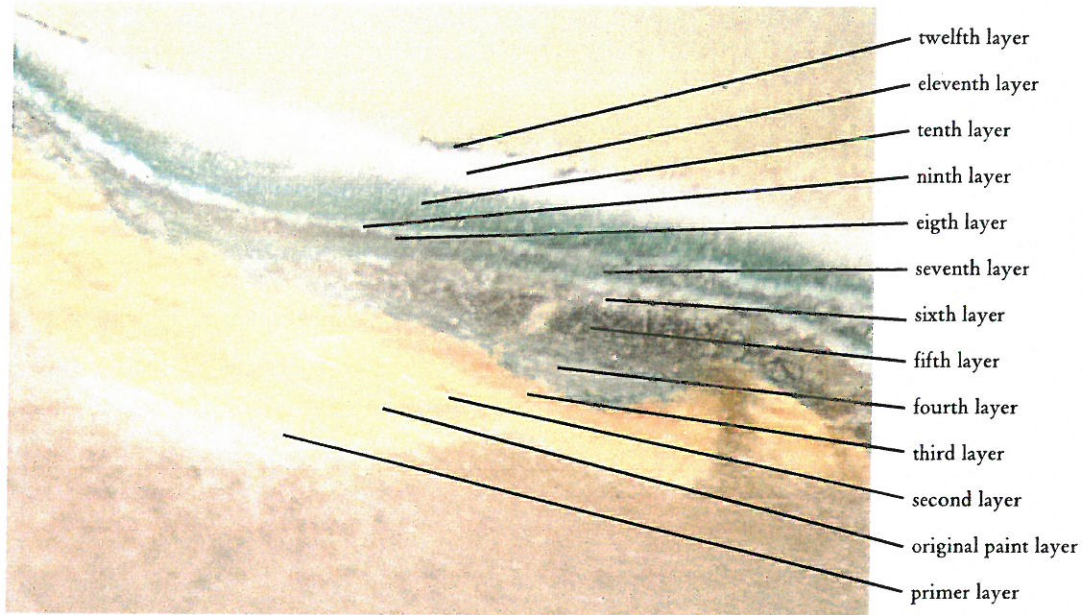
SAMPLE #2 THE WALL

The wall sample (SAMPLE #2) located in the entry and elevator lobbies consists of seven paint layers. The first layer is a taupe/grey color, followed by a beige, a cream, a peach, a deep green with a fleck in it, a black, a cool grey and a green, grey, white, green, white, and green. I found this sequence consistent in most of the samples I took. Several lacked the historic layers and went from plaster to deep green.

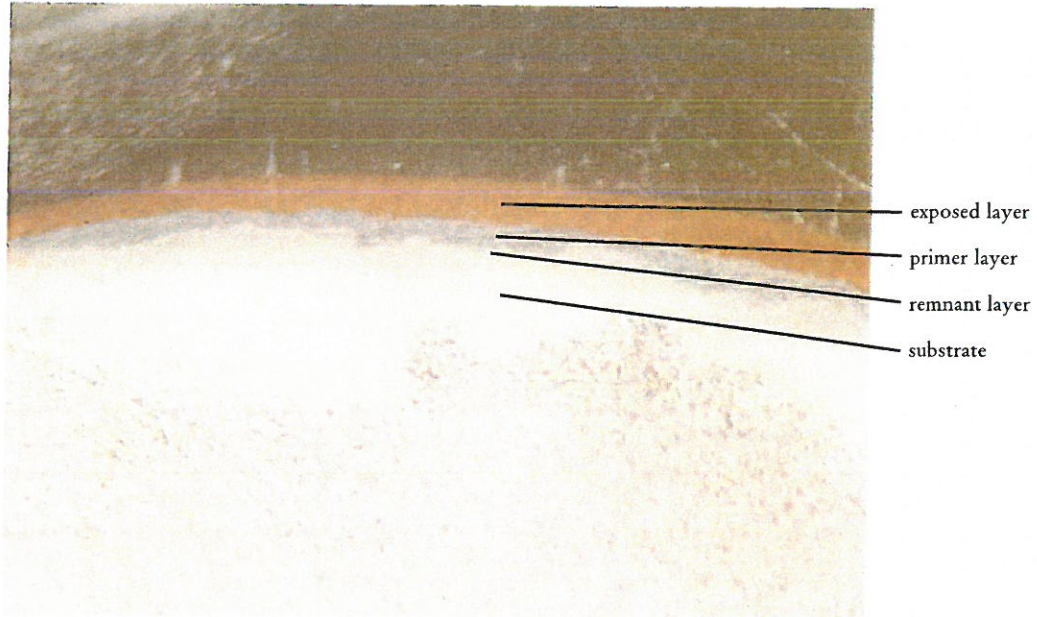
SAMPLE #3 OCHRE CEILING STEP

The other samples (SAMPLE #3) are located in the entry and elevator lobby ceilings on the dark ocher colored step detail. There is very little historic information. Between the plaster and the first paint layer, there appears to be a remnant layer of taupe/grey. This is followed by a cool grey color and the deep ocher. Both the cool grey and the visible paint color are more recent paints. The sequence was consistent with this sample and all the ceiling samples. I found a remnant layer of the taupe color throughout all the samples. The ocher and other ceiling colors had a finer pigment consistency which is typical of modern paints. The paint

layers were even throughout, also a sign of modern application. This information leads me to believe they may have been sanded and repainted in the contemporary palette we see currently.

No historic color reference.

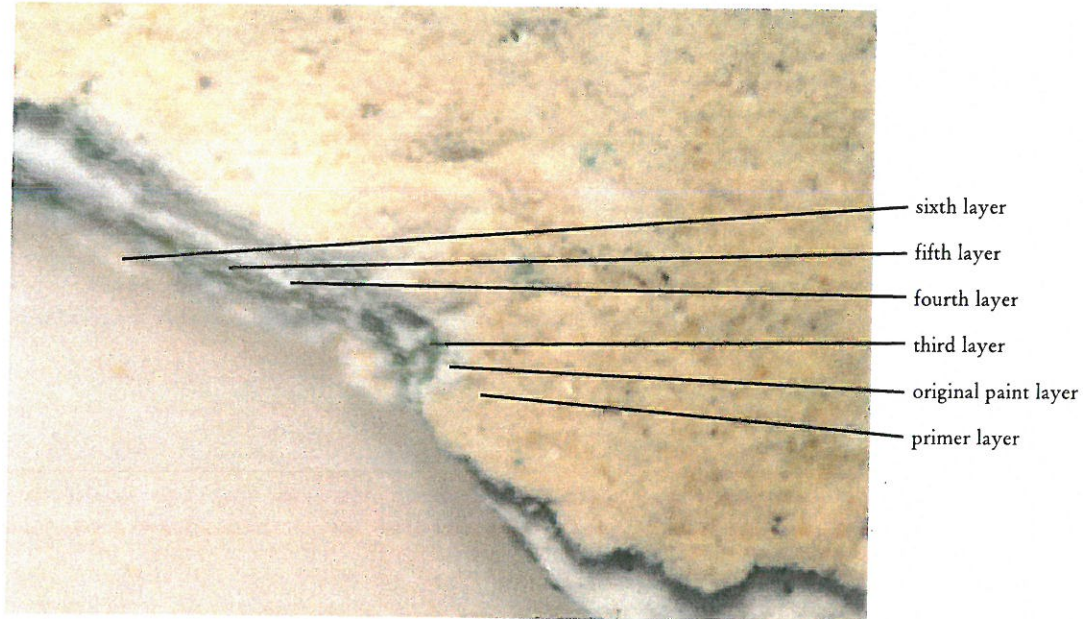
SAMPLE #4 WHITE BAND

The white band (SAMPLE #4) had several layers similar in color to the walls. The first color found was a taupe/grey, then a beige, deep green, white, green, and the exposed white. The white and the colors that followed have a finer pigment consistency which is typical of modern paints.

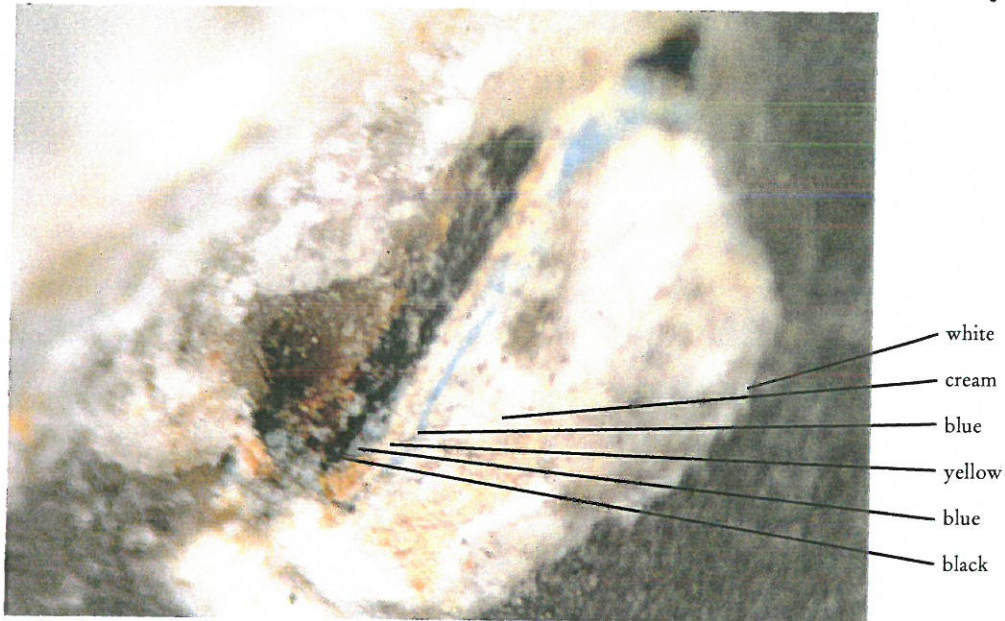
SAMPLE #1 Center Fixed Mullion

The first sample (sample #1) located on the fixed center mullion had several layers of paint. The first paint layer is a black color followed by blue, yellow, blue, cream and white. I found this sequence consistent in both of the samples I took.

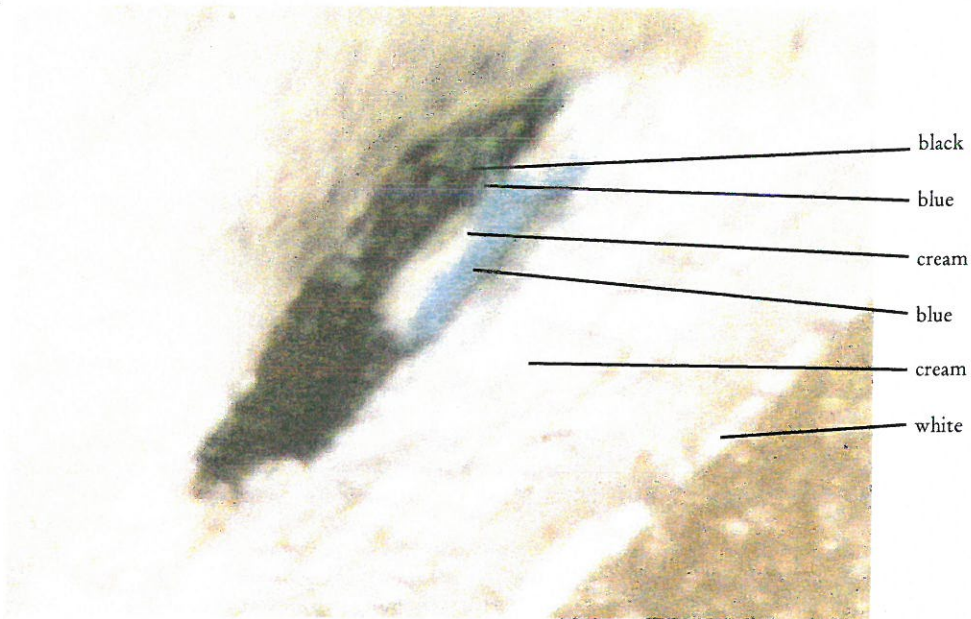
SAMPLE #2 Right Operable Window

The right operable window sample (sample #2) located on the right side rail consists of six paint layers. The first layer is a black color, followed by a blue, a cream, blue, cream, and a white. I found this sequence consistent in both of the samples I took.

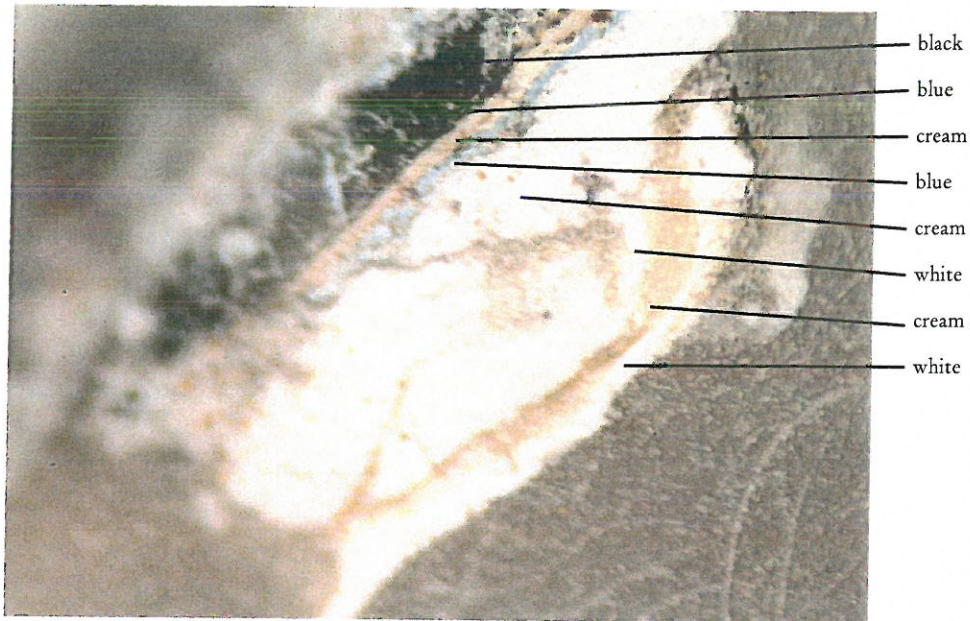
SAMPLE #3 Top Center Mullion

The top center mullion samples (sample #3) are located on the left center fixed mullion and consists of eight paint layers. The first paint layer is a black color followed by a blue color, a cream, blue, cream, white, cream and a white. This sequence was fairly consistent in both of the samples I took.

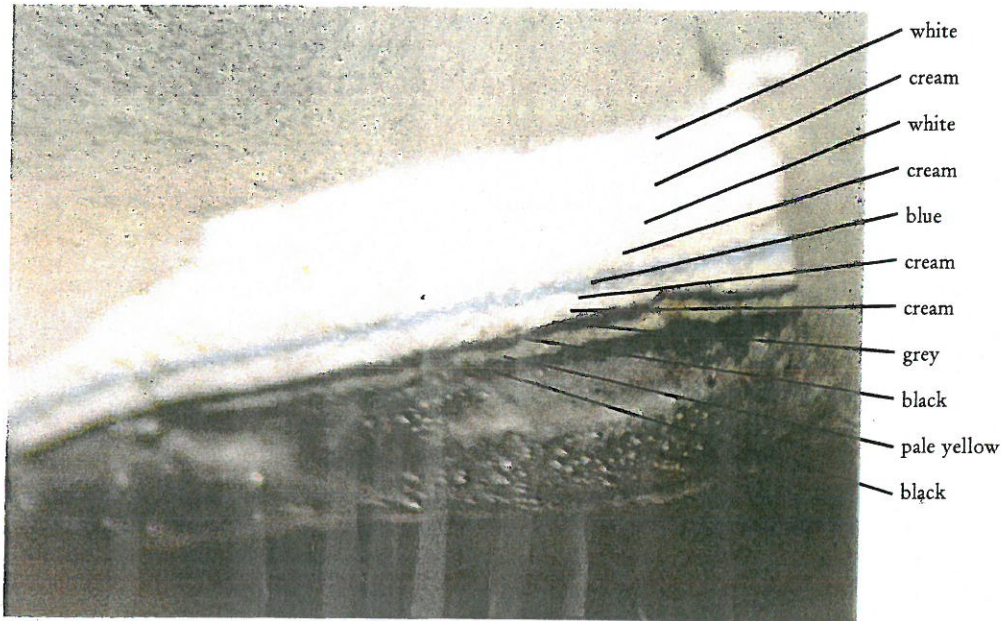
SAMPLE #4 Outside Frame

The outside frame sample (sample #4) had several layers similar in color to the rest of the samples. The first color found was a black, then a pale yellow, black, gray, cream, cream, blue, cream, white, cream, white.
