From: Miyoko Sakashita [mailto:miyoko@biologicaldiversity.org]
Sent: Tuesday, March 21, 2023 3:28 PM
To: CityClerk <CityClerk@longbeach.gov>
Subject: CBD Sources Part 1.5

REPORT OF OCCURRENCE

Subject: Cause and Prevention Plan for Surface Event SE 2011-8-8
Berry Petroleum Company, Project #46400390
Southwestern Lease, Section 2, T31S, R22E, MDBM
Midway Sunset Field
Kern County, CA

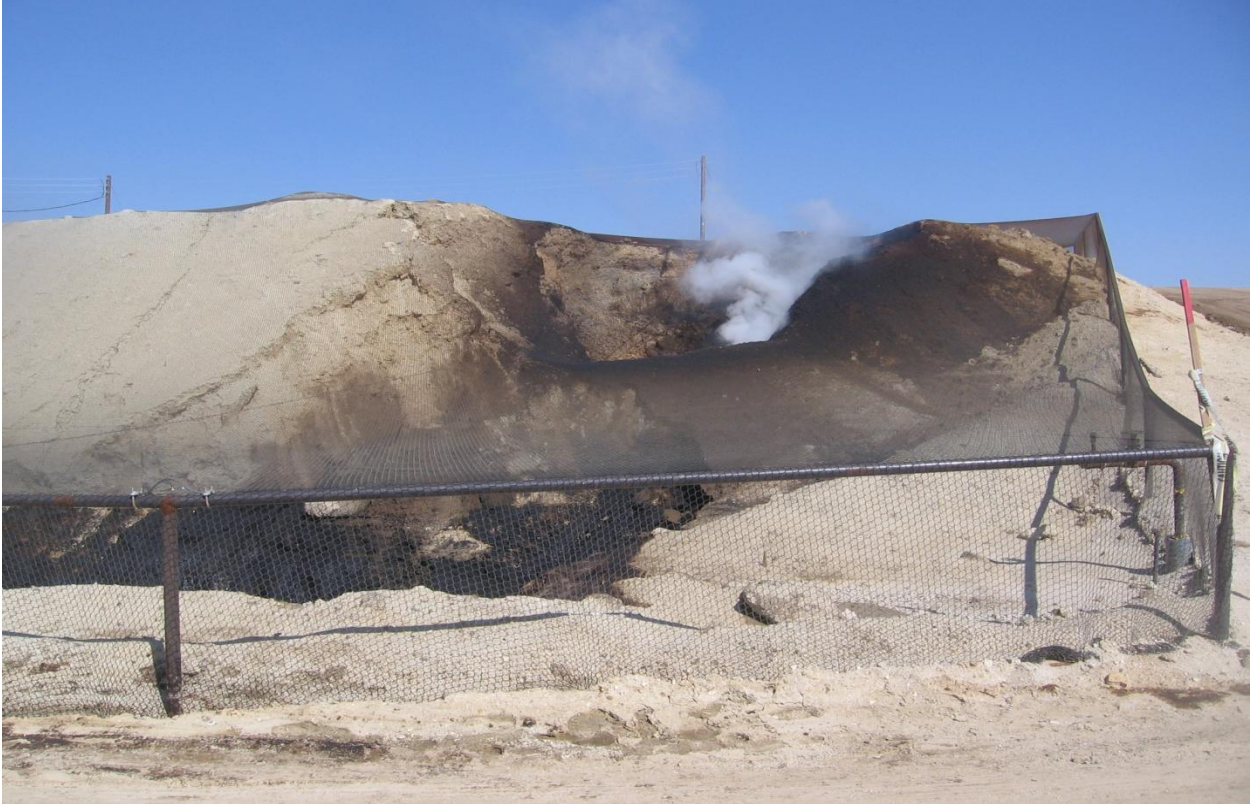
Photograph 1 - View of Well 20 surface expression site, fluid pit and associated crater on 10/11/10. Accident location is in the vicinity or to the left of crater rim.

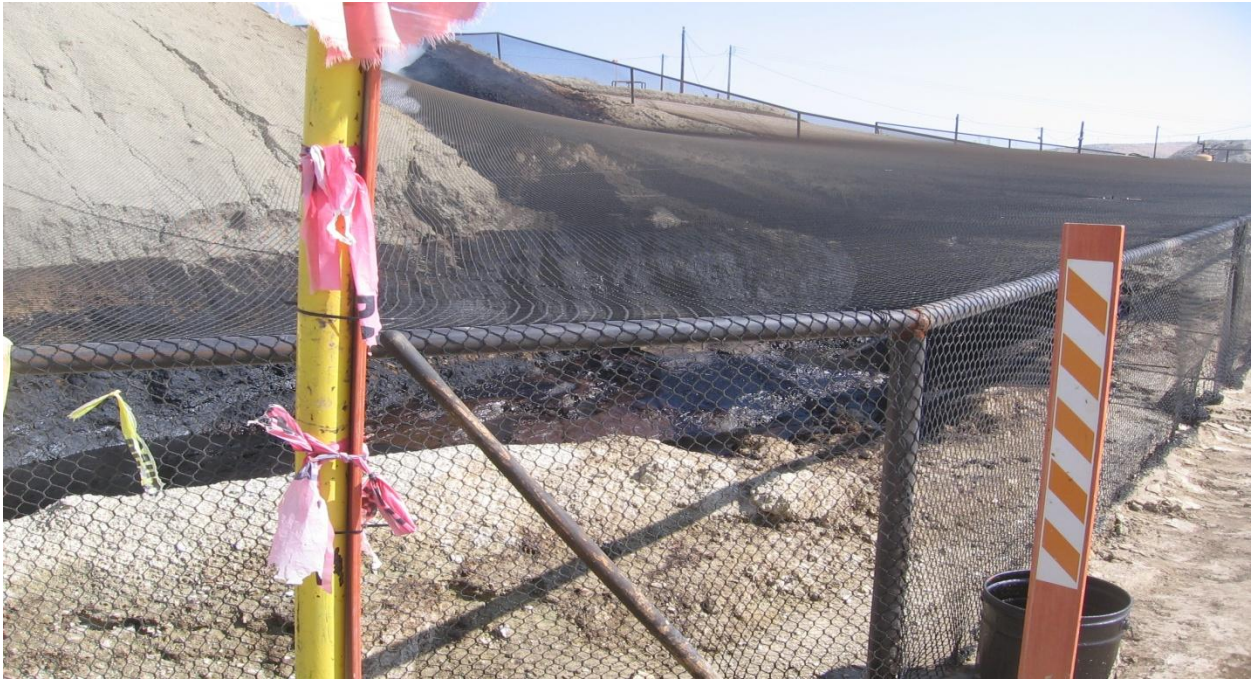
Photograph 2 - View of Chevron Well 20 surface expression site and fluid pit on 10/11/10. Location was continually active with surfacing water, oil and steam. A road at the end of the netting leads to the upper terrace.

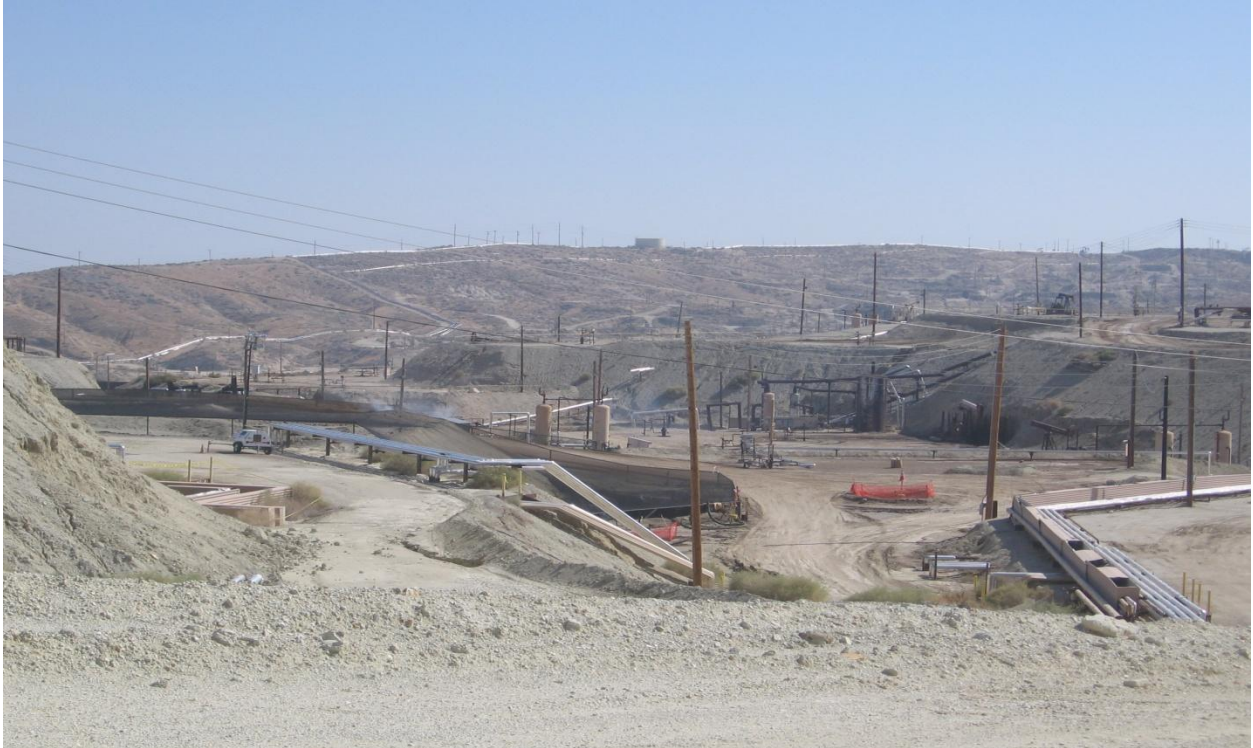
Photograph 3 - View of the Well 20 surface expression area on October 11, 2010. The crater and fluid pit are located on the lower terrace under the netting in the middle of the photograph. Netting is also seen extending around a large area on the upper terrace due to surface expression activity.

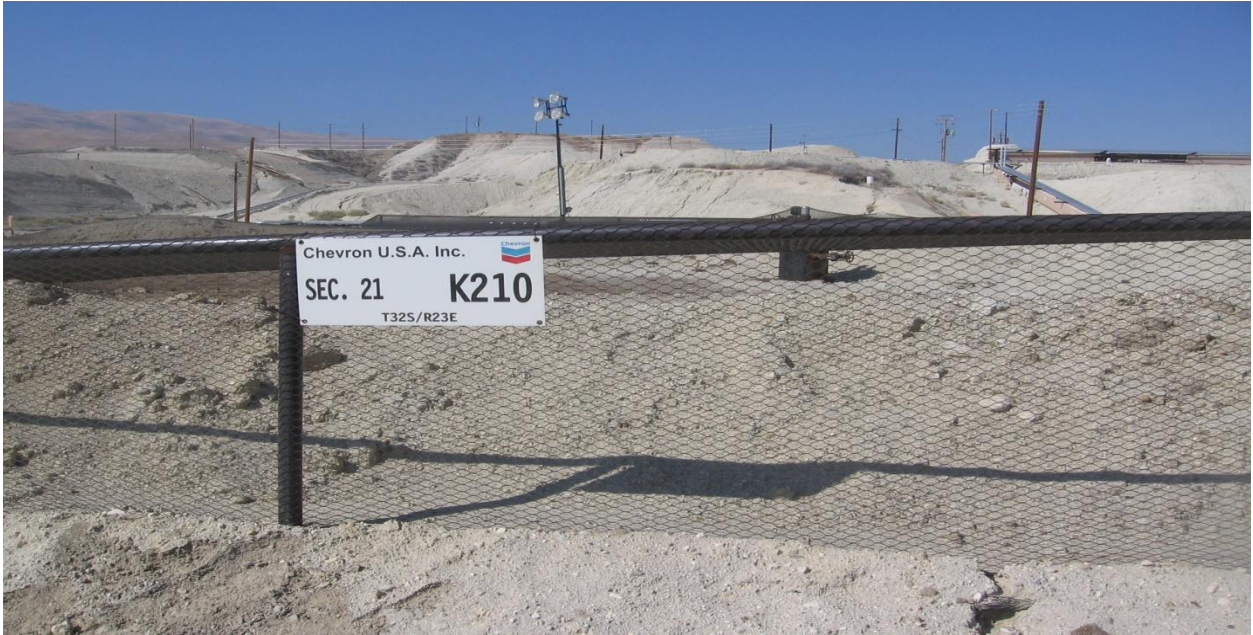
Photograph 4 - Well K210 is located on the upper terrace above the Well 20 surface expression, approximately 30' to 40' from the accident location. This area had surface expressions and was also fenced and netted. Date of photograph is October 11, 2010.

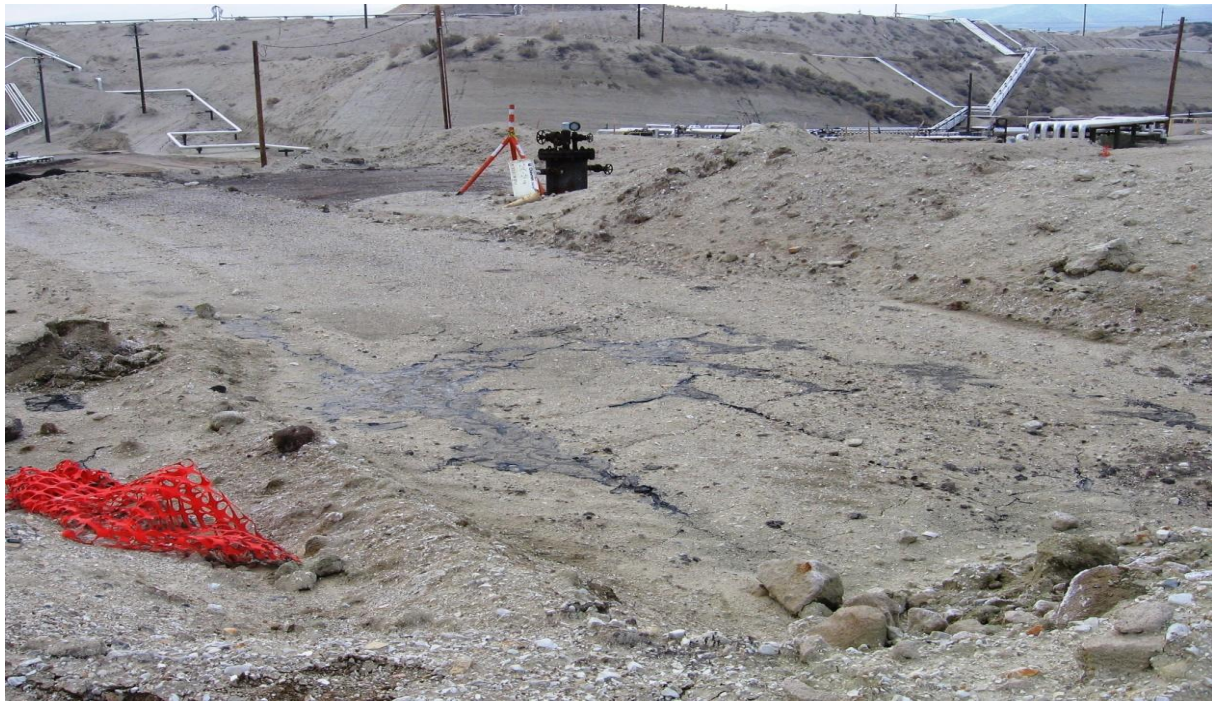
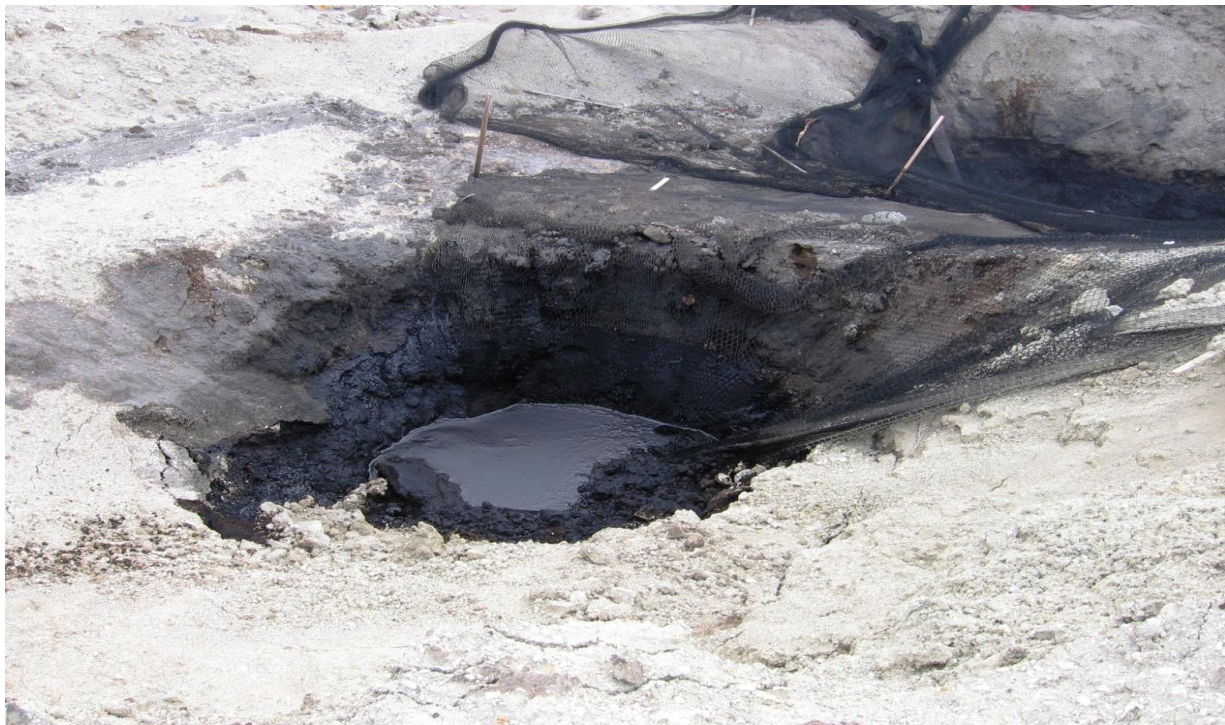
Photographs 5 and 6 – View of surface expression activity on the upper terrace near well K210 on February 16, 2010, prior to the placement of the fencing and netting.

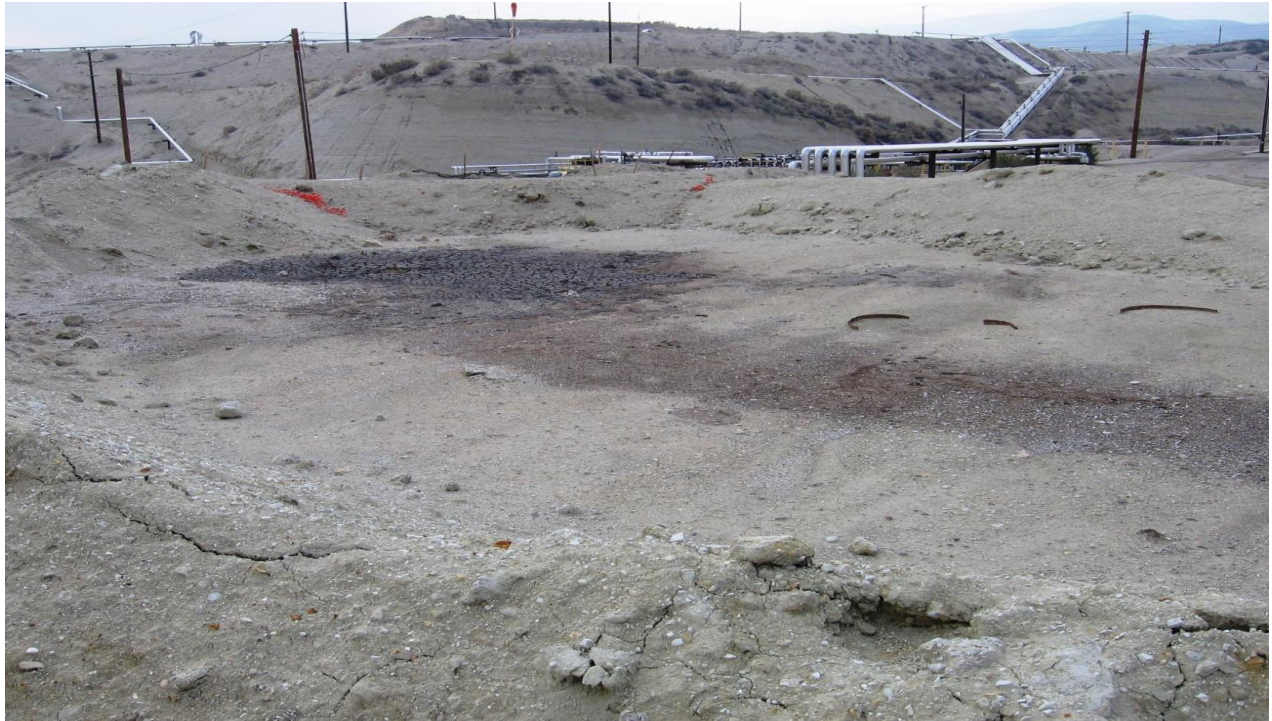
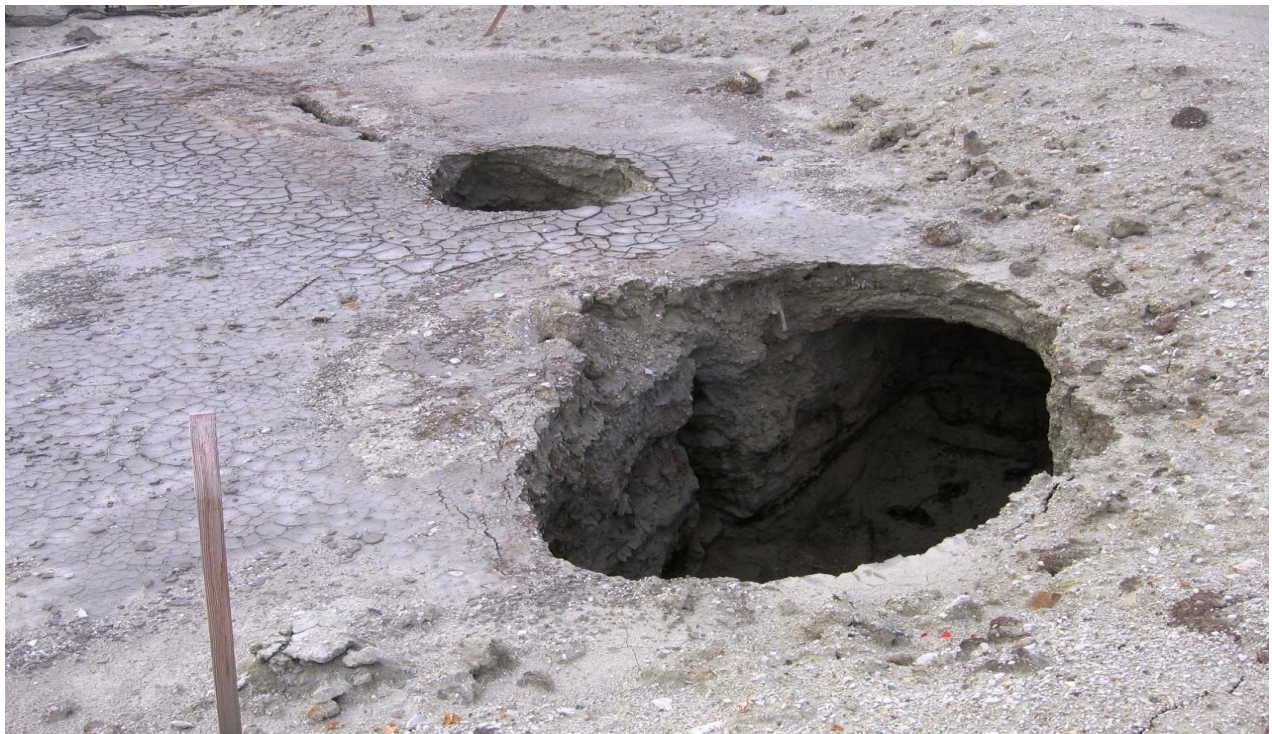
Photographs 7 and 8 – View of upper terrace surface expressions near well K210 on February 16, 2010, prior to the placement of fencing and netting.

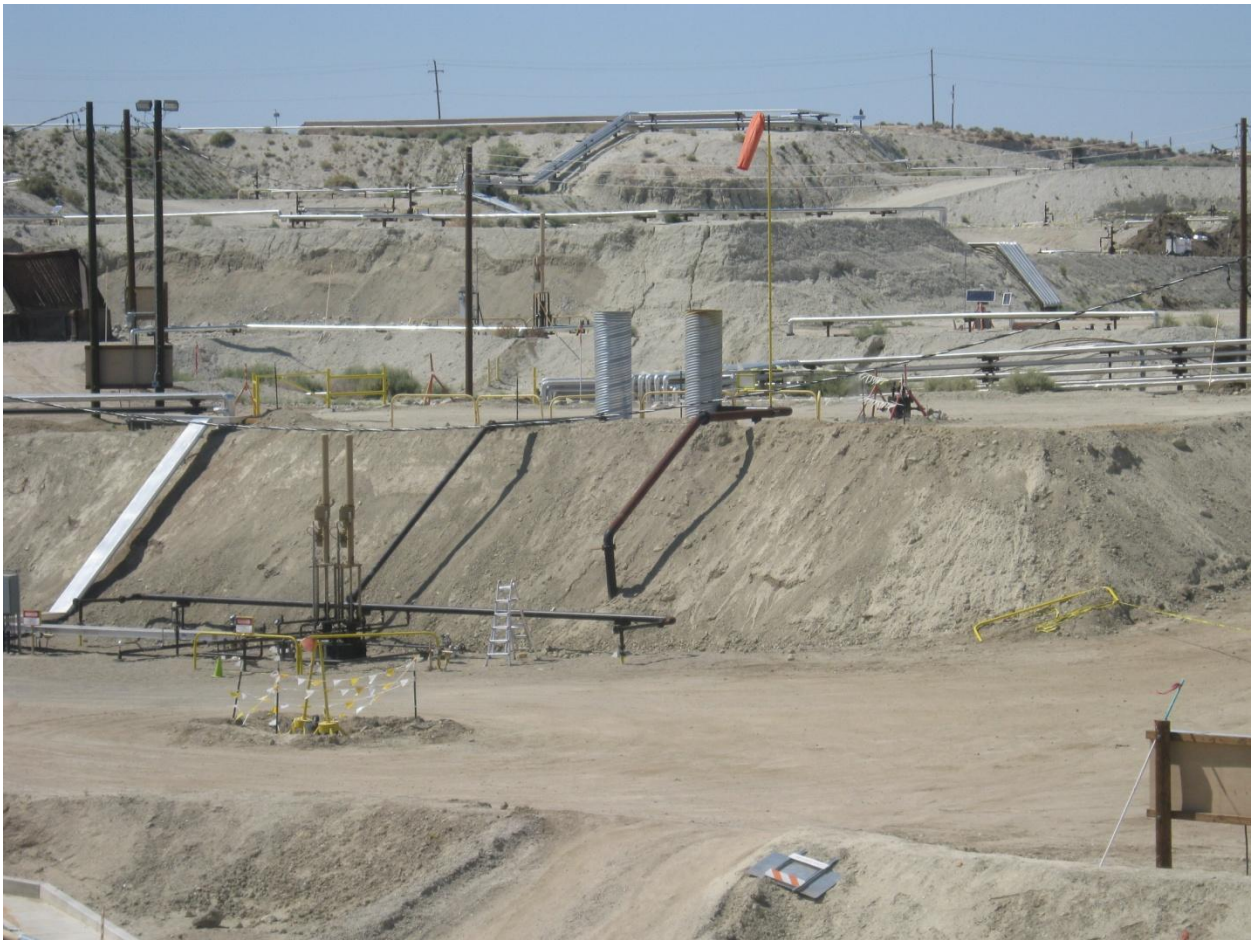
Photograph No. 9 - View of the surface equipment above the subsurface containment structure and remediated surface expression site on the day of the accident, June 21, 2011. The previous surface expression fluid pit was located at the base of the slope above where the present subsurface containment structure exists (the ladder in the picture is a good reference). The crater would have been somewhere between the right of the brown pipe running up the slope of the terrace and the corner of the upper terrace. Well K210 can be seen to the right of the yellow wind sock pole. The accident location is to the right of the wind sock pole approximately 15 feet to 20 feet, at the edge of the terrace. The two vertical cylinders on the upper terrace provide elevated steam release from the subsurface containment structure on the lower terrace. The road connecting the lower and upper terraces is at the extreme right of the picture.

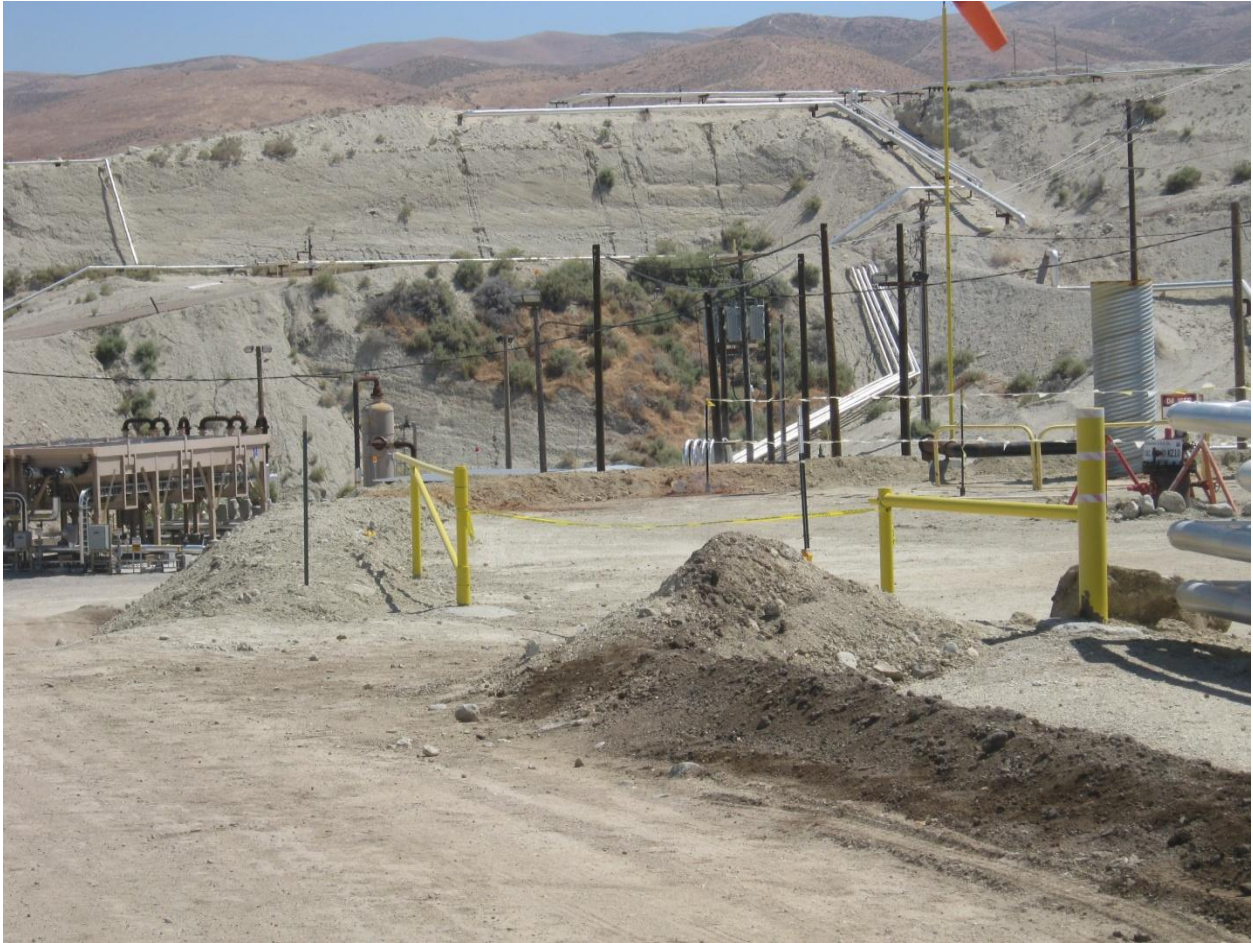
Photograph No. 10 - View of the accident site on the upper terrace overlooking the surface equipment of the subsurface containment structure and the remediated surface expression on June 21, 2011. Well K210 is located on the far right of the picture. The accident spot is 15 feet to 20 feet to the left of the yellow wind sock pole, at the base of the berm. The reddish discoloration of the bermed soil at the accident site, and the future location of the crater, is of interest and may be an early indication of steam migrating to the surface.

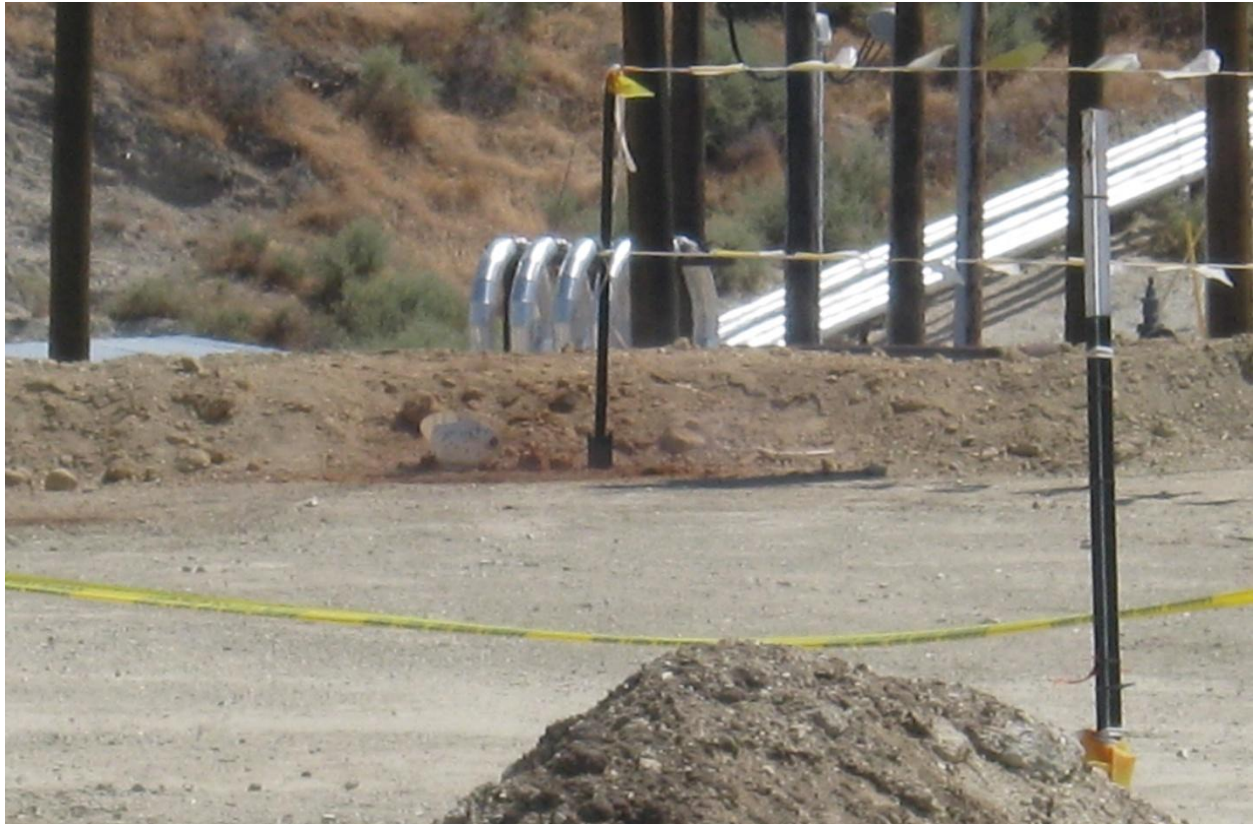
Photograph No. 11 - View of the accident spot. The victim's hard hat can be seen at the base of the berm at the edge of the sink hole.

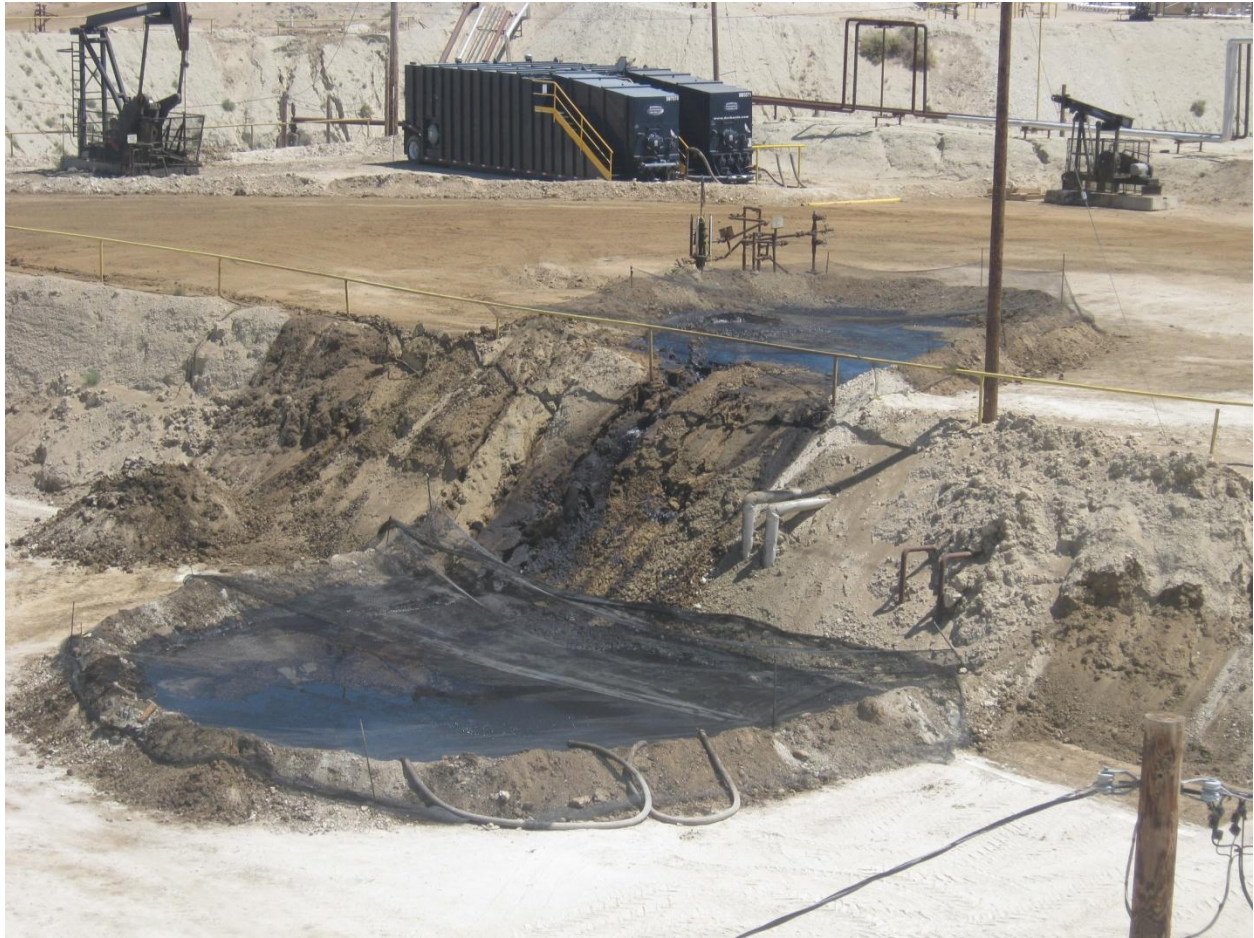
Photograph No. 12 - View of the June 22, 2011 surface expression on TRC Operating Company's "Bull" lease, section 22 T32S/R23E. Crater of the surface expression can be seen on the upper terrace above yellow horizontal guard post. Approximately 600 bbls of fluid were reportedly removed from the bermed pit in 48 hours and approximately 1000 bbls of fluid over the first week of activity. This location is approximately 400 feet from the Chevron accident site.

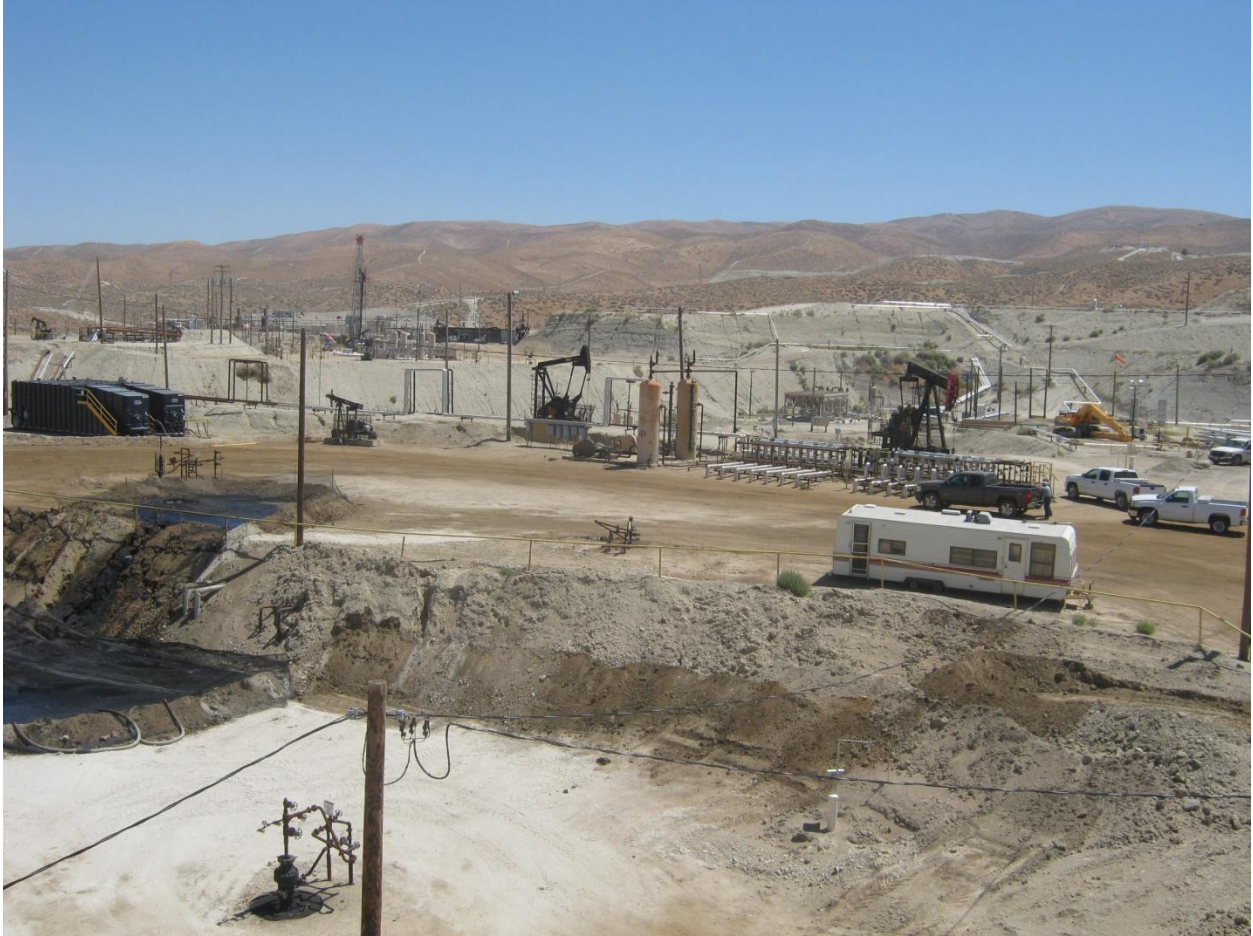
Photograph No. 13 – View of the TRC June 22 surface expression location in relationship to the June 21 Chevron accident site. The TRC surface expression is on the left and the accident site is on the right, approximately 40 yards beyond the yellow excavator, near the base of the orange wind sock’s pole. This surface expression was recorded as tilt meter event on June 22.

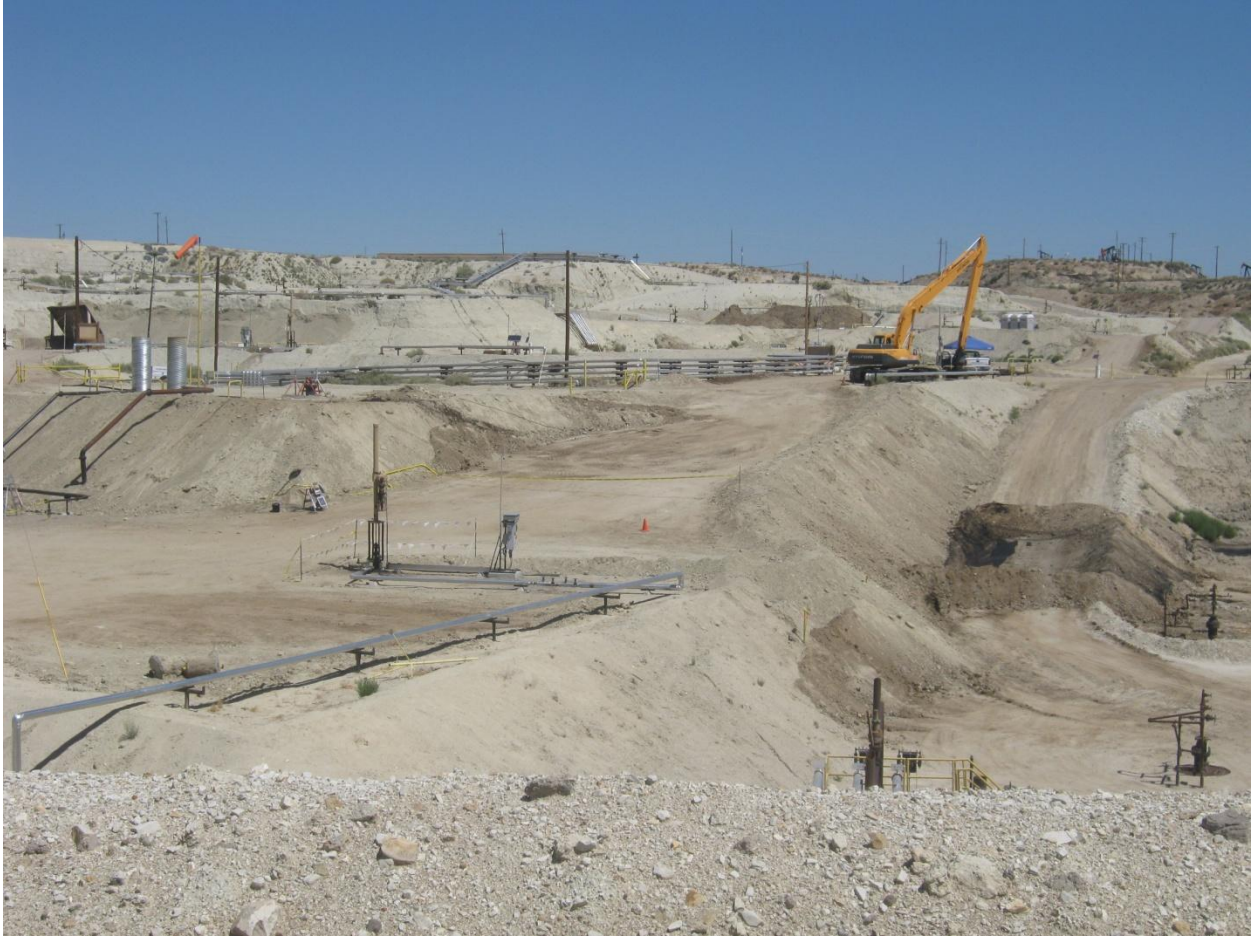
Photograph 14 – View of the June 27 reactivated surface expression location on TRC Operating Company’s “Bull” lease in relationship to the June 21 Chevron accident site and surface equipment of the subsurface containment structure. The reactivated surface expression is the bermed and netted area on the right. The accident site is 15 feet to 20 feet to the right of the wind sock pole. The surface equipment is on the left at the base of the slope. The two pipes running up the slope carry steam from the buried surface containment structure to be vented in the two silver cylinders. The boundary between Chevron and TRC is essentially the slope leading to the yellow excavator.

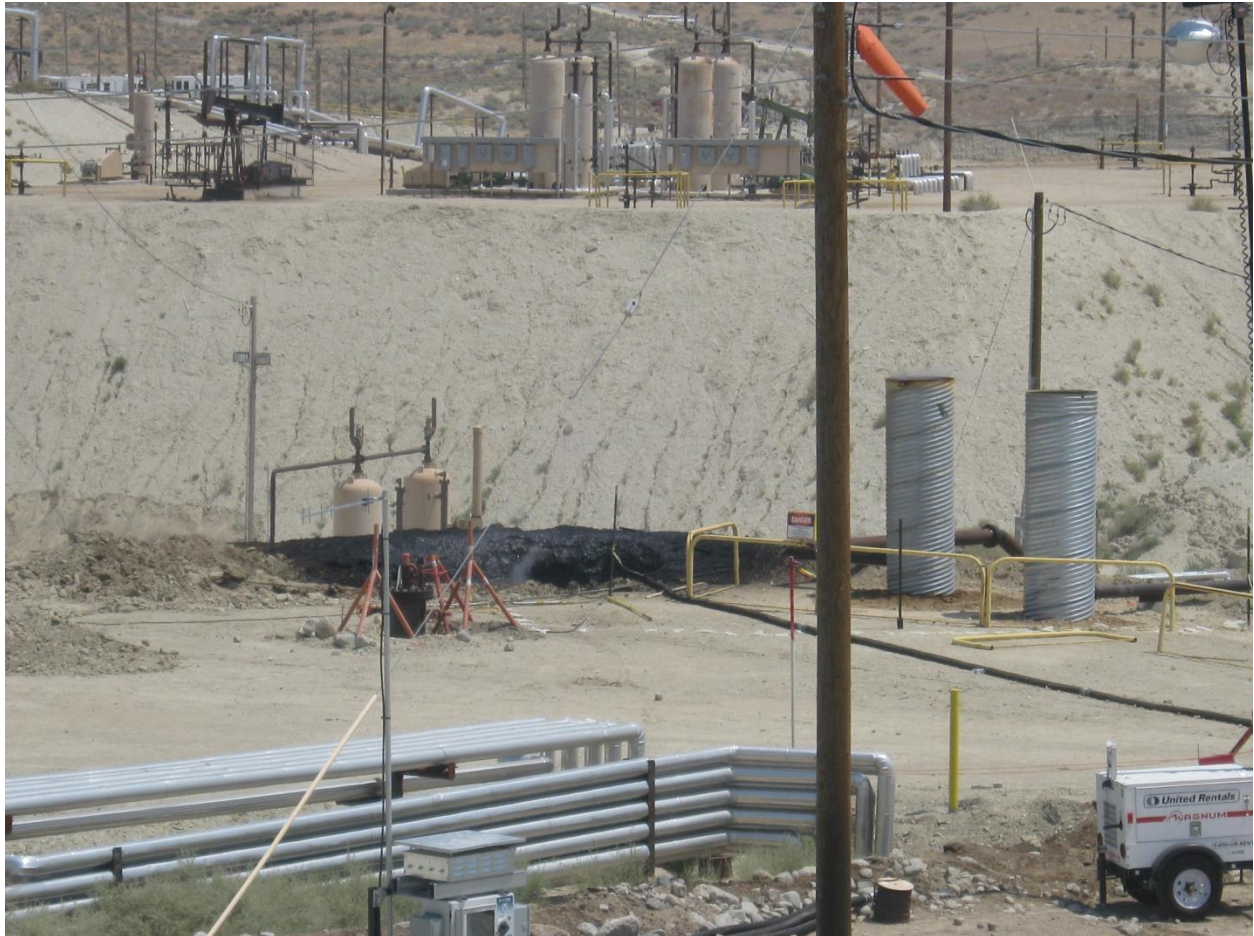
Photograph 15 – View of the Chevron accident location on July 7, 2011. The release of fluid and steam to surface had increased significantly since the June 21 accident, as well as the enlargement of the associated crater.

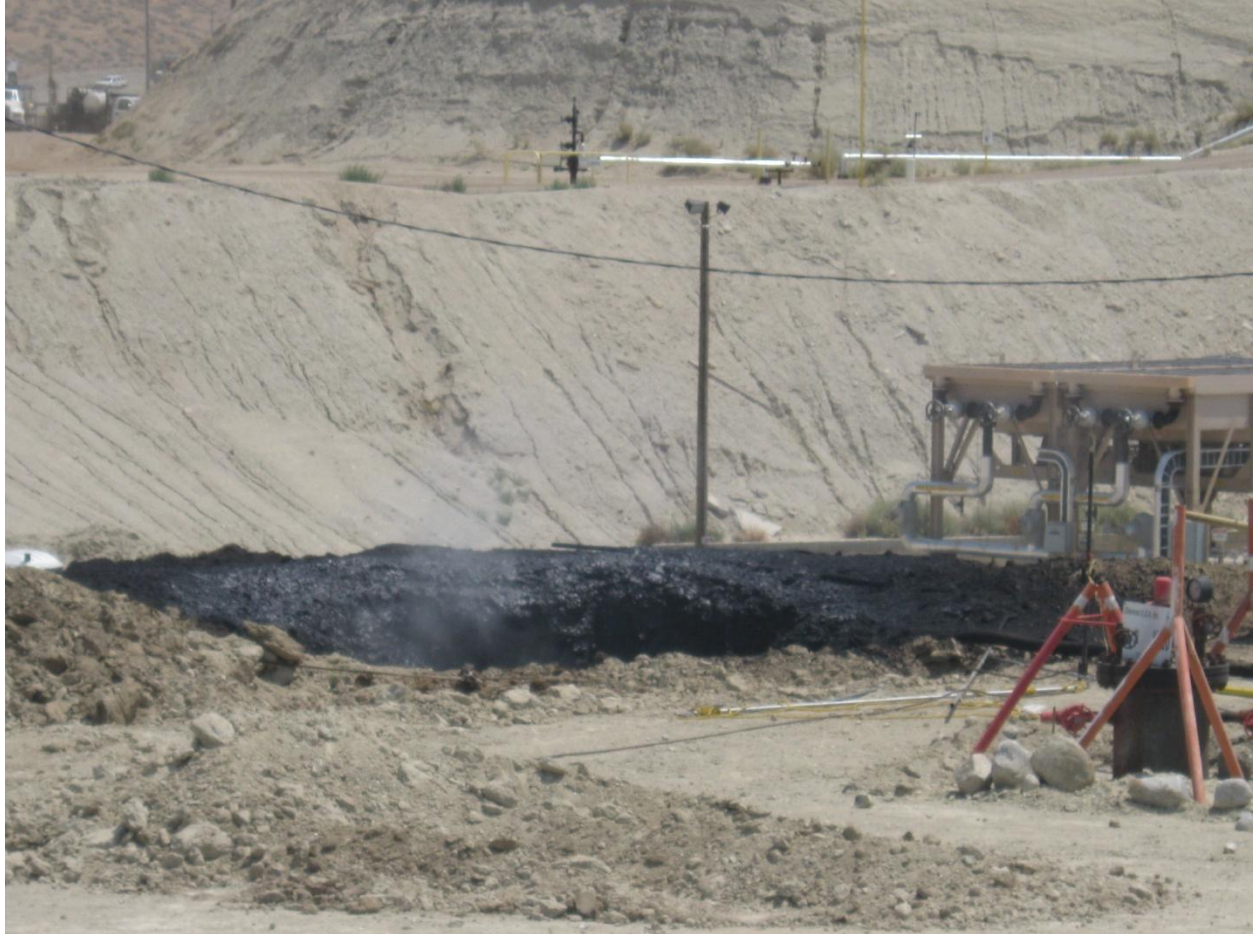
Photograph 16 – View of Chevron accident site on July 7, 2011. The Crater is approximately 10' wide , intermittently expelling oil and water onto the surrounding ground.

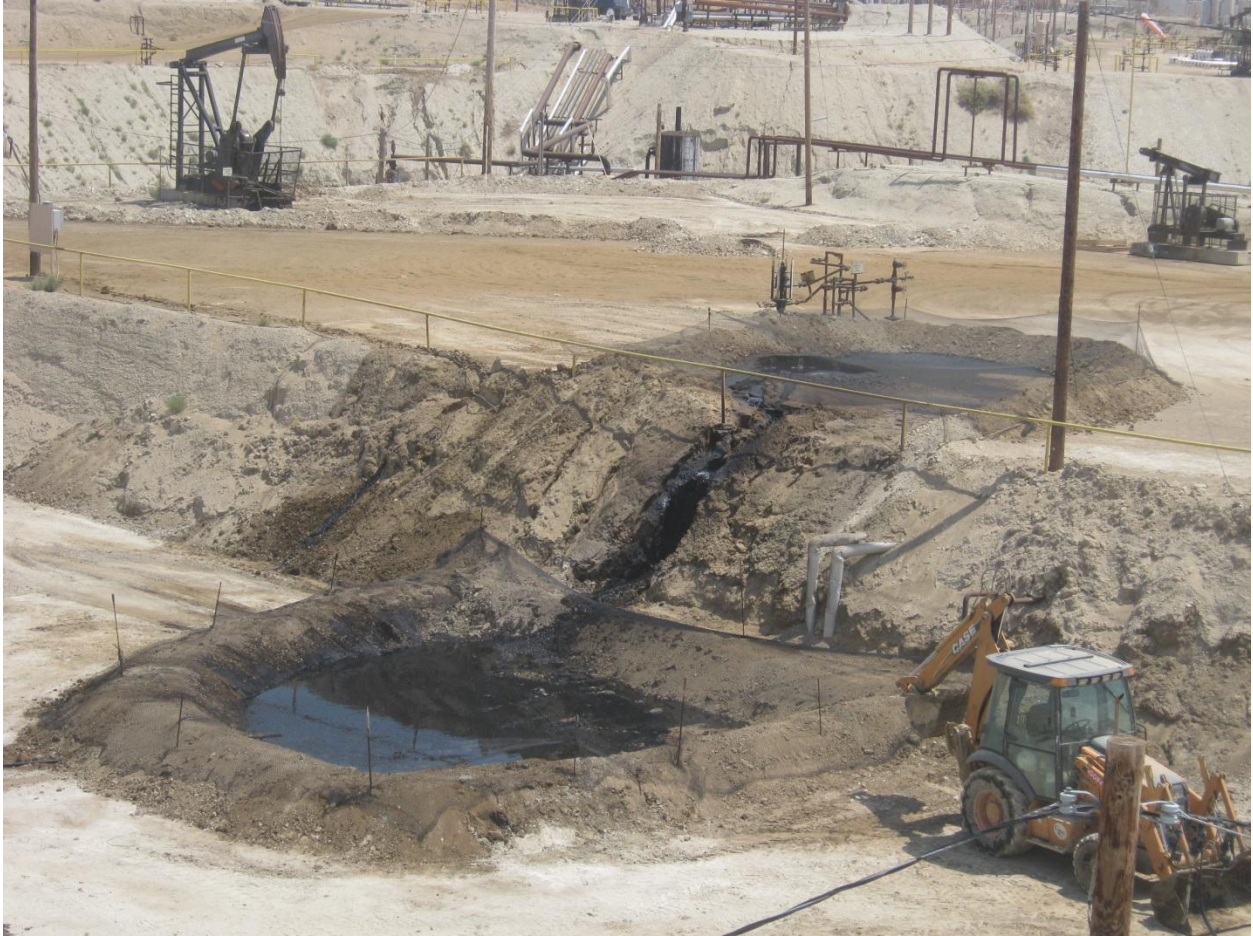
Photograph 17 – View of surface expression on TRC’s “Bull” lease, July 7, 2011. An increase in the crater diameter on the upper terrace and deeper erosion of the terrace slope was noted. Approximately 100 bbls/day of fluid was being removed from the containment berm on the lower terrace.

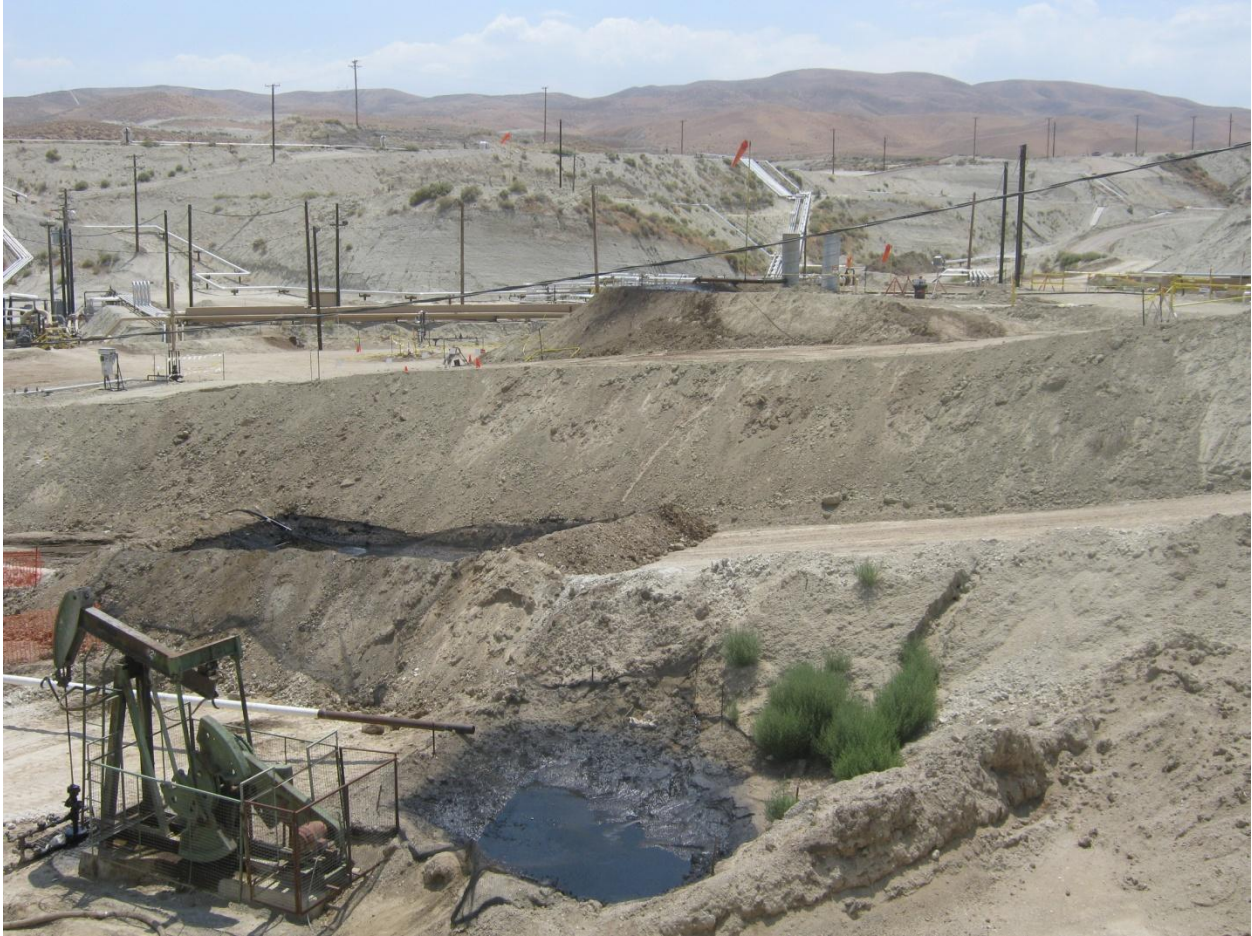
Photograph 18 – View of the TRC reactivated surface expression to the east of the Chevron accident site on July 7, 2011. The TRC reactivated surface expression is at the base of the slope that is essentially the boundary between TRC and Chevron. The crater near the accident site is in the distance with steam rising and oil staining along the terrace slope from fluid recently expelled.

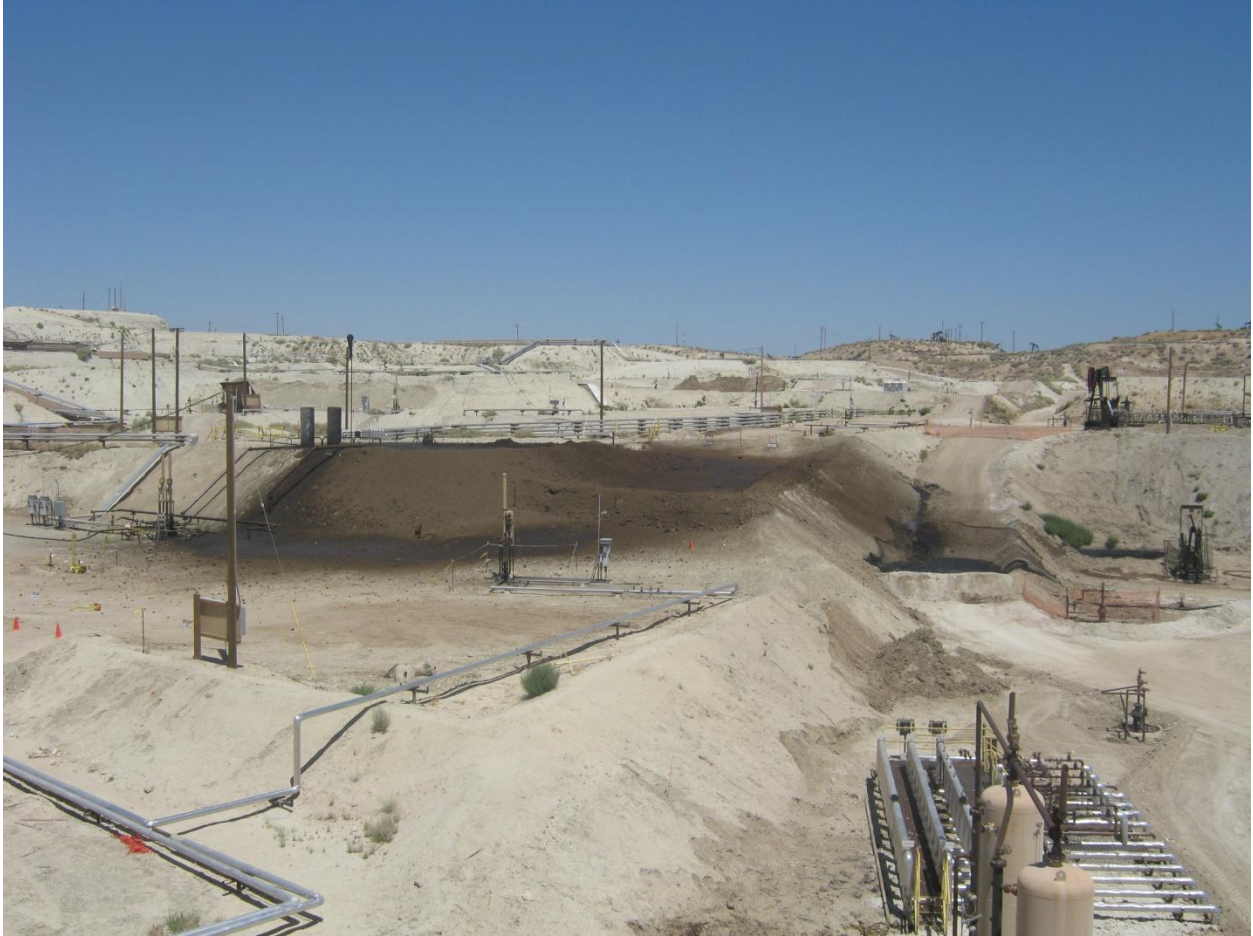
Photograph 19 – View of the Chevron Well 20 and the nearby TRC surface expression areas, on August 5, 2011. The eruption expelling rocks, water and oil occurred sometime during the night of August 4.
