From: Miyoko Sakashita [mailto:miyoko@biologicaldiversity.org]
Sent: Tuesday, March 21, 2023 3:28 PM
To: CityClerk <CityClerk@longbeach.gov>
Subject: CBD Sources Part 1.5

REPORT OF OCCURRENCE

Subject: Cause and Prevention Plan for Surface Event SE 2011-8-8
Berry Petroleum Company, Project #46400390
Southwestern Lease, Section 2, T31S, R22E, MDBM
Midway Sunset Field
Kern County, CA

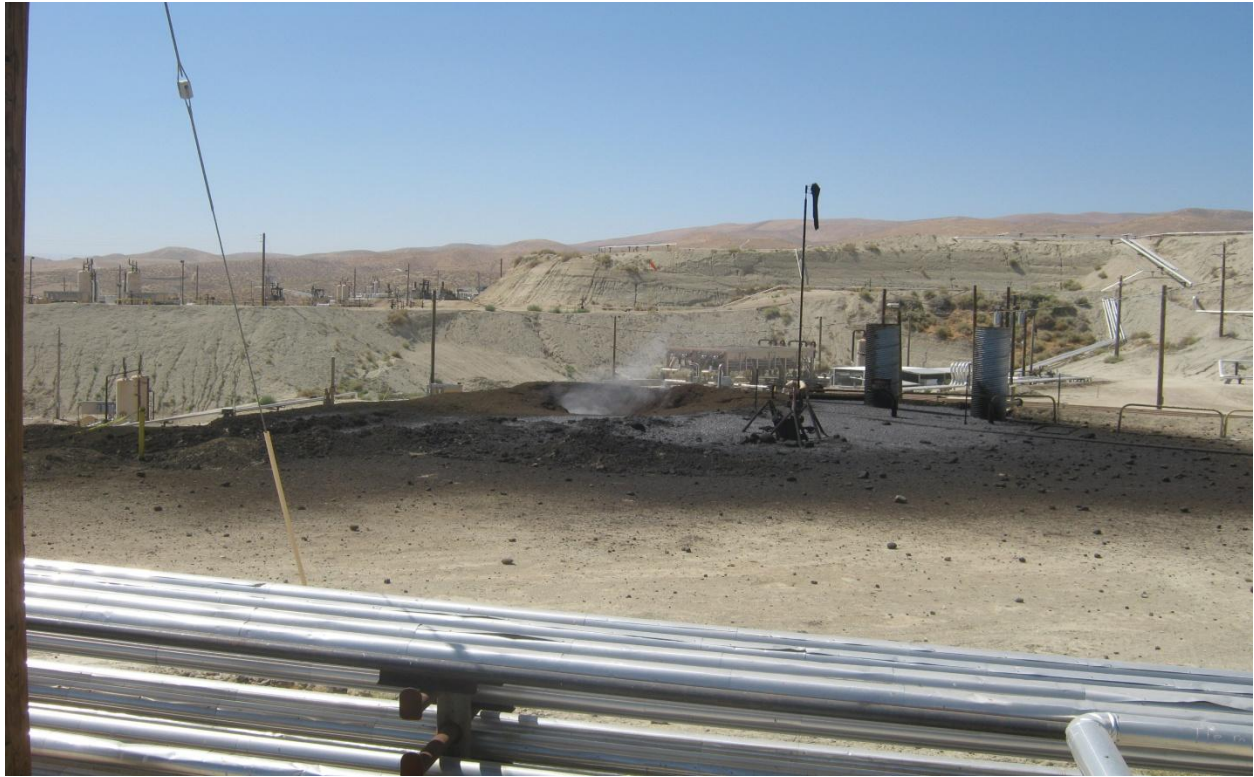
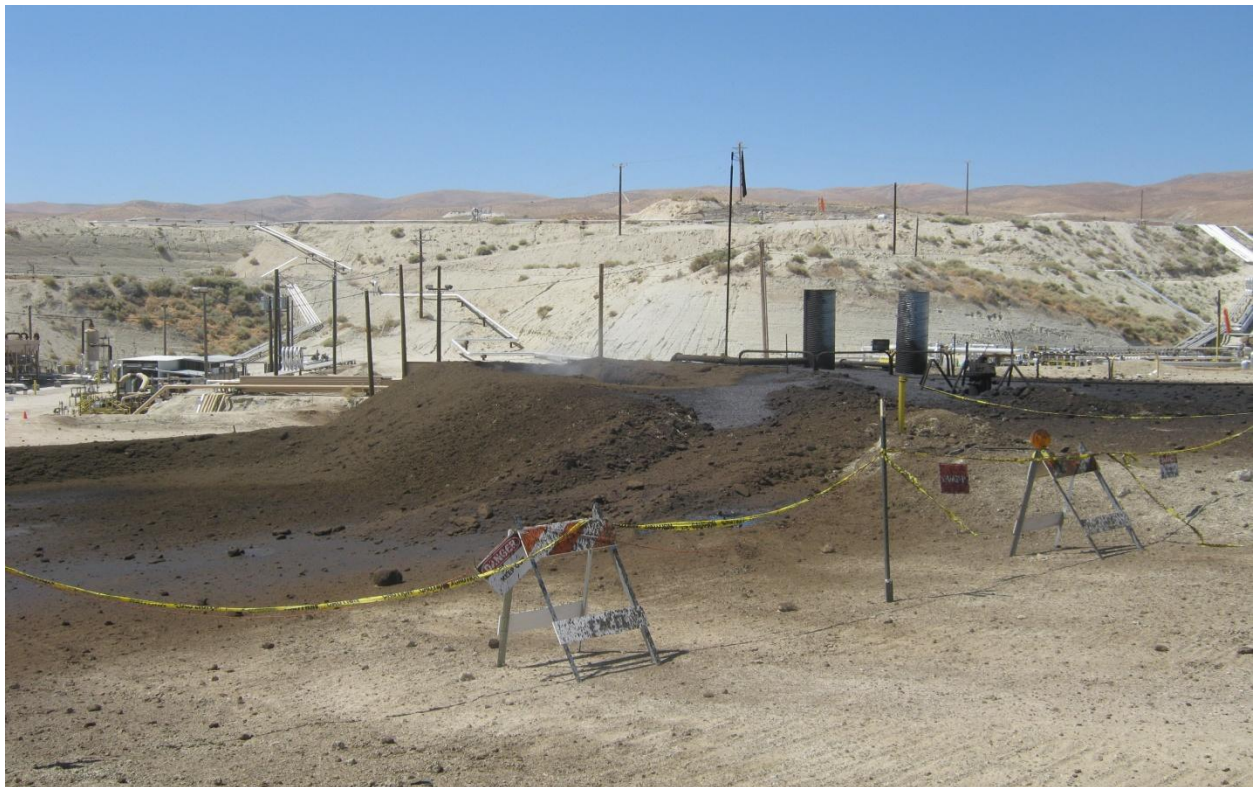
Photographs 20 and 21 – Views on August 5 of the material; water, oil and rocks, expelled from the crater during the night of August 4.

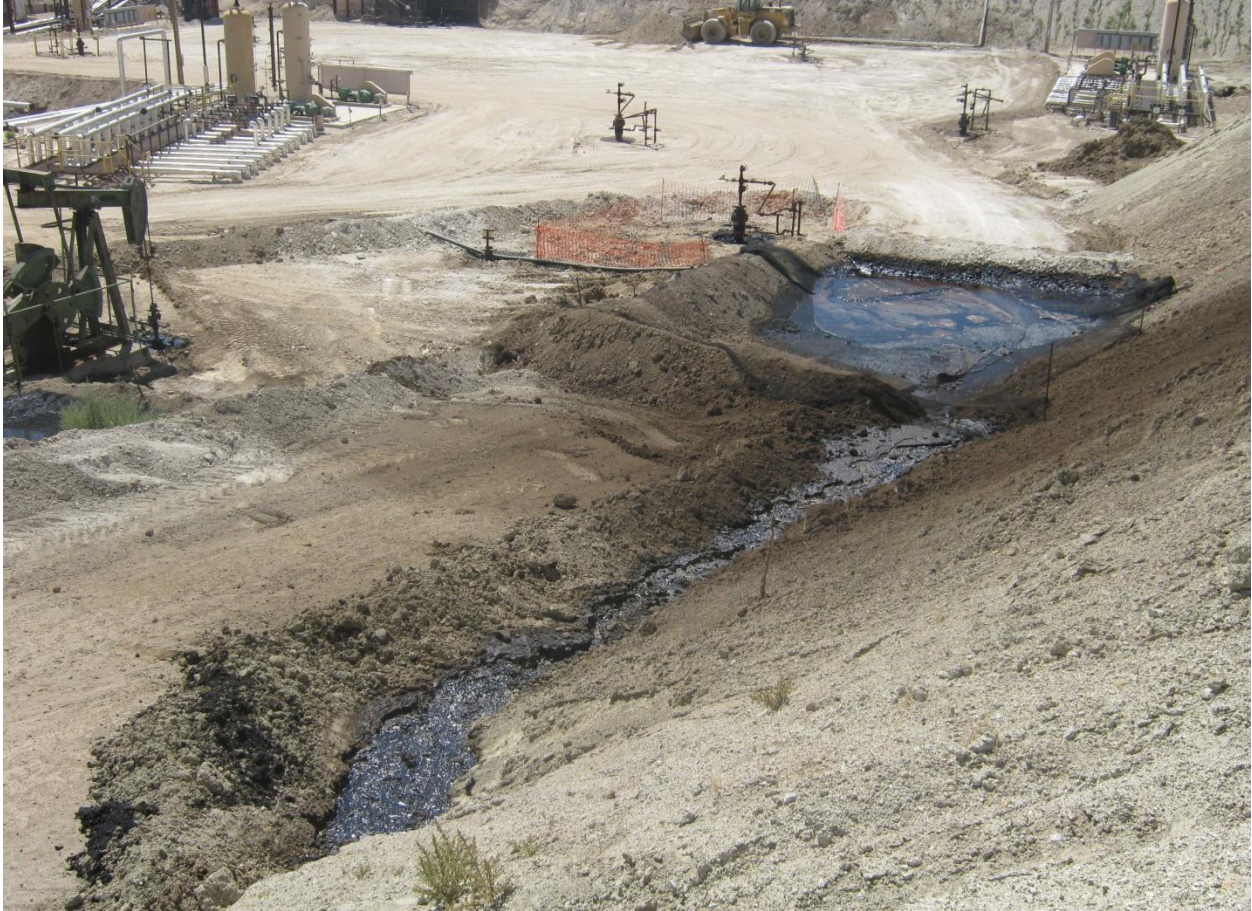
Photograph 22 – View of the two new TRC surface expressions that became active on August 3. They are located at the top and bottom of the stream of fluid. The bermed pit was put in place after the reactivation of a surface expression at that location on June 27.

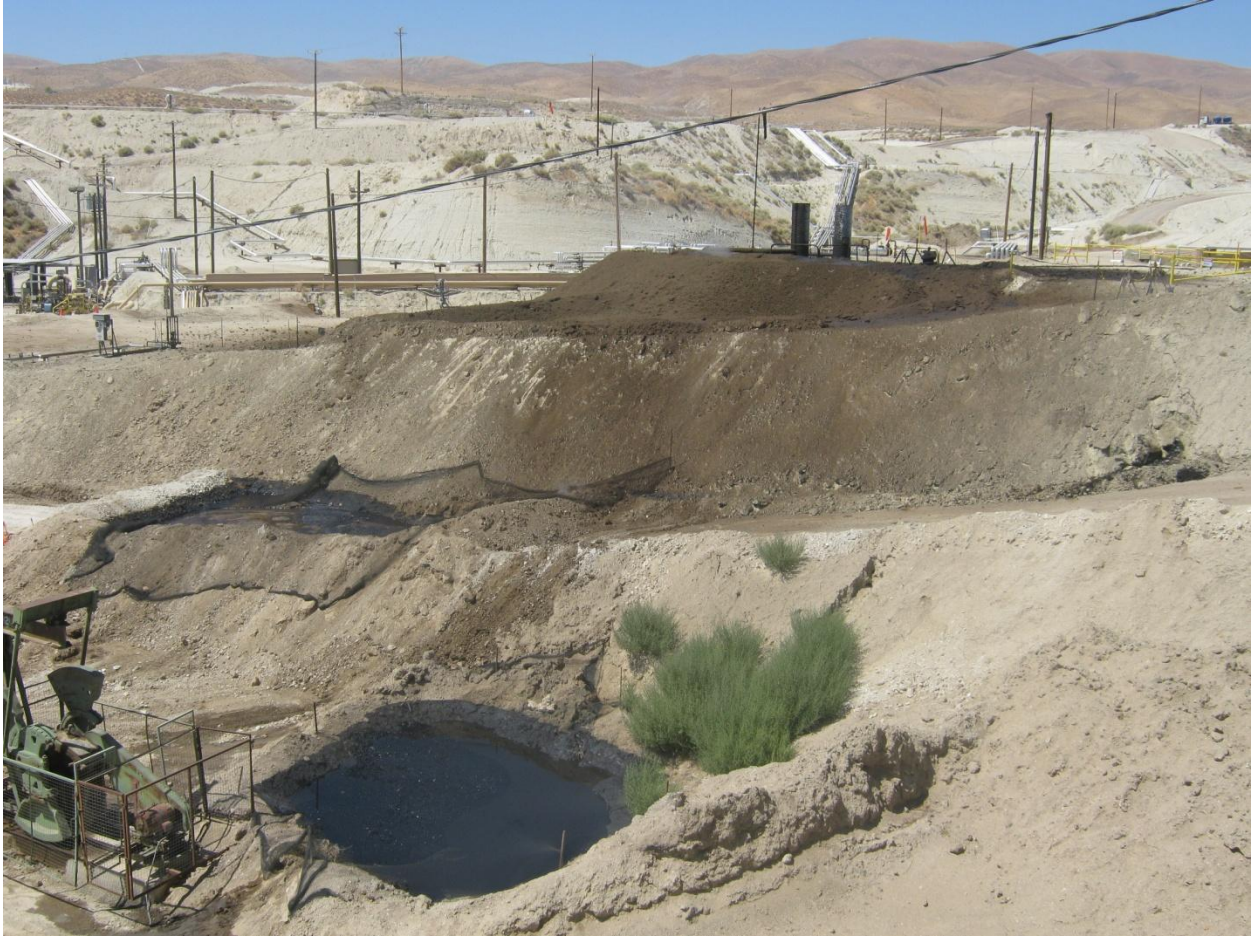
Photograph 23 – View of the eastern extent of the crater eruption onto TRC property and the two new TRC surface expressions located at the base of the oil stained slope.

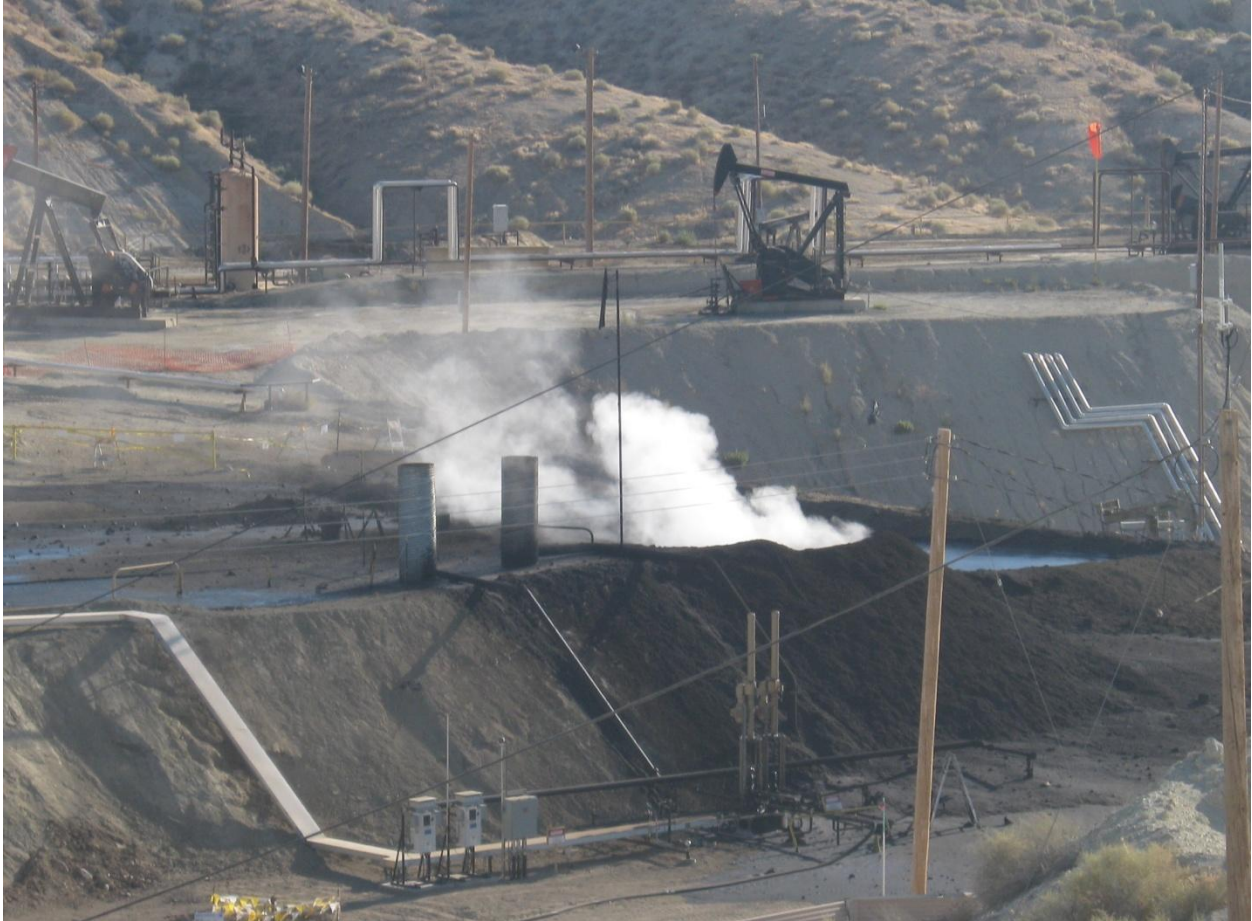
Photograph 24 – View of Chevron Well 20 surface expression crater on August 18, 2011 one day after the large August 17 eruption. Plumes of steam continued to rise from crater for several days following the event.

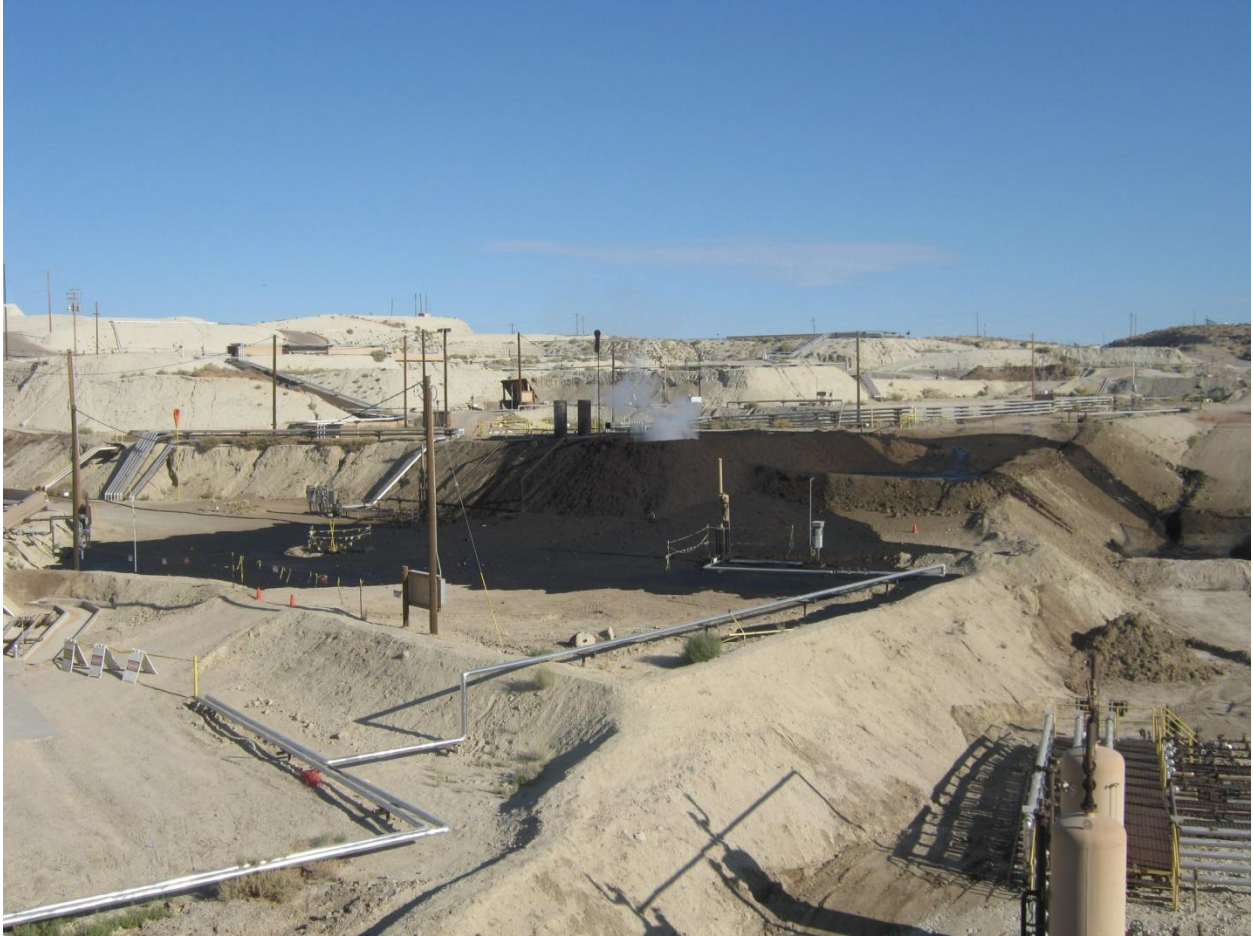
Photograph 25 – View of area extent of fluid flow from the Well 20 surface expression crater during the August 17, 2011 eruption event.

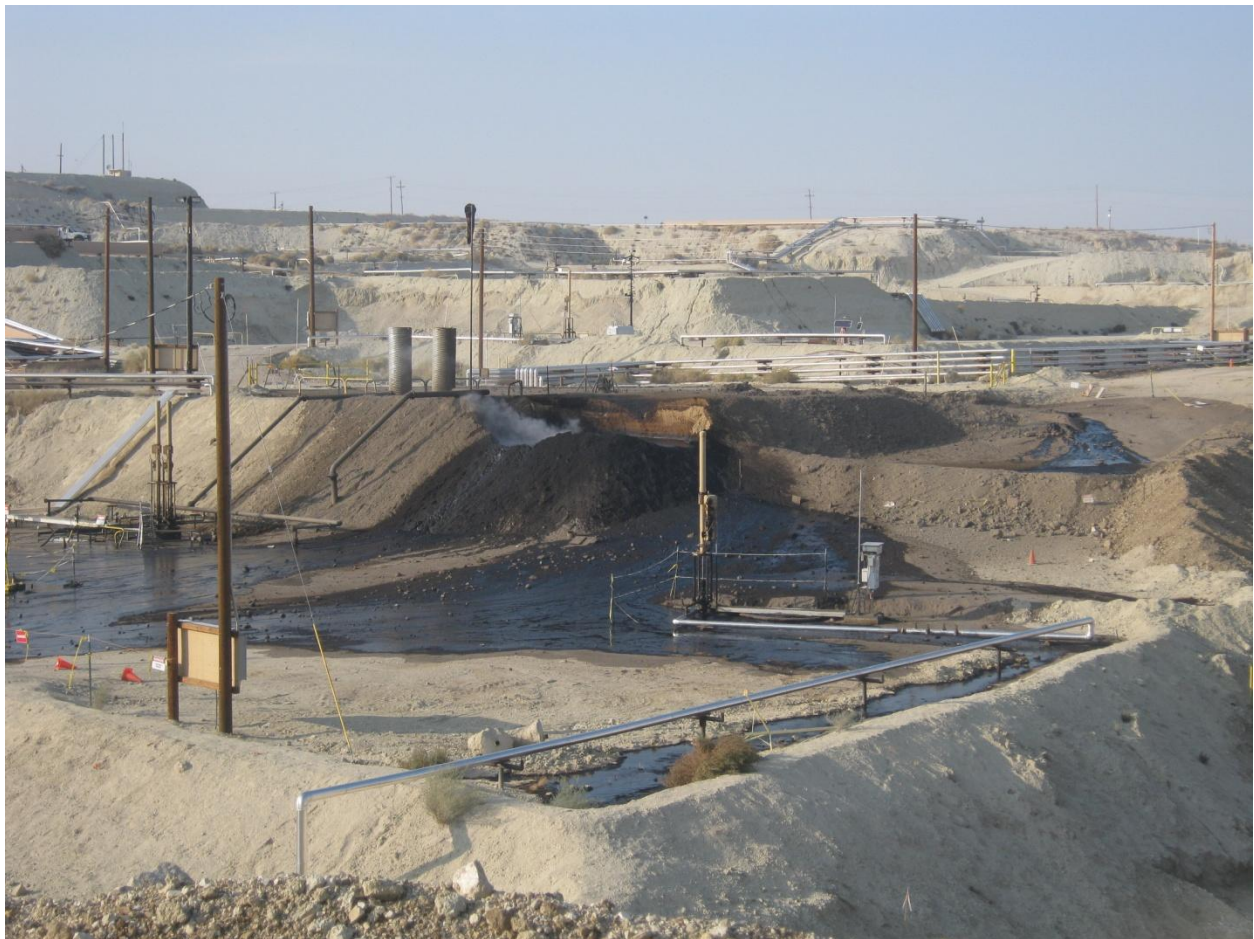
Photograph 26 – View of the Well 20 surface expression area on November 17, 2011. The enlargement of the crater and subsequent collapse of its walls released water and oil onto the lower terrace. Water and oil also flowed to surface at the location of the equipment above the subsurface containment structure.

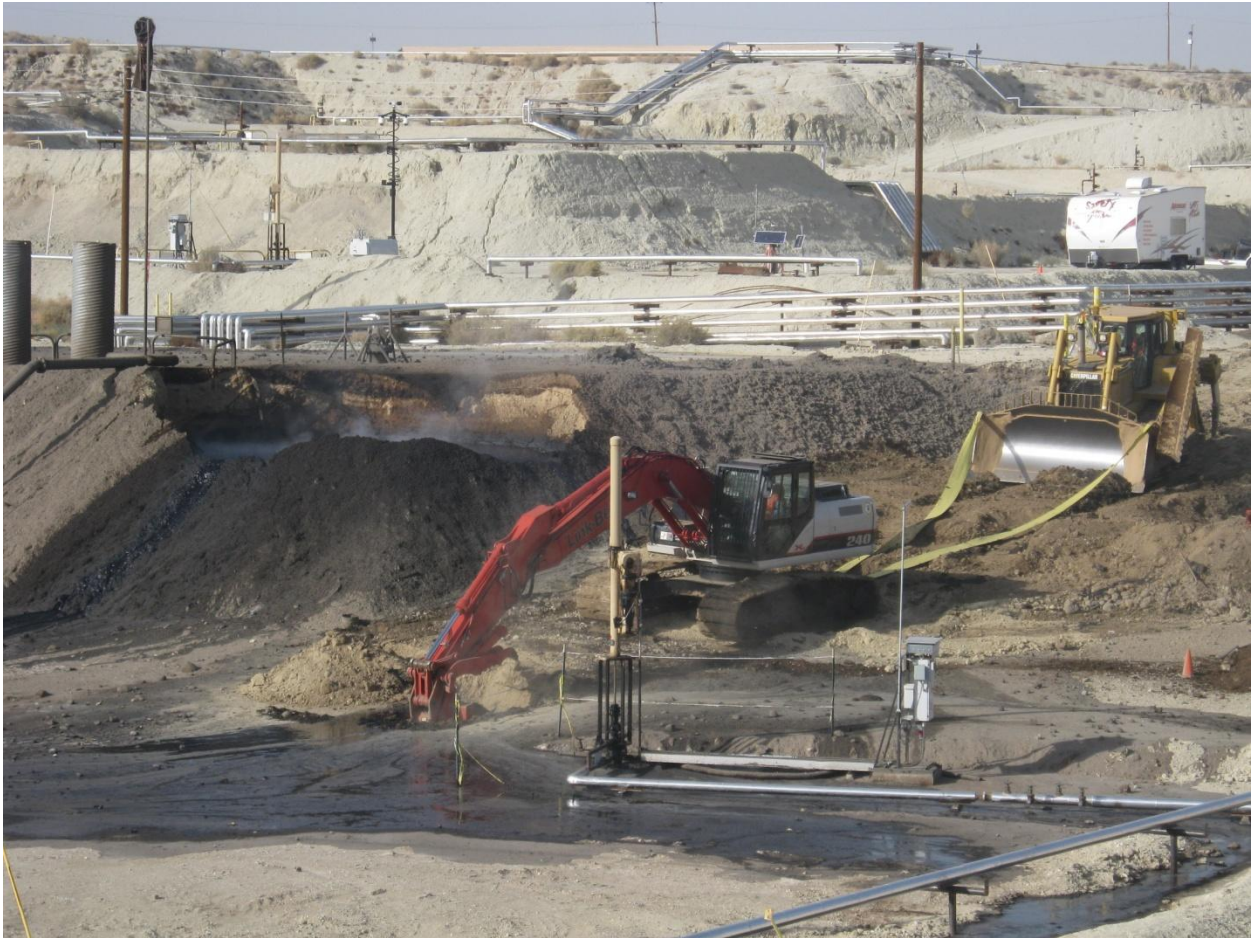
Photograph 27 – View of the start of investigative and remedial excavation of the Well 20 surface expression area on December 1, 2011. Spot locations were excavated to determine the stability of the ground and subsurface. No ground or subsurface instability was discovered.

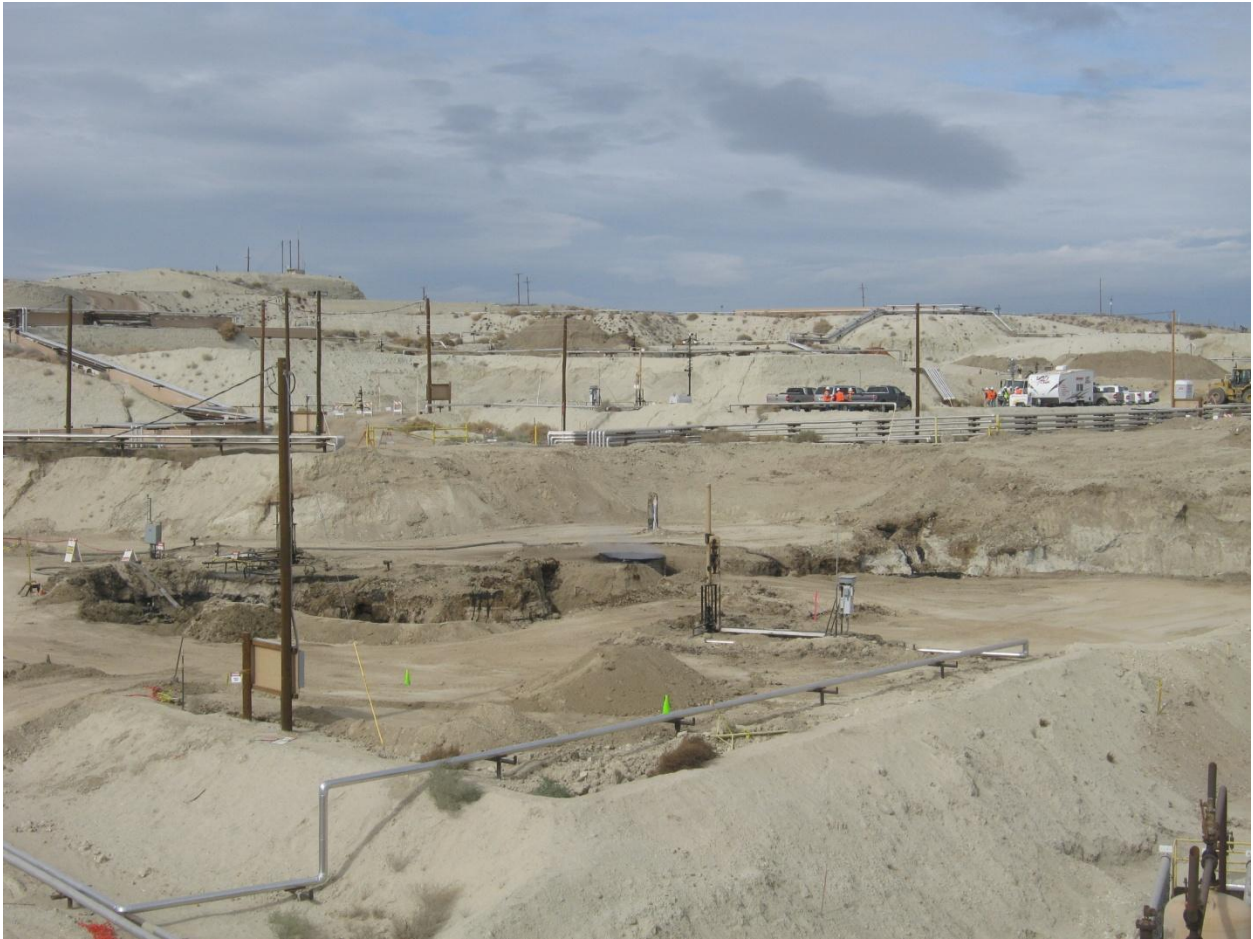
Photograph 28 – View of Well 20 surface expression area on January 20, 2012 after crater and terrace excavation. As seen in the middle of the photograph, a large diameter metal culvert has been placed over the crater vent. Trenches excavated to remove the radial drains can be seen extending from the culvert. Minor amounts of energy, in the form of bubbles, rise to the surface inside the trenches. The subsurface containment structure has not been excavated.

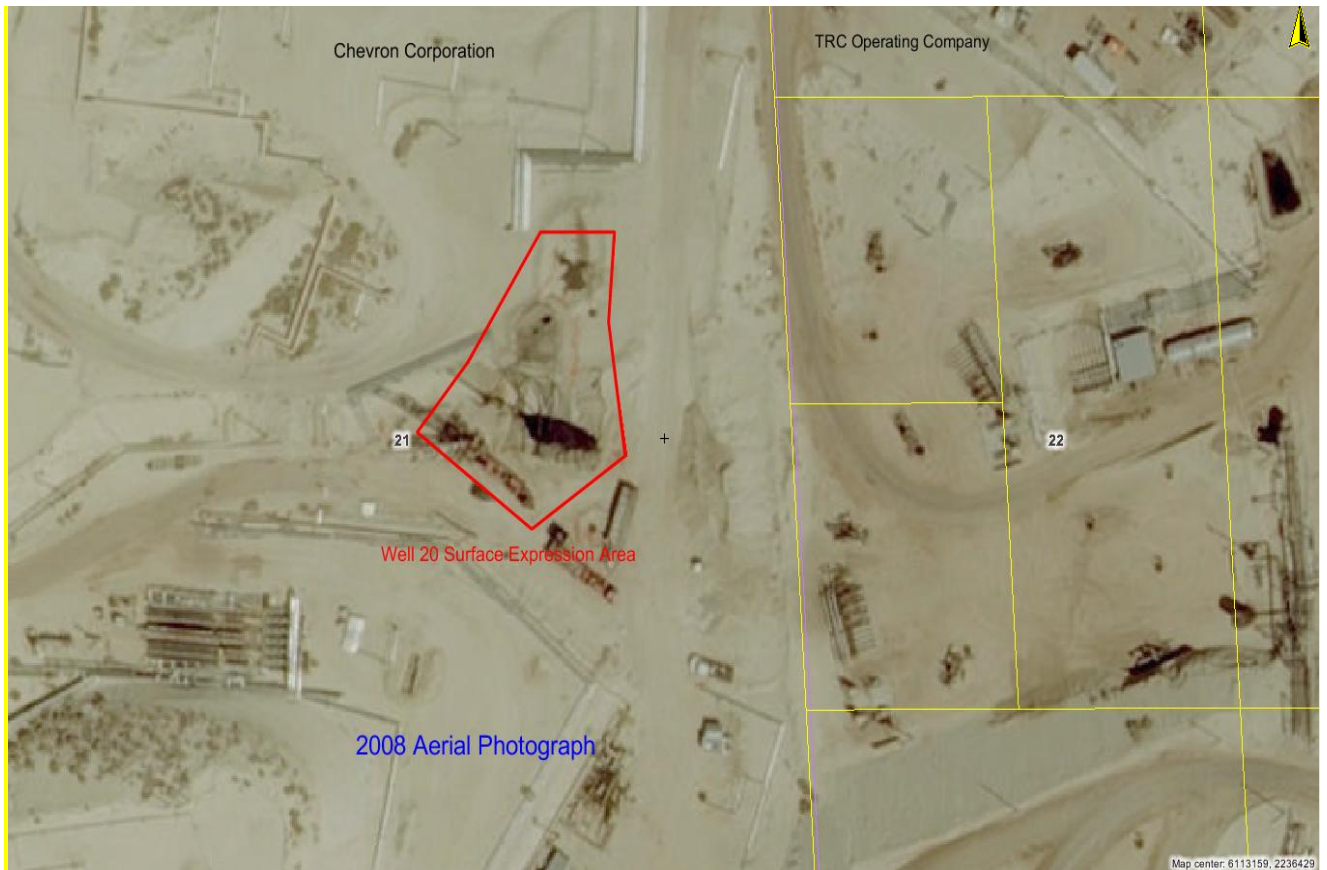
Aerial Photograph 1 – 2008 aerial view of the Chevron Well 20 surface expression area, showing the surface expression containment pit as well as other surface expressions in the immediate vicinity.

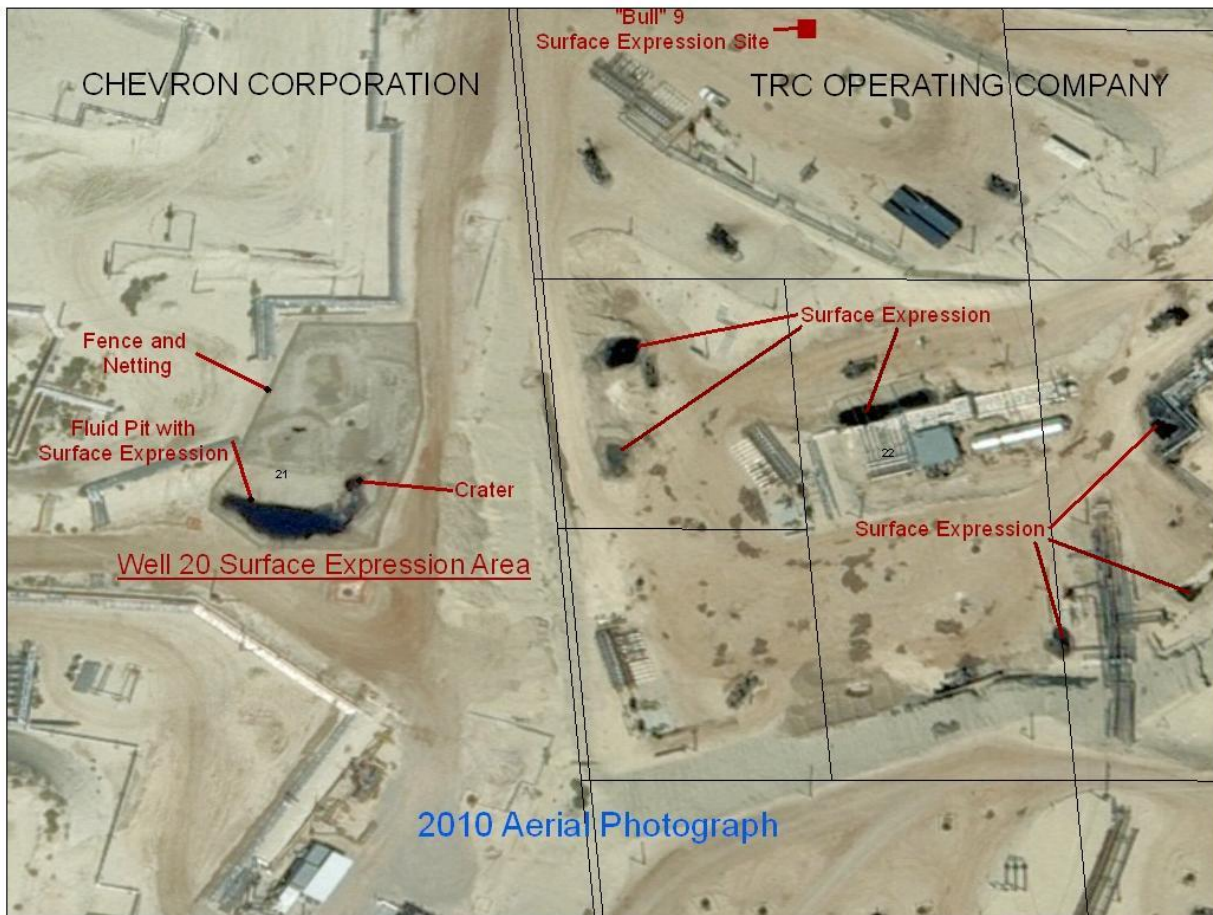
Aerial Photograph 2 – 2010 aerial view of the Chevron Well 20 surface expression area and location of TRC surface expressions, including the approximate future location of the “Bull 9” surface expression.
