#### REHABILITATION/RESTORATION/MAINTENANCE PLAN

3735 Cerritos Ave, Long Beach, CA 90807

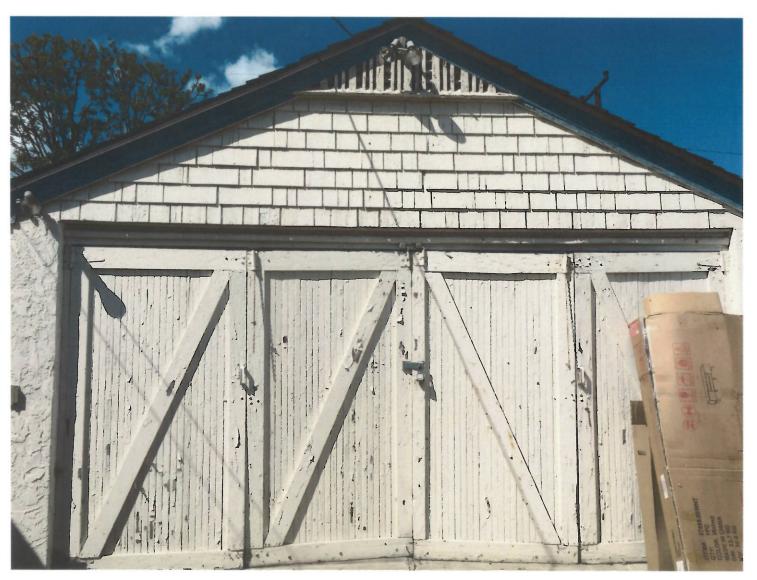
Front View of Garage

#14	Detailed description of work:
Building Feature: Craftsman Wood Sidings on Garage Façade with Decorative Grille (Street View)	The Wood Sidings and the Decorative Grille are salvageable. The cluster of wood sidings and the grille are in serious need of repair due to weather, termite and peeling paint damage. Will scrape, sand and paint to show its beauty.
Completion Year: 20	
Plan to Use Long Beach Vendors For Materials/Labor:	Specify/list: Preliminary Proposal from Long Beach Contractor
