**DRAFT
ARCHITECTURAL BUDGET COST MODEL
OF**

**5870-5874 ATLANTIC AVENUE
LONG BEACH, CALIFORNIA**

**THE CITY OF LONG BEACH
REDEVELOPMENT AGENCY**

**File No. 110018
April 2010**

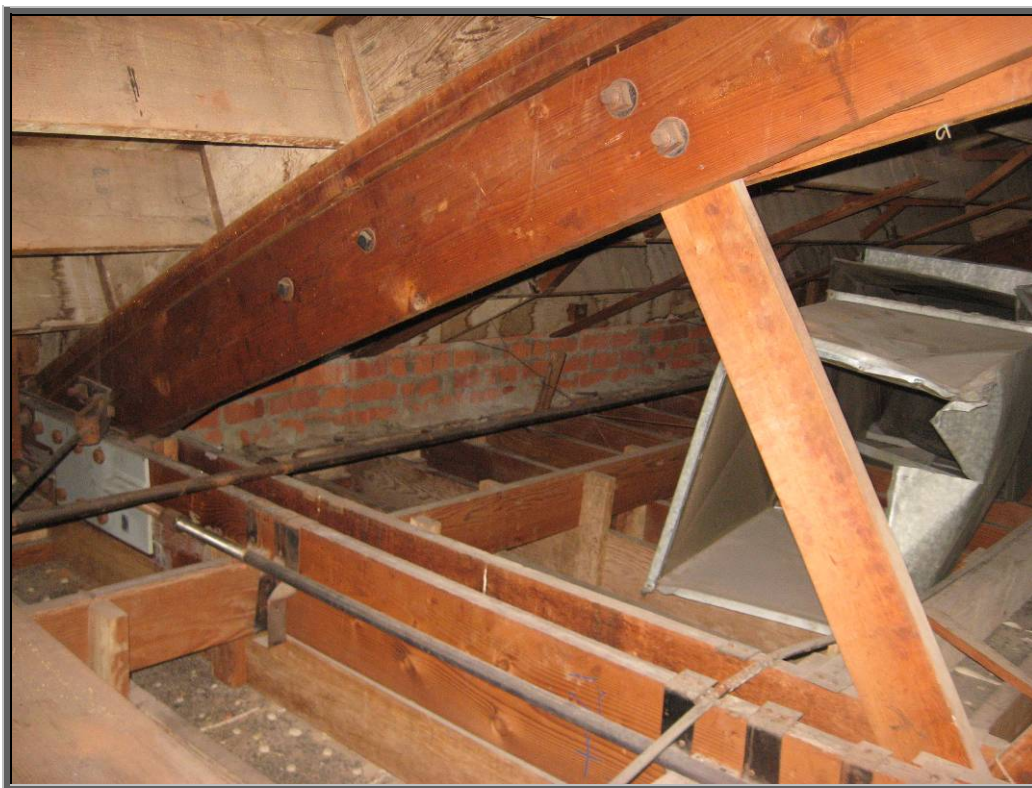
- The barrel-shaped roof structures are constructed using long-span fabricated wood trusses. As these truss assemblies age, local stress concentrations in the truss chords, webs, and connections caused by knots, bolt holes, and loaded end and edge conditions can cause sudden failure. The degree of risk is influenced by the age of the assemblies and the conservatism of the original design and construction. This situation can be further aggravated when added loads associated with mechanical or tenant improvement systems are added to the roof structure.

Photo 5: Typical strengthened bowstring truss.

The existing trusses will require strengthening. Strengthening measures would include the addition of two post-tensioned steel rods along side the bottom chord of each truss. The rods are designed to act as tension members in the event that the vulnerable truss bottom tension chords fail. Attachment of the rods to the trusses would consist of steel brackets bolted to each side of the truss chord. Approximately six trusses have previously been strengthened. The existing rods and brackets should be replaced to account for increased roof dead loads and seismic wall anchorage forces.

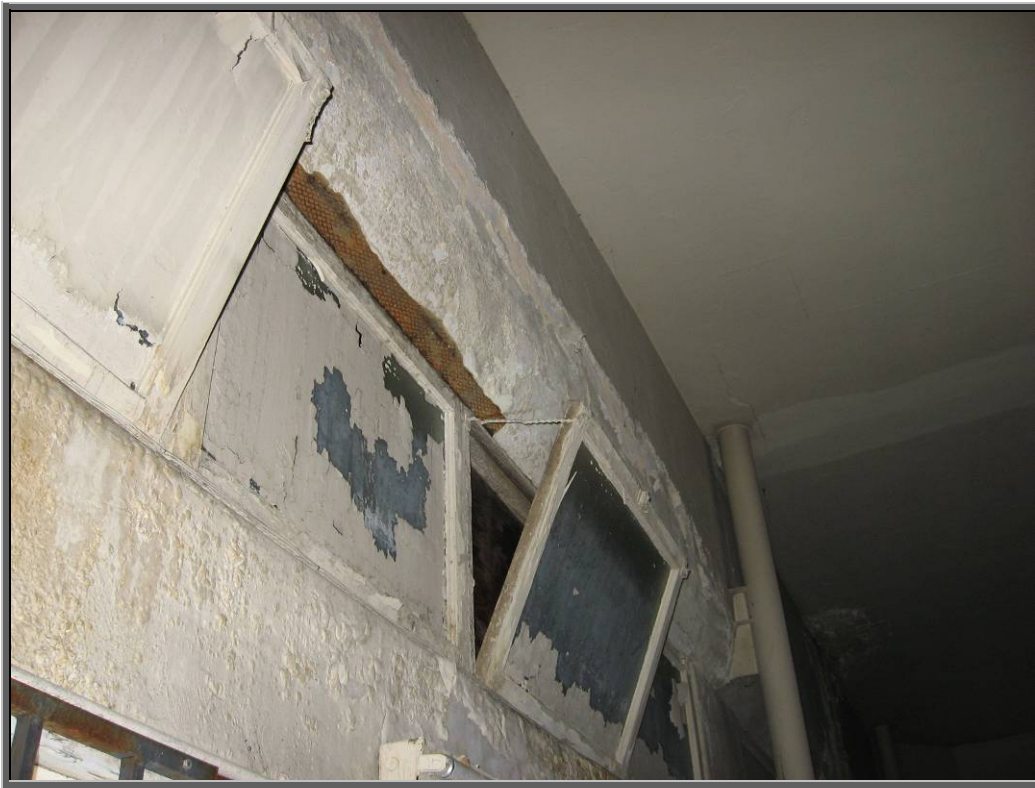
The building has been vacant for over a year and maintenance of the waterproof envelope has not been completed for some time. There is evidence of widespread water leaks through the roofing membrane and window systems. The water intrusion has resulted in significant distress to the plaster wall and ceiling finishes and undoubtedly has caused damage to the underlying structural elements. The extent of structural damage is unknown and cannot be determined without removal of the deteriorated wall and ceiling finishes and roofing membrane. If it is desired to retain and restore the existing structure for a new use, identification and remediation of water intrusion related structural deficiencies should be planned for. The construction cost to address underlying structural damage could be significant.

Photo 7: Water damage at interior face of west Hanson Building storefront.

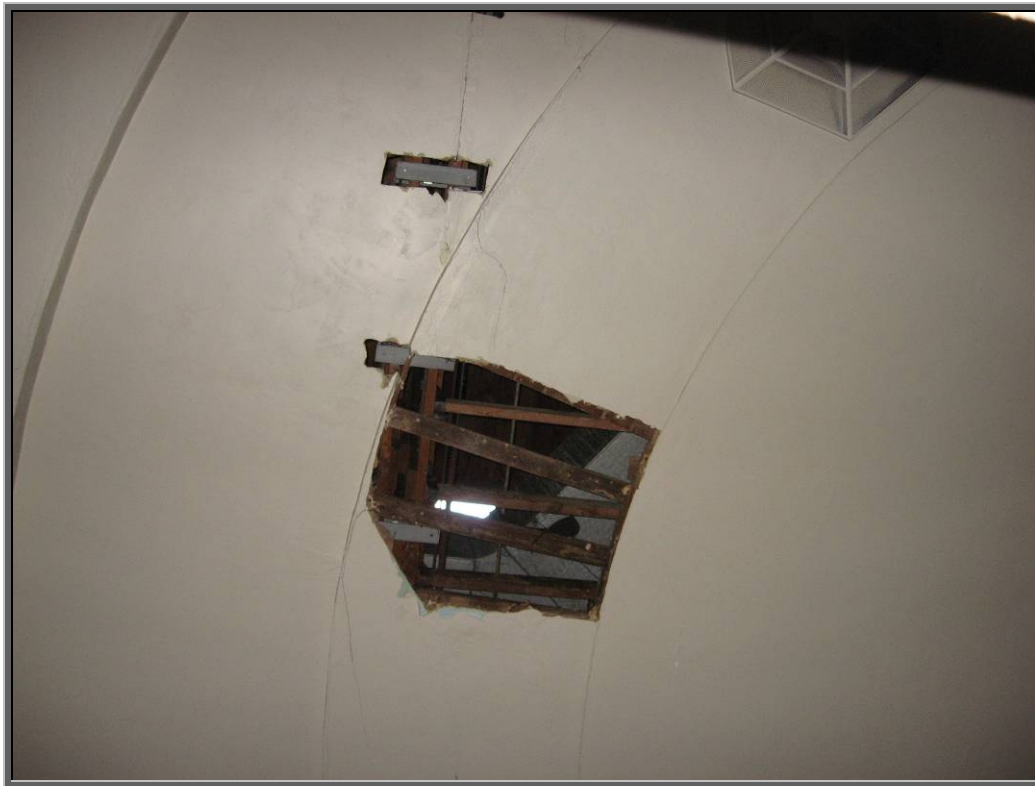
Photo 8: Water damaged plaster ceiling over theater floor.

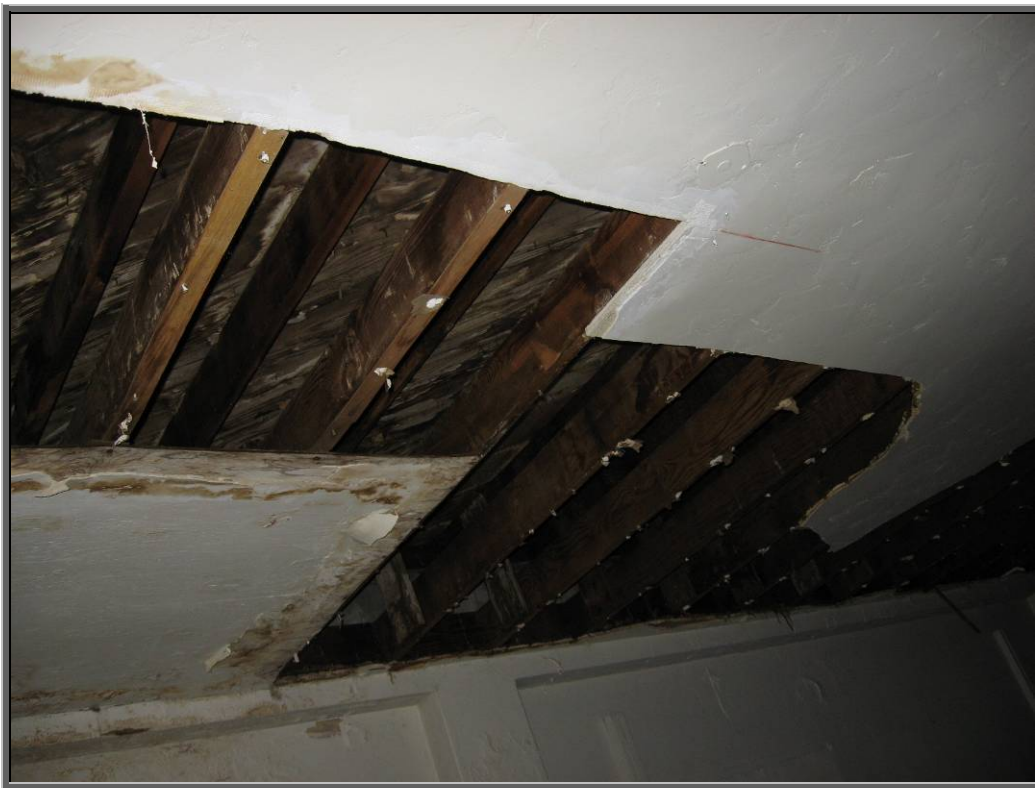
Photo 9: *Water damaged plaster ceiling over Hansen Building floor.*

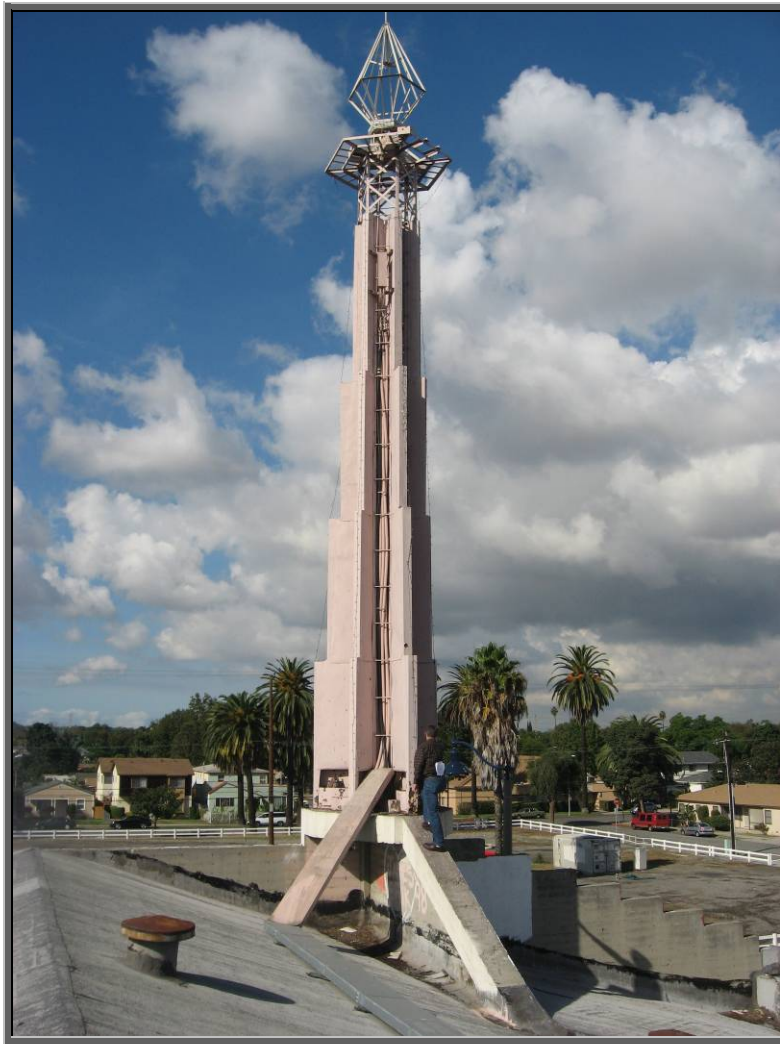
- There is evidence of light to moderate rust corrosion of the steel framed tower. Of particular concern are rusted base plate connections which may have sustained a loss of strength capacity. Structural rehabilitation of the steeple structure is likely warranted. Rehabilitation work will include cleaning and protecting structural steel elements and completing localized member replacement or repair. Additionally, new base connections will likely be required at each leg of the steeple (6 total). Each new base connection will consist of a steel base plate that is welded to the existing steeple column and anchored to the existing concrete platform with new threaded rods set in epoxy. The rehabilitation work will require the removal and replacement of the existing sheet metal steeple cladding in order to gain access to the concealed structural members.

Photo 10: Steel tower spire founded on concrete podium.

Documentation of the existing tower framing and evaluation of its ability to withstand design seismic forces will be required. Further structural strengthening may be required if the tower frame is found to be deficient.

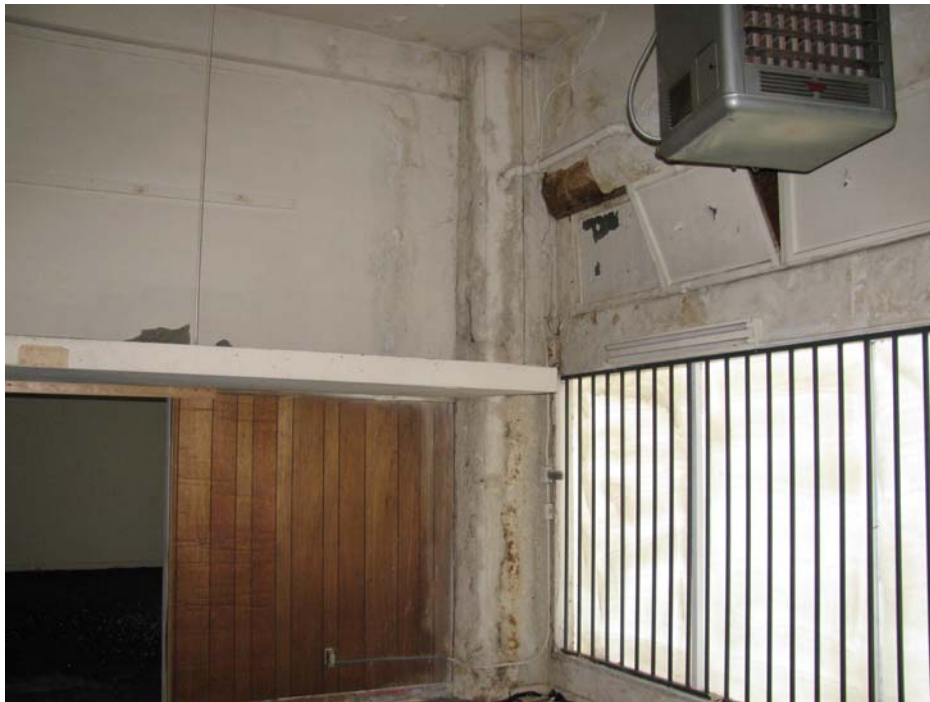
10

10. Water damage at the interior of the Hanson Building.

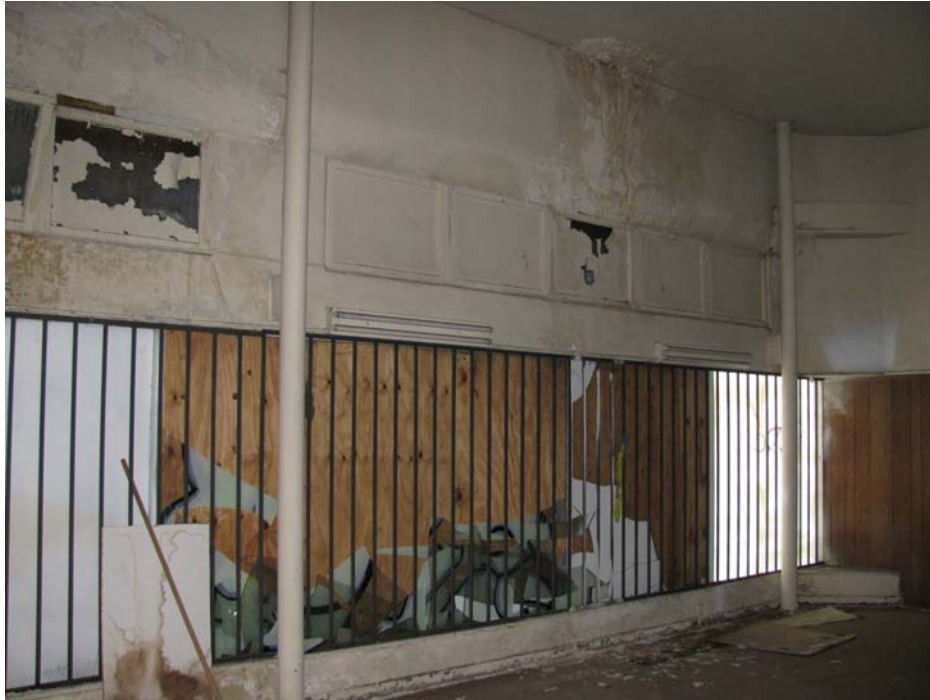
11

11. Water damage along the interior of the Hanson Building.

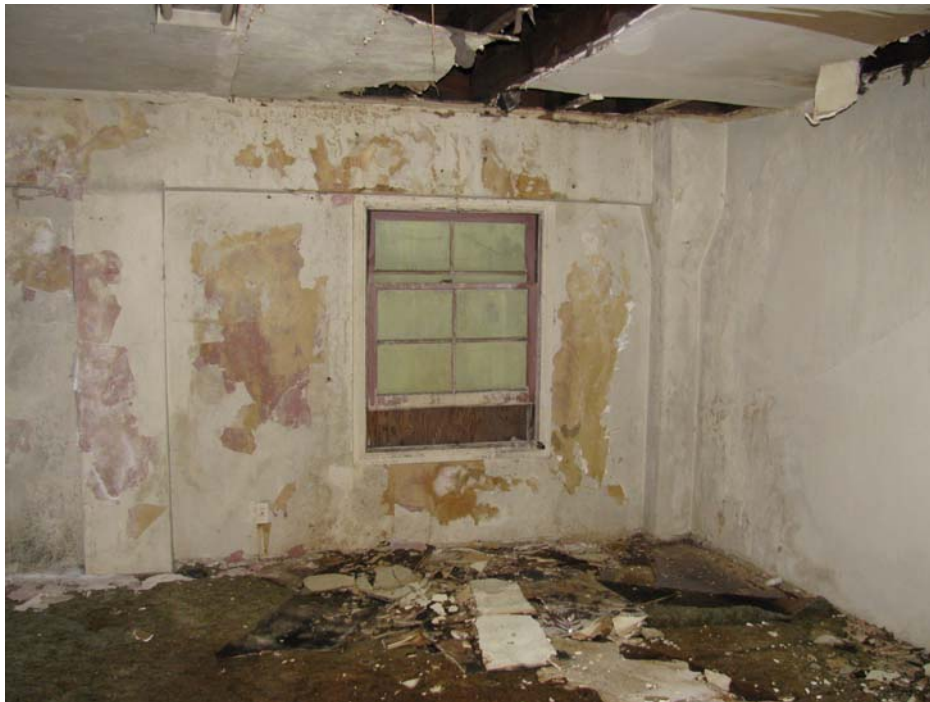
12

12. Water damage to wall and ceiling Hanson Building.

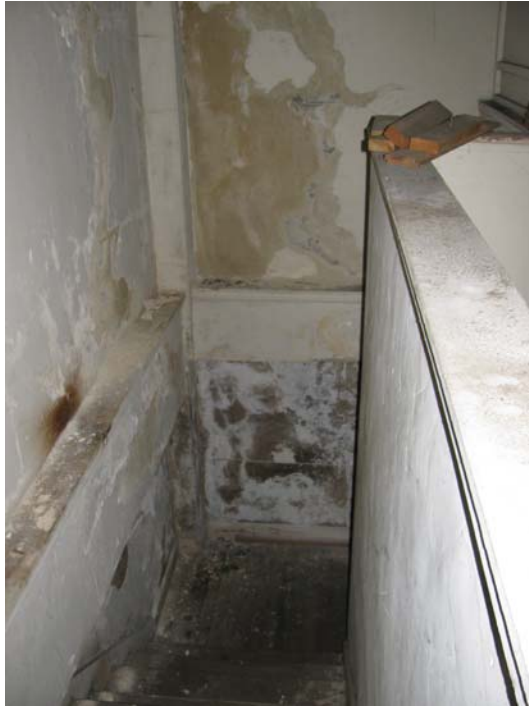
13

13. Water damage at stairway Hanson Building, not mold on walls.

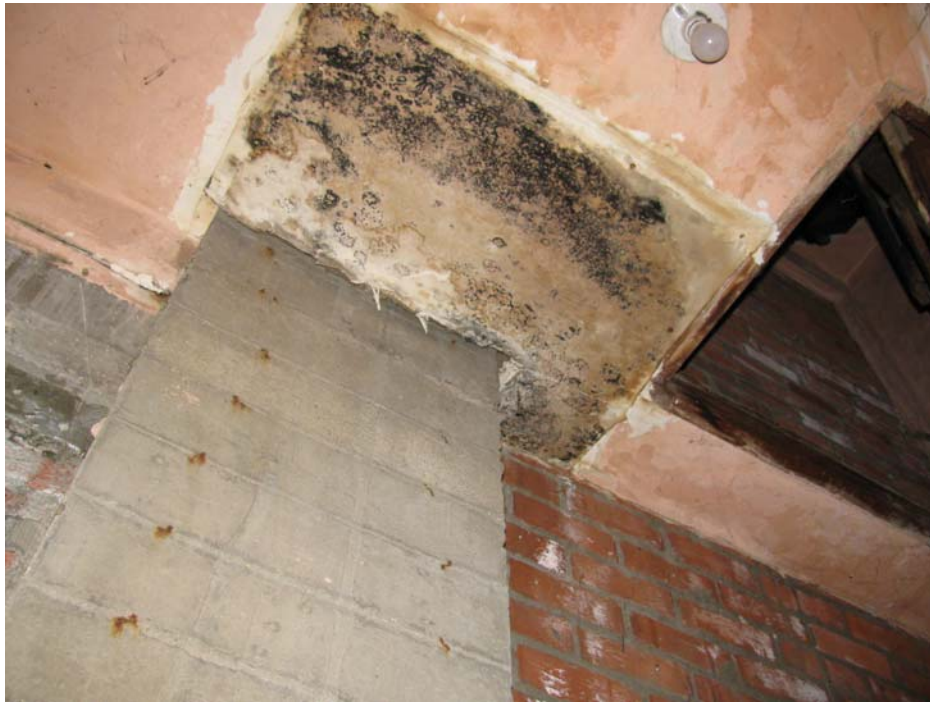
14

14. Mold at theater ceiling finishes.

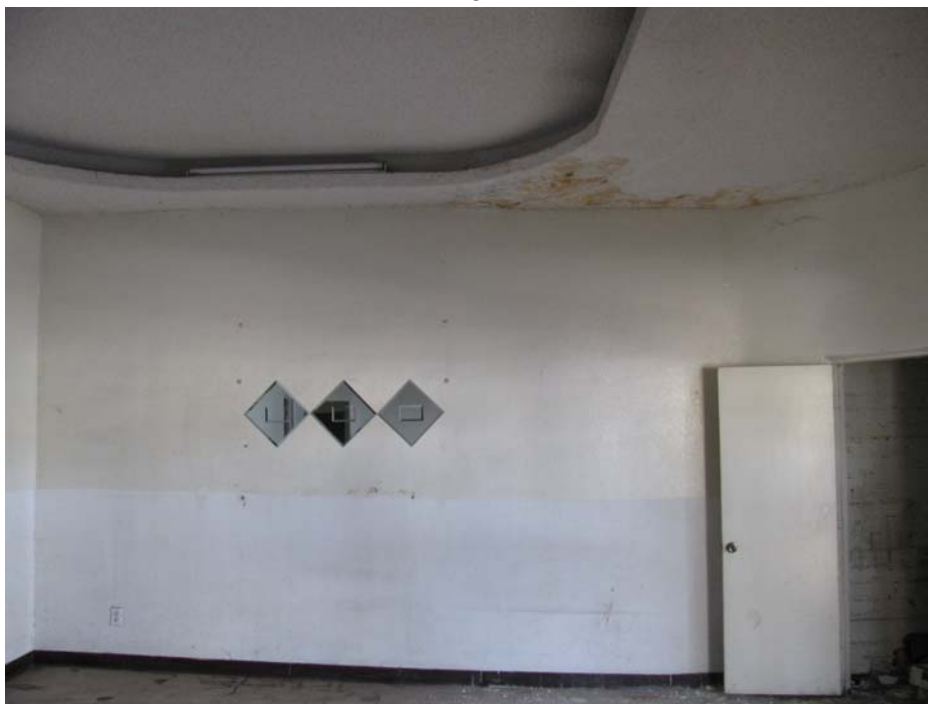
15. Theater interior lobby note water damage at ceiling.

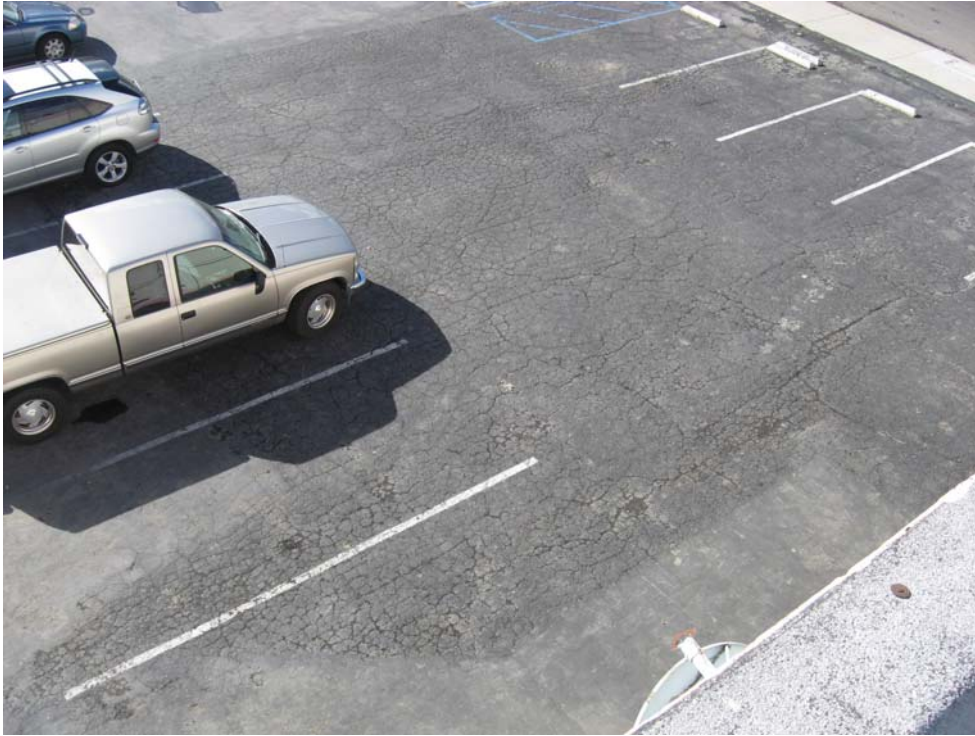
9

The asphalt paving in the parking lot is in very poor condition. Resurfacing the parking lot with another layer of asphalt could be completed but based on the age of the paving, the very poor condition and the number of cracks in the asphalt a complete removable and replacement is highly recommended. There are 46 striped parking stalls including two accessible parking stalls.

9. Cracks visible throughout the paving.

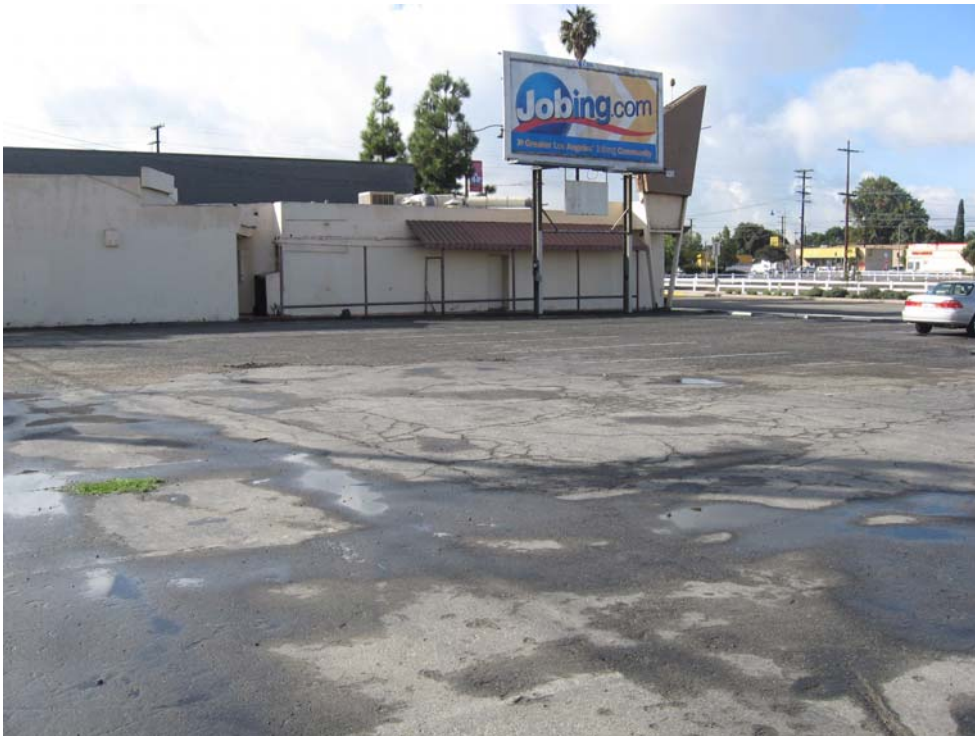
10

10. Poor condition of asphalt paving.

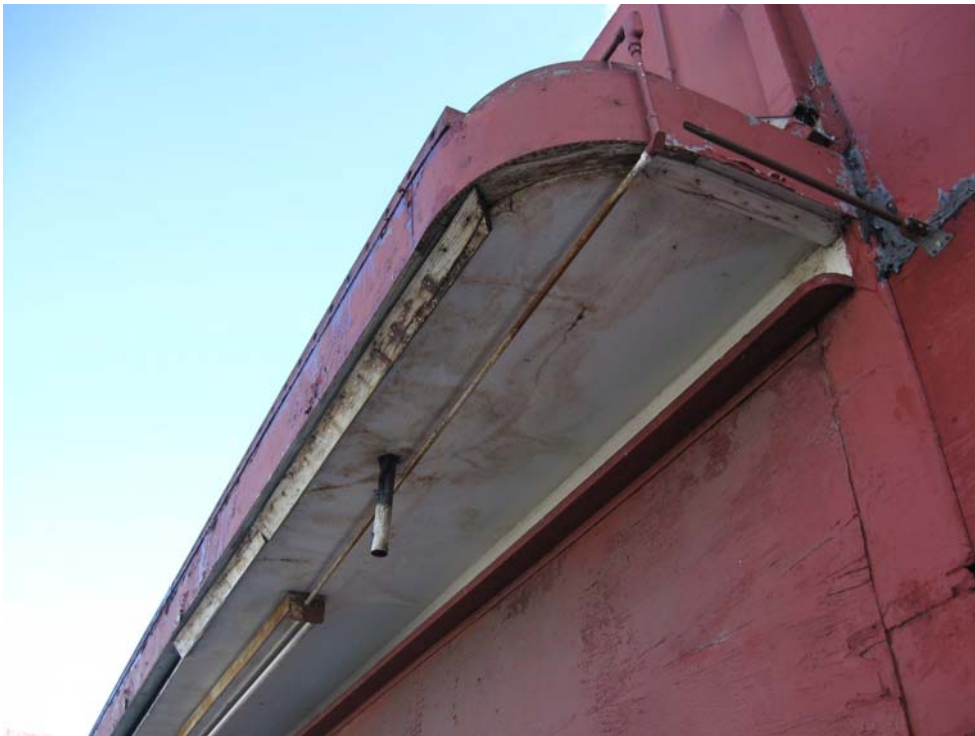
12

12. Poor condition of the overhand at the furniture store.

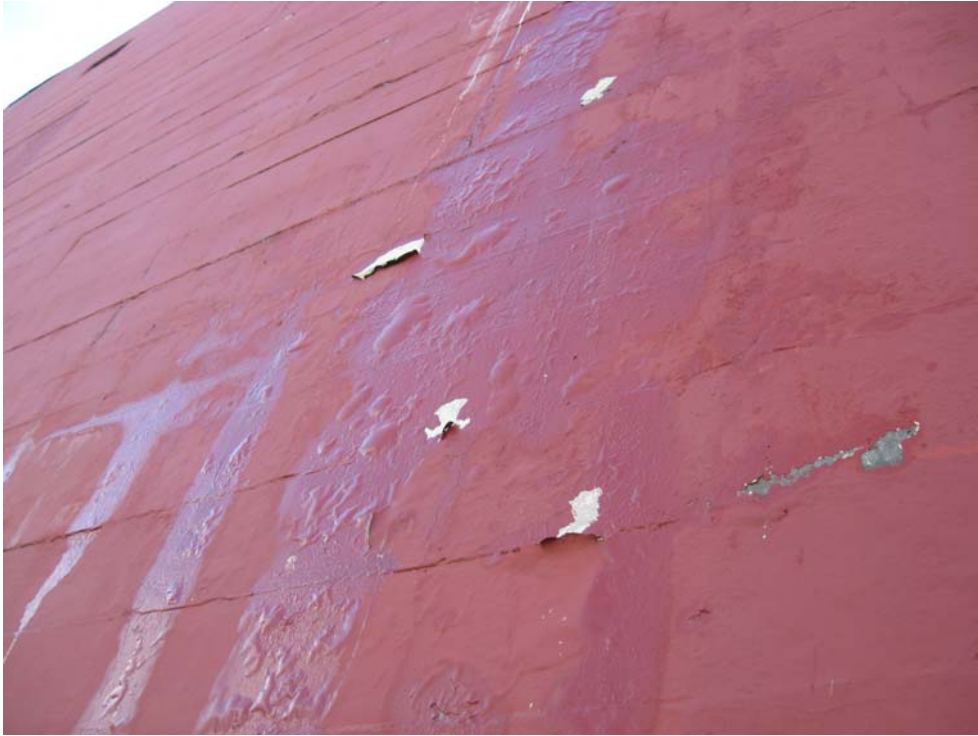
13

13. Water damage over the exterior wall.

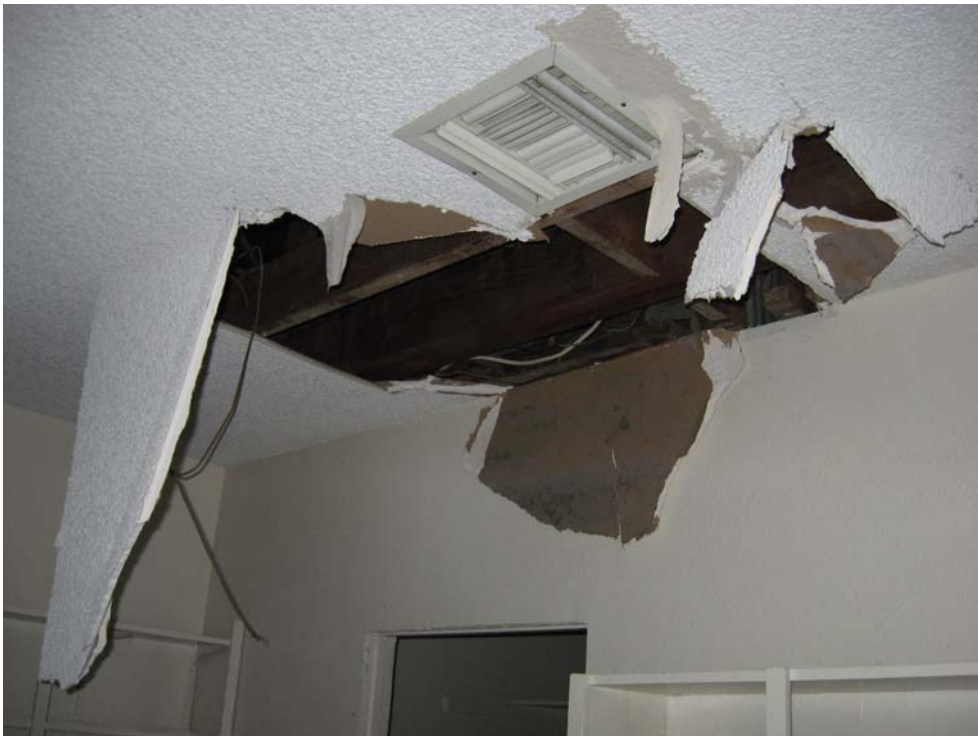
14

14. Water damage on the former church mezzanine level.

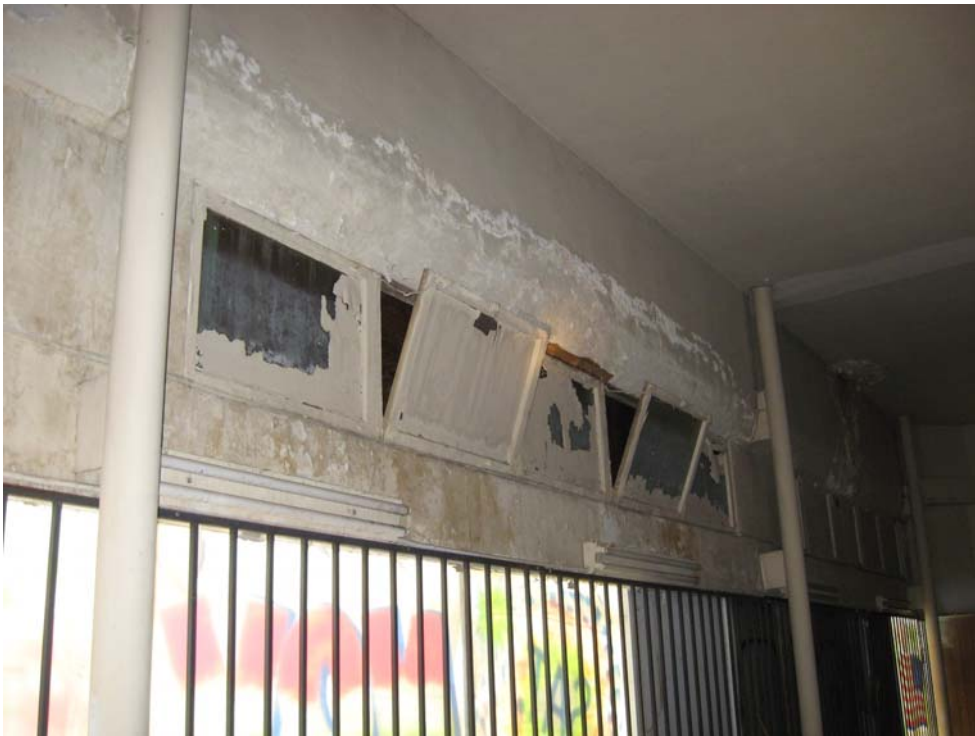
16

16. Water damage in the former furniture store.

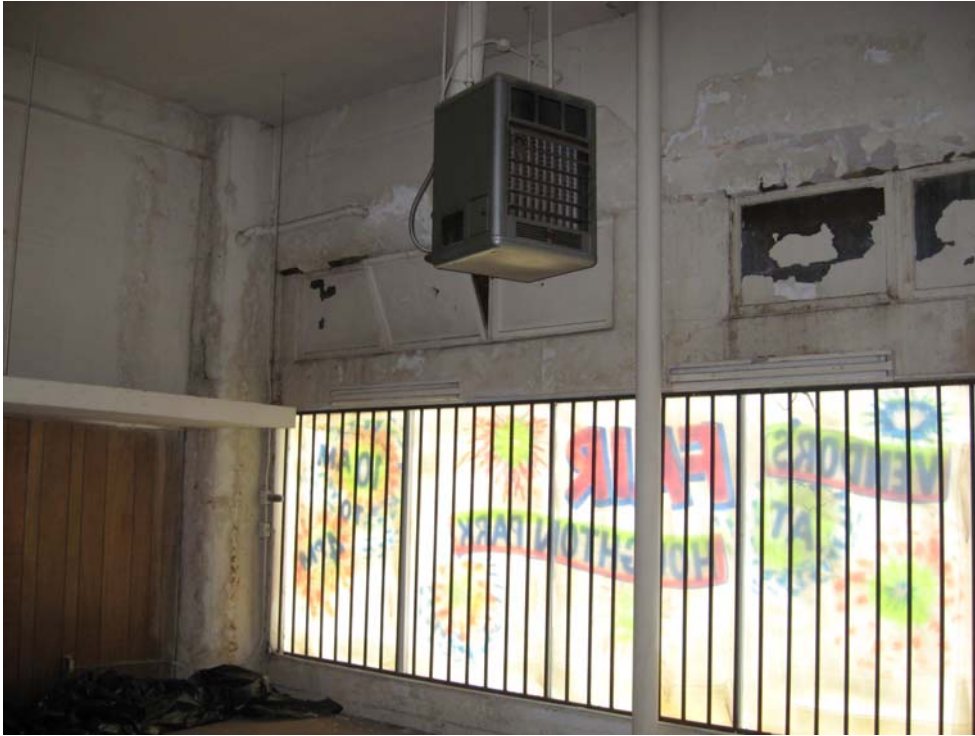
17

17. Water damage in the former furniture store.

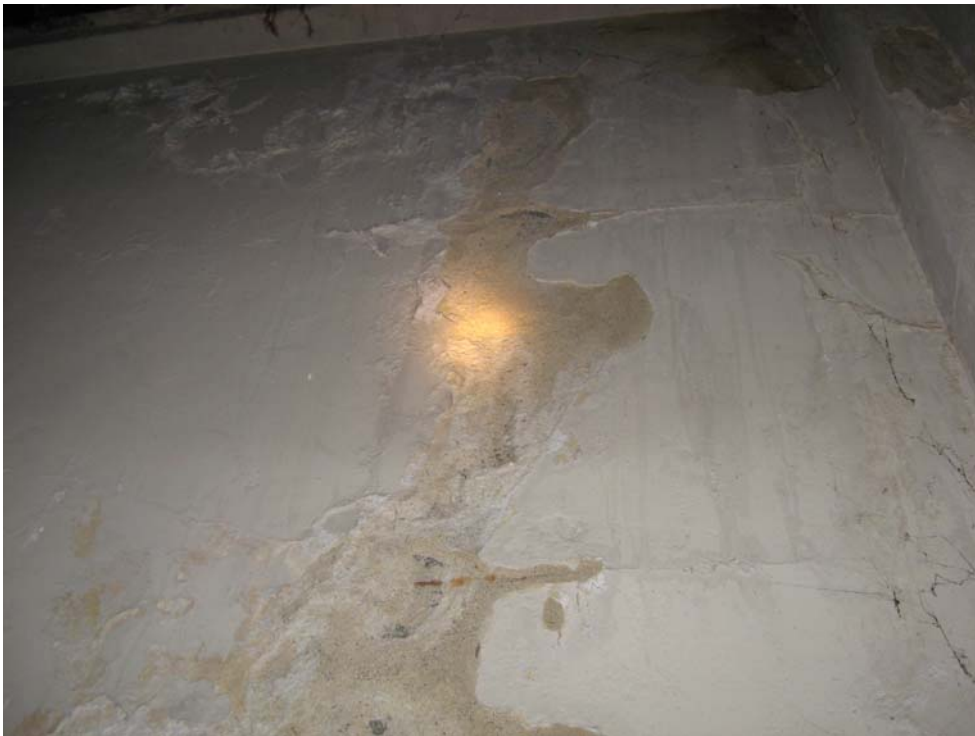
18

18. Water damage in the interior walls of the furniture store.

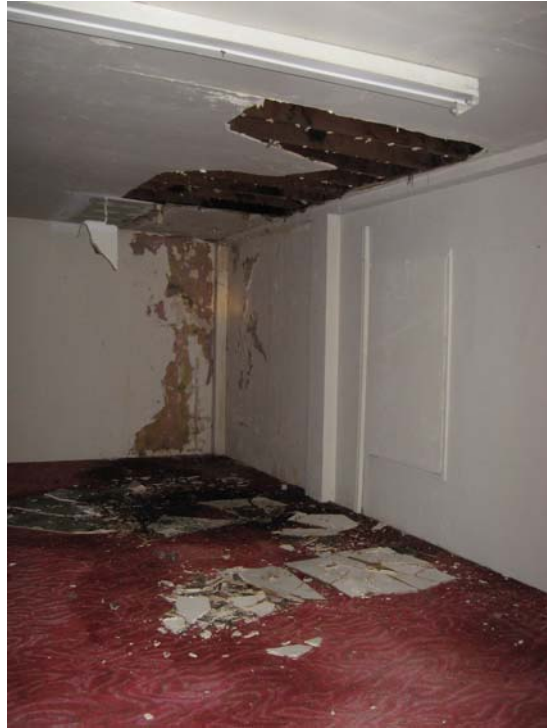
19

Access to the roof was not available during the March 2010 site visit. The roofing system consists of a built-up membrane with mineral faced capsheet. During the March 2010 site visit numerous active roof leaks were observed throughout the building. In several locations the plaster ceilings have collapsed and mold was visible on wall and ceilings. The membrane is in poor condition and needs to be replaced.

19. Active roof leak and damage inside the former furniture store.

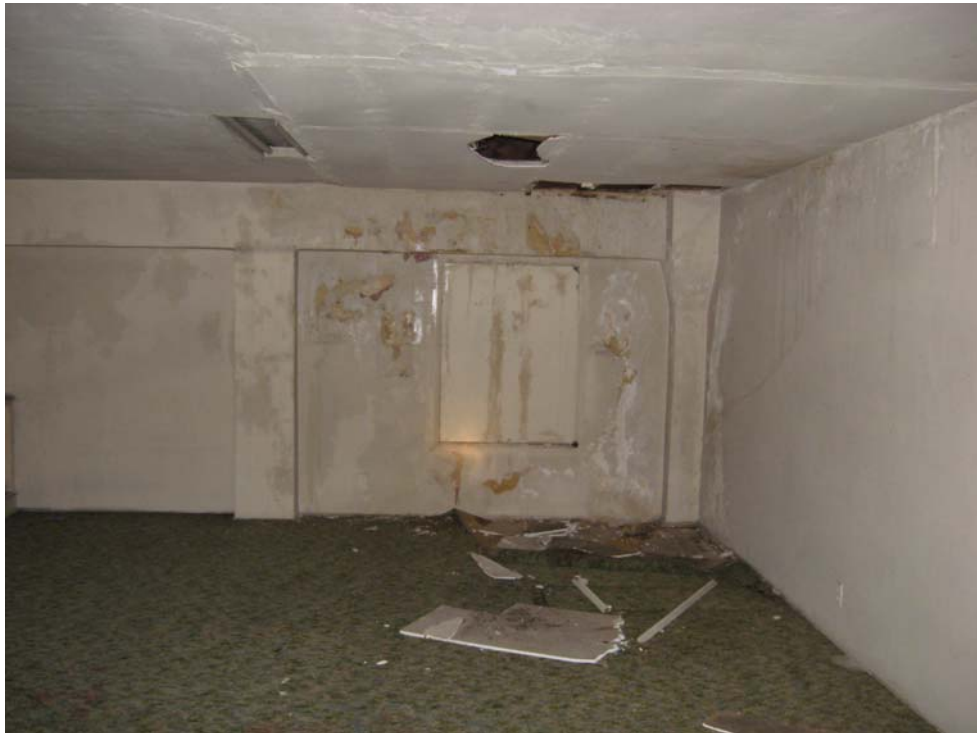
20

20. Active roof leak and damage inside former furniture store.

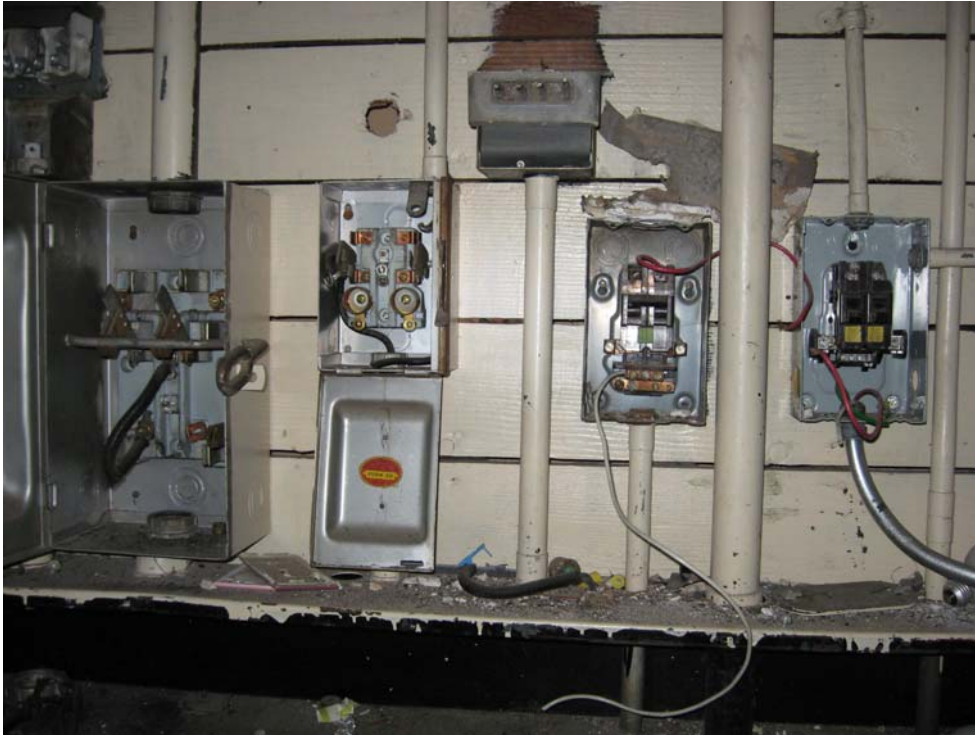
21

Electrical service is provided overhead by Southern California Edison (SCE) to electrical meters located in an electrical closet on the northeast corner of the building. The electrical service has been vandalized and needs to be replaced.

21. Vandalized electrical equipment.

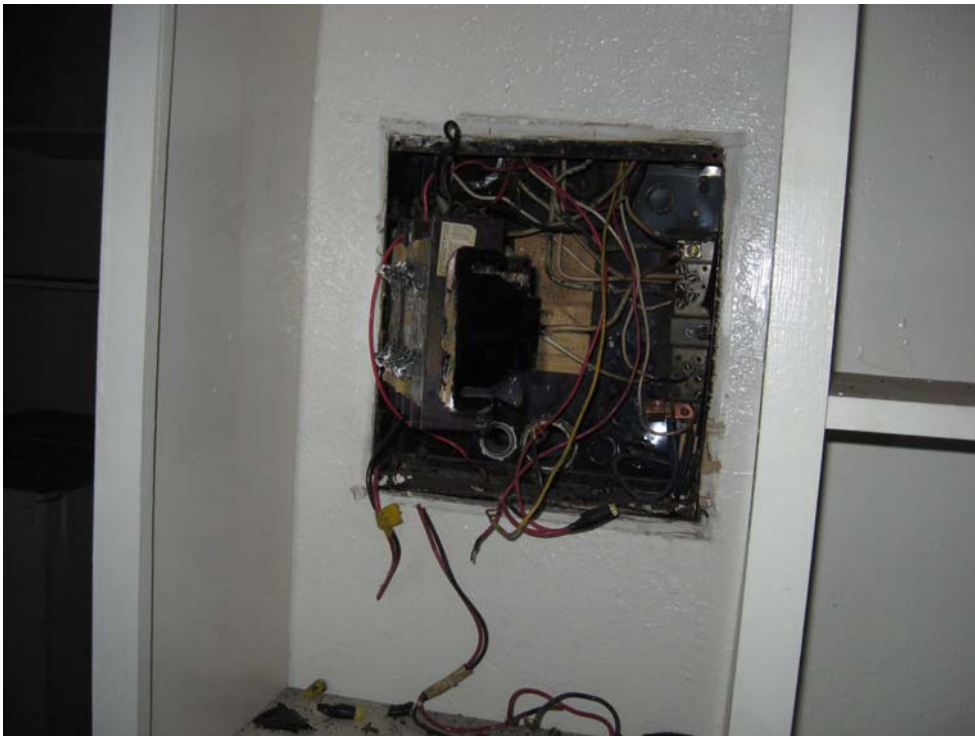
22

22. Electrical panel stripped of wires.

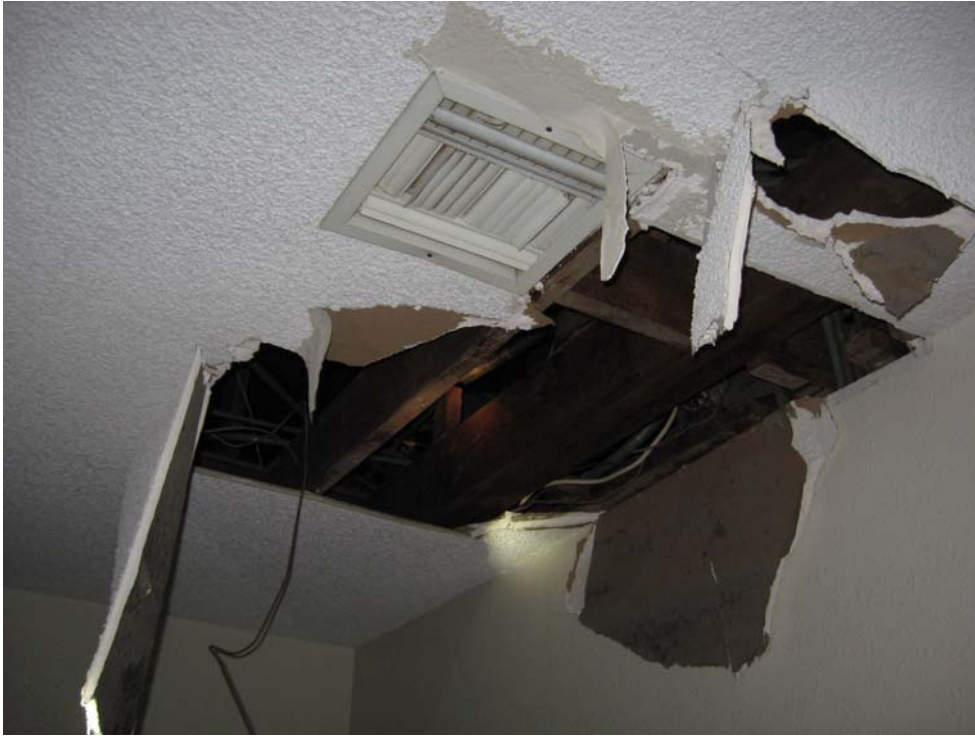
23

23. Water damage to the ceilings is evident throughout.

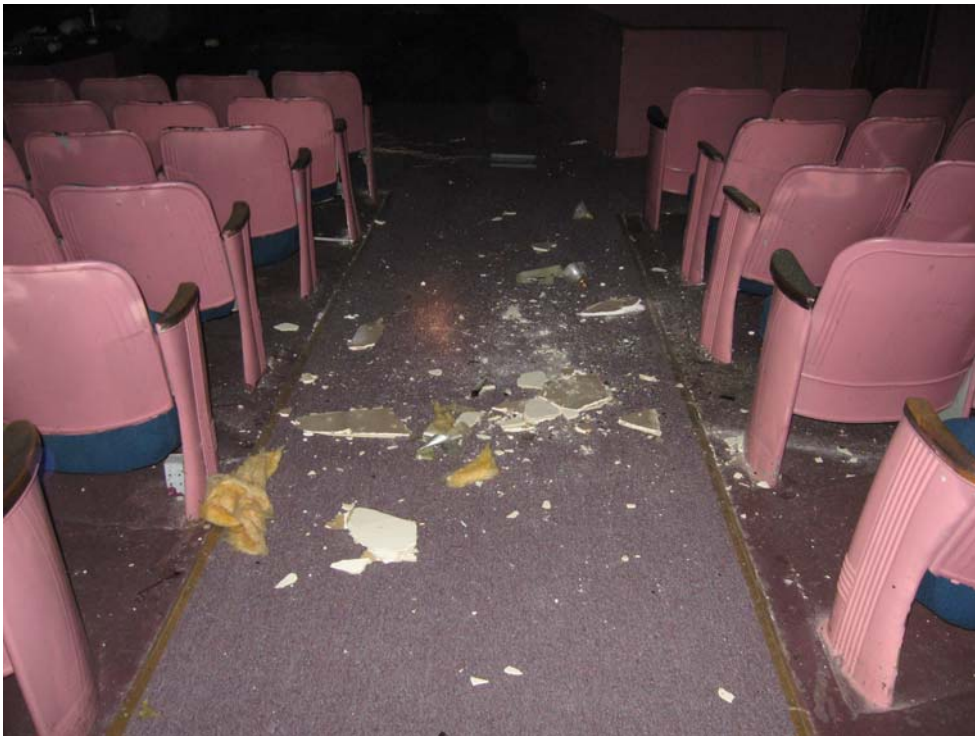
24

24. Water damage from the ceiling of the auditorium is evident throughout.

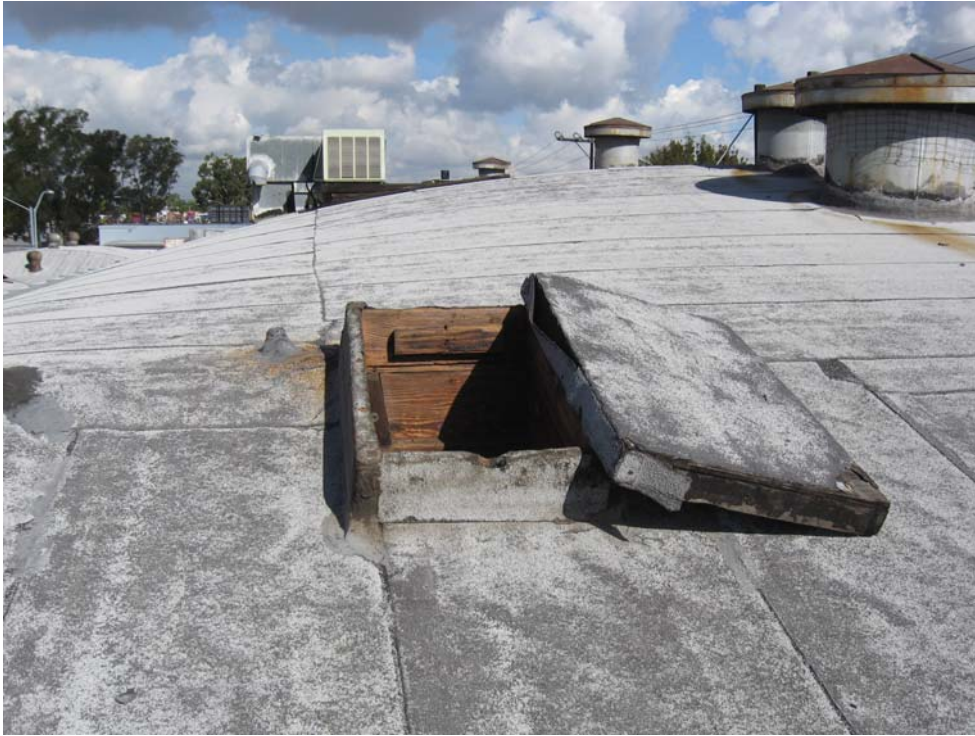
27

27. Roof hatch is unsafe and not up to code.

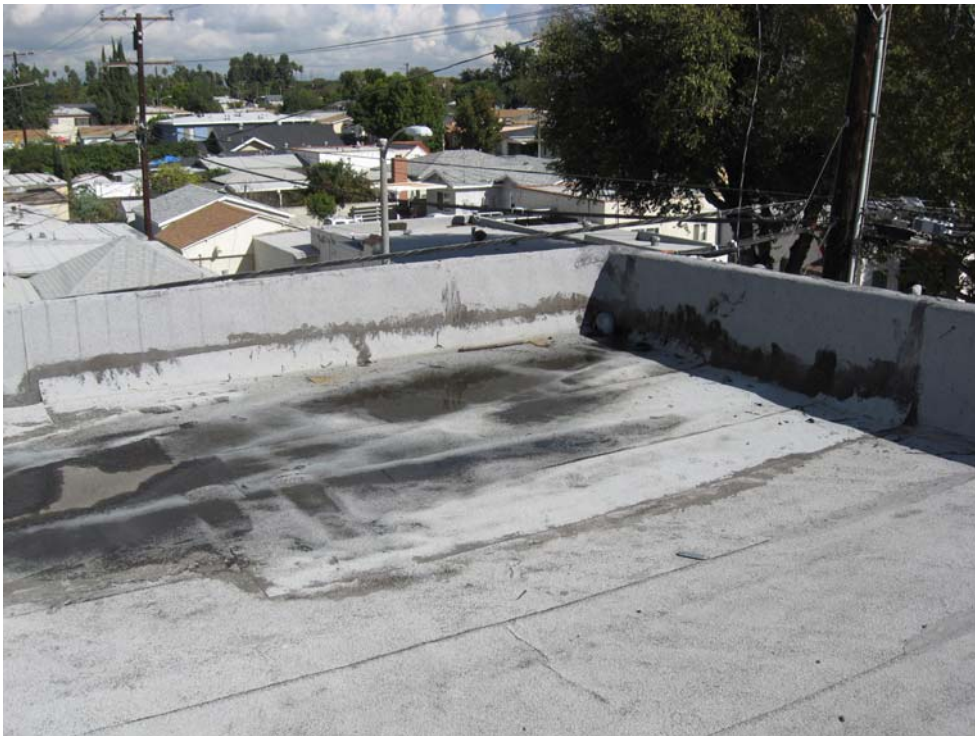
30

30. Poor condition of the roof.

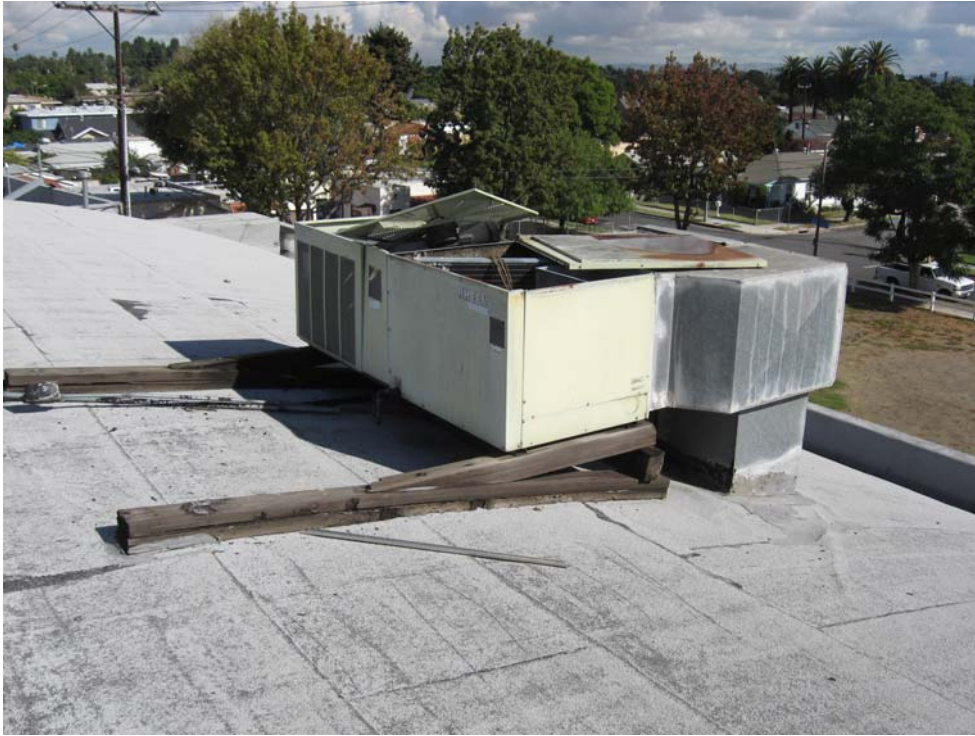
31

The mechanical system for the building has been vandalized and no longer useable. It consisted of three roof mounted packaged heat pump units that served the church. The units were manufactured by *Rheem* and provided approximately 3 to 5 tons of cooling each. The tags on the units were missing making a definitive identification impossible. The units are in poor condition and need to be replaced. The furniture store is not air conditioned. Two old evaporative coolers are mounted on the roof. These coolers are in very poor condition and need to be replaced. Two suspended unit heaters provide heat in the furniture store.

31. Mechanical units on the roof have been vandalized.

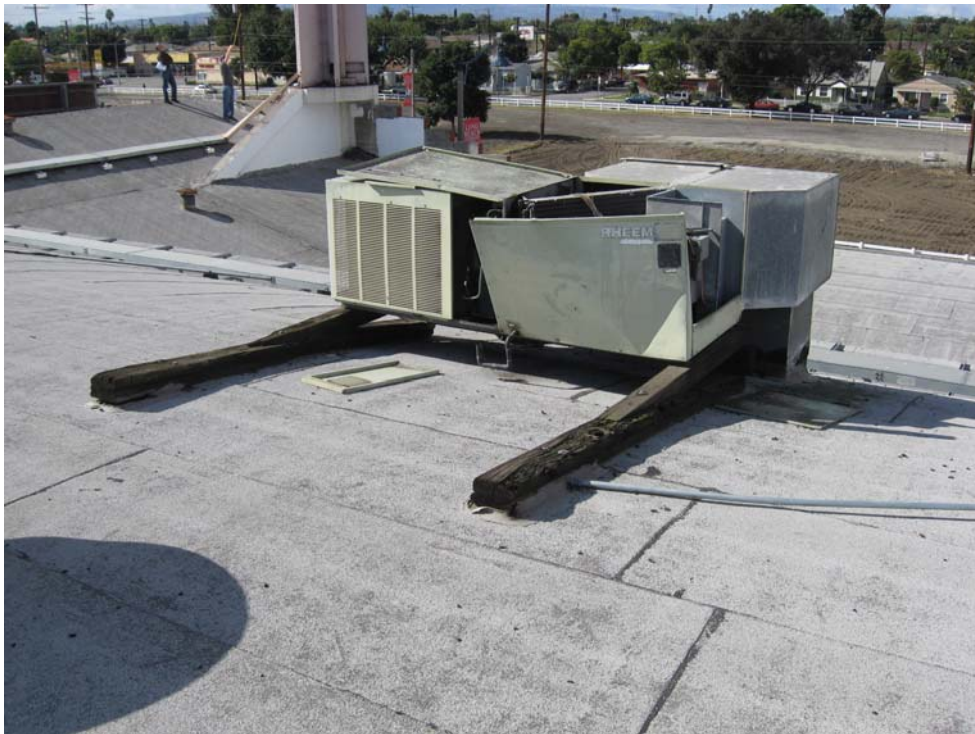
32

32. Vandalized mechanical equipment.
