**DRAFT
ARCHITECTURAL BUDGET COST MODEL
OF**

**5870-5874 ATLANTIC AVENUE
LONG BEACH, CALIFORNIA**

**THE CITY OF LONG BEACH
REDEVELOPMENT AGENCY**

**File No. 110018
April 2010**

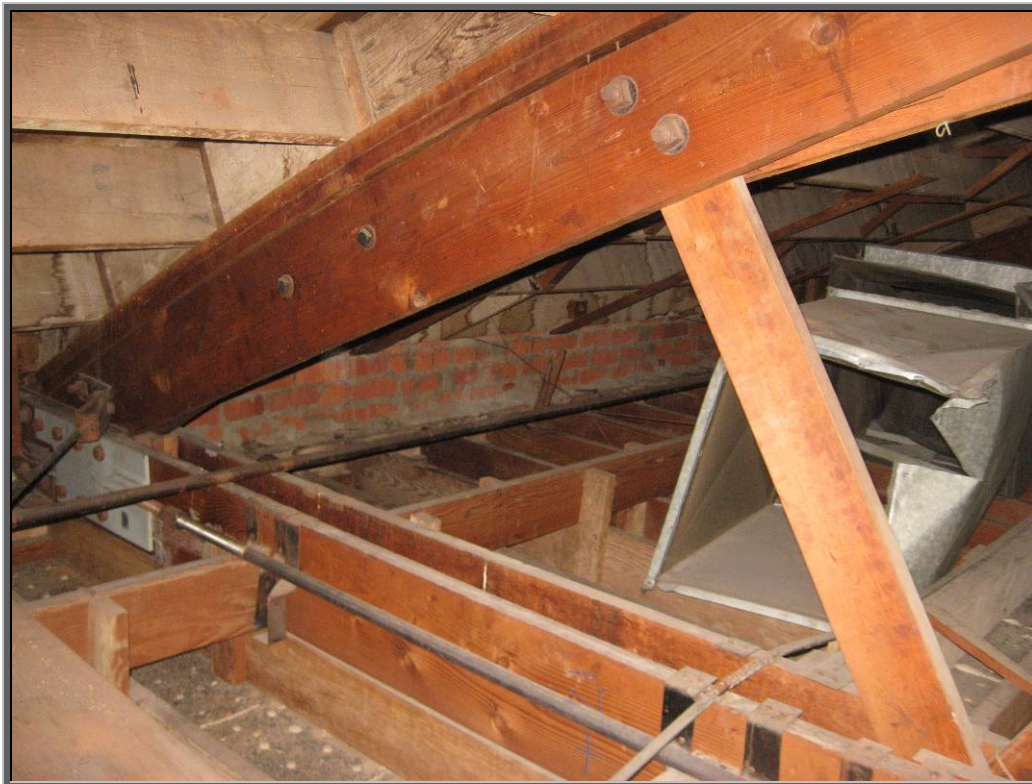
- The barrel-shaped roof structures are constructed using long-span fabricated wood trusses. As these truss assemblies age, local stress concentrations in the truss chords, webs, and connections caused by knots, bolt holes, and loaded end and edge conditions can cause sudden failure. The degree of risk is influenced by the age of the assemblies and the conservatism of the original design and construction. This situation can be further aggravated when added loads associated with mechanical or tenant improvement systems are added to the roof structure.

Photo 5: Typical strengthened bowstring truss.

The existing trusses will require strengthening. Strengthening measures would include the addition of two post-tensioned steel rods along side the bottom chord of each truss. The rods are designed to act as tension members in the event that the vulnerable truss bottom tension chords fail. Attachment of the rods to the trusses would consist of steel brackets bolted to each side of the truss chord. Approximately six trusses have previously been strengthened. The existing rods and brackets should be replaced to account for increased roof dead loads and seismic wall anchorage forces.

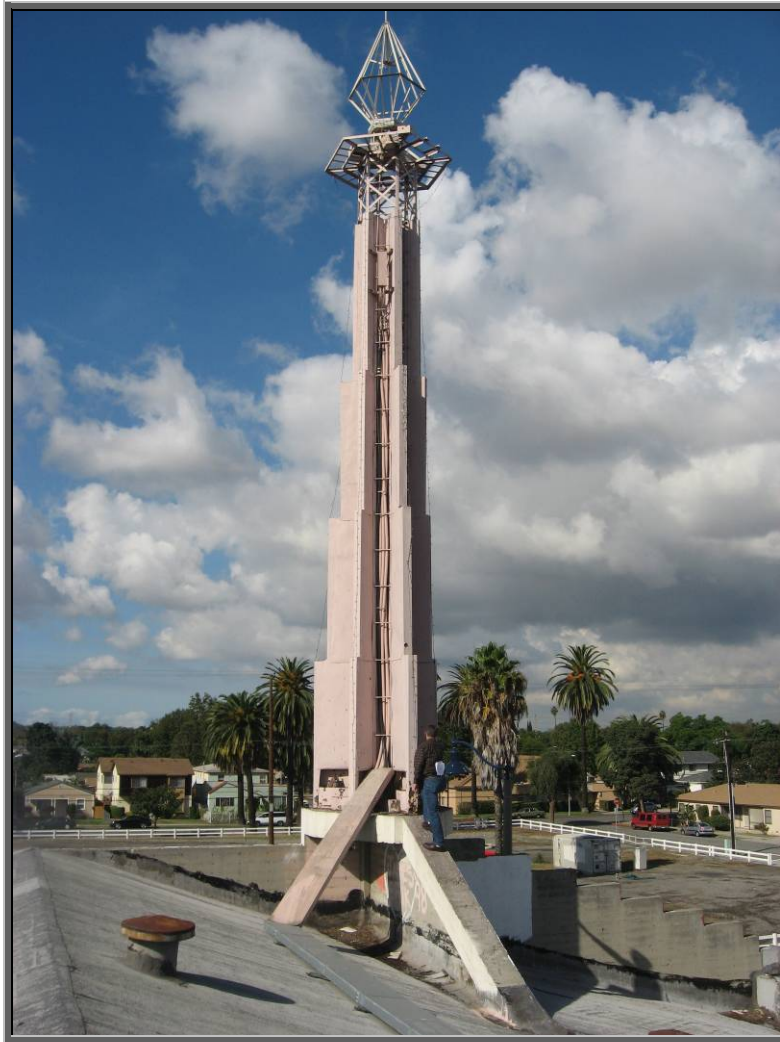
- There is evidence of light to moderate rust corrosion of the steel framed tower. Of particular concern are rusted base plate connections which may have sustained a loss of strength capacity. Structural rehabilitation of the steeple structure is likely warranted. Rehabilitation work will include cleaning and protecting structural steel elements and completing localized member replacement or repair. Additionally, new base connections will likely be required at each leg of the steeple (6 total). Each new base connection will consist of a steel base plate that is welded to the existing steeple column and anchored to the existing concrete platform with new threaded rods set in epoxy. The rehabilitation work will require the removal and replacement of the existing sheet metal steeple cladding in order to gain access to the concealed structural members.

Photo 7: Church steeple.

Documentation of the existing tower framing and evaluation of its ability to withstand design seismic forces will be required. Further structural strengthening may be required if the tower frame is found to be deficient.
