PARSONAGE RESIDENCE
640 PACIFIC AVENUE
LONG BEACH, CALIFORNIA 90813

HISTORIC STRUCTURE REPORT

Katie Rispoli Keaotamai
Master of Heritage Conservation
on behalf of
KEAOTAMAI, LLC
July 12, 2018

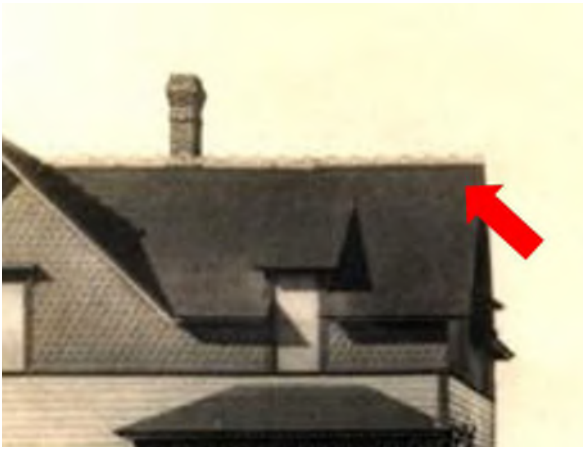
<p>Roof Cresting in Historic Photograph, Primary Elevation</p>	Decorative metal cresting originally existed on the building, and followed the line of the roof gables. In the above photograph, it can be seen spanning this form, and is noticeably differentiated from the brick texture of the chimney rising from the rear of the building. The edge of the cresting fronts with the asymmetrical gable on the primary elevation of the building. This cresting was removed at an unknown date.	N/A	No action recommended	N/A
Roof Location: <ul style="list-style-type: none"> Roof 	General Feature

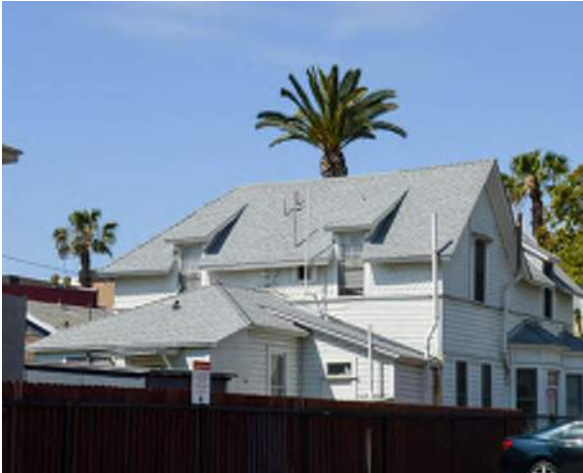
<p>Parsonage Roof, East Elevation, View Southwest</p>	The roof of the building is asymmetrical with a distinguished gable on the primary elevation, and cross gables on both the north and south elevations. Bracketed roof elements exist over select windows. Roof projections are observed over the grouping of three windows on the north elevation, and over the Box-Bay window on the northwest corner of the first story. In addition, there is a roof projection from the primary elevation over the entry porch. The cross gables on the north and south elevations have an open-eave roof-wall junction.	Relocation Preparation Relocation Reassembly Rehabilitation	Prior to relocation, the roof will be separated from the first floor of the residence along with the second story walls of the residence. This portion of the building will be supported with a steel beam system and lowered onto dollies for relocation. Once relocated, the roof and second story will be re-connected with the first story atop the new foundation according to the approach determined by Melvyn Green & Associates (Attachment B.) During rehabilitation, damaged interior roof framing will be removed and replaced with like materials. Exterior roof cladding will be replaced with new asphalt shingle cladding.	Following the Secretary's Standards for Rehabilitation, the roof form will not be altered as it is considered characteristic of the historic nature of the building. Additionally, deteriorated interior wood framing or other damaged components will be repaired rather than replaced when possible. When replaced, the new materials will match the original in design, color, texture, and (if possible) material. Asphalt roofing will be used in lieu of conjecture in choosing a period-appropriate roof material.

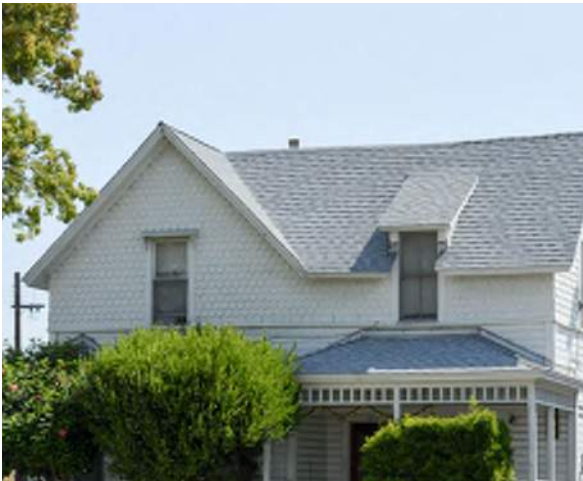
Asymmetrical Roof Gable Location: <ul style="list-style-type: none"> Roof, Primary (West) Elevation 	Historic Character-Defining Feature

<p>Roof Gable on West Elevation, View Northeast</p>	The use of a gabled roof in an asymmetrical fashion is consistent with roof typologies of the Stick Style. The gable only slightly projects from the wall of the building, and has an open eave on its northernmost edge, which continues to a cross gable on the north elevation. A cross gable is also prominent on the south elevation.	Relocation Preparation Relocation Reassembly Rehabilitation	Prior to relocation, the roof will be separated from the first floor of the residence along with the second story walls of the residence. This portion of the building will be supported with a steel beam system and lowered onto dollies for relocation. Once relocated, the roof and second story will be re-connected with the first story atop the new foundation according to the approach determined by Melvyn Green & Associates (Attachment B.) During rehabilitation, gable trim will be replaced, if damaged, with like materials and repaired where possible.	Following the Secretary's Standards for Rehabilitation, the roof form will not be altered as it is considered characteristic of the historic nature of the building. Additionally, deteriorated wood or other damaged components will be repaired rather than replaced when possible. When replaced, the new materials will match the original in design, color, texture, and (if possible) material. Asphalt roofing will be used in lieu of conjecture in choosing a period-appropriate roof material.

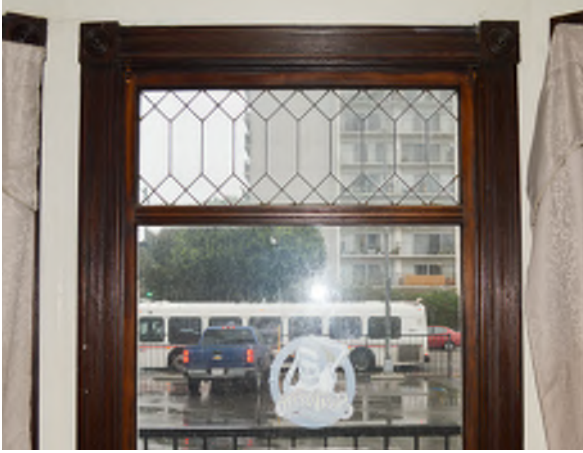
<p>Wood Window on North Elevation, View North</p>	<p>All original windows throughout the residence are wood. A number of original windows are unpainted, while some are painted.</p>	<p>Relocation Preparation</p> <p>Reassembly</p> <p>Rehabilitation</p>	<p>For treatment approach of wood windows, see the treatment for "Bracketed Rectangular Windows" in this attachment. Additionally, windows which house leaded glass must be removed prior to relocation to ensure protection of original glasswork.</p>	<p>Following Standards for Rehabilitation, damaged windows will be repaired rather than replaced. Extensive care and caution will be taken to ensure that windows are not damaged beyond repair in the course of this relocation. As a backup, windows in the kitchen addition (which were matched to original windows at the time of that addition's construction) will be removed and stored with original windows for use if needed.</p>

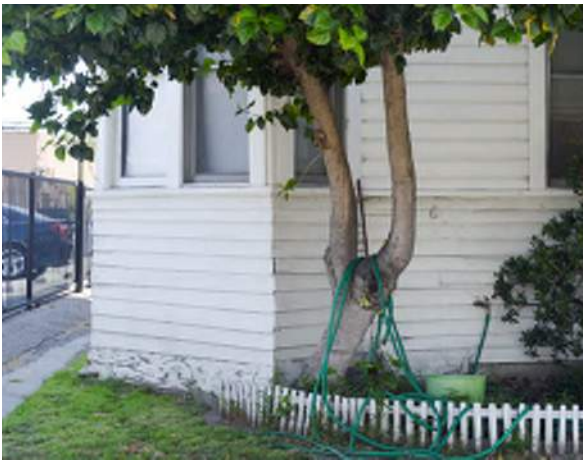
<p>Box-Bay Window on Northwest Corner, View East</p>	<p>The Box-Bay window is consistent with the Stick Style, popular during the period of historic significance. The Box-Bay window consumes the northwest corner of the first story of the building, and contains four windows which are vertically-oriented.</p>	<p>Relocation Preparation</p> <p>Rehabilitation</p>	<p>Prior to disassembly, windows within the Box-Bay window should be removed and their openings framed with wood supports to reduce risk of damage. Alternatively, windows may stay in place with wood bracings with the consent of the City of Long Beach. After relocation, waterproofing around window edges should be replaced with new which does not visually disrupt the features of the building, and window frames should be cleaned prior to installation. Any windows which have suffered broken glass should be fitted with contemporary tempered glass.</p>	<p>Following Standards for Rehabilitation, damaged windows will be repaired rather than replaced. Extensive care and caution will be taken to ensure that windows are not damaged beyond repair in the course of this relocation. As a backup, windows in the kitchen addition (which were matched to original windows at the time of that addition's construction) will be removed and stored with original windows for use if needed.</p>

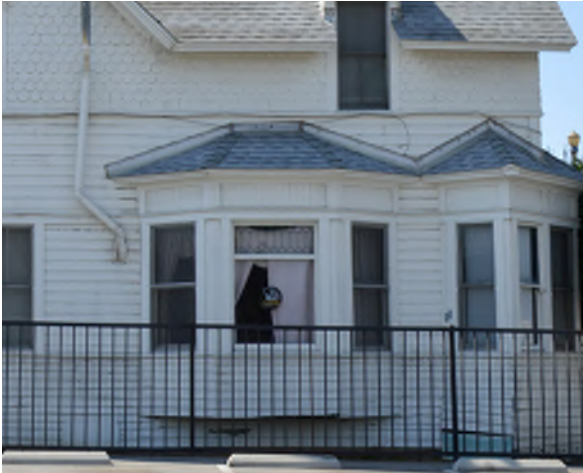
<p>Feature Observed on North Elevation, View South</p>	<p>On the North elevation of the building is a grouping of three windows. This grouping is comprised of one primary window with a decorative leaded glass inlay in the upper portion, flanked on either side by a vertically-oriented rectangular window. Above this grouping of windows are ornamental wood panels.</p>	<p>Relocation Preparation</p> <p>Reassembly</p> <p>Rehabilitation</p>	<p>All ornamental wood panels on the exterior, including those above the Box-Bay window, should be retained. Damaged wood portions within the panels should be replaced by new, compatible in size and material. The panels and their surrounds should be repainted to match the building's original color scheme. Treatment direction for this window bay should follow the direction for treatment regarding the Box-Bay window.</p>	<p>Following the Secretary's Standards for Rehabilitation, damaged wood panels and wood elements of this feature will be repaired rather than replaced when possible. When replaced, the new materials will match the original in design, color, texture, and (if possible) material. Replaced shingles and clapboard siding will be painted to match existing.</p>

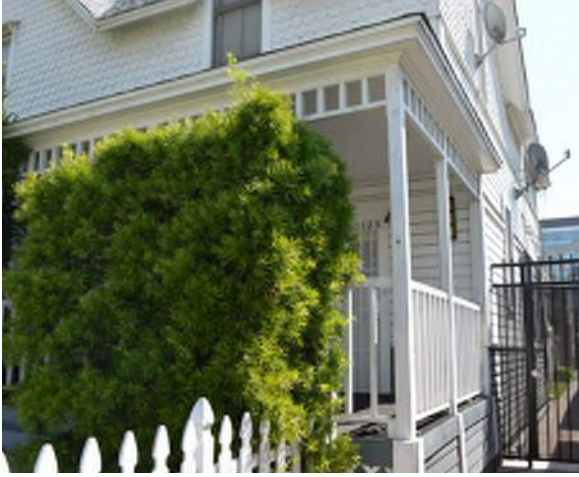
<p>Porch on West Elevation, View Northeast</p>	<p>The wood porch on the primary elevation is simplistic, following plain aesthetics popular of Single Style around the date of construction. The porch is comprised of minimal posts with a simplistic fence, as well as a simplistic frieze comprised of rectangular wood components which line the roof above.</p>	<p>Relocation Preparation</p> <p>Relocation</p> <p>Reassembly</p> <p>Rehabilitation</p>	<p>Prior to relocation, the porch will be wood-framed vertically and with cross-beams between each post to ensure structural integrity throughout the move. In rehabilitation, damaged porch materials will be repaired where possible and replaced with like materials where necessary. A new hand railing will be constructed on the right side of the staircase, modeled after the existing railing on the left as it exists prior to relocation. As part of an exterior restoration, the porch and all of its components should be painted to match the building's original color scheme.</p>	<p>Following the Secretary's Standards for Rehabilitation, damaged wood components of this feature will be repaired rather than replaced when possible. When replaced, the new materials will match the original in design, color, texture, and (if possible) material. Replaced materials will be painted to match existing.</p>

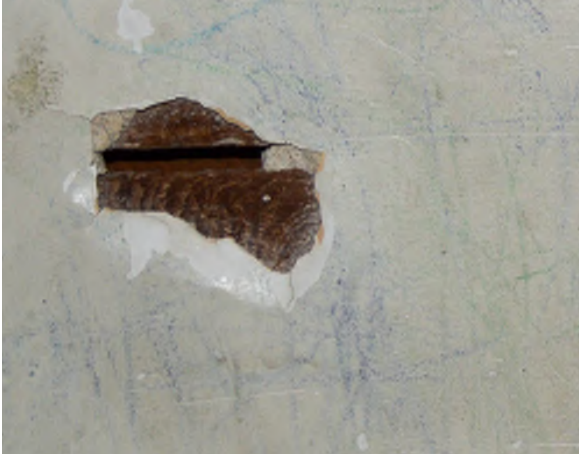
<p>Exposed Lath and Plaster on Interior</p>	<p>The interior walls are made of wood lath with plaster. Plaster is roughly 0.25 to 0.5 inches deep. The plaster is in fair condition in nearly all rooms throughout the building, and has separated from the wall where lath is exposed in some instances.</p>	<p>Relocation Preparation</p> <p>Rehabilitation</p>	<p>It is likely that lath and plaster wall structures will be severely compromised throughout the course of relocation. Restoration of these features will be costly and intensive. The replacement of these materials with in-kind is financially infeasible for the project. Though plaster repair may be performed in select areas where feasible, the majority of the building's interior will be re-clad with drywall in lieu of lath and plaster to replace damaged portions of interior walls.</p>	<p>Following the Secretary's Standards for Rehabilitation, damaged components of this feature will be repaired rather than replaced when possible. When replaced, the new materials will match the original in design and color. Replaced materials will be painted to match existing.</p>

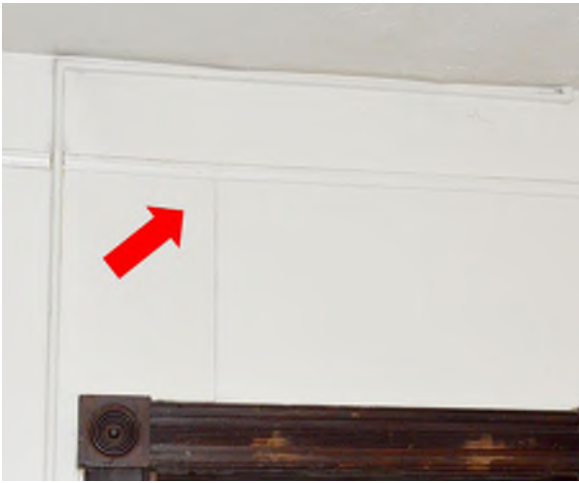
<p>Interior Picture Rail Molding</p>	<p>Roughly 1 foot from parlor room ceilings runs a narrow band of wood picture rail molding, originally used to hang artwork and portraits in lieu of damaging plaster walls. The wood band runs from the fireplace edge around the Box-Bay window, and is raised from the wall.</p>	<p>Rehabilitation</p>	<p>Picture rail molding will be retained throughout the course of rehabilitation. If plaster walls housing picture molding are damaged beyond repair as a result of relocation, new picture rail matching the original in size and shape will be installed atop new drywall to effectively continue this historic feature.</p>	<p>Following the Secretary's Standards for Rehabilitation, damaged components of this feature will be repaired rather than replaced when possible. When replaced, the new materials will match the original in design and color. Replaced materials will be painted to match existing.</p>

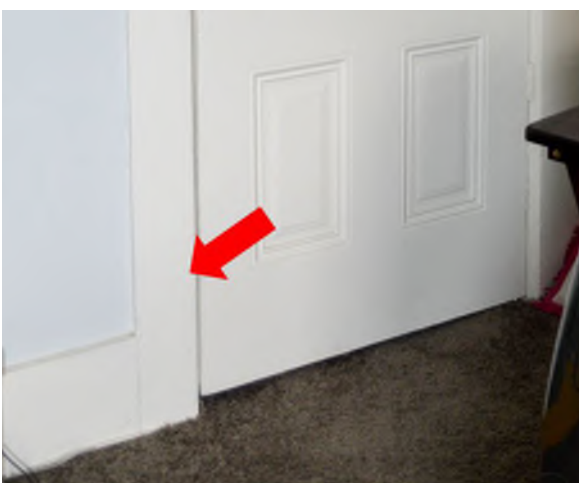
<p>Feature as Observed Throughout Interior</p>	<p>Wood baseboards, 6 inches wide, and door frames, 4 inches wide, are noted throughout upstairs and downstairs. These wood components are simplistic and in most cases bear no ornament. Many of have been painted.</p>	<p>Rehabilitation</p>	<p>Upstairs baseboards will be compromised by the act of disassembly, and will not be salvageable during the rehabilitation process. Downstairs baseboards and door frames should be cleaned and painted as appropriate following relocation.</p>	<p>Following the Secretary's Standards for Rehabilitation, damaged components of this feature will be repaired rather than replaced when possible. When replacement is chosen as the course of action, the new materials will match the original in design and color. Replaced materials will be painted to match existing.</p>

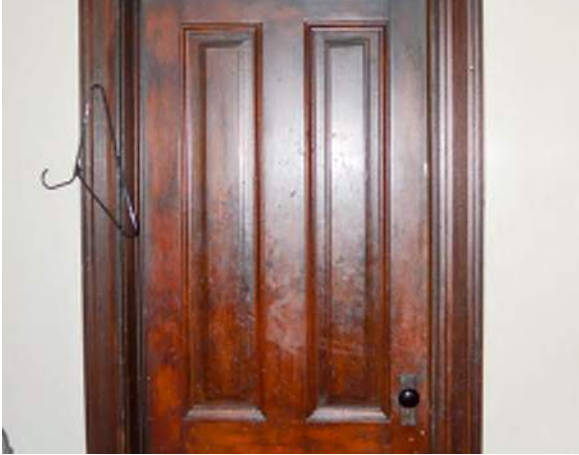
<p>Interior Wood Panel Door</p>	<p>Wood panel doors are observed throughout the interior. These doors, original to the building, are identified by the placement of two inset wood panels, rectangular in nature, which run vertical down the upper two thirds of the door surface. The lower two thirds of the door surface contains two inset wood panels of smaller rectangular nature. Several of these doors remain, however only two are unpainted.</p>	<p>Rehabilitation</p>	<p>Wood panel doors will be stripped of finishing with care not to damage historic fabric. Following removal of varnish and other elements, holes in wood panel doors should be filled with suitable wood filler, and then wood should be lightly sanded, stained, and sealed if appropriate to match current stain. Painted wood panel doors may receive a new coat of paint, and those unpainted should be stained and varnished to match the existing color.</p>	<p>Following the Secretary's Standards for Rehabilitation, any doors damaged throughout the course of relocation will be repaired rather than replaced when possible. When replaced, the new materials will match the original in design, color, and texture. Replaced materials will be painted or treated to match existing.</p>

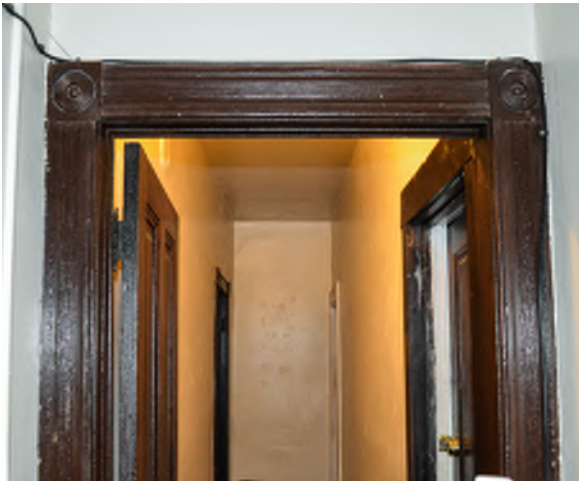
<p>Interior Door Frame Ornamentation</p>	<p>Wood door frames with ornamental dart and carvings are observed throughout the interior, and are particularly prevalent in areas that would have been used for entertaining guests in the Parsonage during its period of significance. These door frames are original to the building.</p>	<p>Rehabilitation</p>	<p>It is recommended that door frames and ornamentation be stripped of finishing with care not to damage historic fabric. Following removal of varnish and other elements, holes in ornamentation and surrounding door frame areas should be filled with suitable wood filler, and then wood should be lightly sanded, stained, and sealed if appropriate to match current stain. Painted door frames may receive a new coat of paint, and unpainted frames should be stained and varnished to match the existing color of undamaged portions of the frame.</p>	<p>Following the Secretary's Standards for Rehabilitation, any door frames damaged throughout the course of relocation will be repaired rather than replaced when possible. When replaced, the new materials will match the original in design, color, and texture. Replaced materials will be painted or treated to match existing.</p>

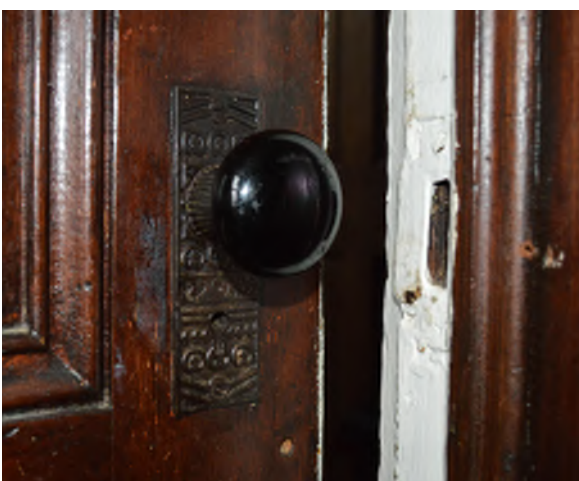
<p>Original Door Hardware</p>	<p>Original door hardware is observed on four doors throughout the residence. In the first story, this hardware is found on the entrance door to the hallway, which would have greeted guests, and on the door to a room off of the dining area, which would have been used for entertaining. This door hardware is ornate in nature and contains a decorative backplate with lock and porcelain door knob. Upstairs door hardware is observed in two instances. In both instances, door knobs have been painted and are accompanied by simplistic backplates.</p>	<p>Rehabilitation</p>	<p>Original door hardware on the first story should be retained and reused following relocation in the rehabilitation of the building. Door hardware on the second story may be reused if desired by the property owner. However, it is in poor condition. If desired, this hardware may be replaced.</p>	<p>Following the Secretary's Standards for Rehabilitation, any damaged door hardware will be repaired rather than replaced when possible. When repaired, abrasive agents or agents which may damage the historic material will not be used. When replaced, the new materials will match the original in design, color, and texture.</p>
