August 5, 2011

Subject: Letter Report for 3801 East Fifth Street (Assessor's Parcel Number 7255-017-013),  
City of Long Beach, Los Angeles County (LSA Project No. LRG1101)

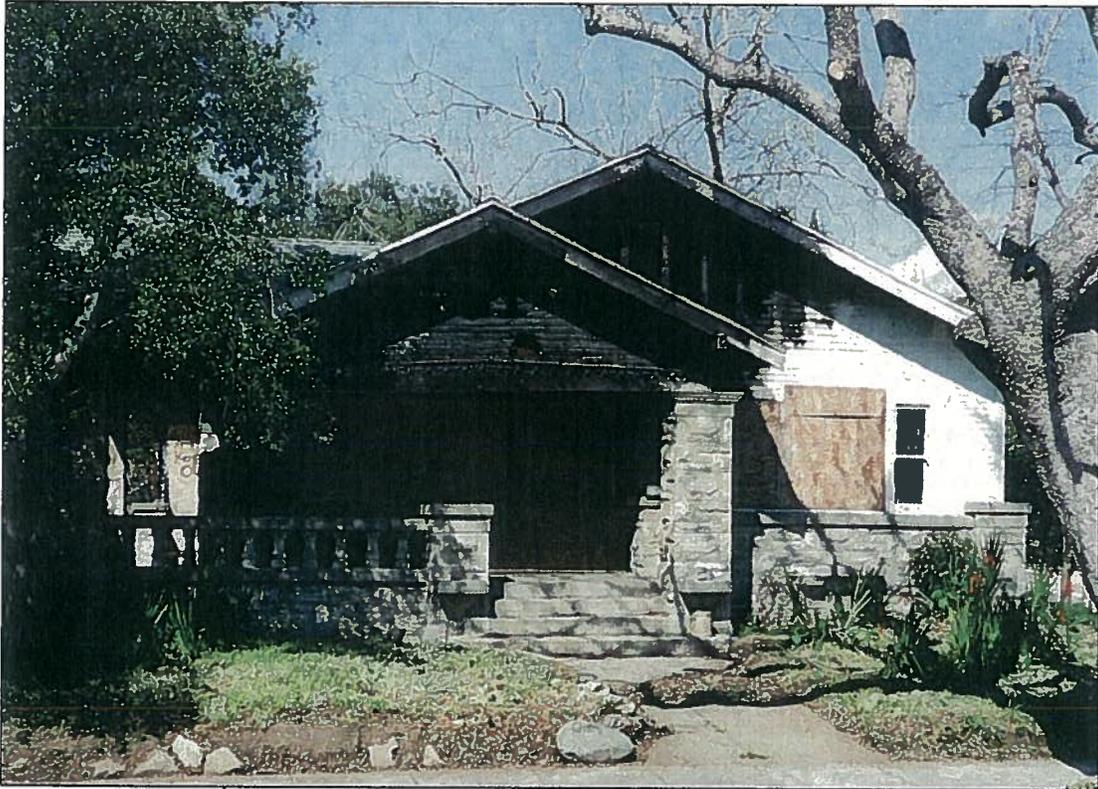
The approximately 1,530-square-foot residence is a typical Craftsman bungalow with an interior floor plan that is generally rectangular. It rests on a raised concrete foundation and is surmounted by a cross-gable roof (Attachment A, Figures 1–3). The exterior walls are sheathed with clapboard siding and there is flat wood trim around the windows. The south-facing façade is dominated by a concrete

Figure 1: 3801 East 5<sup>th</sup> Street, view to the north. (Photograph taken on 2/23/11 and provided by the owner.)

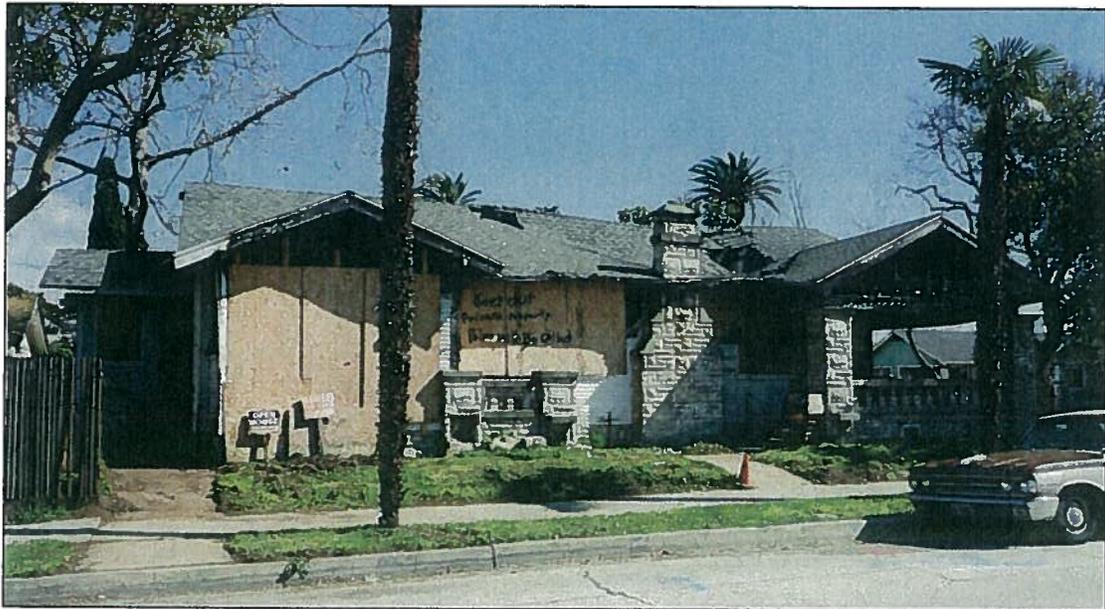
Figure 2: View to the east. (Photograph taken on 2/23/11 and provided by the owner.)

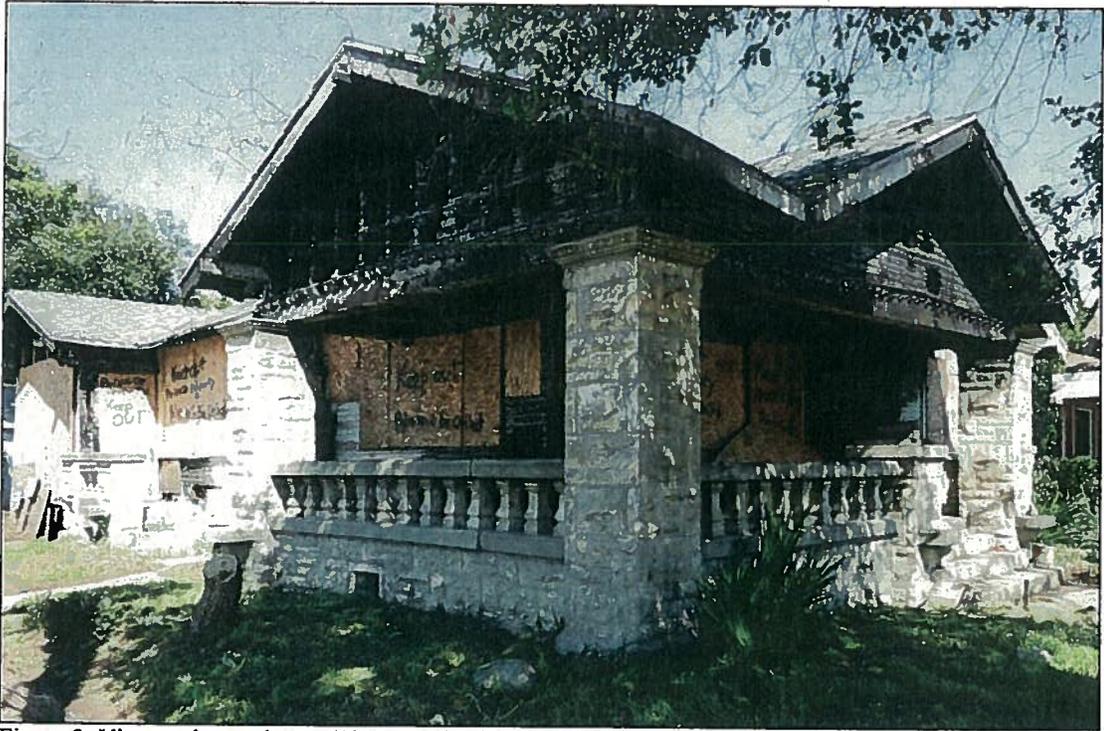
Figure 3: View to the northeast. (Photograph taken on 2/23/11 and provided by the owner.)

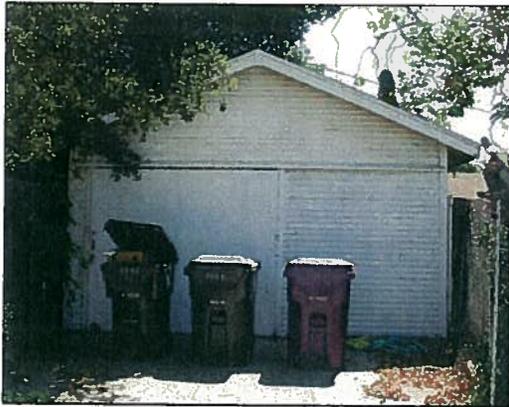
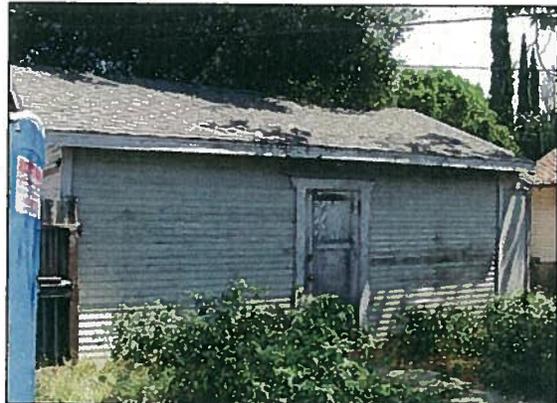
Figures 4 and 5: Detached garage located north of the residence. Views to the east and northeast (7/25/11).

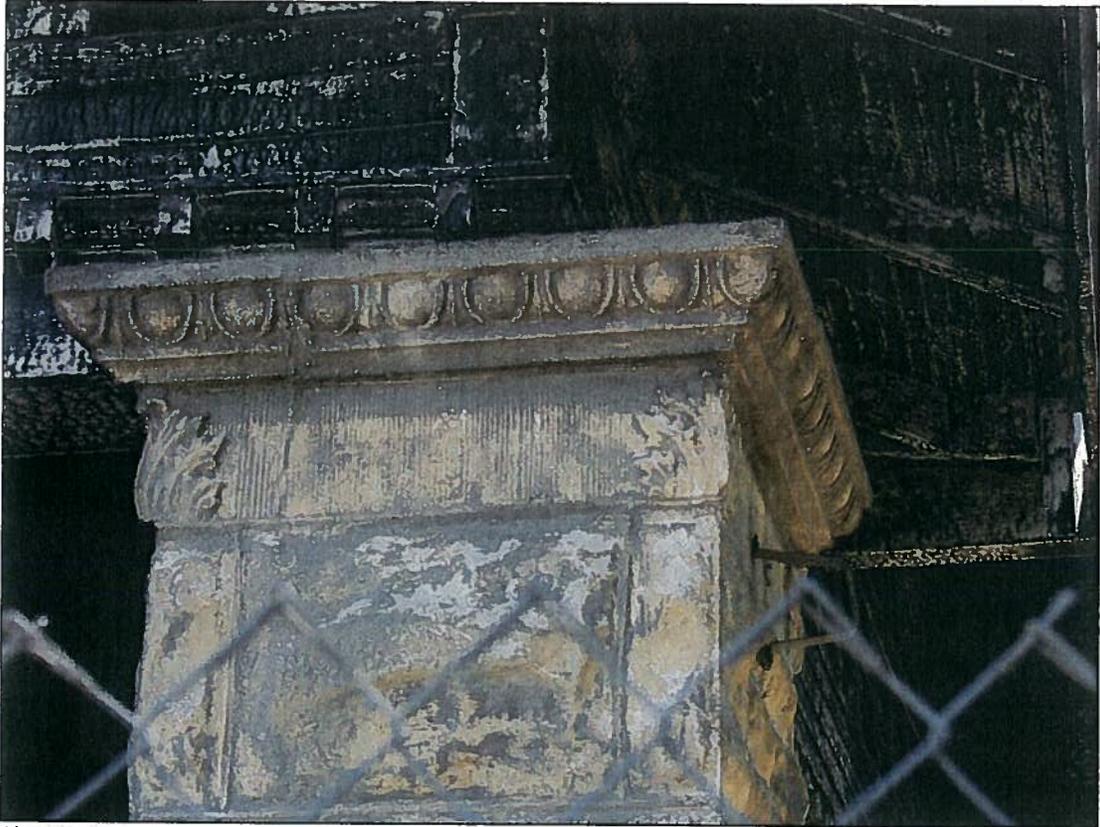
Figure 6: Detail of concrete pier capital.

All of these character-defining features should be preserved to the maximum extent feasible or reconstructed using in-kind (typically wood) materials and specifications. In addition, replacement doors that are reflective of the style and period (typically a combination of wood and glass) should be installed.

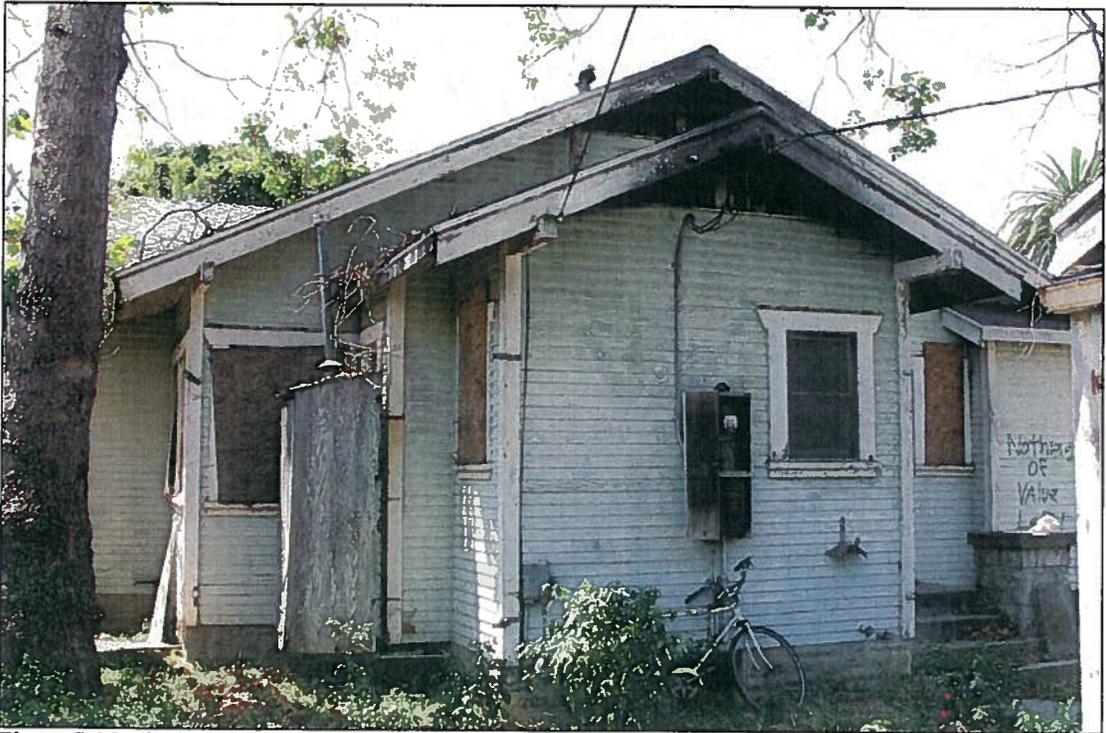
Figure 7: North elevation (rear) of house. View to the southwest (7/20/11).

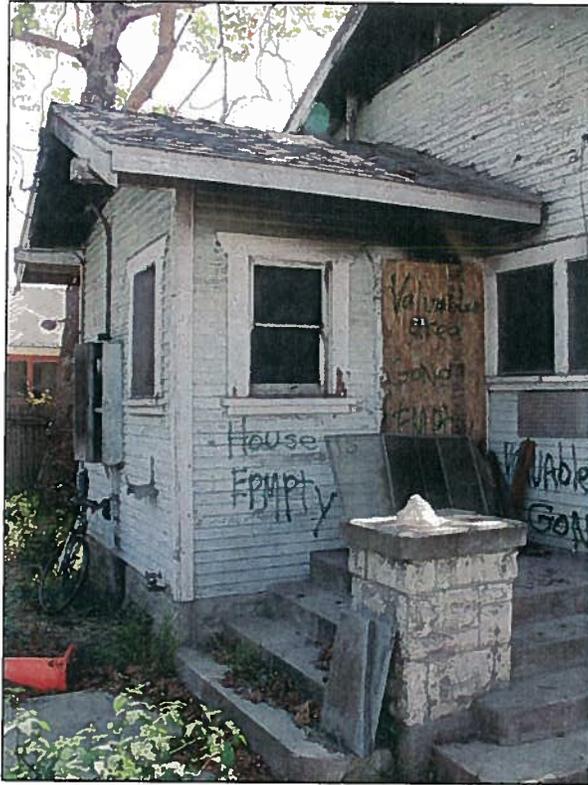
Figure 8: Northwest corner and rear of the residence. View to the southeast (7/20/11).

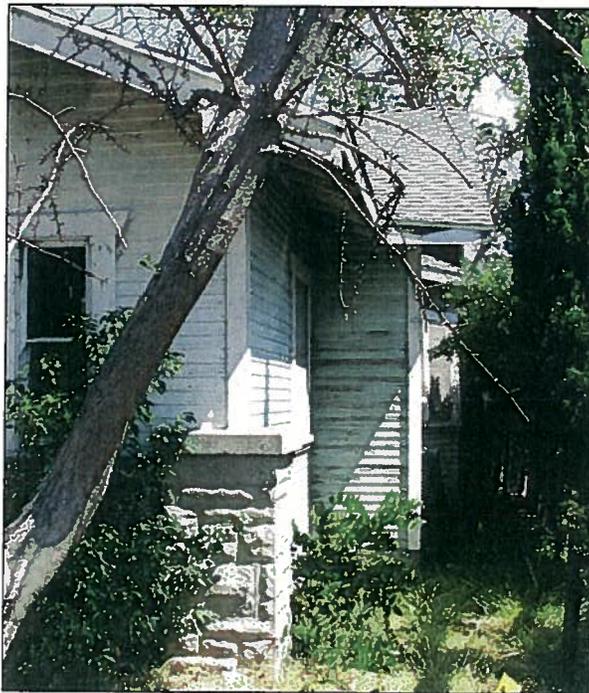
In addition to the wrap-around porch, the west side of the house includes a concrete or stone chimney flanked by projecting gables, wood-framed double-hung windows, boarded-over window and door openings, and concrete steps with a concrete balustrade and piers adjacent to concrete steps that access a south-facing door (Attachment A, Figure 2). The rear of the residence has wood-framed double-hung windows and a small, raised concrete porch with a short concrete pier at the corner (Attachment A, Figures 7 and 8). The east side of the residence has wood-framed double-hung and fixed windows and a bay window (Attachment A, Figure 9).

Figure 9: East side of residence. View to the north (7/20/11).

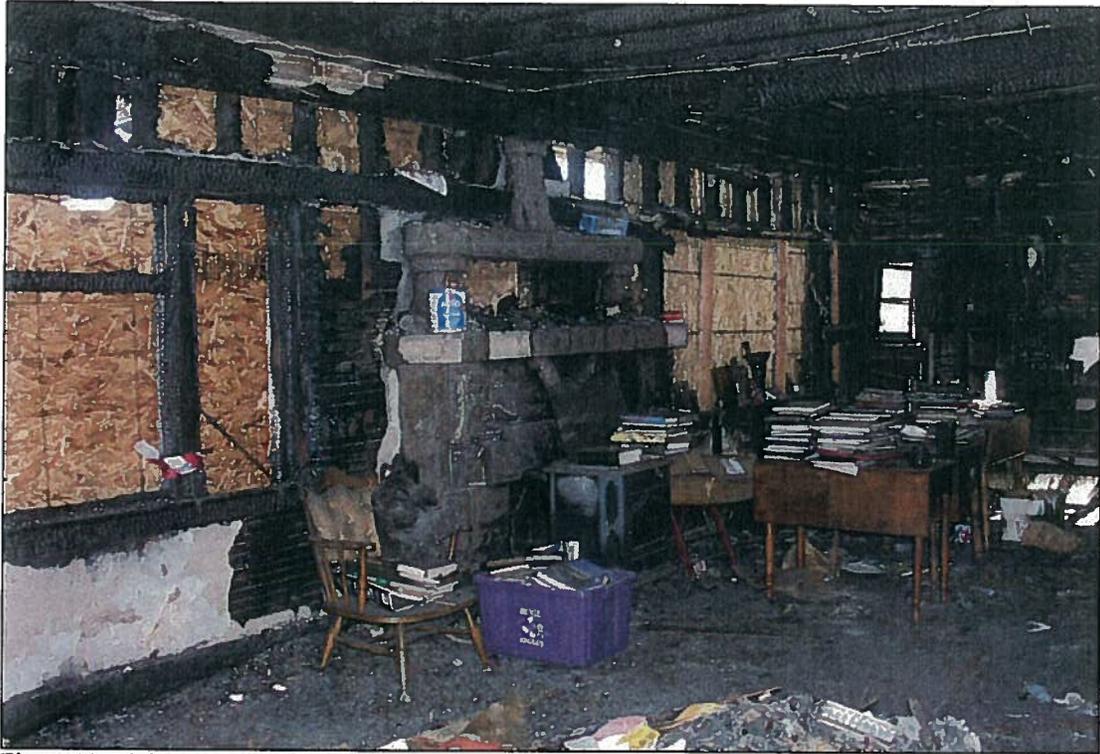
The main entrance opens into a large room that appears to be a combination living/dining room and features a fireplace on the west wall and a built-in cabinet on the north wall. The living/dining area has been significantly damaged by fire (Attachment A, Figures 10–15). The kitchen and a small room (perhaps a bedroom or den) are located behind (north of) the living/dining area and do not appear to have sustained as much fire damage as the living/dining area. A hallway on the east side of the living/dining area accesses three bedrooms and a bathroom (Attachment A, Figure 16). Of these, the hallway and front bedroom (southeast corner of the house) have sustained the most fire damage.

Figure 10: Living room and fireplace. View to the northwest (7/20/11).

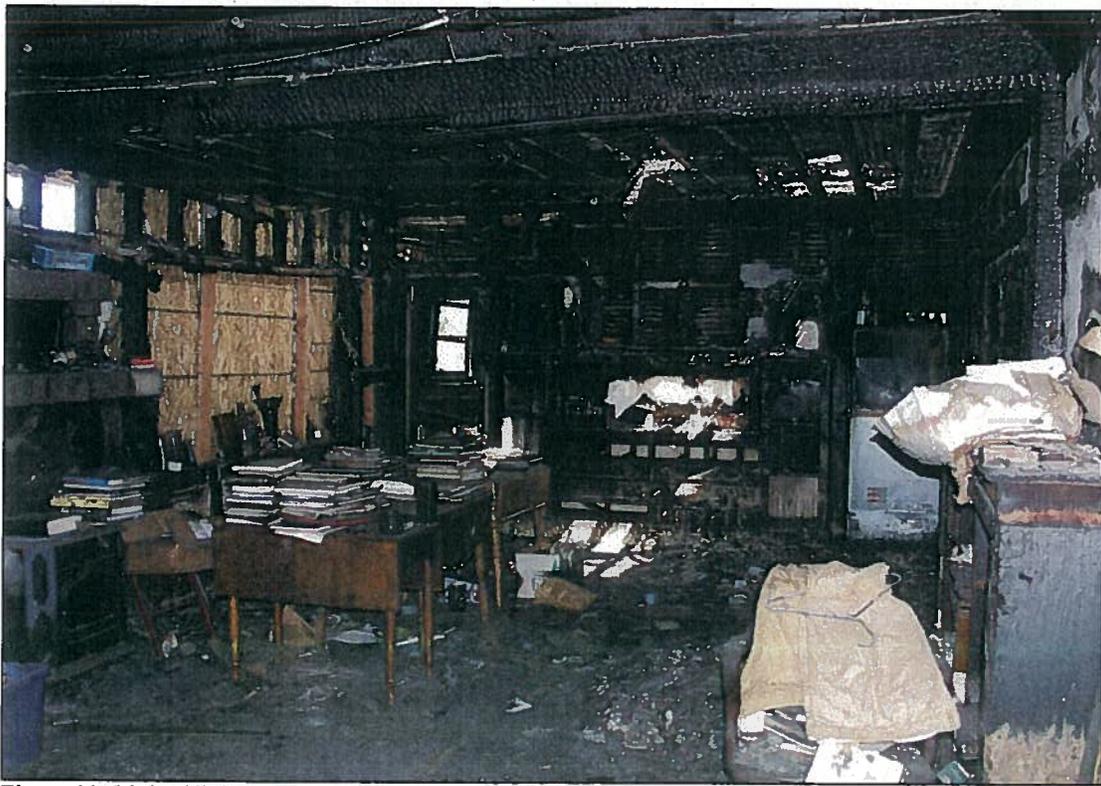
Figure 11: Living/dining room. View to the north (7/20/11).

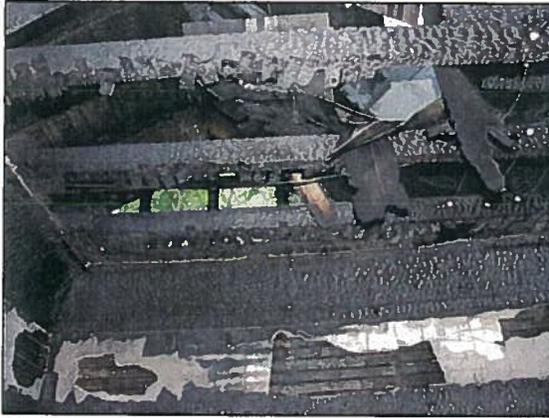
Figure 12: Ceiling in living room (7/20/11).

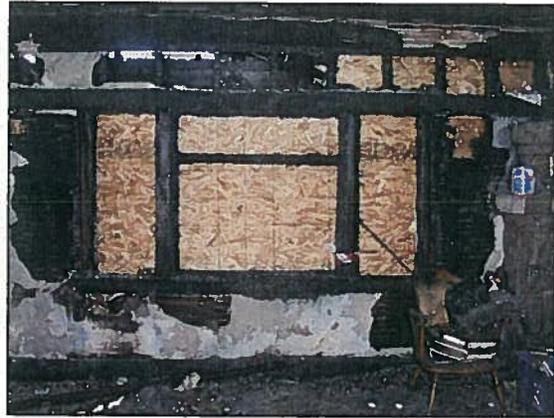
Figure 13: Window in living room (7/20/11).

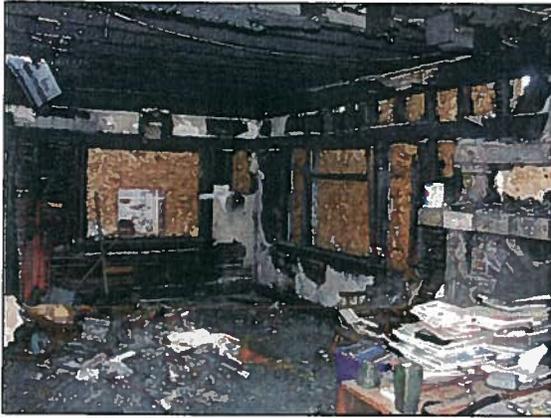
Figure 14: Southwest corner of living room (7/20/11).

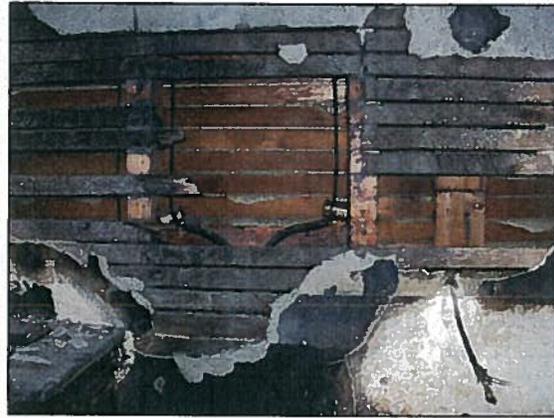
Figure 15: East wall of living room showing knob and tube wiring (7/20/11).

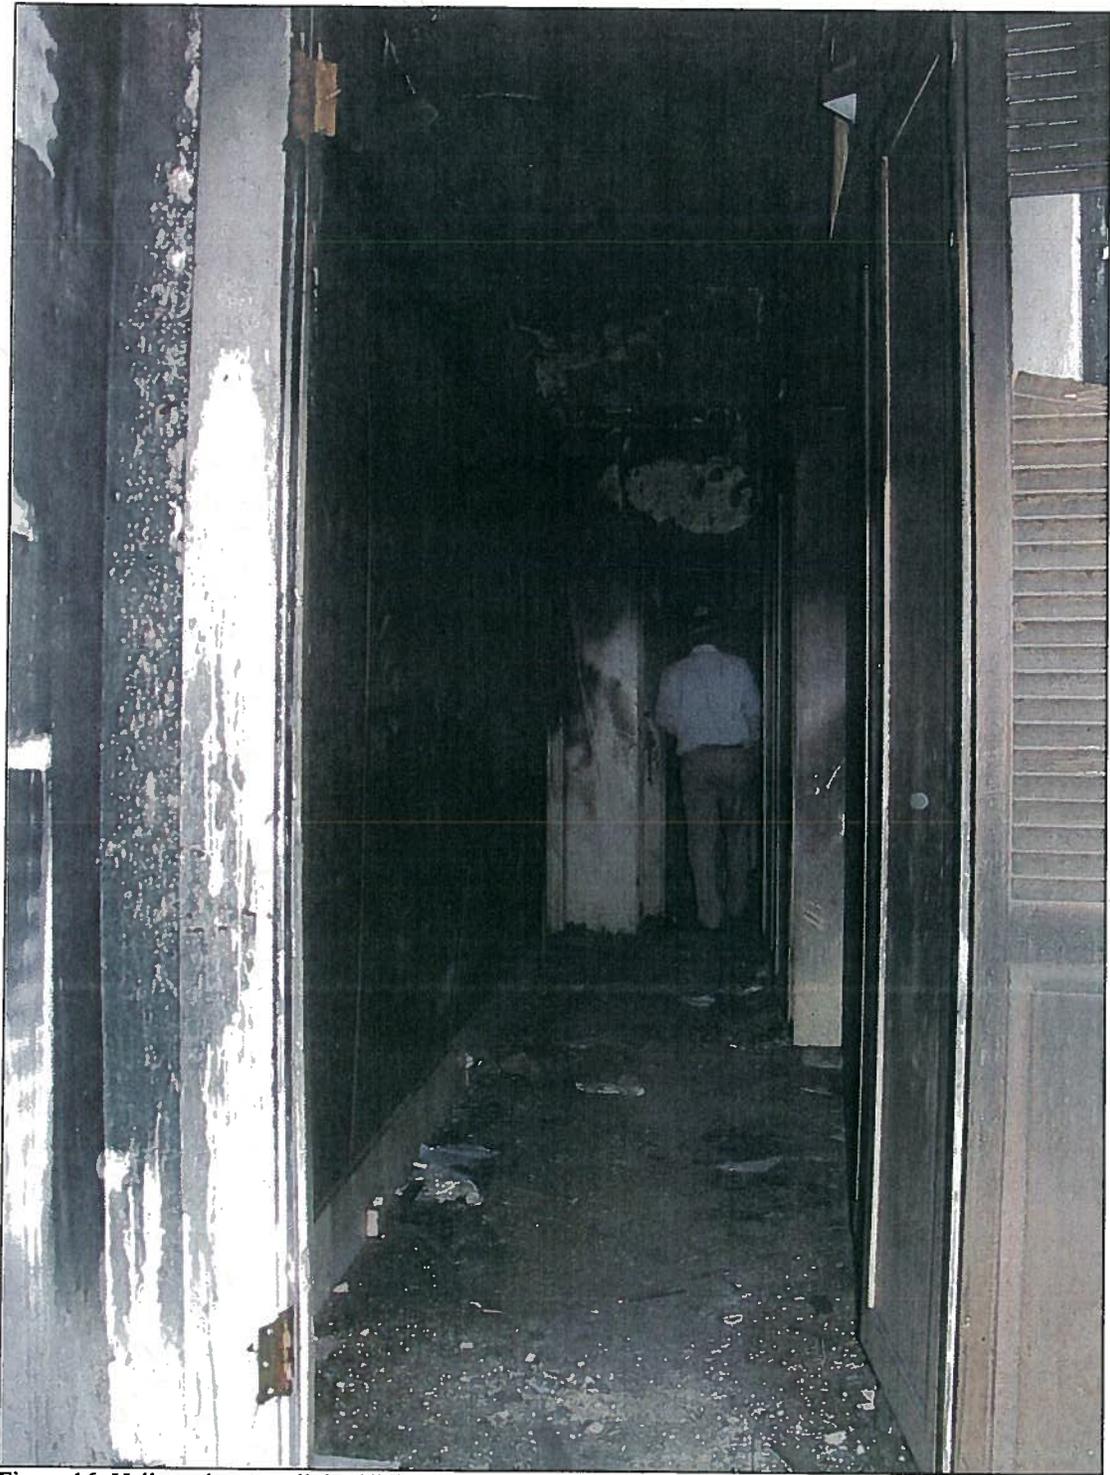
Figure 16: Hallway between living/dining area and bedrooms/bathroom (7/20/11).
