August 10, 2011

RE: 3801 East Fifth Street, Long Beach
Structural Assessment
NYA #11231.00

Structural Observation and Findings

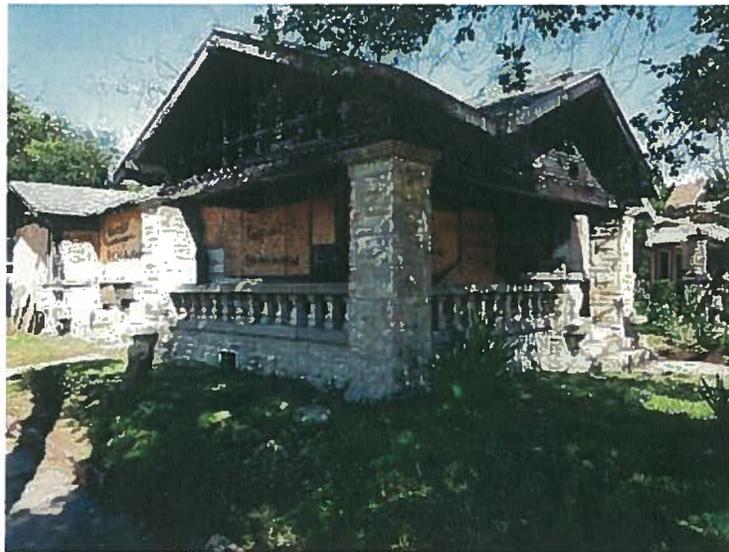
Photo 1: Exterior View from the corner of Fifth & Grand

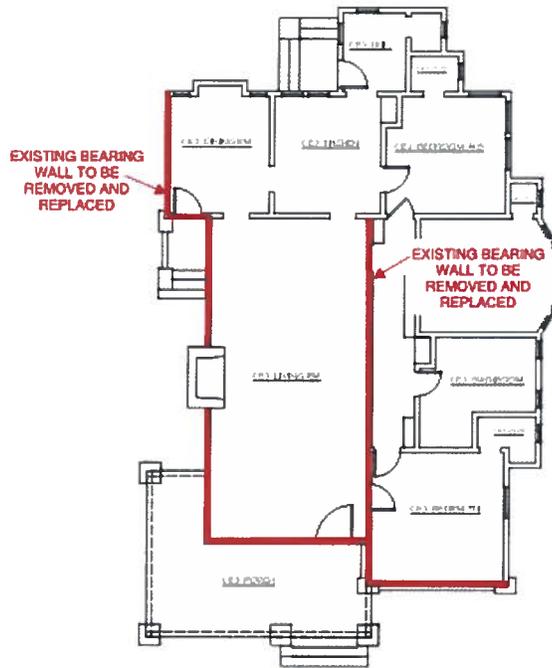
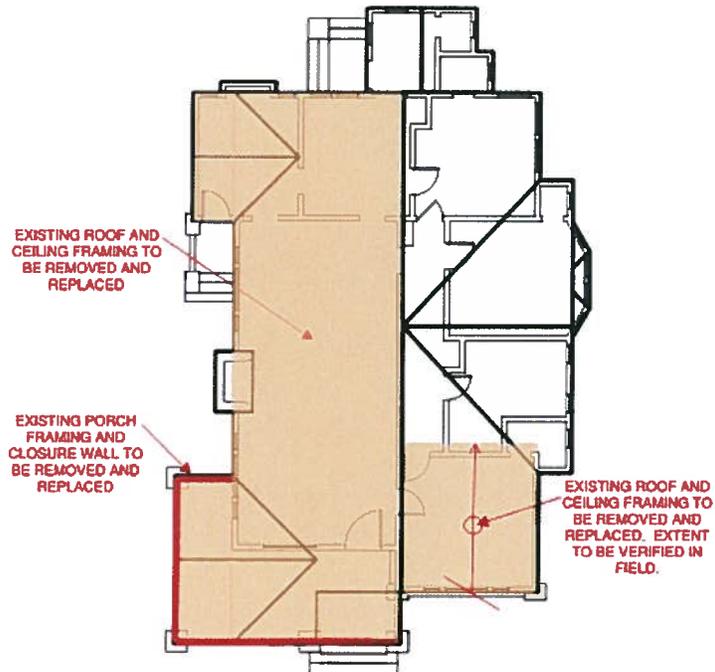
Diagram 1: Reference Plans

- The structural damage was limited to the south and west sides of the structure. Refer to Diagram 1 and Photos 2 and 3.
- The roof framing suffered most of the damage, including partial collapse over the living room. Refer to Photo 3 and 4.

Based on the results of our evaluation and expertise working with Historic Structures, due to the extent of fire damage, partial selective demolition will be required. Diagram 1 indicates the structural elements that will need to be removed and replaced. The intent of this letter is to identify the structural deficiencies. Structural design of the retrofit is not part of this scope.

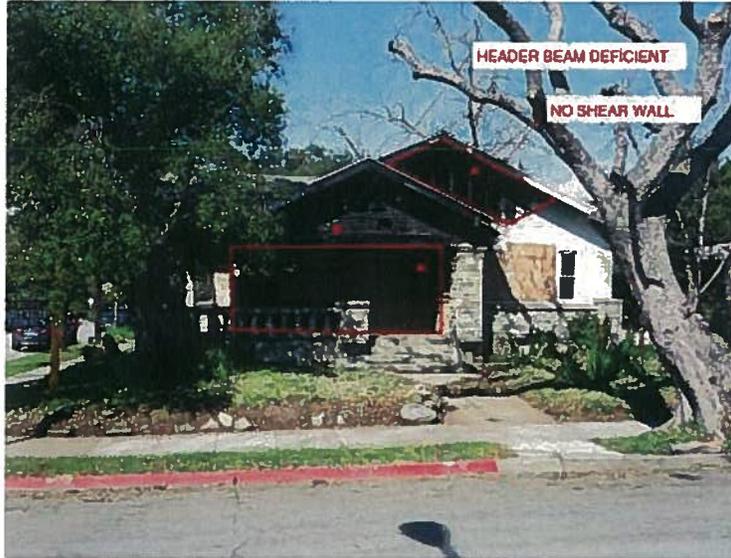
- At the porch, the header beam supporting the roof has a reduced cross sectional area and capacity due to extent of the fire damage. The header beam appears to be sagging and may not be able to continue to support the weight of the roof. Refer to Photos 2 and 3.

Photo 2: South Elevation – Facing Fifth Street

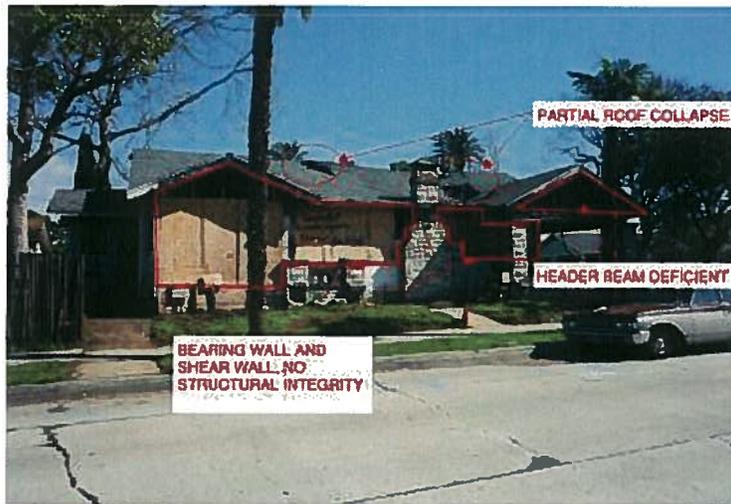
- The west facing bearing wall studs have lost their essential structural attributes and engineering properties to allow them to be augmented or strengthened. Refer to Photo 3.

Photo 3: West Elevation – Facing Grand Avenue

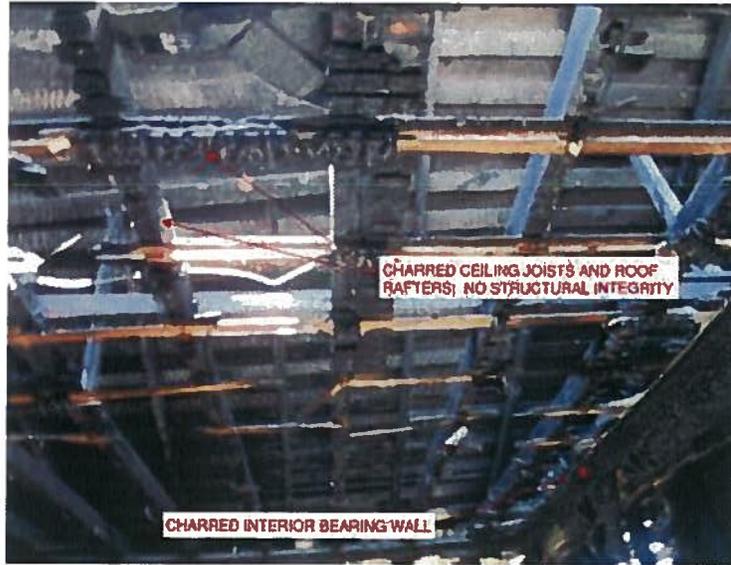
Photo 4: Interior View of Ceiling and Roof Framing

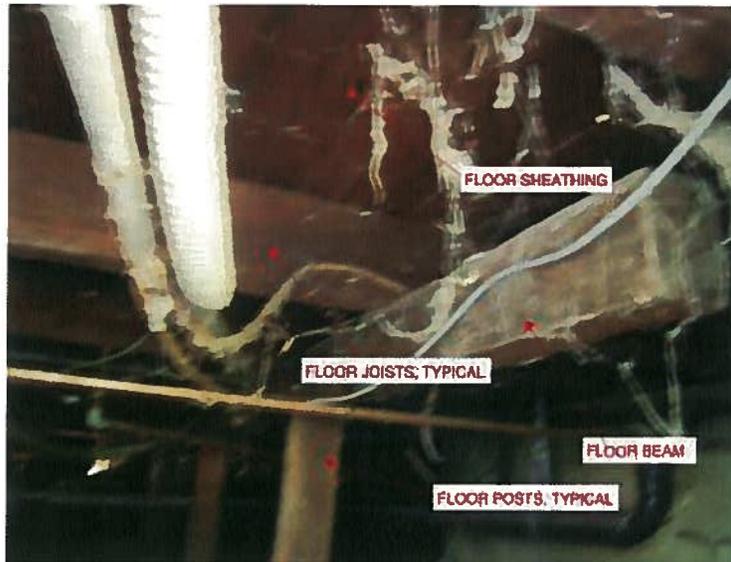
- The floor Framing does not appear to have suffered major fire damage and may be able to be kept or strengthened to continue to support the floor loads. Refer to Photo 5.

Photo 5: Floor Framing – From Crawl Space
