# Arlington Avenue Flooding

February 7, 2009

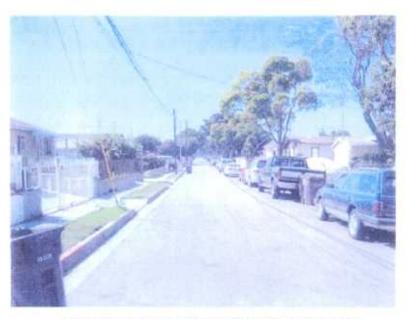
ARLINGTON STREET (FACING WEST FROM RIVER AVENUE)

CATCH BASINS ON ARLINGTON STREET BETWEEN RIVER AVENUE AND HESPERIAN AVENUE AT THE LOW POINT

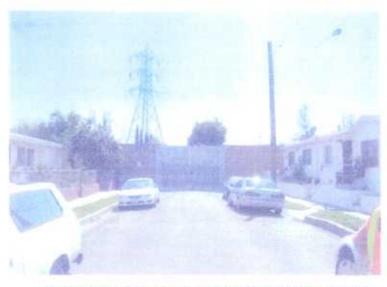
RIVER AVENUE SOUTH OF ARLINGTON STREET (FACING SOUTH)

DOOR AT END OF RIVER AVENUE

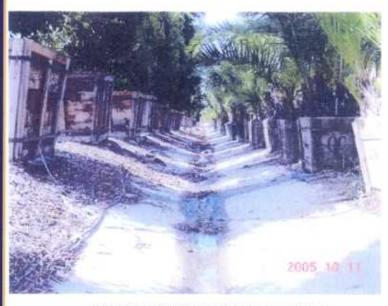
V-DITCH ON NURSERY SITE BEHIND BLOCK WALL

GRATED CATCH BASIN ALONG V-DITCH
