# CITY OF LONG BEACH

## ADA SELF-EVALUATION SUMMARY OF FINDINGS *for* *Public Outreach*

*March 2019*

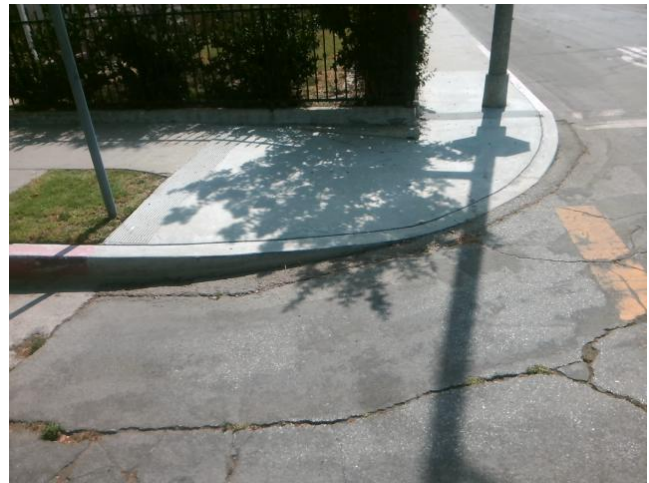
- Uneven heaving in the sidewalk concrete comprises the majority of obstruction counts.
- Vegetation growing overhead or on the sidewalk represent the next two highest factors in barriers to the sidewalk.
- These top three factors are more easily addressed than some of the other obstructions identified.
- Light Poles and Power Poles represent 1870 locations combined, and these types of obstructions are costly to relocate and/or require challenging design solutions. In some cases, obstruction removal may be the responsibility of other agencies (such as CalTrans, a utility company, etc.) and these must be coordinated in order to remediate effectively.

**Sidewalk Obstruction**

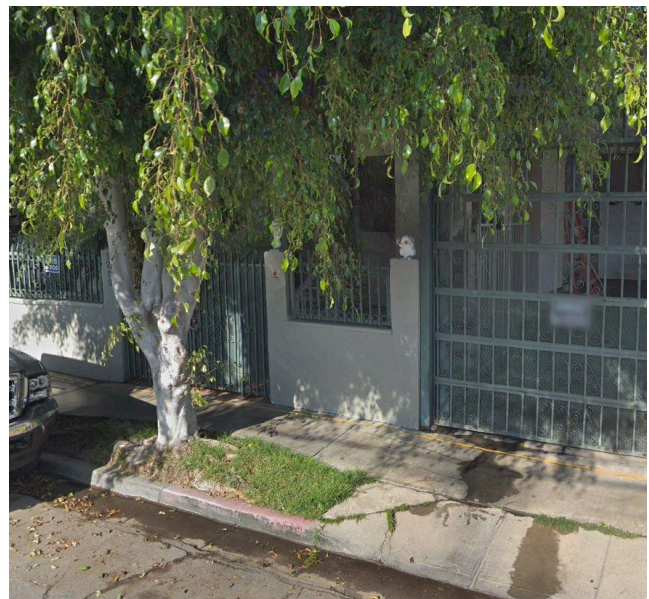
**Sidewalk Obstruction - Vegetation Overhead**

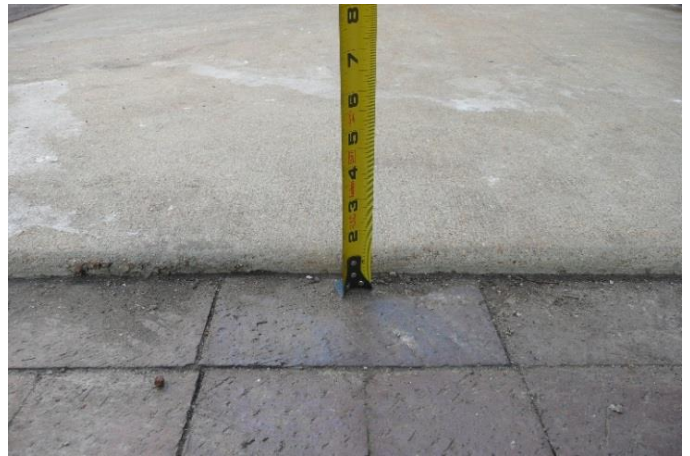
- Changes in level, or heaves, are common issues found in sidewalks for every community.
- Heaves are caused by many factors, to include tree root growth, and changing soil conditions over time.
- Uneven heaving in the sidewalk concrete is the majority of obstruction counts, as previously reported.
- Heaves of a certain dimension can often be addressed by cutting or grinding sidewalks.
- Only 6% of heaves are 1" or higher.
- Over 69% of the heaves measured fall between  $\frac{1}{4}$ " and  $\frac{1}{2}$ ", which often represent an opportunity for remediation without replacing an entire sidewalk segment. While not compliant, these are also found to be less severe.

**Change in Level at Sidewalk Joint**

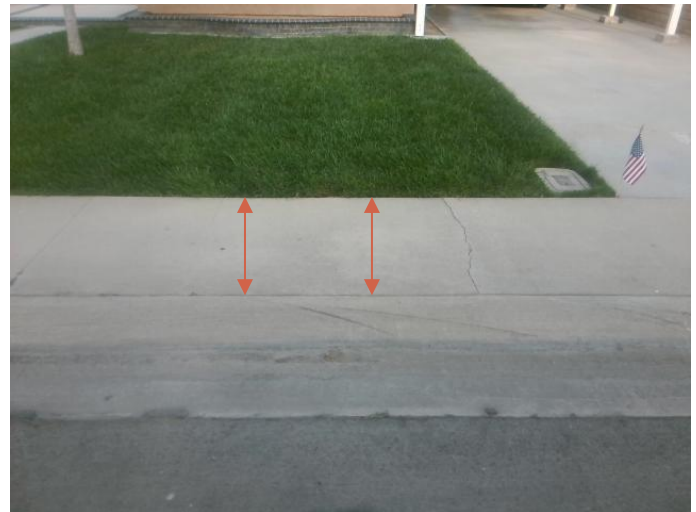
- 58% of the cross slope issues fall into the 2-3% cross slope violation range and many of these fall to just above the 2% maximum allowable standard. This is considered a less severe violation, unless additional compliance issues are present.
- 25% of cross slope violations fall in the 3-4% range, and 16.5% of the remaining violations are above 4% cross slope, where the slope may become very visible.
- Driveways are a common issue seen in the sidewalk cross slope violations.
- Run slope violations were less common, at 26.2 miles of compliance concerns, compared to cross slope.
- 8.8 miles, or 33% of the violations fell above 8.33% run slope grade, which are considered more severe than the 17 miles at 5-8.3% grade.

Sidewalk Cross Slope, as depicted by arrows

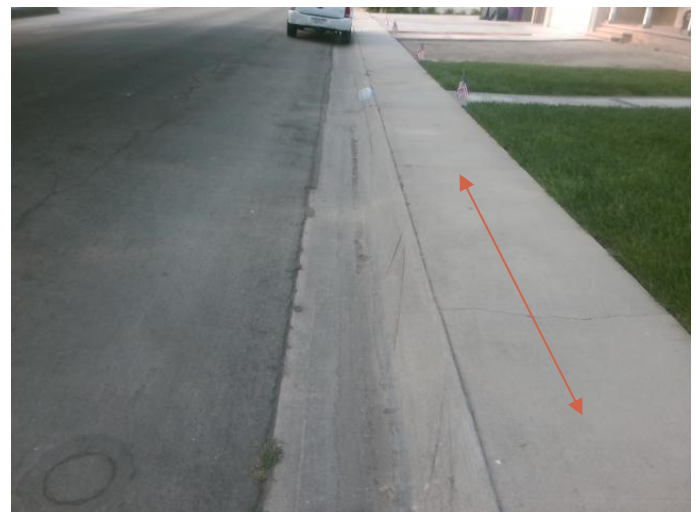
Sidewalk Run Slope, as depicted by the arrow

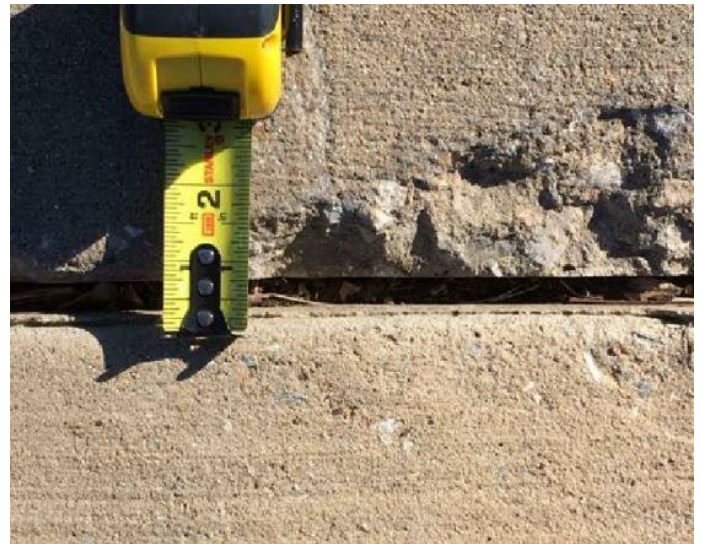
- Sidewalk gaps create mobility challenges in similar ways to sidewalk heaves, but gaps are horizontal instead of vertical. Wheelchairs, canes, or other devices may be hindered by these gaps. While gaps represented only 112 instances across all mileage collected, 74% were ¾" or greater.
- Driveway Crossings: Cross slopes of driveway crossings often exceeded the 2% maximum allowable per the standards for cross slope.
- Driveways are a common reason for cross slope violations, unless the sidewalk is built through the driveway to keep a continuous slope, while a ramp extends from the sidewalk continuing to the street.

**Sidewalk Gap**

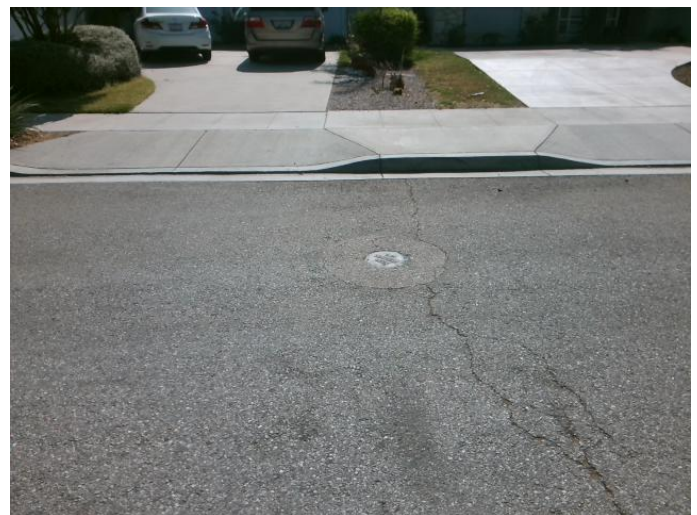
**Sidewalk built through a driveway**

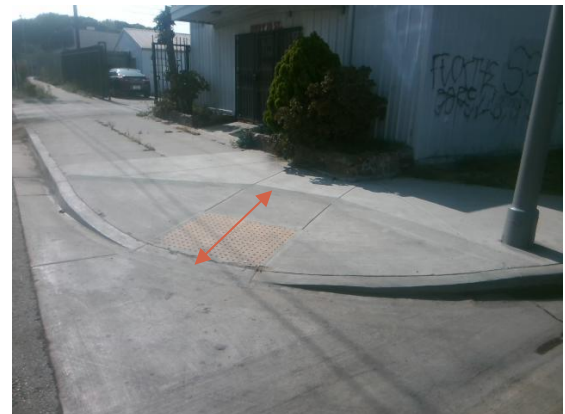
- 68% of Run Slope in Curb Ramps were compliant
- Of the 7,013 compliant ramps, \*408 of these were Blended Transition ramps with run slopes not compliant, measuring over the 5% allowable slope for this type of ramp.
- 31% of all curb ramps failed compliance on run slope alone.

**Curb Ramp Run Slope**

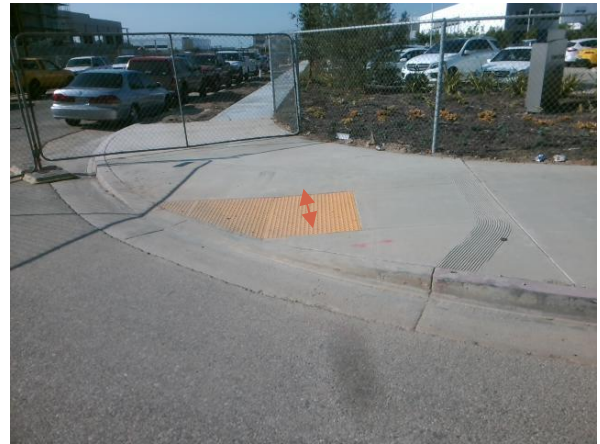
- 79% of Curb Ramps were compliant in Cross Slope.
- 2,523 ramps failed on cross slope related issues.
- 56% of those that failed on cross slope fell into a 2-3% cross slope range, generally considered less severe than higher ranges.
- These are clear indications that more than one issue within the curb ramp systems created overall compliance concerns.

**Curb Ramp Cross Slope**

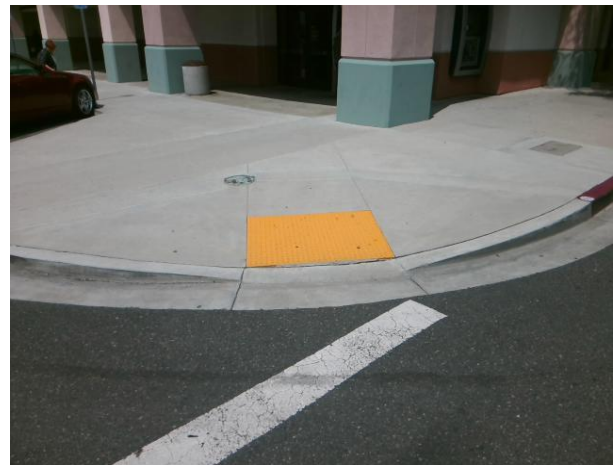
- Detectable Warning Surfaces were most often not the full width of the ramp
- 20% of the DWS were missing altogether
- For ramps where the only compliance issue is a missing DWS, an installation of compliant DWS can help a ramp system achieve ADA compliance.
- \* Of the 4,862 ramps not assessed, these ramp systems failed at an early Initial Pass/Fail scenario and therefore will require full replacement.

**Curb Ramp Detectable Warning Surface**

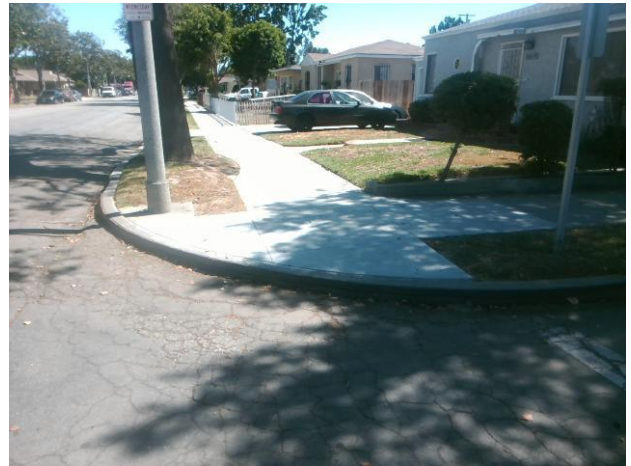
**Missing Curb Ramp**

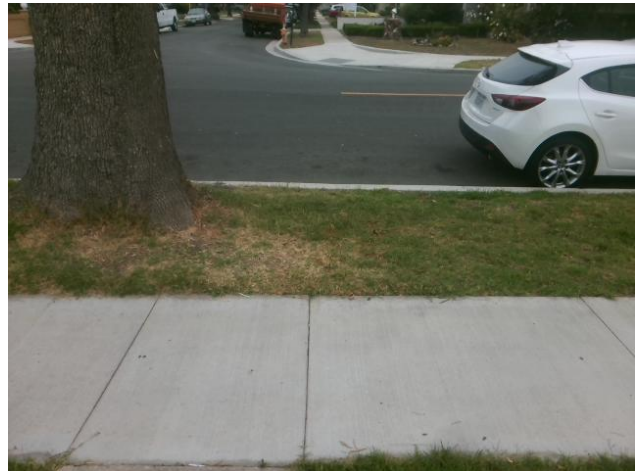
- Missing Curb Ramps, are ramps that are not present where required.
- A very high percentage, 67%, of missing ramps are represented in areas identified as “T-Intersections”. In these locations, some missing ramps may be remediated with signage and physical barriers eliminating an unmarked pedestrian crossing. Other design solutions may be found to address these areas and the City will be evaluating these locations.

**Missing Curb Ramp – T-Intersection**

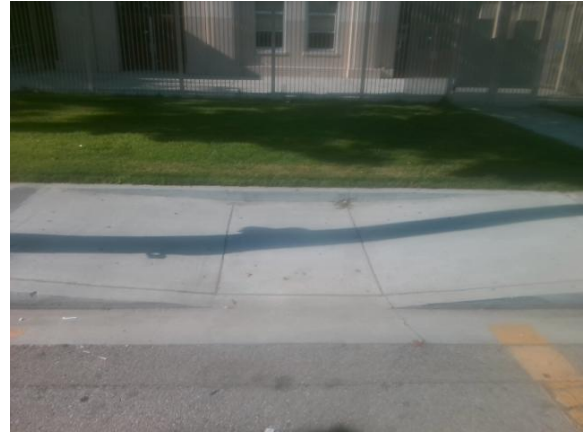
**Curb Ramp Type – Parallel Ramp**
