Subject: **Update on Queen Mary Lease Management - REVISED**

# CRITICAL STRUCTURAL REPAIRS STRUCTURAL ANALYSIS: STRESS RESULTS & TANK TOP REPAIR

## QUEEN MARY LONG BEACH, CALIFORNIA

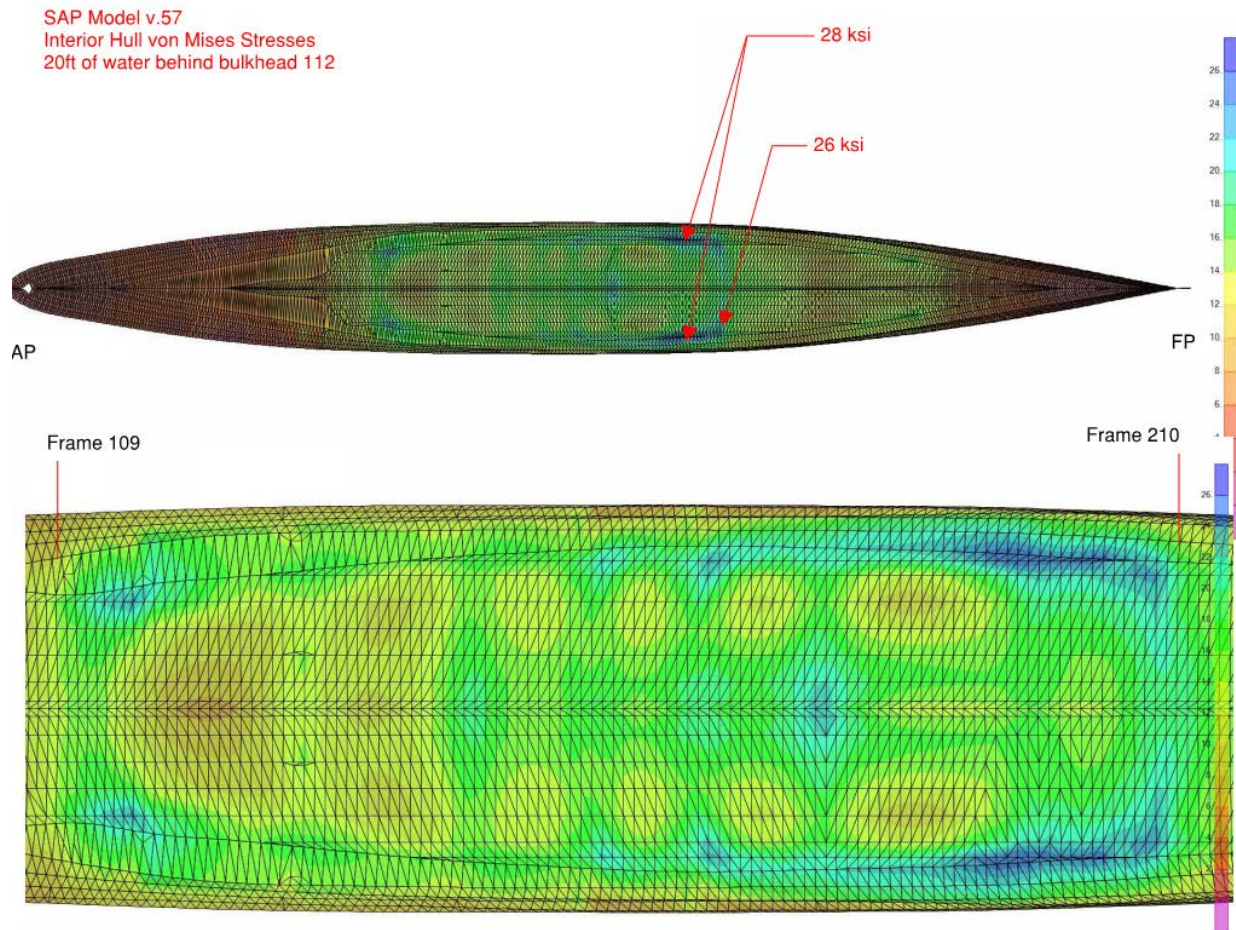
**Figure 39. Von Mises heat map showing locations where allowable stresses on exceeded on the interior hull in the case with 20 ft. of water behind bulkhead 112.**

The calculations and subsequent recommendation to allow flooding through the bulkhead at frame 112 in the event of flooding aft of frame 112, produces a condition that is more favourable than if the bulkhead was to be intact, for this vessel in its current stationary location. This condition of "Cross-flooding" is an established aspect of ship design to reduce stresses and minimize the list and trim of a vessel during flooding.

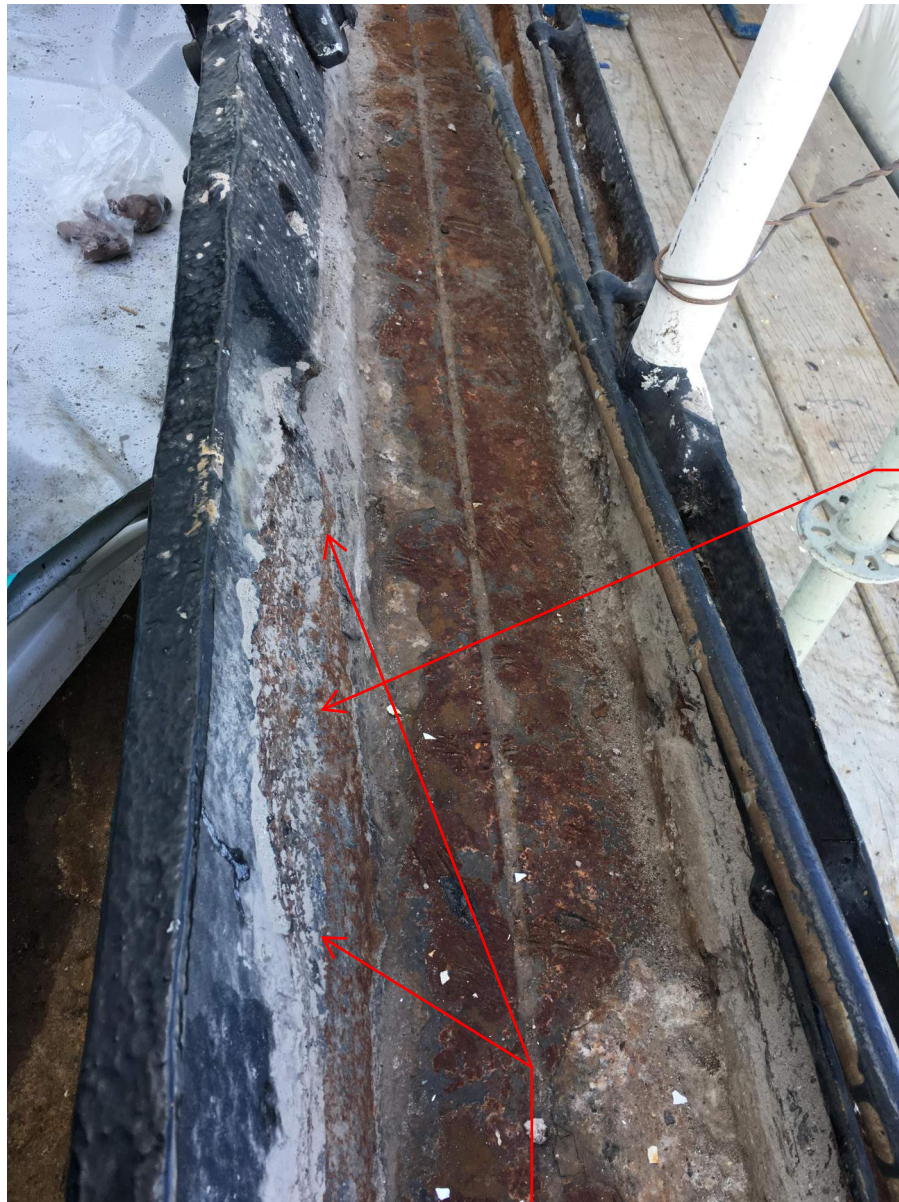
Photo 1 - Existing continuous bent plate corrosion

On the port side, the steel plate had several areas where it had rusted completely through. (Only the thinner plate, not the thick gusseted portions where the clevis attached).

The primary concern is this plates integrity and the integrity of the plate's connection to the ship.

Assuming the plate damage is significant, a reinforcing bent plate has been designed to transfer the load of a single cable to two beams below the deck surface. New plates used to reinforce the damaged plate are designed to span the load from existing cables to the beams below. Existing details showing the attachment of cables to the deck are shown in Figure 2. As the original design loads are not known (loading was likely based on unknown sailing conditions), cables are assumed to carry loads equal to the root area at the threads multiplied by the cable yield stress. This is a conservative assumption that is safe and relatively easy to apply, but not too egregious. This plate will be notched around the existing cable clevis and designed to span between existing beams below the deck surface. To engage the plate with existing framing, the plate will be welded above the deck to the damaged plate, and it will be bolted through the new bent plate into existing beams supporting the deck (See Figures 3 and 4). Bolts are called out as twist-off bolts, installed from below the deck and requiring access only from the top to tighten, and will be galvanized to delay any possible future corrosion and the entire connection will be waterproofed again.

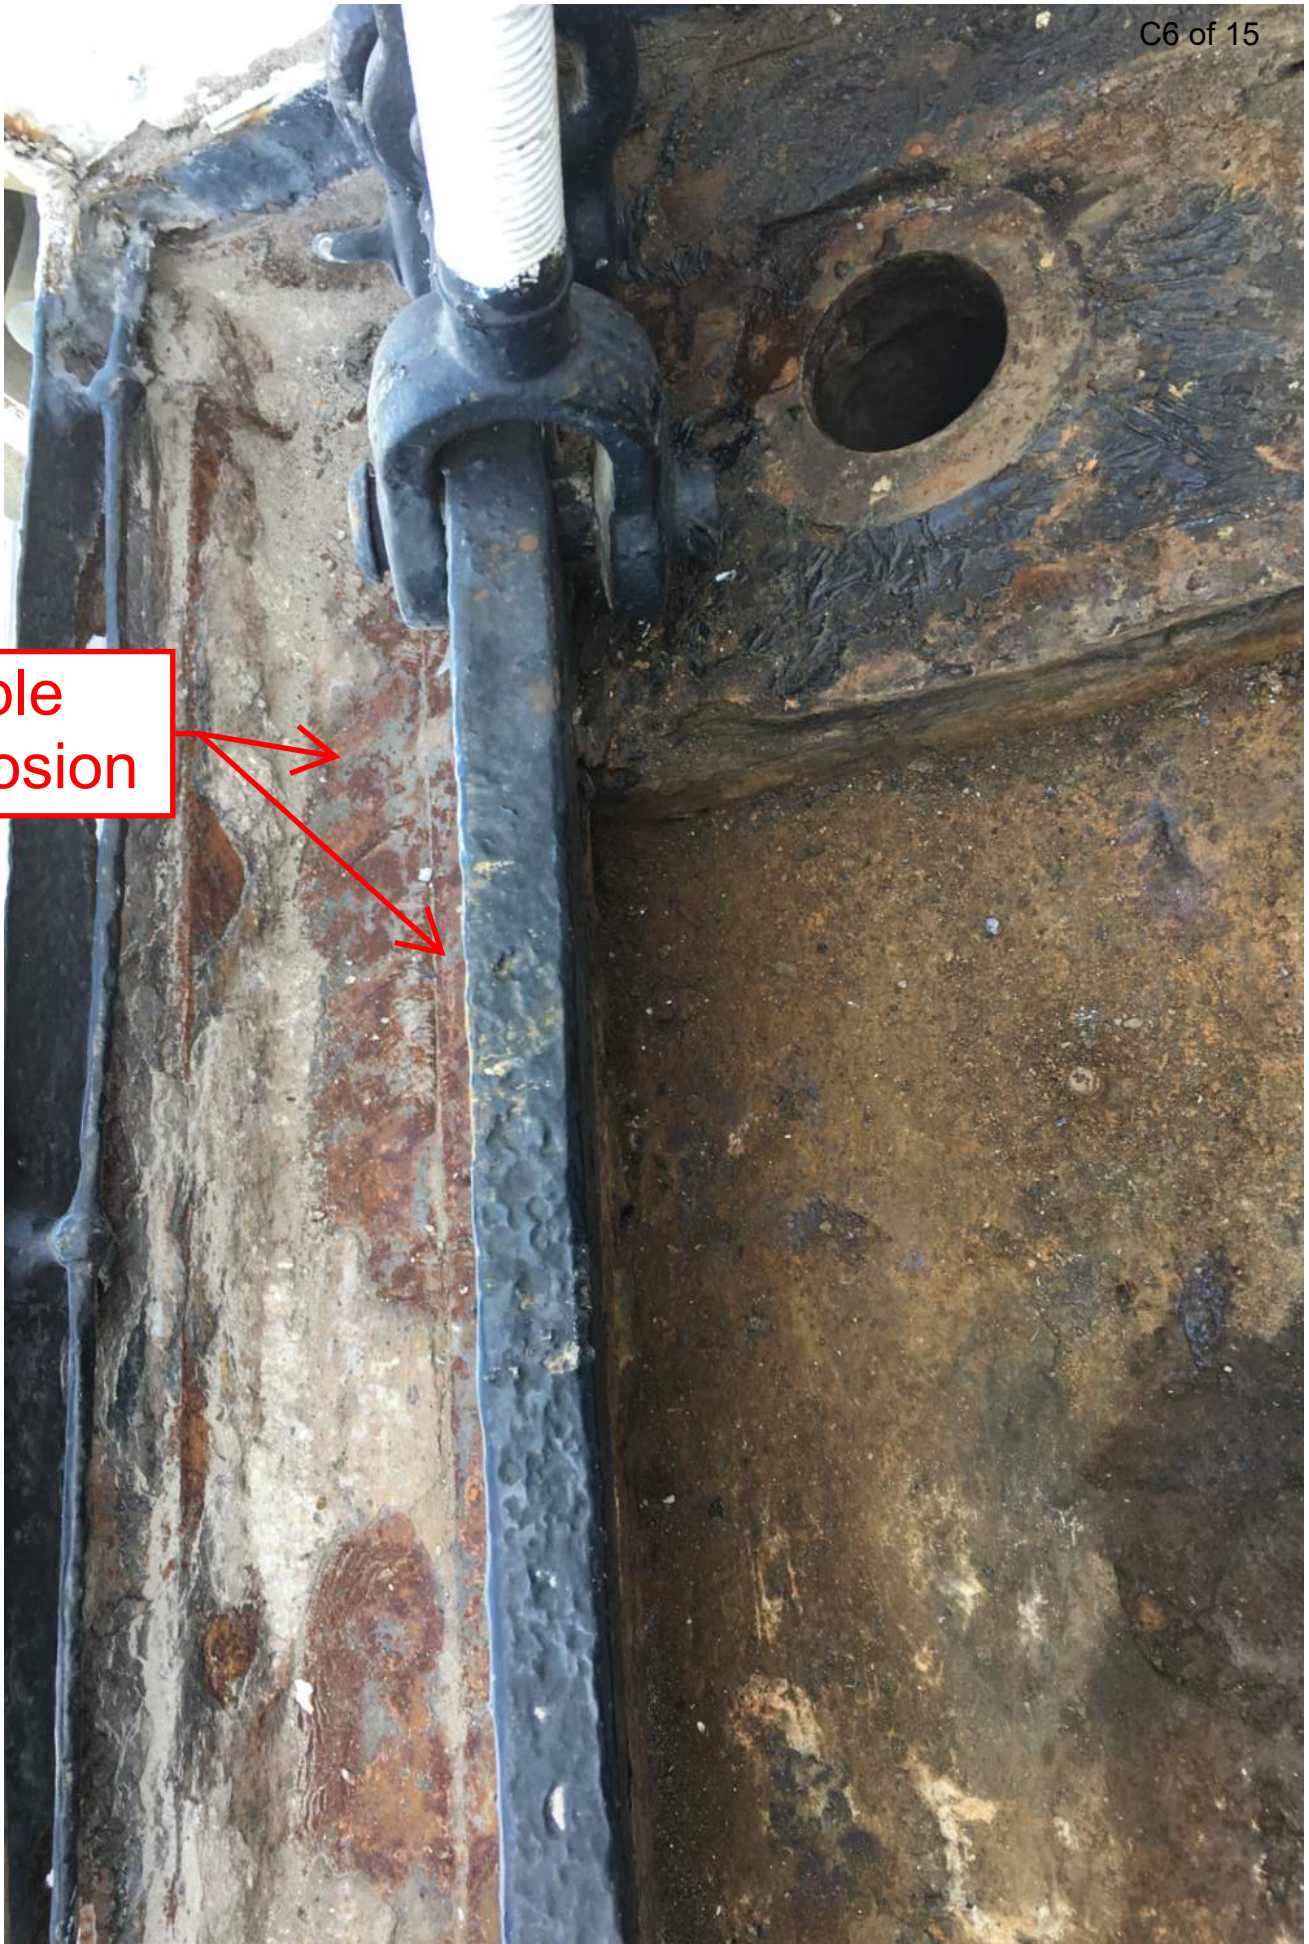
Photo 2 - Existing continuous bent plate corrosion

Visible  
corrosion
