957 E 4TH STREET
 FEATURE IDENTIFICATION KEY

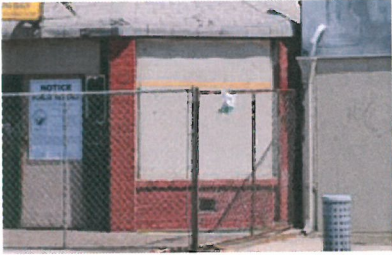
100-5

South Elevation	2006	Wood Window	The wood windows on the building were removed in 2006 by the barbershop tenant. They were subsequently replaced with new single-hung wood windows. The current wood window in this location measures 54" high x 55" wide, and is painted.	Fair	The wood windows on the building are less than ten years old. Though these windows are not original, they are in good condition. The glass in nearly all window frames is missing or broken and the wood frames are in need of minor cosmetic repair and repainting.	<p>Steps to repair wood windows:</p> <ol style="list-style-type: none"> 1. Remove window frames from installed position. 2. Sand window frames to make smooth and prepare for paint application. 3. Install new glass in lower window frame and install new stained glass reproduction in transom frame. 4. Prime window frame with specified primer. 5. Paint window frame with specified finish (color based upon historically-accurate color scheme determined as a result of paint analysis). 6. Reinstall window into its original location. 	<p>Materials Used:</p> <ul style="list-style-type: none"> - Sanding paper. - DAP Drywall and Hard Surface Glazing Compound. - New glass for lower window frame to be 1/4" plate glass. - New reproduction stained glass window (refer to item #100-6 for specification). - Primer: Sherwin Williams Multi-Purpose Latex Primer / Sealer. - Exterior Paint: Sherwin Williams SuperPaint Exterior Acrylic Latex Paint, Satin Finish.

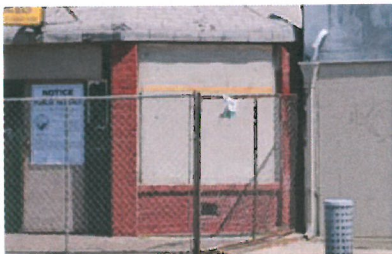
100-6

South Elevation	1940-1960	Stained Glass Transom Window	The wood windows on the building once contained stained glass transom windows, but they were removed in 2006 by the barbershop tenant and replaced with new painted wood windows. The upper portion of the window in this location designed to house stained glass measures 18" high x 55" wide.	Removed	The original Stained glass transom window used in the single-hung window on the west elevation was removed is in need of replacement. A replacement stained glass window should be designed and created by a trained specialist and installed within the existing window frame to replicate the intent of the original design.	<p>Steps to replace stained glass transom window:</p> <ol style="list-style-type: none"> 1. While windows are removed, install new leaded glass reproduction window in transom frame (glass design to be based upon photographic documentation and created by a trained specialist). 2. Follow steps to repair wood windows for painting and installation instructions. 	<p>Materials Used:</p> <ul style="list-style-type: none"> - New reproduction leaded glass window with 1/2" height and 3/8" width lead to be used in conjunction with clear restoration glass determined by stained glass specialist to be period appropriate.

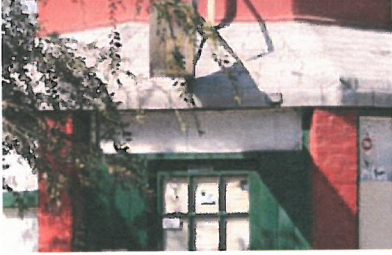
100-7

South Elevation	After 2000	Wood Transom Window	The wood transom window above the primary entrance was once a connection point for an aluminum awning mounted above the primary entrance. When the awning was removed a window was installed in the negative space. The space above the entrance has been operating as a window for at least fifteen years. Photographic documentation from the 1990s shows the awning intact, while photographs from 2004 show it removed and boarded. The current window is wood-framed and non-operable. The window measures 12" high x 54 3/4" wide.	Good	In lieu of replacing the awning mounted on the building after the 1950s, the transom window created above the primary entrance should be retained. The window is in good condition and is only in need of minor cosmetic repair and repainting. The glass, however, is in need of replacement.	<p>Steps to replace glass in wood transom window:</p> <ol style="list-style-type: none"> 1. Remove window and frame from installed position. 2. Sand window frame and prepare for repainting. 3. Remove existing glass. 4. Replace existing glass with new reproduction leaded glass designed to match original stained glass pattern (based upon photographic documentation). 5. Prime window frame. 6. Paint window frame with specified finish (color based upon historically-accurate color scheme determined as a result of paint analysis). 7. Reinstall window and wood frame. 	<p>Materials Used:</p> <ul style="list-style-type: none"> - Sanding paper. - New reproduction stained glass window (refer to item #100-6 for specification). - Primer: Sherwin Williams Multi-Purpose Latex Primer / Sealer. - Exterior Paint: Sherwin Williams SuperPaint Exterior Acrylic Latex Paint, Satin Finish.

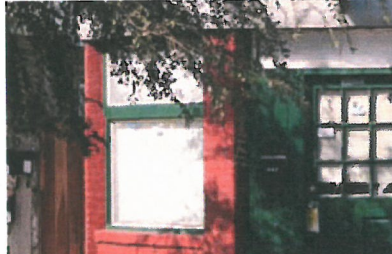
100-8

South Elevation	2006	Wood Window	The wood windows on the building were removed in 2006 by the barbershop tenant. They were subsequently replaced with new single-hung wood windows. The current wood window in this location measures 54" high x 55" wide, and is painted.	Good	The wood windows on the building are less than ten years old. Though these windows are not original, they are in good condition. The glass in nearly all window frames is missing or broken and the wood frames are in need of minor cosmetic repair and repainting.	<p>Steps to repair wood windows:</p> <ol style="list-style-type: none"> 1. Remove window frames from installed position. 2. Sand window frames to make smooth and prepare for paint application. 3. Install new glass in lower window frame and install new stained glass reproduction in transom frame. 4. Prime window frame with specified primer. 5. Paint window frame with specified finish (color based upon historically-accurate color scheme determined as a result of paint analysis). 6. Reinstall window into its original location. 	<p>Materials Used:</p> <ul style="list-style-type: none"> - Sanding paper. - DAP Drywall and Hard Surface Glazing Compound. - New glass for lower window frame to be 1/4" plate glass. - New reproduction stained glass window (refer to item #100-6 for specification). - Primer: Sherwin Williams Multi-Purpose Latex Primer / Sealer. - Exterior Paint: Sherwin Williams SuperPaint Exterior Acrylic Latex Paint, Satin Finish.

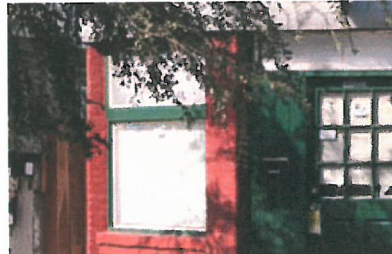
100-9

South Elevation	1932	Stained Glass Transom Window	The wood windows on the building once contained stained glass transom windows, but they were removed in 2006 by the barbershop tenant and replaced with new painted wood windows. The upper portion of the window in this location designed to house stained glass measures 18" high x 55" wide.	Removed	The original Stained glass transom window used in the single-hung window on the east elevation was removed is in need of replacement. A replacement stained glass window should be designed and created by a trained specialist and installed within the existing window frame to replicate the intent of the original design.	<p>Steps to replace stained glass transom window:</p> <ol style="list-style-type: none"> 1. While windows are removed, install new leaded glass reproduction window in transom frame (glass design to be based upon photographic documentation and created by a trained specialist). 2. Follow steps to repair wood windows for painting and installation instructions. 	<p>Materials Used:</p> <ul style="list-style-type: none"> - New reproduction leaded glass window with 1/2" height and 3/8" width lead to be used in conjunction with clear restoration glass determined by stained glass specialist to be period appropriate.

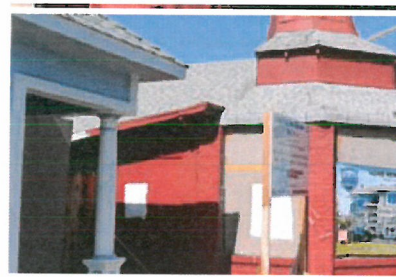
100-10

The wood windows on the building were removed in 2006 by the barbershop tenant. They were subsequently replaced with new single-hung wood windows. The current wood window in this location measures 54" high x 34" wide, and is painted.

Good

The wood windows on the building are less than ten years old. Though these windows are not original, they are in good condition. The glass in nearly all window frames is missing or broken and the wood frames are in need of minor cosmetic repair and repainting.

Steps to repair wood windows:

1. Remove window frames from installed position.
2. Sand window frames to make smooth and prepare for paint application.
3. Install new glass in lower window frame and install new stained glass reproduction in transom frame.
4. Prime window frame with specified primer.
5. Paint window frame with specified finish (color based upon historically-accurate color scheme determined as a result of paint analysis).
6. Reinstall window into its original location.

- Sanding paper.
- DAP Drywall and Hard Surface Glazing Compound.
- New glass for lower window frame to be 1/4" plate glass.
- New reproduction stained glass window (refer to item #100-6 for specification).
- Primer: Sherwin Williams Multi-Purpose Latex Primer / Sealer.
- Exterior Paint: Sherwin Williams SuperPaint Exterior Acrylic Latex Paint, Satin Finish.

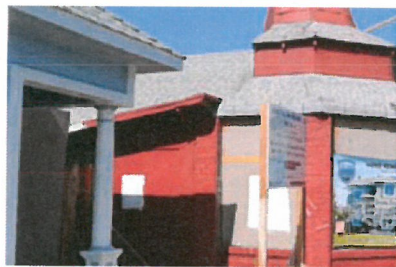
100-11

The wood windows on the building once contained stained glass transom windows, but they were removed in 2006 by the barbershop tenant and replaced with new painted wood windows. The upper portion of the window in this location designed to house stained glass measures 18" high x 34" wide.

Removed

The original Stained glass transom window used in the single-hung window on the east elevation was removed is in need of replacement. A replacement stained glass window should be designed and created by a trained specialist and installed within the existing window frame to replicate the intent of the original design.

Steps to replace stained glass transom window:

1. While windows are removed, install new leaded glass reproduction window in transom frame (glass design to be based upon photographic documentation and created by a trained specialist).
2. Follow steps to repair wood windows for painting and installation instructions.

- New reproduction leaded glass window with 1/2" height and 3/8" width lead to be used in conjunction with clear restoration glass determined by stained glass specialist to be period appropriate.

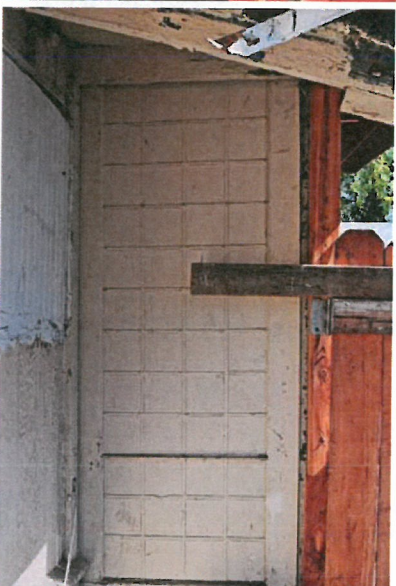
100-12

This wood-framed multi-lite window faces north. It is located on the rear of the octagonal coffee pot's east-facing projection. The window has 48 glass panels which have been painted. It's perimeter is framed with wood and the interior panels are framed with aluminum. This window measures 67" high x 27" wide. This window is believed to be the last remaining original window in the building.

Fair

This wood-framed multi-lite window has been painted and is in need of restoration. The window casing is in good condition and is only in minor need of repair, but panes of glass throughout the window have cracked and are in need of replacement. Glass panes able to be kept should have their paint removed to ensure proper restoration.

Steps to repair wood multi-lite window:

1. Remove window from installed position for repair.
2. Remove all paint with organic solvent paint remover.
3. Clean and assess health of each pane of glass to determine whether repair or replacement is appropriate.
4. Remove and replace glass panes where necessary with single-pane untempered glass.
5. Paint window frame with hazardous material encapsulation primer.
6. Prime window frame with specified primer.
7. Paint window frame with specified finish (color based upon historically-accurate color scheme determined as a result of paint analysis).

- Sanding paper.
- DAP Drywall and Hard Surface Glazing Compound.
- New glass for window frames to be plate glass fitted to existing frame.
- Primer: Sherwin Williams Multi-Purpose Latex Primer / Sealer.
- Exterior Paint: Sherwin Williams SuperPaint Exterior Acrylic Latex Paint, Satin Finish.

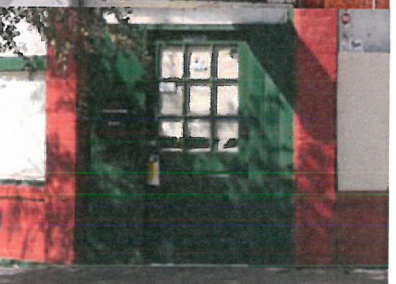
100-13

The door which composes the primary entrance of the building is divided with a nine-lite window pane combination on the upper half. The door is composed of wood and was installed on the building in 2006 when it was converted for use as a barbershop. The previous door was wood and did not hold historical significance based upon photographic evidence from 2005.

The current door within the primary entrance of the building is in good condition, but does not hold historic significance. The door was replaced in 2006. No photographic evidence exists of the building's original door.

Steps to replace current door:

1. Detach door from current positioning and discard.
2. Replace with newly fabricated wood-frame door with a single lite in center.

- Douglas Fir to match existing wood used throughout the building's exterior.
- Tempered dual-pane glass for protection and additional security on new door to be installed on street-facing elevation.

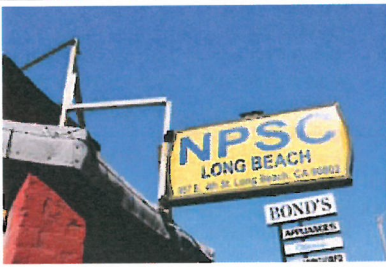
200-1

South Elevation	Contemporary	Blade Sign	The blade sign is attached to the mounting mechanism on one side. The existing sign is not original. It is believed that the original sign was rectangular with a hanging lower portion based upon historical photographs. The sign was removed to install this replacement sign before 2003, when this sign begins to appear in photographic documentation.	Good	The current sign is in good condition. The sign does not hold historical significance and should be removed.	<p>Steps to maintain the intent of the historical sign:</p> <ol style="list-style-type: none"> Existing sign will be disposed of properly and replaced by new. Tenant will commission a new sign that is mounted in a similar manner and maintains the street-oriented approach of the original sign. 	<p>Materials Used:</p> <ul style="list-style-type: none"> New sign designed and created with new materials to match needs of occupant.

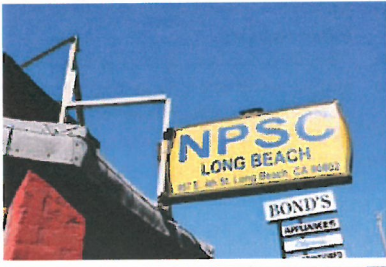
200-2

South Elevation	Before 1970	Sign-Mounting Mechanism	The sign-mounting mechanism is attached to the building at the lower roof level and secures for stability on the higher roof level. The mounting mechanism is steel and is most likely originates from the 1940s or 1950s.	Poor	The sign-mounting mechanism shows signs of rust and corrosion, and may not be salvageable. Regardless of its potential for reuse, the mounting mechanism will be removed and placed into storage for restoration and reinstallation in the future if so desired by owners and/or tenants. The mechanism is likely derived from the period of significance.	<p>Steps to maintain the intent of the historical sign:</p> <ol style="list-style-type: none"> Existing sign-mounting mechanism will be removed and stored for repair and future use if desired. Tenant will commission a new sign that is mounted in a similar manner and maintains the street-oriented approach of the original sign.

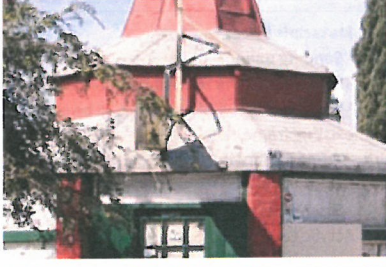
200-3

East Elevation West Elevation South Elevation	1932	Clerestory Stained Glass Windows	The clerestory windows between each level of roofing were originally rectangular. The area that once housed these windows was filled with concrete when the windows were removed, and was clad in stucco.	Poor	The stained glass windows originally located within the clerestory level have been removed and replaced with concrete clad with stucco.	<p>Steps to repair clerestory area:</p> <ol style="list-style-type: none"> Identify damaged portions of the stucco surface. Prep and repair stucco in damaged areas. Prime clerestory stucco area. Paint with specified finish in color to match brick cladding (body color) on lower level (color based upon historically-accurate color scheme determined as a result of paint analysis). 	<p>Materials Used:</p> <ul style="list-style-type: none"> Stucco patch mix created to match existing compound and finish. Primer: Sherwin Williams Multi-Purpose Latex Primer / Sealer. Exterior Paint: Sherwin Williams SuperPaint Exterior Acrylic Latex Paint, Satin Finish.

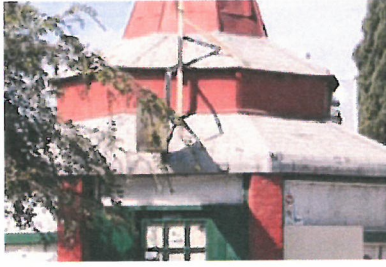
200-4

East Elevation West Elevation South Elevation	1932	Asphalt Roofing	The roofing used on the octagonal portion of the building is composed of asphalt. The current roof application is rolled while the original was composed of asphalt shingles. The shingles were originally arranged in a decorative geometric pattern and utilized blue, red, white, and gray asphalt tiles.	Fair	The current roofing is rolled asphalt. It should be removed and replaced with historically appropriate asphalt shingle roofing, known to have been used during the period of significance on the octagonal portion of the building.	<p>Steps to restore asphalt shingle roofing (octagonal roof):</p> <ol style="list-style-type: none"> Verify stability of roofing and support system. Take protective measures to secure roof structure as necessary. Remove existing layers of roofing with caution to protect underlying roof structure and sheathing. Examine earliest layers of roofing to evaluate materials for historic authenticity and ability to be salvaged. Remove unsalvageable sheathing and replace with new composed of in-kind material as necessary. Install new red, white, blue, and gray asphalt shingles in design of original (design to be based upon historic documentation). 	<p>Materials Used:</p> <ul style="list-style-type: none"> Douglas Fir or other in-kind wood material to replace sheathing damaged beyond repair. New rolled asphalt roofing material.

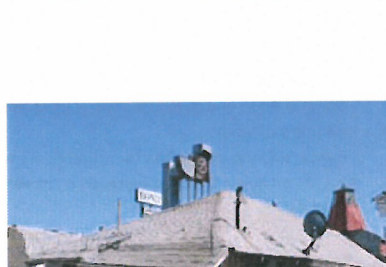
200-5

East Elevation West Elevation North Elevation	1932	Asphalt Roofing	The roofing used on the rear portion of the building was originally rolled asphalt. The current application is of the same material.	Poor	The current roofing on the building was applied within the last ten years. It is layered atop several additional layers of previous rolled asphalt roofing, which is weighing on the roof structure.	<p>Steps to removing current rolled asphalt roofing (rear roof):</p> <ol style="list-style-type: none"> Verify stability of roofing and support system. Take protective measures to secure roof structure as necessary. Remove existing layers of roofing with caution to protect underlying roof structure and sheathing. Remove unsalvageable sheathing and replace with new composed of in-kind material as necessary. Install new gray rolled asphalt roofing, as historically appropriate. 	<p>Materials Used:</p> <ul style="list-style-type: none"> Douglas Fir or other in-kind wood material to replace sheathing damaged beyond repair. New rolled asphalt roofing material.
