**KOFFEE POT CAFÉ (HOT CHA)**  
957 E 4<sup>TH</sup> STREET  
LONG BEACH, CALIFORNIA 90802

**PRESERVATION PLAN TO BE PRESENTED TO THE  
CITY OF LONG BEACH CULTURAL HERITAGE COMMISSION:**

IDENTIFICATION OF HISTORIC CHARACTER-DEFINING FEATURES, DIRECTION FOR  
TREATMENT, AND EVALUATION OF IMPACT ON HISTORIC INTEGRITY

*for*  
CITRON DESIGN GROUP  
July 30, 2015

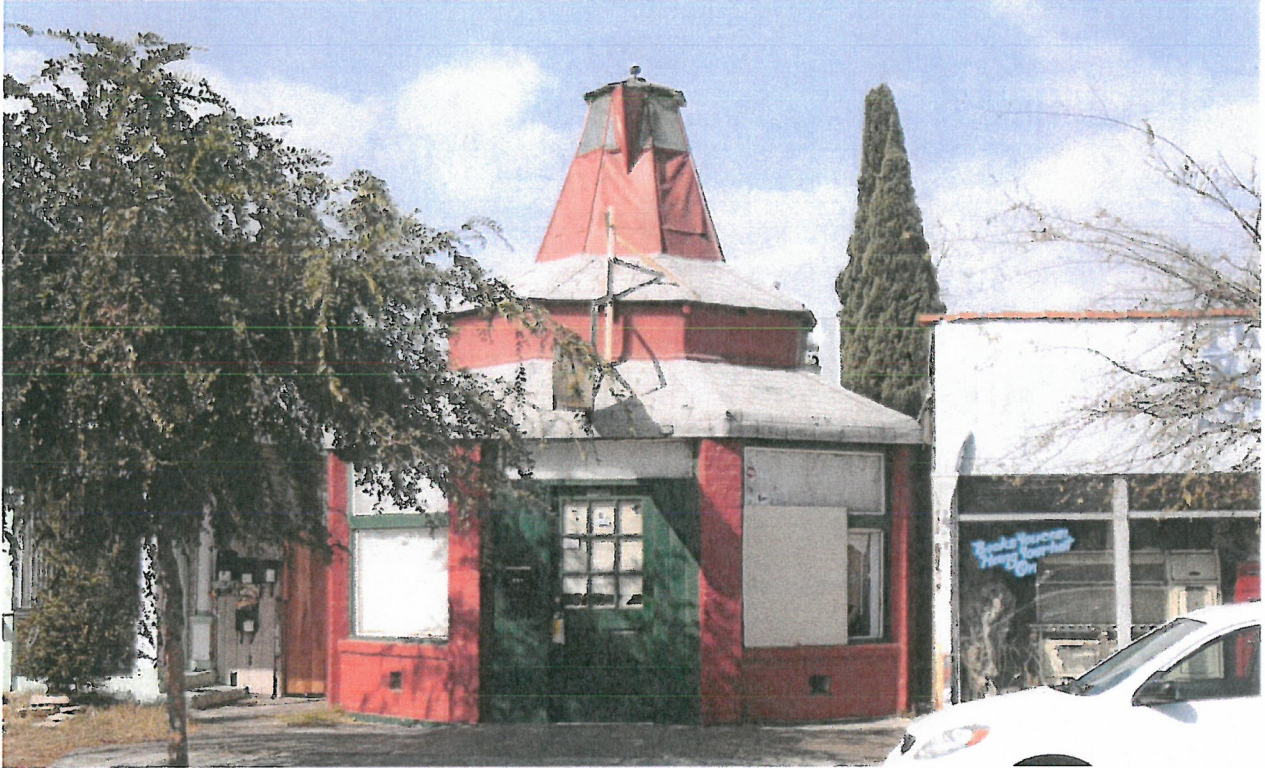
### FEATURE: BUILDING FOOTPRINT

*Overview of Octagonal Plan, View North, Photograph: February 2015*

The building footprint on the south elevation was designed to imitate the appearance of a coffee pot through its octagonal plan. The octagonal shape has a rooftop projection adorned with a coffee pot 'spout,' three wood-framed windows, and one door which serves the primary entrance.

1. Gently clean brick structure.
2. Encapsulate brick with lead barrier compound.
3. Prime and paint with color based upon historically-accurate color scheme determined as a result of paint analysis.

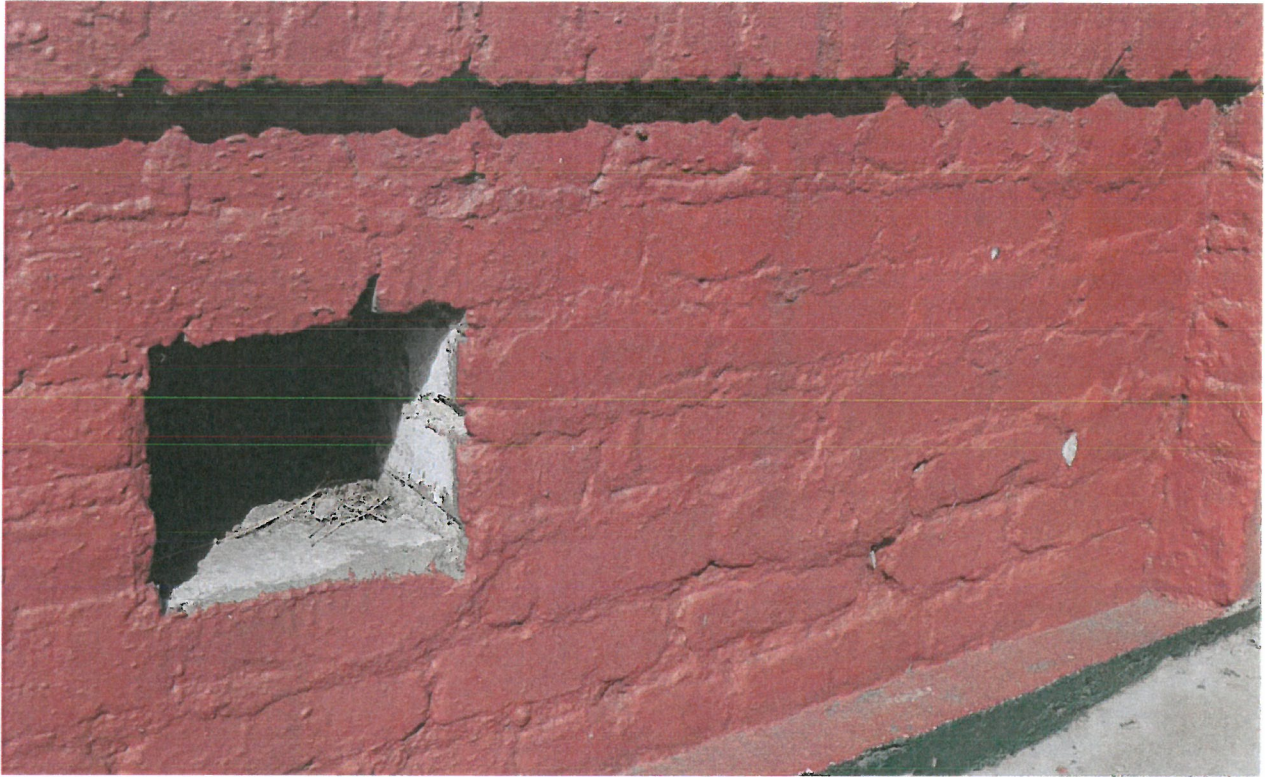
**FEATURE: BRICK CLADDING**

*Close-up of Brick Cladding on the Primary Elevation, Photograph: May 2015*

The building's octagonal street-facing portion and east elevation are composed of brick. The body of the coffee pot has been painted since at least the 1970s as shown by photographic evidence.

1. Clean brick structure by water washing with gentle non-ionic soap.
2. Encapsulate brick with designated hazardous material finish to reduce risk of lead exposure.
3. Prime and paint brick with specified paint finish (color based upon historically-accurate color scheme determined as a result of paint analysis).

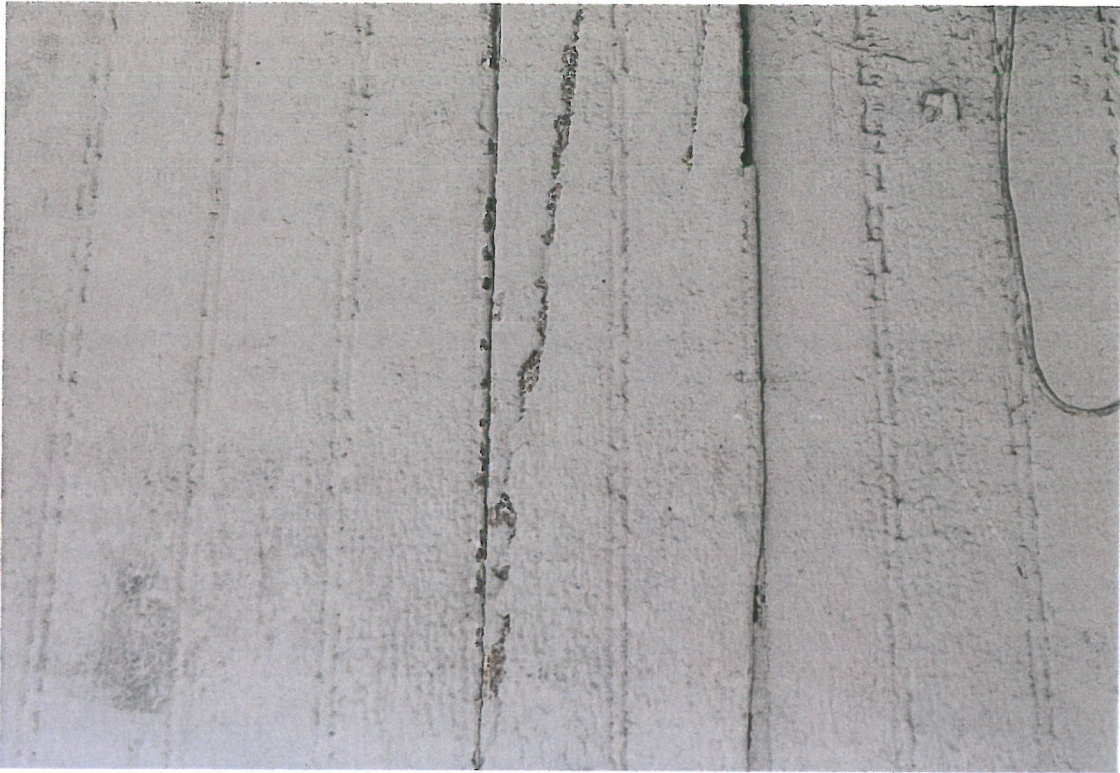
**FEATURE: WOOD CLADDING (WEST ELEVATION)**

*Close-up of Wood Siding on West Elevation, Photograph: May 2015*

The west and north elevations of the building are cladded in Redwood siding. The planks are 2 1/2" wide, and they are carved to resemble bed boarding down the center. The wood has been patched spontaneously throughout and is interjected by small windows, one entrance on the east elevation, and one entrance on the north (rear) elevation.

The wood is in extremely deteriorated condition and is not suitable for reuse. The existing material has been cut and patched numerous times, as well as exposed and repainted repeatedly. Replacement of the material with in-kind material which replaces the method of installation will allow the building to communicate its original design while enabling it to be given a new use.

1. Remove all wood cladding on the west and north elevations.
2. Replace with in-kind wood material cut to match dimensions and design of existing original.
3. Prime and paint with specified finish (color based upon historically-accurate color scheme determined as a result of paint analysis).

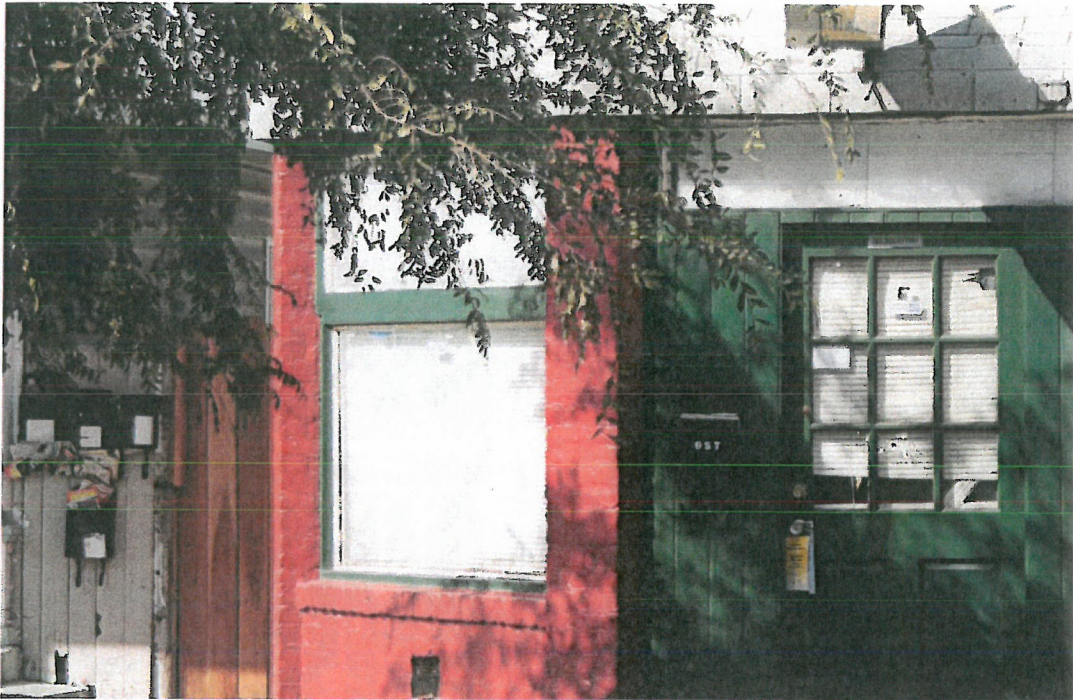
**FEATURE: WOOD WINDOWS**

*Wood Window on South Elevation, View North, Photograph: February 2015*

The original wood windows on the building were removed in 2006 by the barbershop tenant. They were subsequently replaced with new single-hung wood windows. The lower portions of all windows are in need of replacement glass. Stained glass windows in the upper portion of all windows were removed and in need of replacement (See Feature: Stained Glass Windows).

1. Remove window frames from installed position.
2. Sand window frames to make smooth and prepare for paint application.
3. Install new glass in lower window frame and install new stained glass reproduction in transom frame.
4. Prime and Paint window frame with specified finish (color based upon historically-accurate color scheme determined as a result of paint analysis).
5. Reinstall window into its original location.

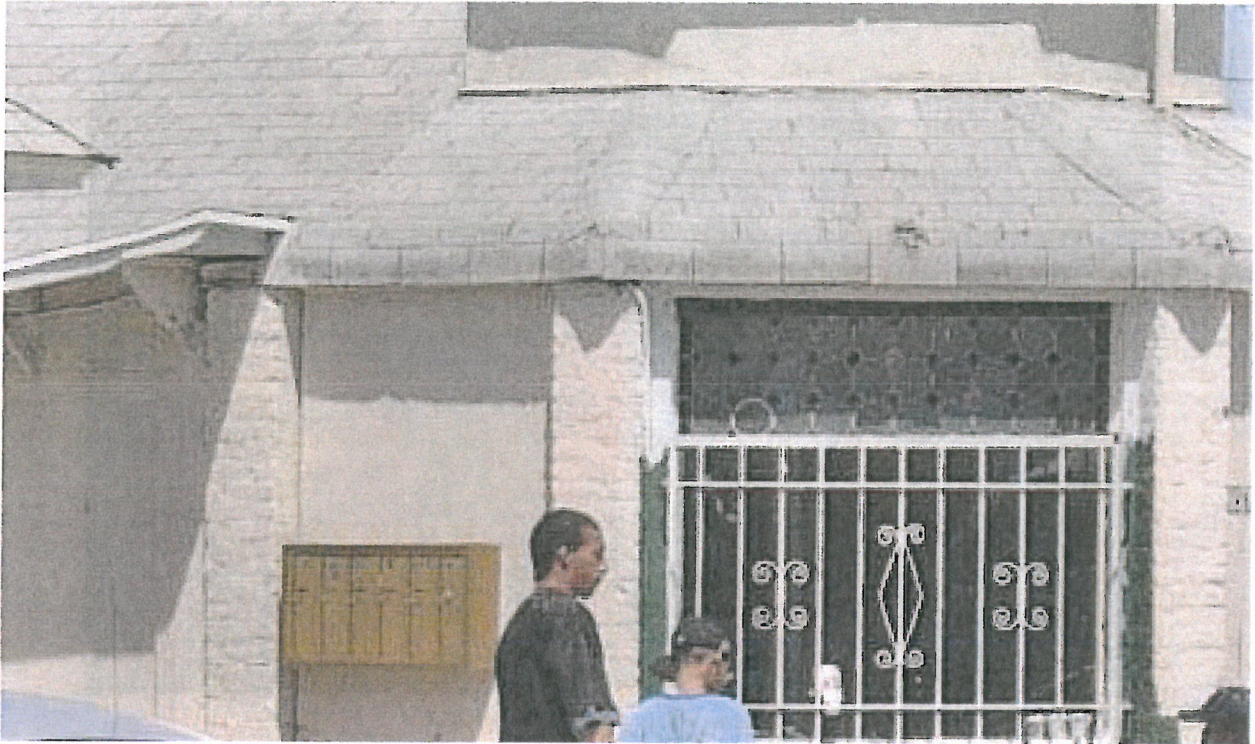
**FEATURE: STAINED GLASS TRANSOM WINDOW**

*Original Stained Glass Windows Now Removed From Hot Cha Café, View Northeast, Photograph by Raphael Mazor: August 17, 2006*

The wood windows on the building once contained stained glass transom windows, but they were removed in 2006 by the barbershop tenant and replaced with new painted wood windows. The upper portion of the window in this location designed to house stained glass measures 18" high x 55" wide. At the time of removal, a separate stained glass design representing the text "Eat - Shoppe" was placed within the frame of the eastern-facing window. After consulting stained-glass experts, it was determined that the window was most likely added in the 1960s after an original was broken. As the window was not added during the period of significance, it is recommended that replacement stained glass windows be designed in a pattern duplicating that shown in the window above.

1. While windows are removed, install new leaded glass reproduction window in transom frame (glass design based upon photographic documentation and created by a trained specialist).
2. Follow steps to repair wood windows for painting and installation instructions.

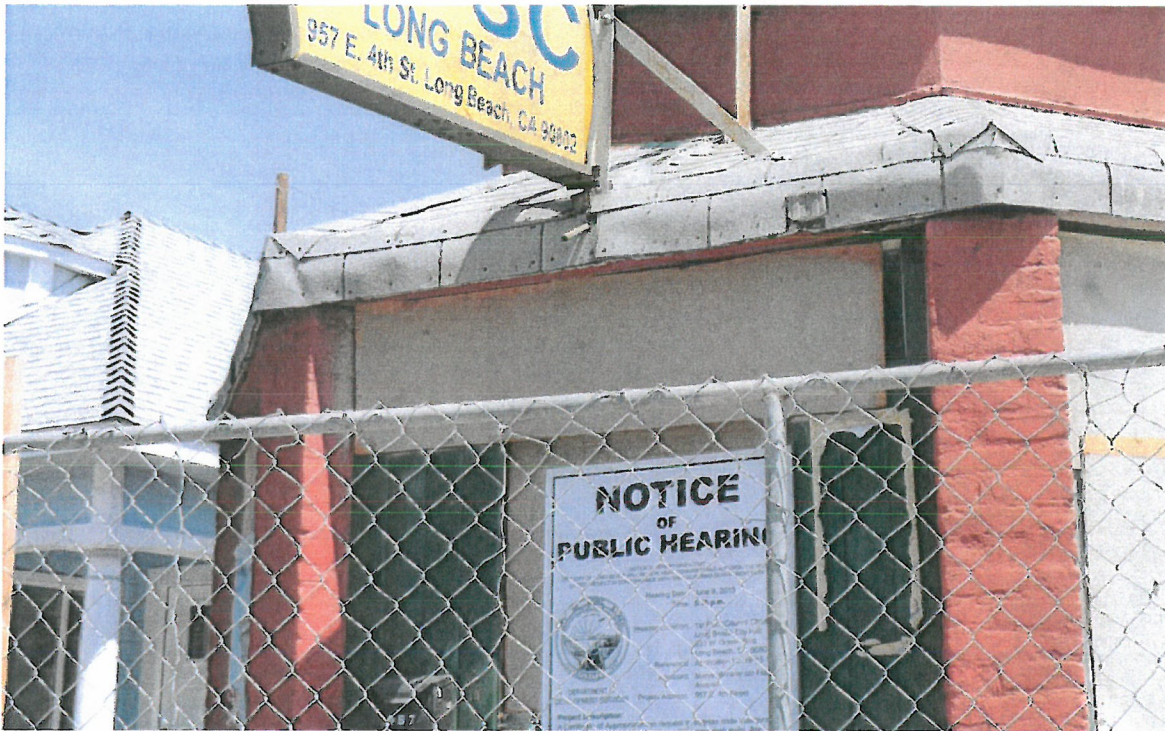
**FEATURE: WOOD TRANSOM WINDOW**

*Wood Transom Window above Primary Entrance, Photograph, May 2015.*

The wood transom window above the primary entrance was once a connection point for an aluminum awning mounted above the primary entrance. When the awning was removed a window was installed in the negative space. The space above the entrance has been operating as a window for at least fifteen years. Photographic documentation from the 1990s shows the awning intact, while photographs from 2004 show it removed and boarded. The current window is wood-framed and non-operable. The window measures 12" high x 54 3/4" wide.

1. Remove window and frame from installed position.
2. Sand window frame and prepare for repainting.
3. Remove and replace existing glass with new reproduction leaded glass designed to match original stained glass pattern (based upon photographic documentation).
4. Prime and paint window frame with specified finish (color based upon historically-accurate color scheme determined as a result of paint analysis).
5. Reinstall window and wood frame.

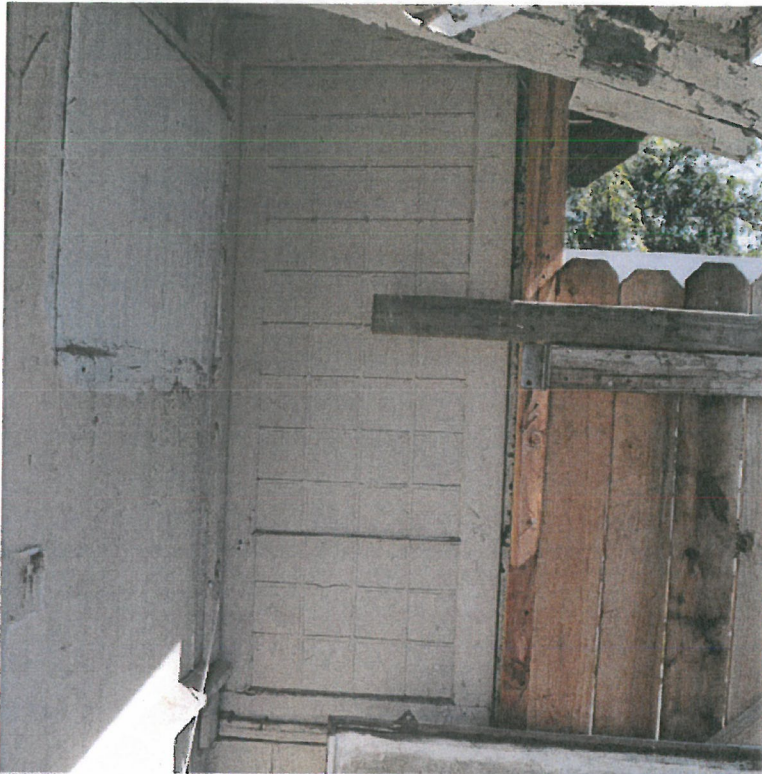
**FEATURE: MULTI-LITE WOOD WINDOW**

*Original Multi-Lite Wood Window on North Elevation, Photograph, May 2015.*

This wood-framed multi-lite window faces north. It is located on the rear of the octagonal coffee pot's east-facing projection. The window has 48 glass panels which have been painted. It's perimeter is framed with wood and the interior panels are framed with aluminum. This window measures 67" high x 27" wide. This window is believed to be the last remaining original window in the building.

1. Remove window from installed position for repair.
2. Remove all paint with organic solvent paint remover.
3. Clean and assess health of each pane of glass to determine whether repair or replacement is appropriate.
4. Remove and replace glass panes where necessary with single-pane untempered glass.
5. Prime and paint window frame with specified finish (color based upon historically-accurate color scheme determined as a result of paint analysis).

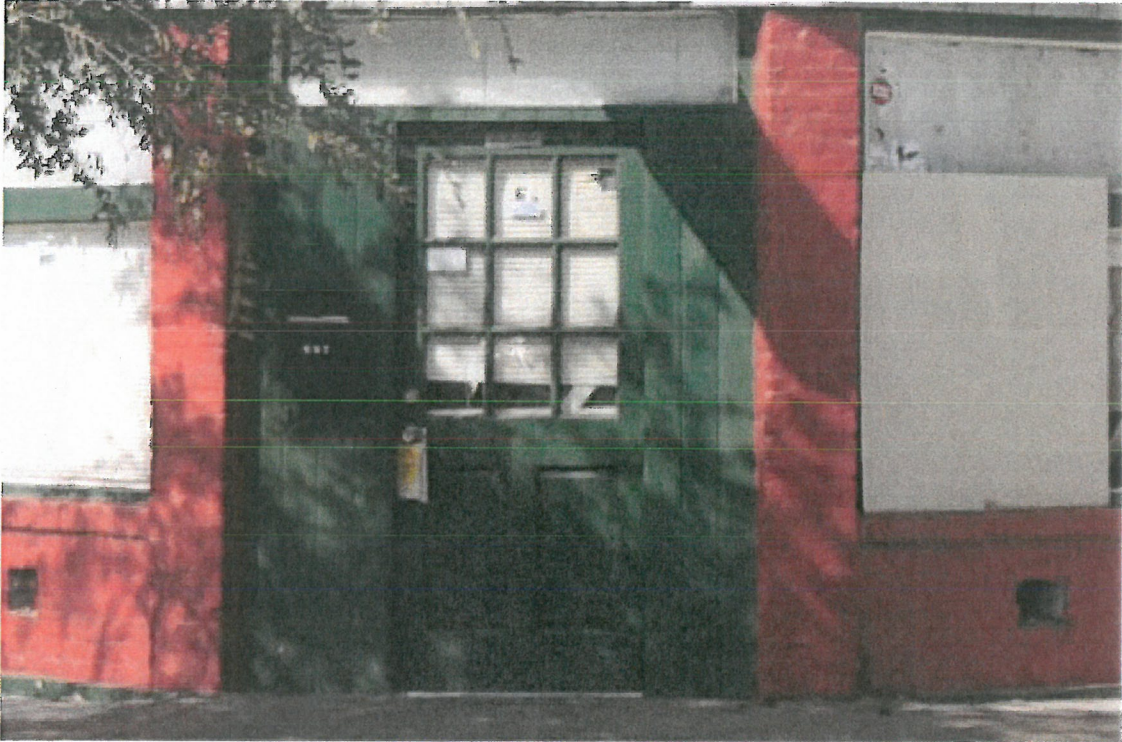
**FEATURE: WOOD DOOR**

*Existing Door, View North, Photograph: February 2015*

The existing door is not original to the building, and no photographic documentation exists of an original door. The proposed replacement single-lite door will allow for the building to take on a commercial use and differentiate the door from the historic materials so as not to create a sense of false history.

1. Detach door from current positioning and discard.
2. Replace with newly fabricated wood-frame door with a single lite and wood panel with decorative vertical wood board on bottom half.

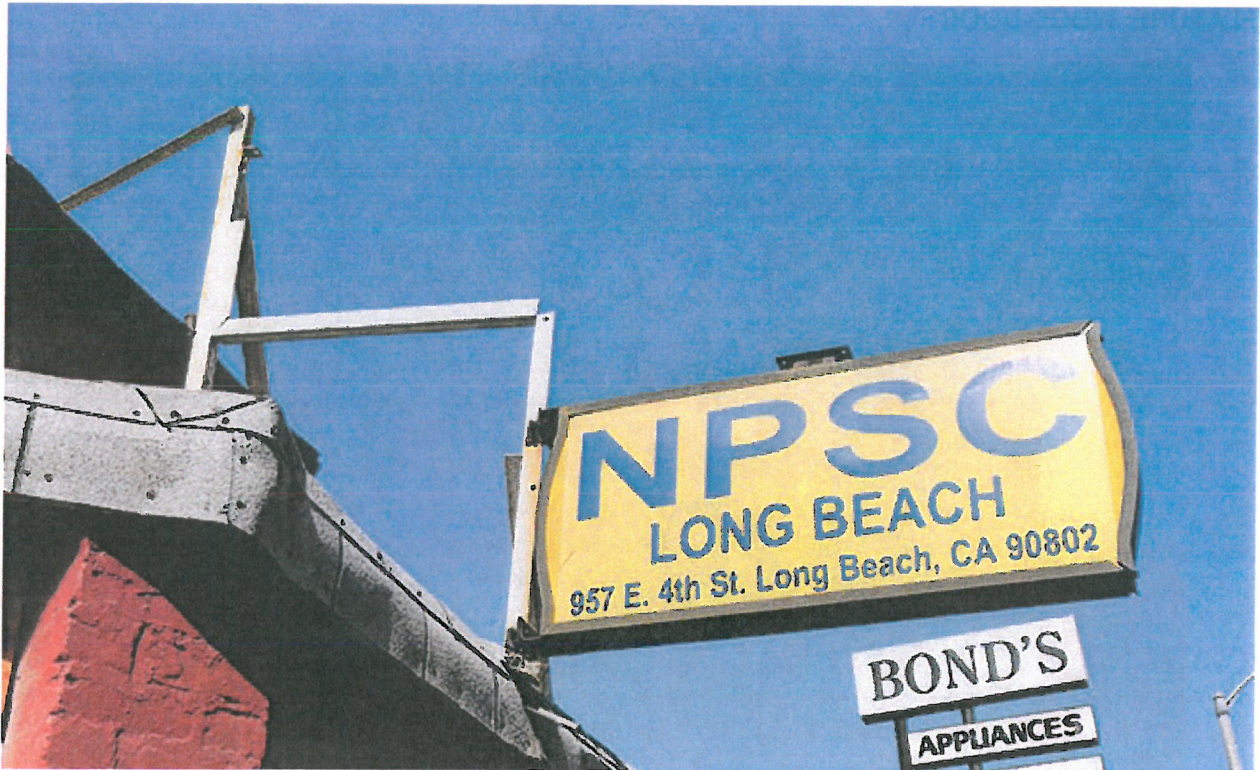
**FEATURE: SIGN AND SIGN-MOUNTING MECHANISM**

*View of Sign and Sign-Mounting Mechanism, Photograph: May 2015*

The sign-mounting mechanism is attached to the building at the lower roof level and secures for stability on the higher roof level. The mounting mechanism is steel and is most likely originates from the 1940s or 1950s. The blade sign is attached to the mounting mechanism on one side. The existing sign is not original. It is believed that the original sign was rectangular with a hanging lower portion based upon historical photographs. The sign was removed to install this replacement sign before 2003, when this sign begins to appear in photographic documentation.

1. Existing sign will be disposed of properly and replaced.
2. Existing sign-mounting mechanism will be removed and stored for repair and future use if desired.
3. Tenant will commission a new sign that is mounted in a similar manner and maintains the street-oriented approach of the original sign.

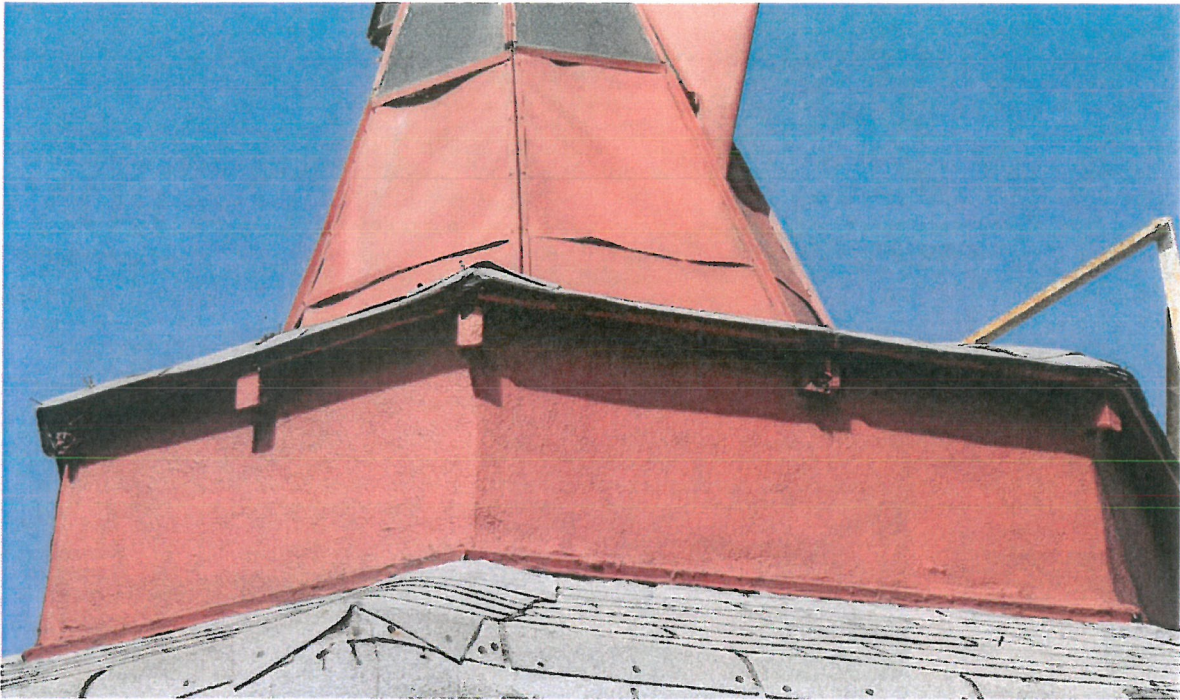
## FEATURE: CLERESTORY STAINED-GLASS WINDOWS

*View of Clerestory Level, Photograph: May 2015*

1. Identify damaged portions of the stucco surface.
2. Prep and repair stucco in damaged areas.
3. Prime clerestory stucco area.
4. Paint with specified finish in color to match brick cladding (body color) on lower level (color based upon historically-accurate color scheme determined as a result of paint analysis).

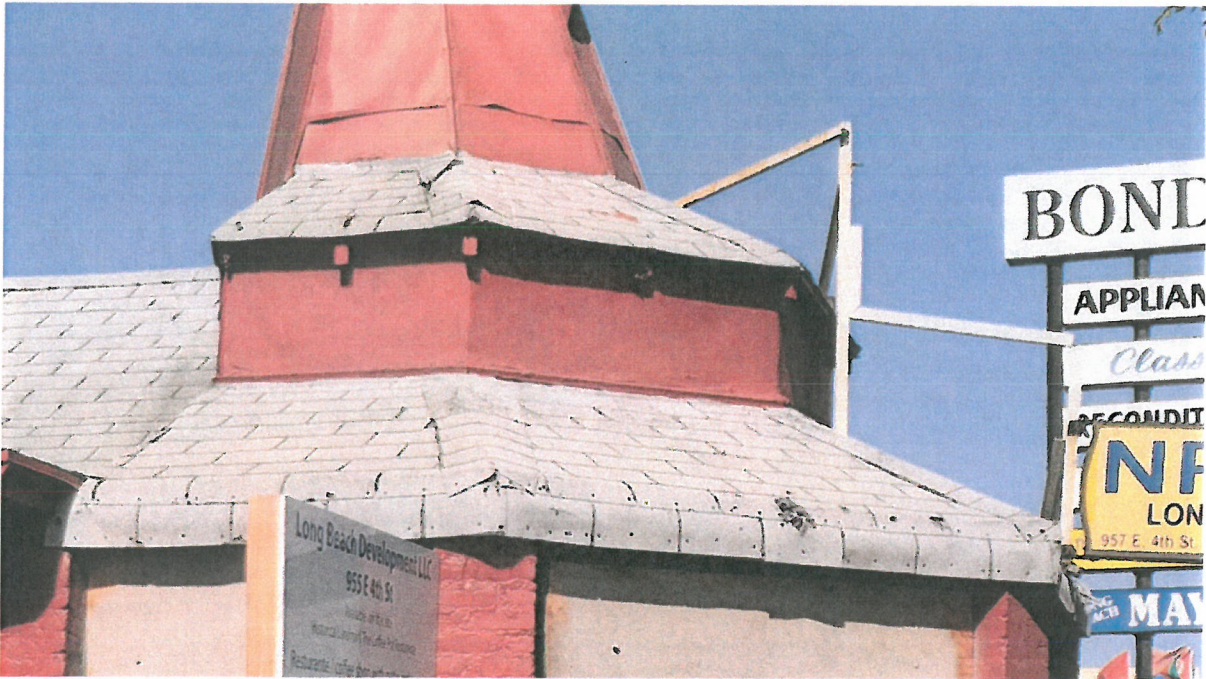
**FEATURE: ASPHALT SHINGLE ROOFING (OCTAGONAL PORTION)**

*View of Asphalt Roofing on Octagonal Building Portion, Photograph: May 2015*

The project will result in new roofing which replicates the pattern of the original, based upon photographic documentation and examination of original roofing remnants. Original roof tiles were found and examined, but color is inconsistent and cannot be reliably replicated. In addition, new reproductions will be less imperfect in color application and will not comply with the historic feeling of the building.

1. Take protective measures to secure roof structure as necessary.
2. Remove existing layers of roofing with caution to protect underlying roof structure and sheathing.
3. Remove unsalvageable sheathing and replace with new composed of in-kind material as necessary.
4. Install new asphalt shingles, replicating the pattern of original.

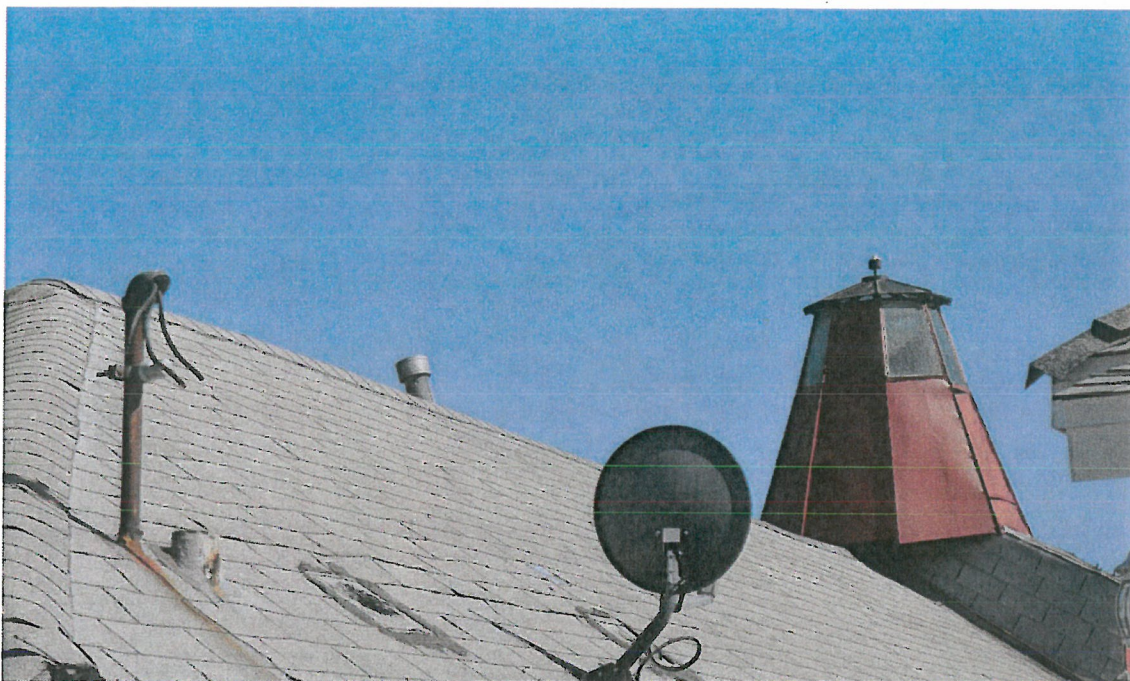
**FEATURE: ASPHALT ROLLED ROOFING (REAR PORTION)**

*View of Asphalt Roofing on Building Rear, View Southeast, Photograph: May 2015*

The weight of the existing roofing material is compromising the structural integrity of the building. Removing decades of roofing material will allow the building to be stabilized, the roof to be resupported, and the building to be safely occupied by a future tenant.

1. Take protective measures to secure roof structure as necessary.
2. Remove existing layers of roofing with caution to protect underlying roof structure and sheathing.
3. Remove unsalvageable sheathing and replace with new composed of in-kind material as necessary.
4. Install new rolled asphalt roofing to match color of front portion, as historically appropriate.

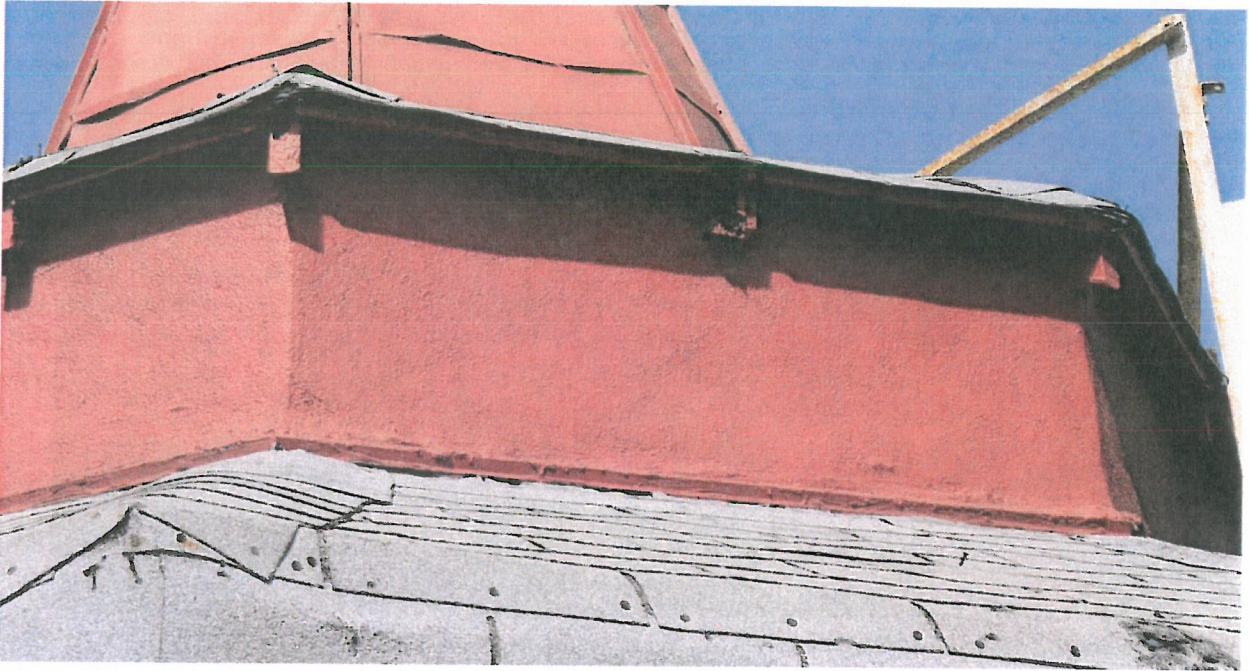
**FEATURE: FASCIA BOARD**

*View of Missing Fascia Board on Primary Elevation, Photograph: May 2015*

A fascia board which ran horizontally below the roof of the building's clerestory level has been removed. Underneath where the board was once mounted are exposed rafter tails in need of repair.

1. Cut new replacement fascia board of Douglas Fir wood sized to fit in place of missing.
2. Prime and paint with specified finish (color to be based upon historically-accurate color scheme determined as a result of paint analysis).
3. Install new fascia board.

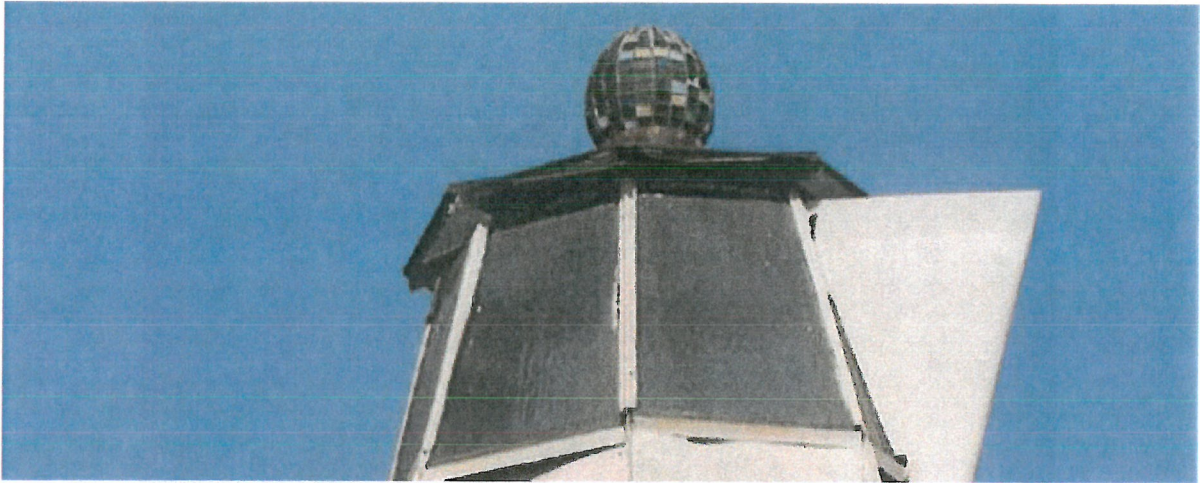
**FEATURE: STAINED GLASS KNOB**

*View of Missing Knob, Photograph: RoadArchitecture.com, dated March 24, 2008*

'Mounted atop of the 'lid' of the spout was once a stylized knob composed of small squares of stained glass formed into a rounded shape. This shape was likely formed around a molded metal frame that could be affixed to the building.

1. Owner and owner's representatives will work with stained glass design team and supplier to reconstruct the knob.
2. New knob frame will be constructed of steel. Method of attachment will be designed through analysis of existing light above roof-mounted spout.
3. Colors of the knob will be based upon photographic evidence and will be coordinated to match the proposed color scheme of the building.

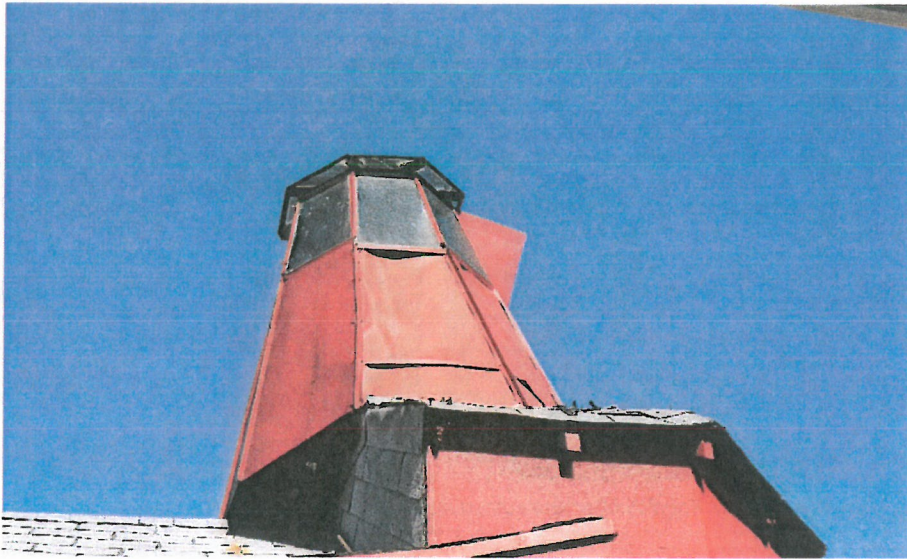
**FEATURE: ROOF-MOUNTED 'SPOUT'**

*View of Roof-Mounted Spout, Photograph, May 2015.*

The roof-mounted spout is composed of steel and glass. The spout was once adorned with a stained glass knob (see Feature #300-2). Below the knob's location is its support base, lined with glass panes around the circumference. Below the support base are eight metal panels held within a steel frame which form the body of the spout. Within each of the eight sides is a glass pane above one or two pieces of steel. Only the northernmost panel does not have a piece of glass above. The three panels which face north are single pieces of steel while the panels facing south and those adjacent are composed of two pieces of steel divided horizontally.

1. Detach and lower spout with proper care under supervision of preservation consultant.
2. Gently detach deteriorated steel panels from frame, measure, and replicate size with like material.
3. Reinstall new steel panels replicating method of attachment.
4. Remove existing paint while protecting historic material.
5. Gently prep, prime, and paint spout with specified material. Paint will be painted silver metallic as derived from period of significance (identified by professional paint analysis).
6. Gently raise spout back into exact position with proper care, labor, and supervision by preservation consultant.
7. Resecure spout into its original location with salvageable hardware and reinforce with contemporary hardware as necessary (not to be invasive or visible from exterior perspective).

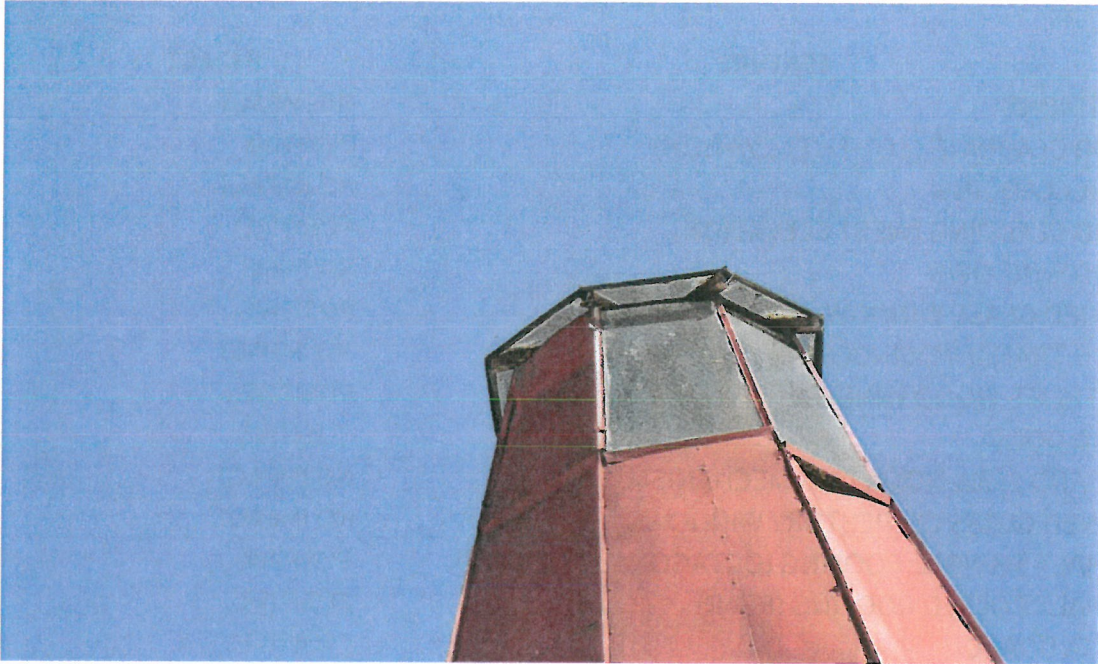
## FEATURE: GLASS PANELS

*View of Glass Panels within Coffee Pot Spout, Photograph: May 2015*

1. Glass panels will be removed from their current position along with the spout for maintenance.
2. Glass will be cleaned with nonsudsing household ammonia so as not to degrade the historic material.
3. After cleaning, glass panels will be remounted along with the remainder of the spout onto the top of the building.
