KOUJAH CONSULTING ENGINEERS

Reference Property Address: 1640 E. Seventh Ave., Long Beach, CA. 90813

Subject: Report on limited Visual Inspection/observation.

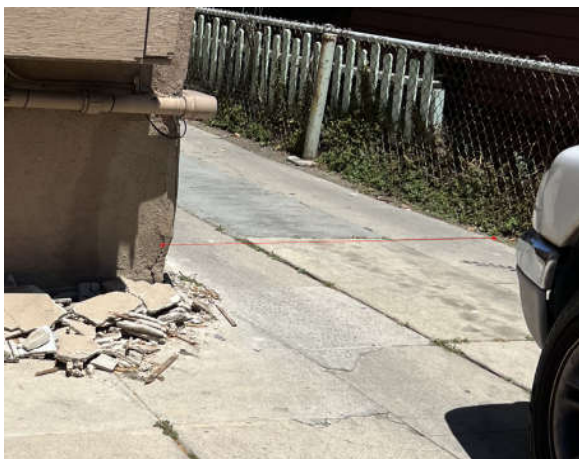
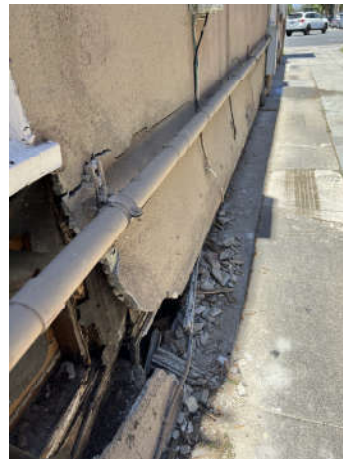
- A. The impact of the car crashing into the exterior wall of the building is insignificant. It does not appear to sustain damage to the structural system beyond the localized stucco breakout. One of the neighbors said that this was not the first time a car crashed into the wall of the building. This is happening because tenets must go through a narrow driveway, about 10'-0" wide, to exit the building from the detached parking garages located in the back of the property. This narrow driveway distance has intrusions into it such as plumbing and roof drainage pipes, and electrical boxes.

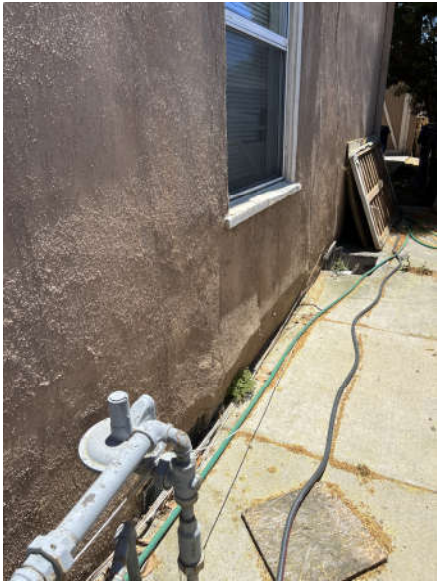
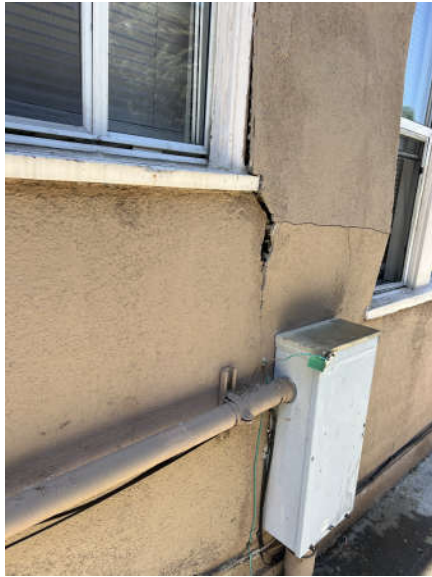
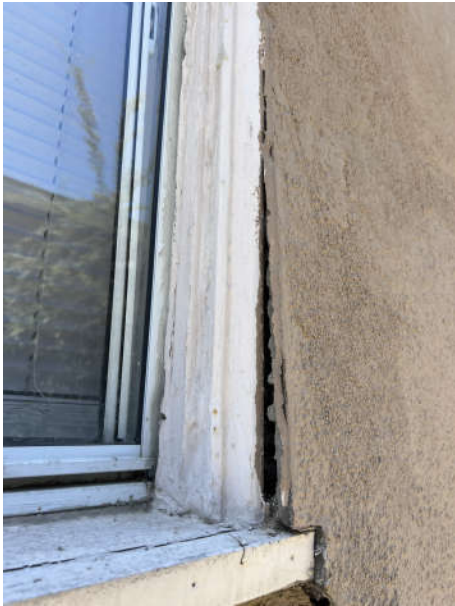
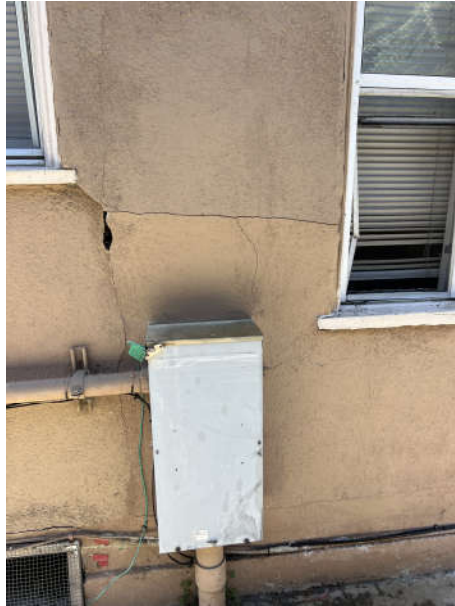
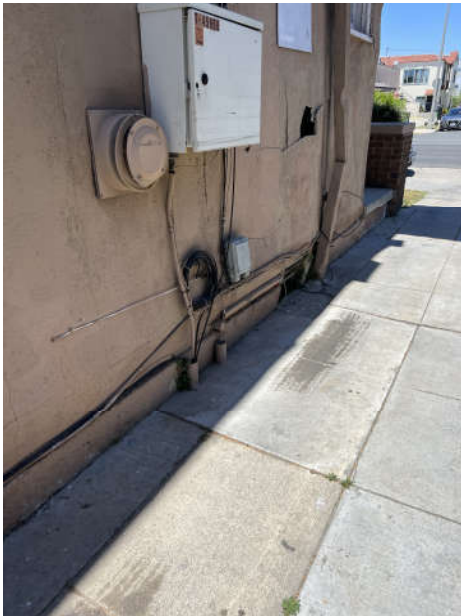
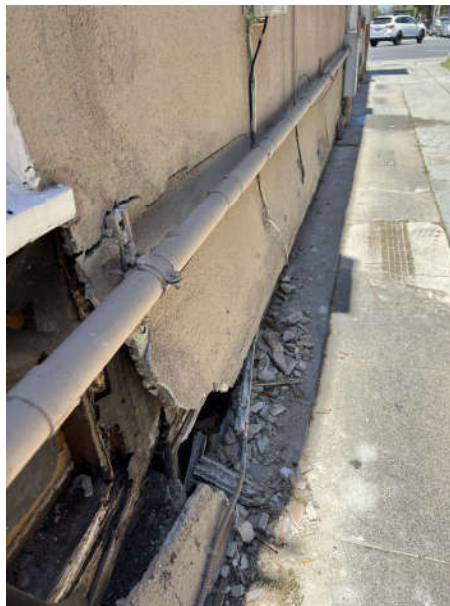
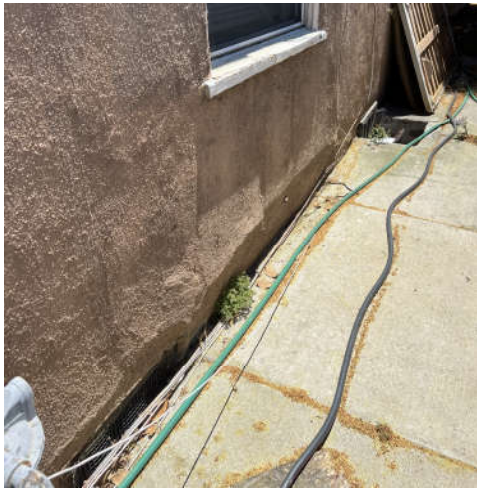
- B. The exterior of the building has suffered water damage and termite damage is apparent on three sides of the building, the back and two longer side walls. As a result, the exterior stucco finish is detached from the wood framed walls and buckled.

2. Remove and replace all damaged stucco, sill/sole plate, and framing members.
3. Consult with a licensed engineer and or architect to perform detailed lateral wind and seismic analysis and provide adequate wall bracing to ensure proper load path from roof sheathing to foundation per the latest applicable building code and City ordinance.

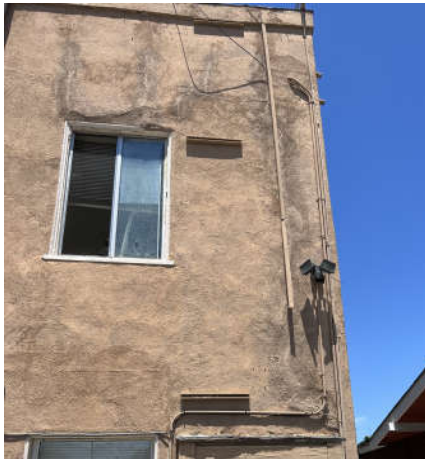
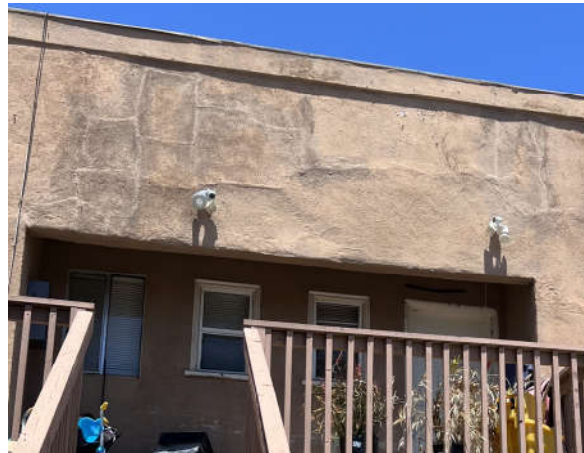
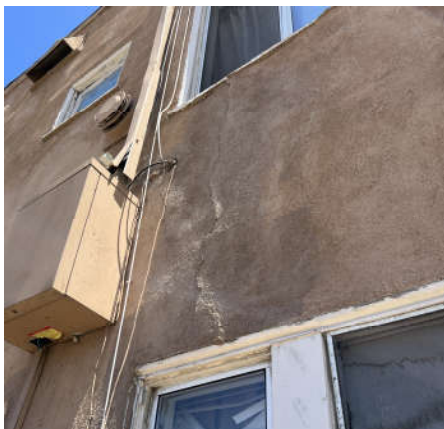
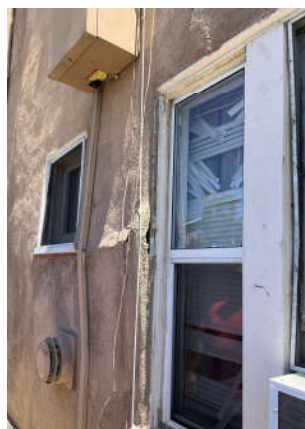
- C. The roof drain system and slope to drains surface were not accessible at the time of observation and need to be checked. The stucco on the 2nd floor walls appears to separate from the walls due to moisture intrusion and needs to be replaced.

4. Check if the existing roofing material needs to be replaced or resurfaced to slope to drain.
5. Provide adequate drainage system from the roof and decks.

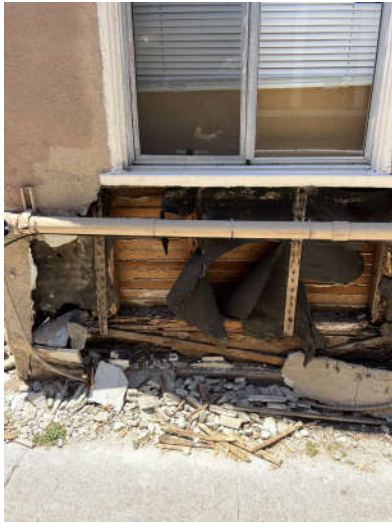
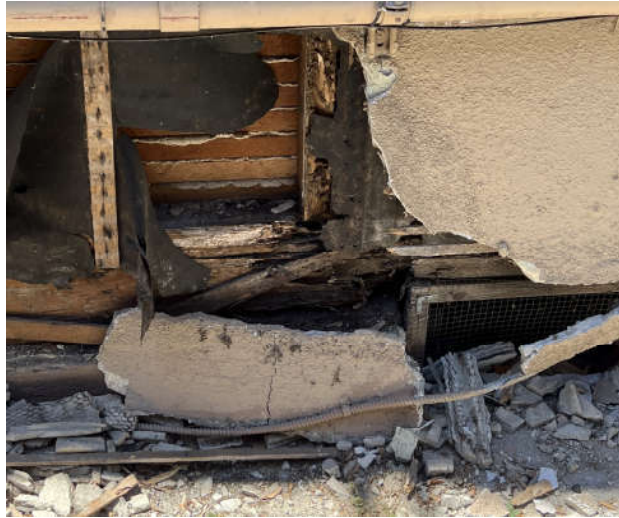
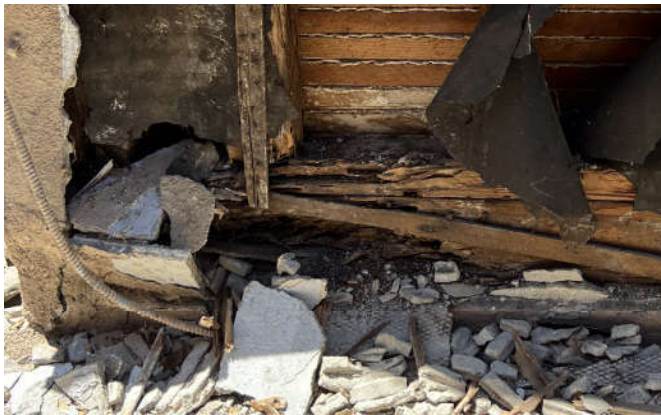
- D. The sill/sole plates are damaged due to moisture and termite activity and need to be replaced. Also, the sill/sole plates do not appear to be mechanically anchored to the foundation. As a result, the load path to foundation to resist seismic and wind loads is no longer adequate and needs to be reconstructed to comply with the latest applicable building code.

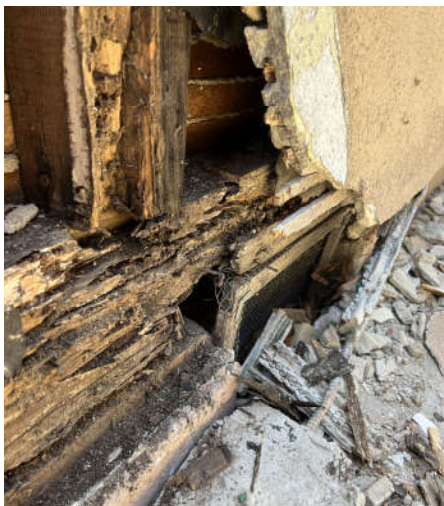
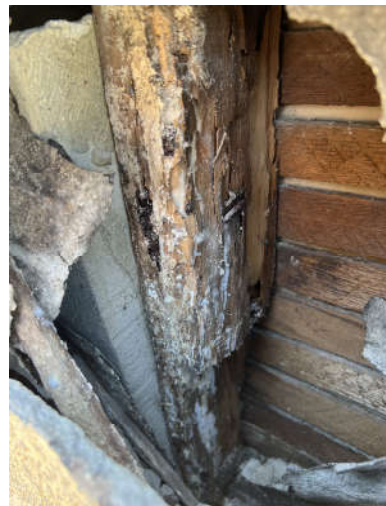
- E. It is unknown how many stud walls deteriorate due to moisture, termite, and molding. The visual observation, where studs are exposed, shows a few studs with severe damage. A termite report from a specialized termite company is required to determine which stud wall needs to be replaced.

1. Consult with termite and wood testing companies to check the adequacy of the existing stud walls, exterior beams, and header where stucco was detached, and the raised floor foundation system.

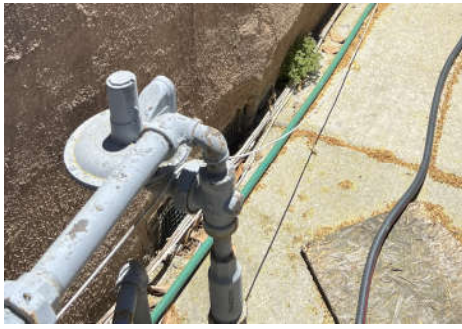
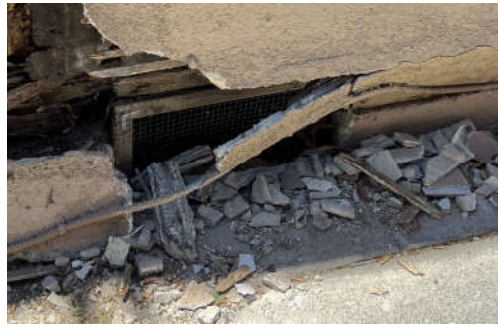
- F. Concrete slab is poured against the under-floor ventilation openings along the longer sides of the structure. Required under floor ventilation needs to be recalculated and verified for compliance with the minimum code requirement to provide proper ventilation.

6. Provide curbs around all under floor ventilation system.
7. Consult with an architect and/or electrical engineer for the proper installation of all electrical wirings system that could pose danger to the tenants.
