# CITY OF LONG BEACH

HONORABLE MAYOR AND CITY COUNCIL  
City of Long Beach  
California

Authorize the City Manager to proceed with the entitlement phase of the proposed Long-Term Belmont Pool Revitalization Project (Project), and with the installation of a temporary outdoor pool or other interim option. (District 3)

PROPOSED LONG TERM CONCEPT  
**BELMONT PLAZA POOL REPLACEMENT**  
 CITY OF LONG BEACH, CALIFORNIA

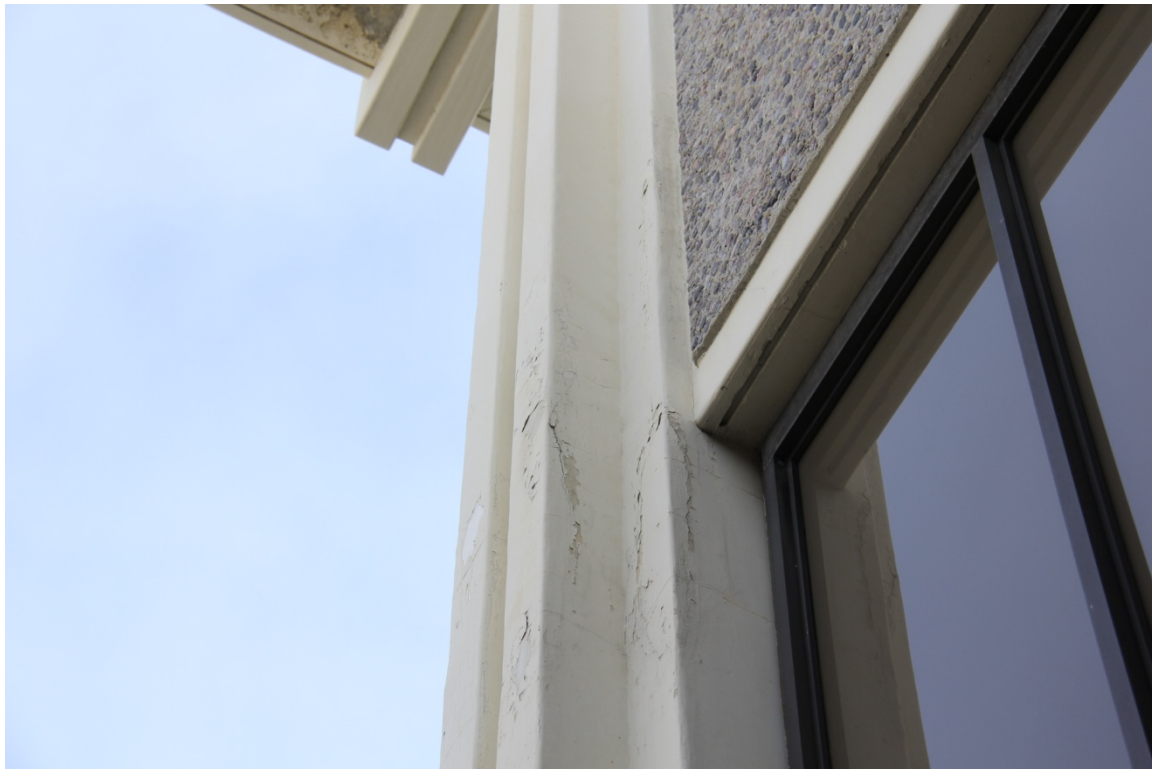
Concrete Deterioration – Cracks in the concrete members and corrosion of steel reinforcement are observed in the columns, beams and walls; concrete deterioration deficiencies exist.

Figure 16 – Natatorium Building, Cracks in Column at Northeast Corner (Grid A/7)

Per the HAZUS evaluation, TTG recommends that the Natatorium concrete columns be strengthened to reduce the risk of building collapse in the event of a Design Earthquake A, allowing the Belmont Plaza Pool Complex to remain operational through the next 5 years. This, however, is a limited structural retrofit which can only achieve a short-term collapse prevention objective. Long-term collapse prevention of the site will either be achieved through a comprehensive structural upgrade of the existing buildings to mitigate earthquake risk, or the removal of the buildings from service.

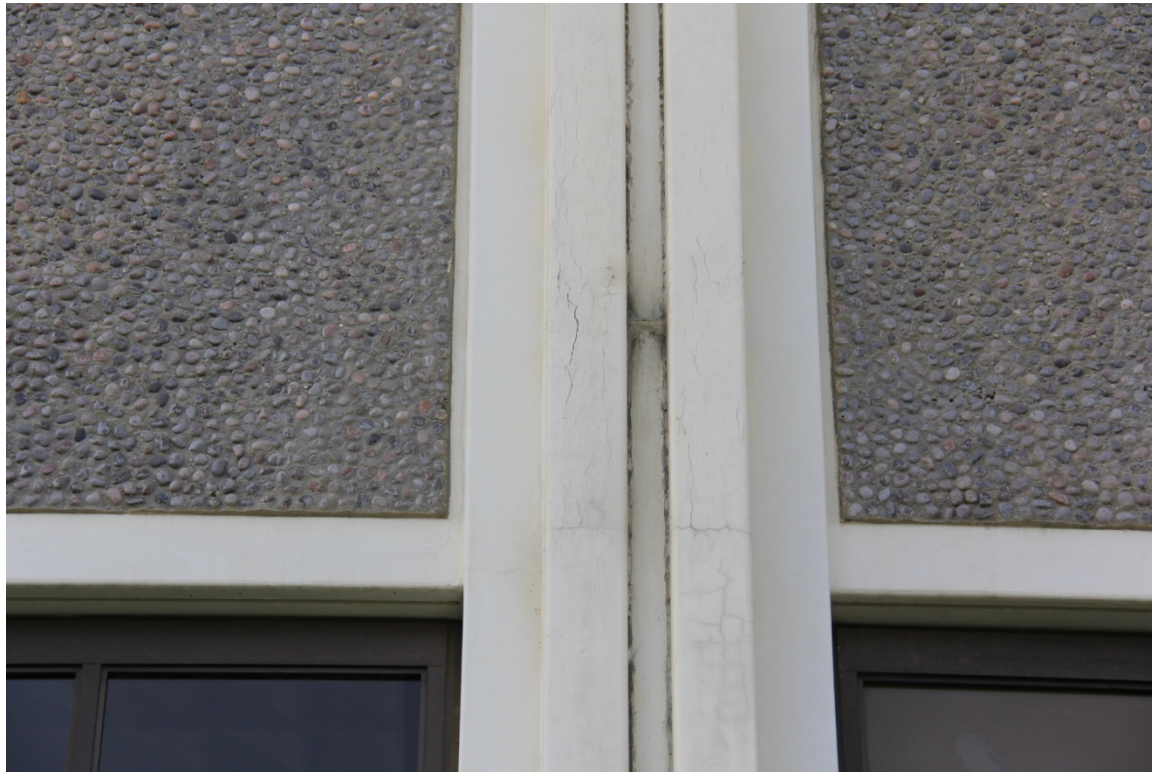
Figure 17 – Natatorium Building, Cracks in Column at North Elevation (Grid A/11)

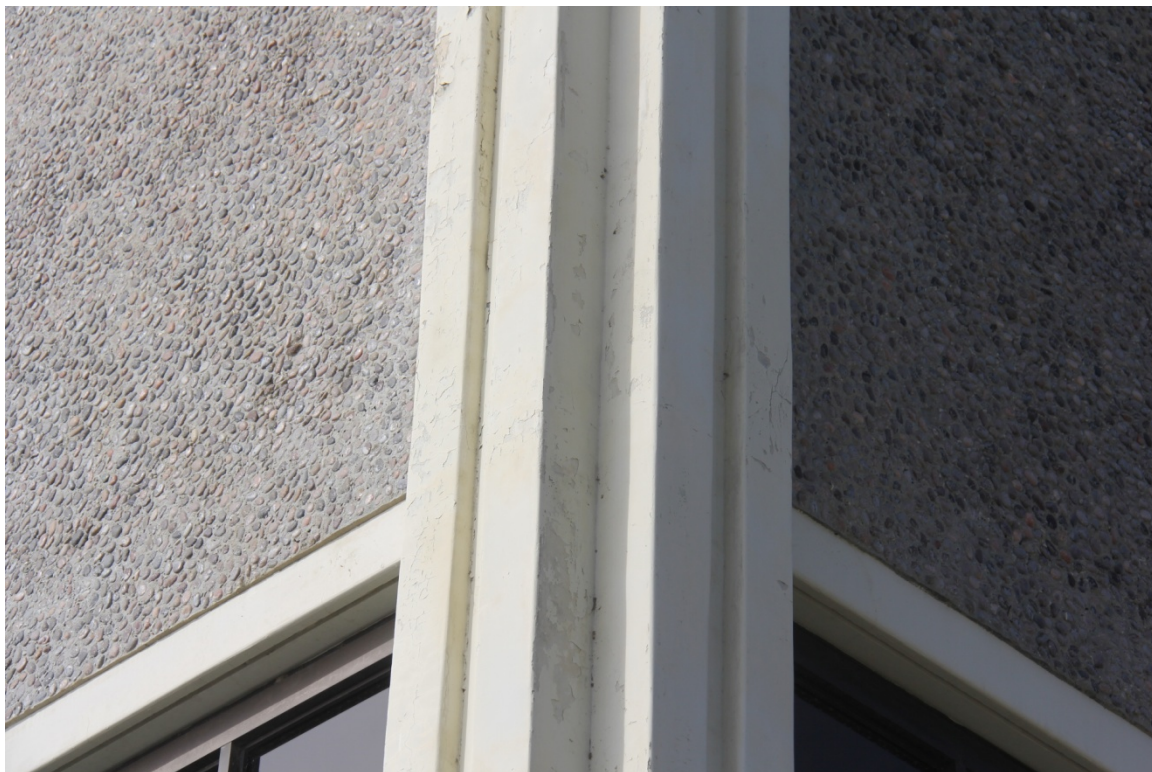
Figure 18 – Natatorium Building, Cracks in Column at Northeast Corner (Grid A/18)

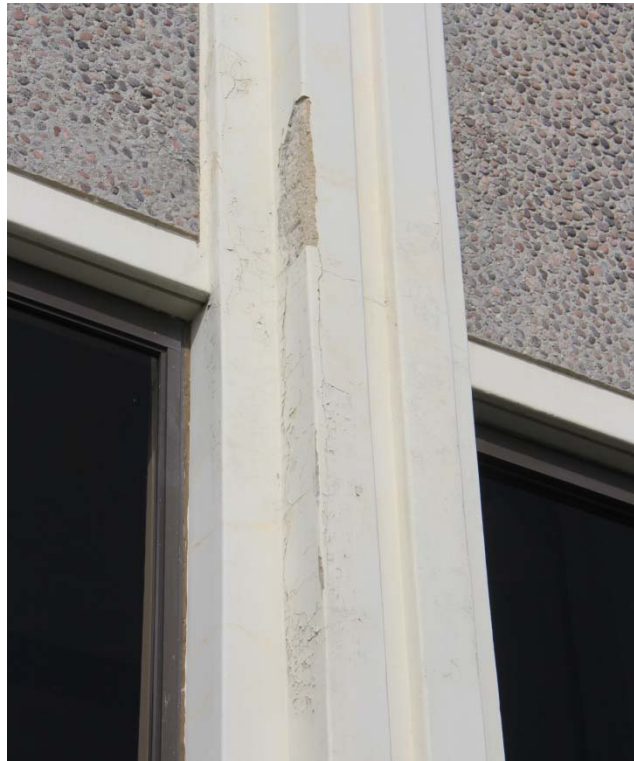
Figure 19 – Natatorium Building, Cracks in Column at East Elevation (Grid B/18)

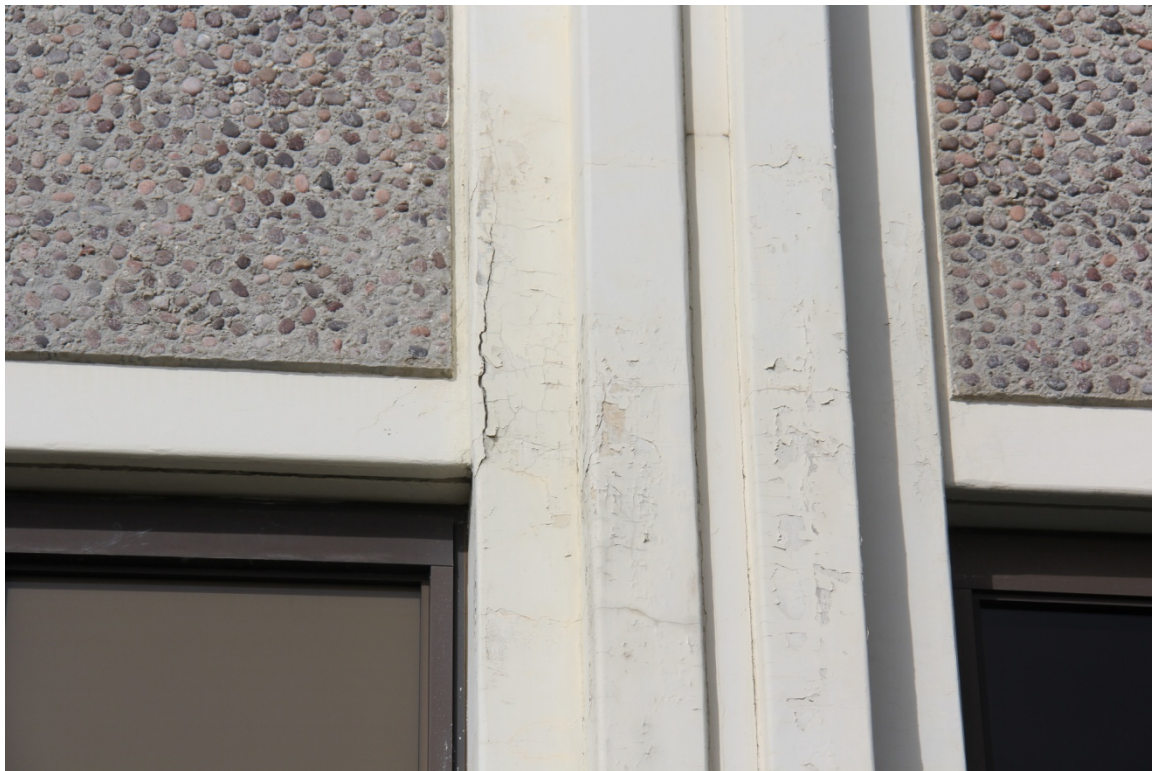
Figure 20 – Natatorium Building, Cracks in Column at East Elevation (Grid C/18)

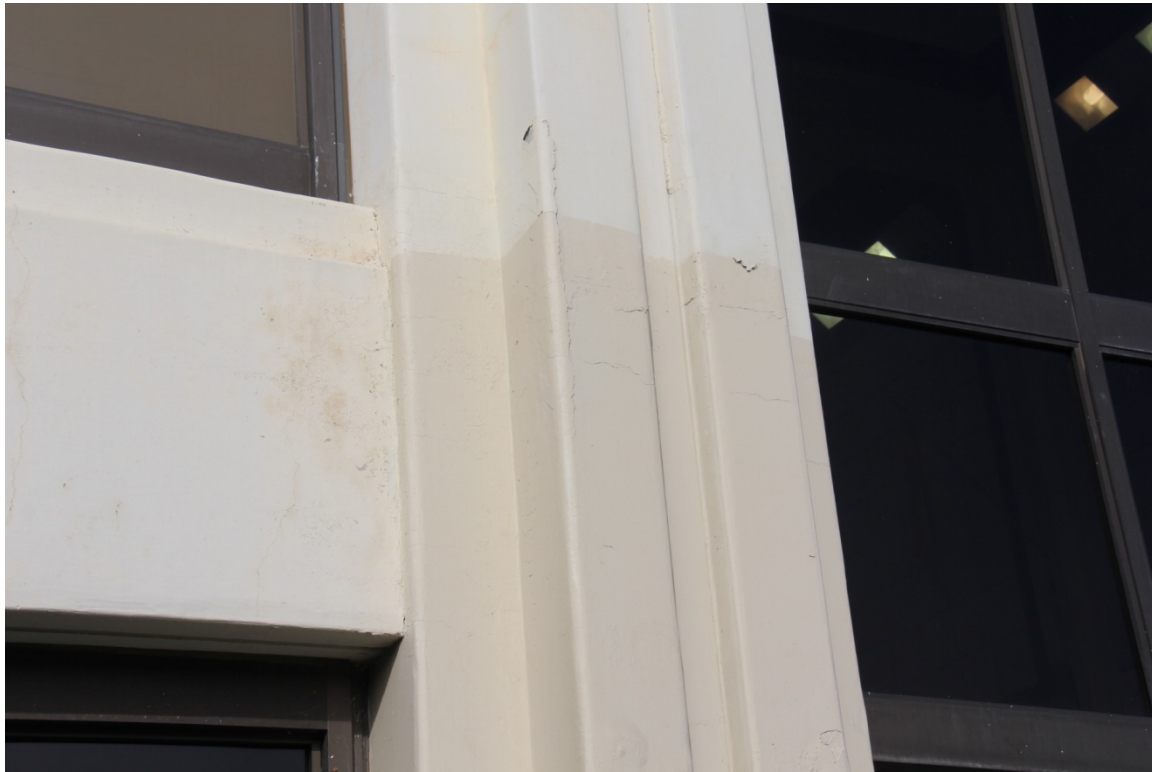
Figure 21 – Natatorium Building, Cracks in Column at East Elevation (Grid C/18)

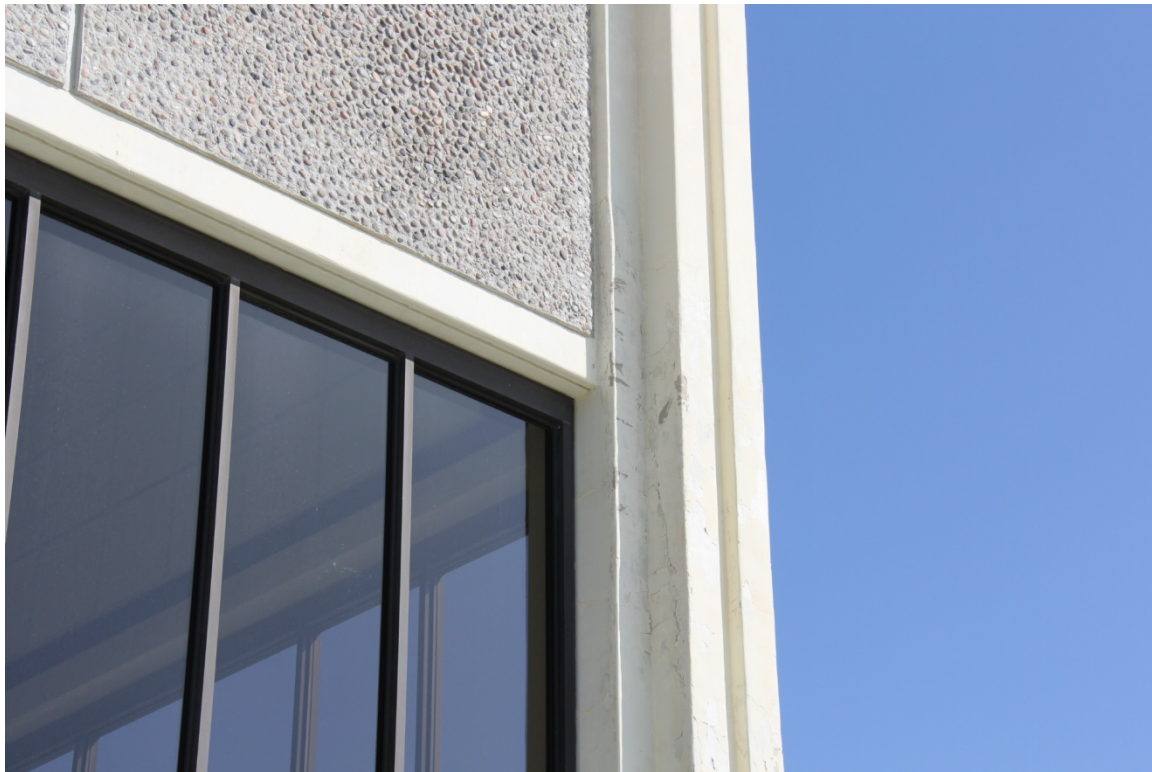
Figure 22 – Natatorium Building, Cracks in Column at Southeast Corner (Grid H/18)

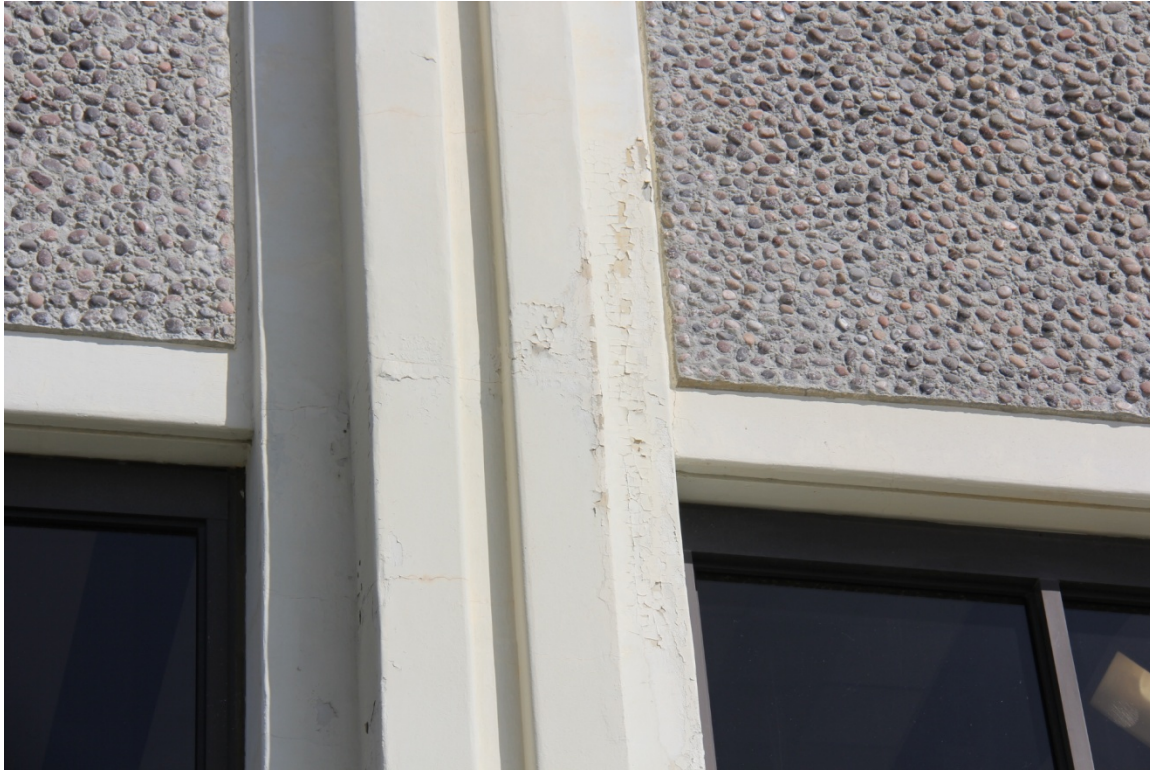
Figure 23 – Natatorium Building, Cracks in Column at South Elevation (Grid H/17)

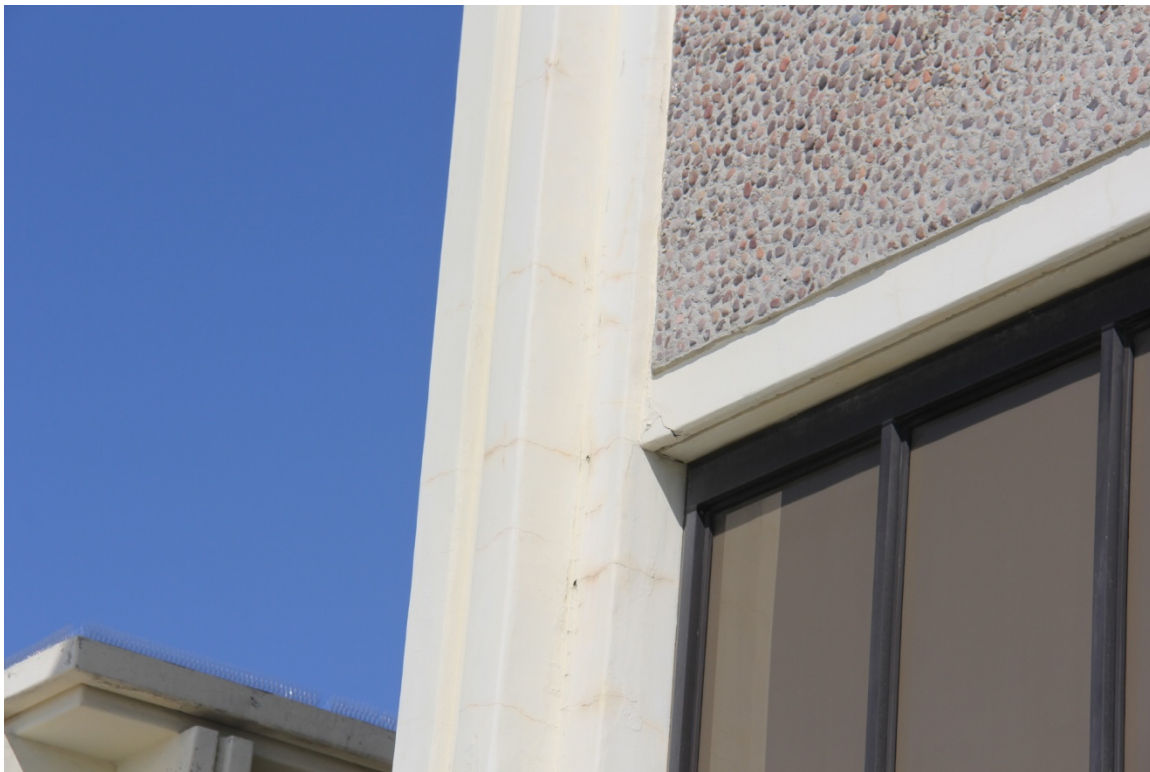
Figure 24 – Natatorium Building, Cracks in Column at Southwest Corner (Grid H/7)

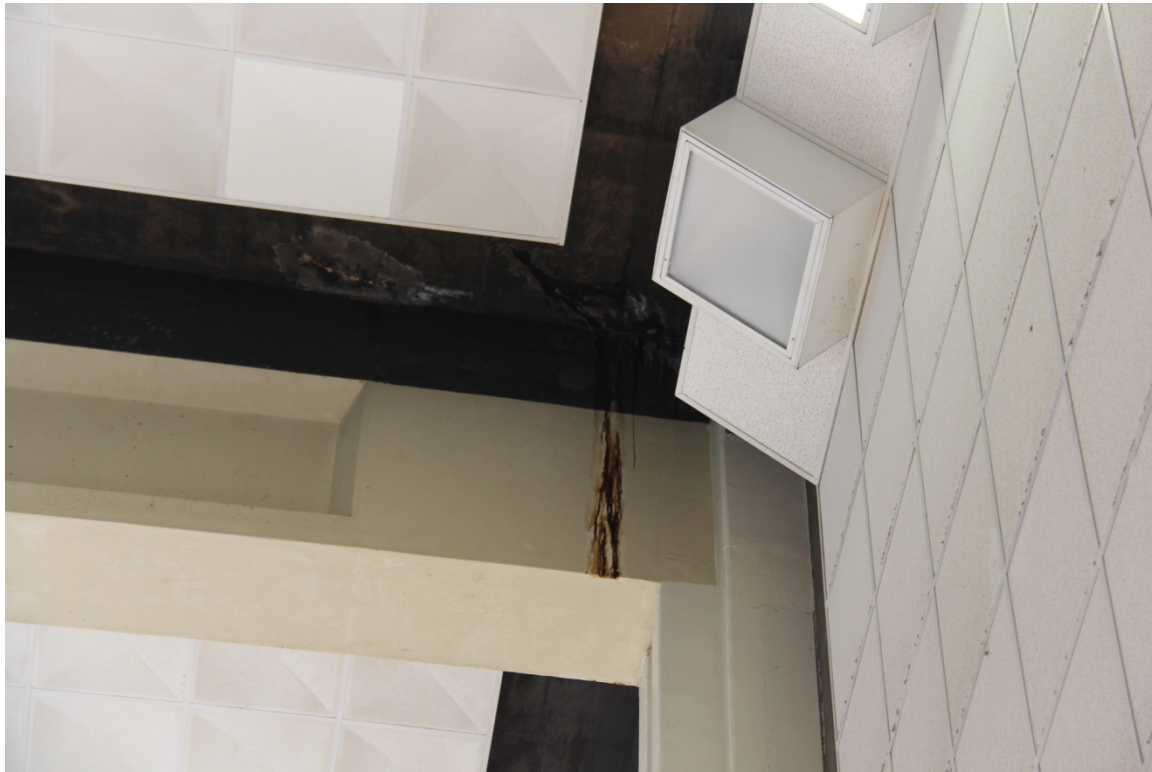
Concrete discoloration and streaking are observed in the roof framing of the Natatorium Building, and similar conditions can be seen around the skylights (see Figure 25 of Appendix A). It is not clear whether this is due to roof leakage or condensation of pool water. The interior and exterior environments surrounding the buildings are very conducive to the corrosion of steel reinforcement in the concrete, possibly because of the chemicals used in pool water maintenance, and also the Belmont Plaza Buildings' proximity to the ocean. Cracks and stains can be seen on the roof-overhang of the Natatorium Building, indicating possible corrosion of the reinforcement in the concrete (see Figure 26 of Appendix A). Cracks in the concrete roof slabs overhangs are also present in the Locker Building (see Figure 27 of Appendix A). There are also concrete cracks in the Private Event Building's basement area (see Figure 28 to 30 of Appendix A). Very large, horizontal cracks and signs of heavy rebar corrosion can be seen in the wall separating the pool from the basement of the Private Event Building (see Figure 30 of Appendix A). The electrical distribution boxes have also been damaged by corrosion (see Figure 29 of Appendix A). As seen, the basement environment is clearly corrosive to steel. There are signs of heavy water leaks, which are most likely being caused by faulty pipe connections in the water treatment system. The prolonged exposure of reinforcing steel to this corrosive water and moisture is of great structural safety concern.

Figure 25 – Natatorium Building, Stains in Roof Slab/Beam at Interior South End

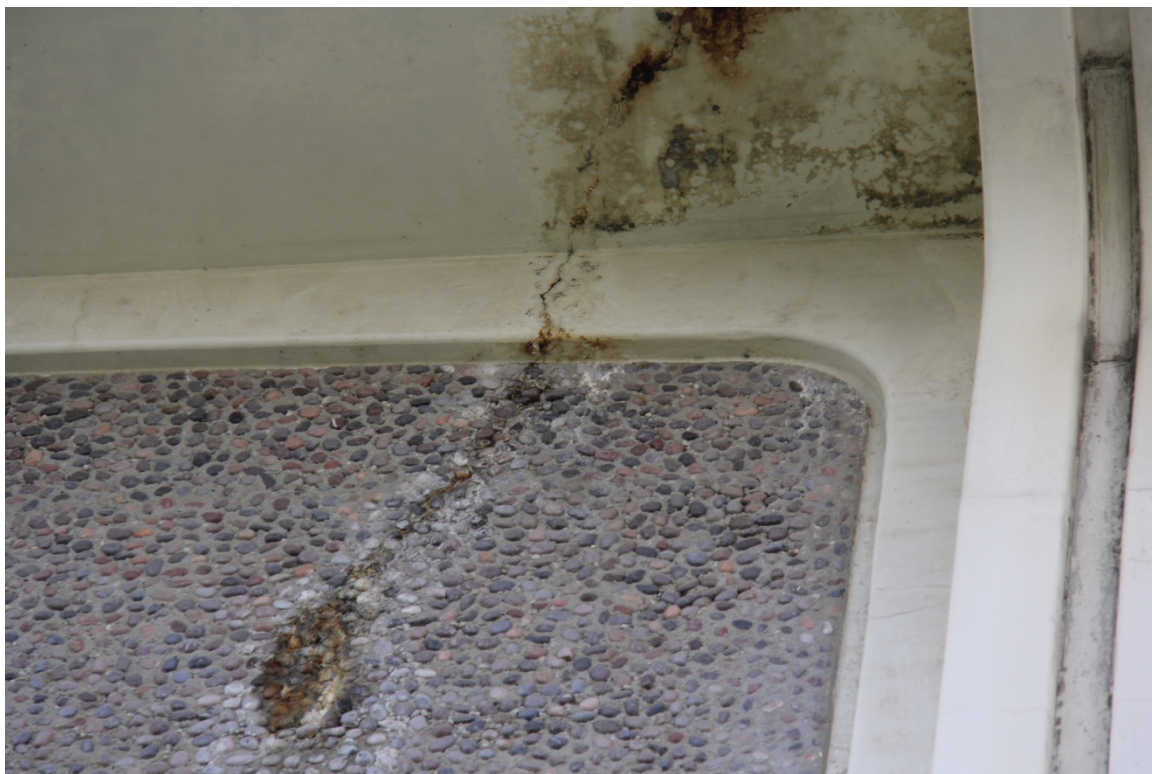
Figure 26 – Natatorium Building, Cracks in Concrete Wall/Roof at North Elevation

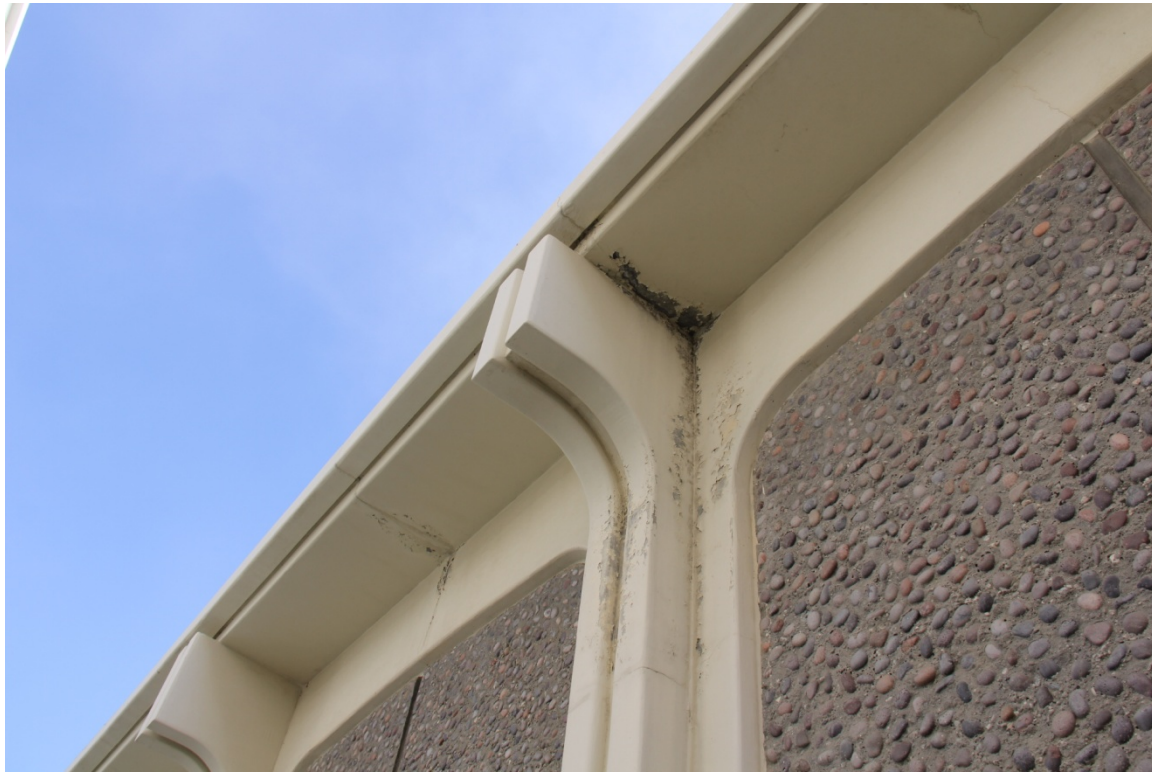
Figure 27 – Locker Building, Cracks in Concrete Roof Slab at West Elevation

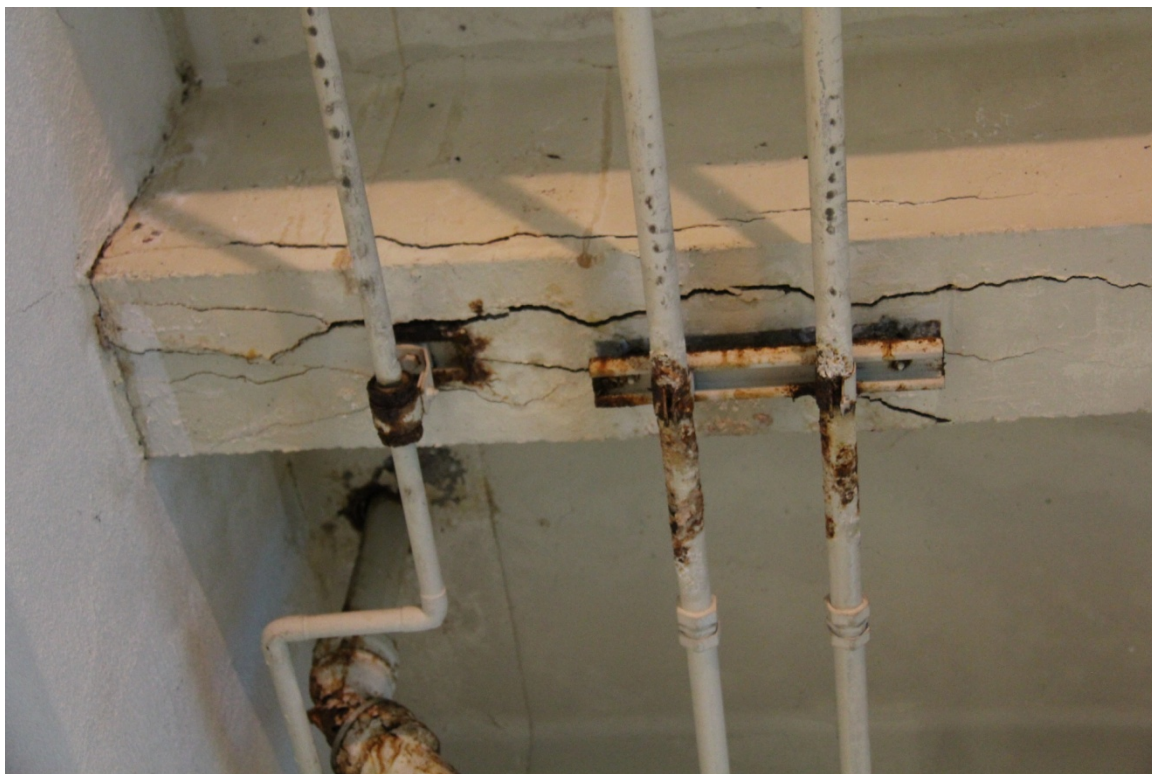
Concrete Deterioration – Cracks in concrete members and corrosion of the reinforcement are observed in beams and walls, causing concrete deterioration deficiencies to exist.

Figure 28 – Community Building, Cracks in Concrete Beams in Basement

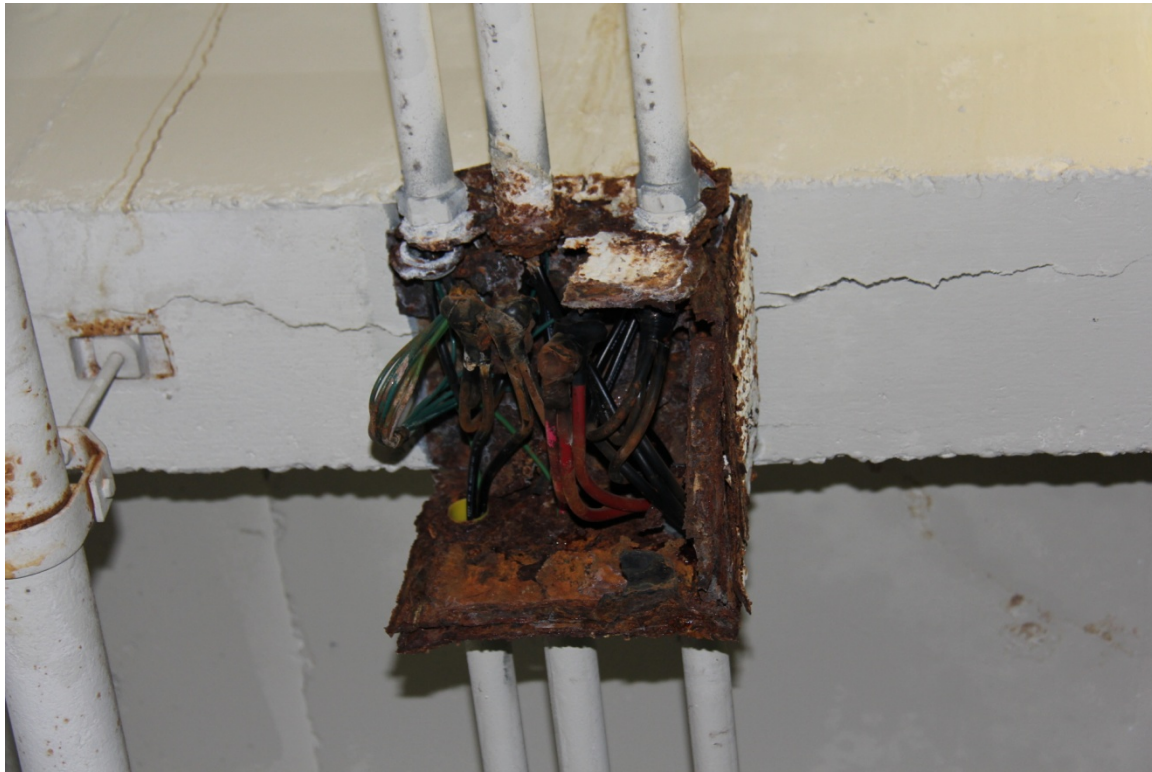
Figure 29 – Community Building, Cracks in Concrete Beams in Basement

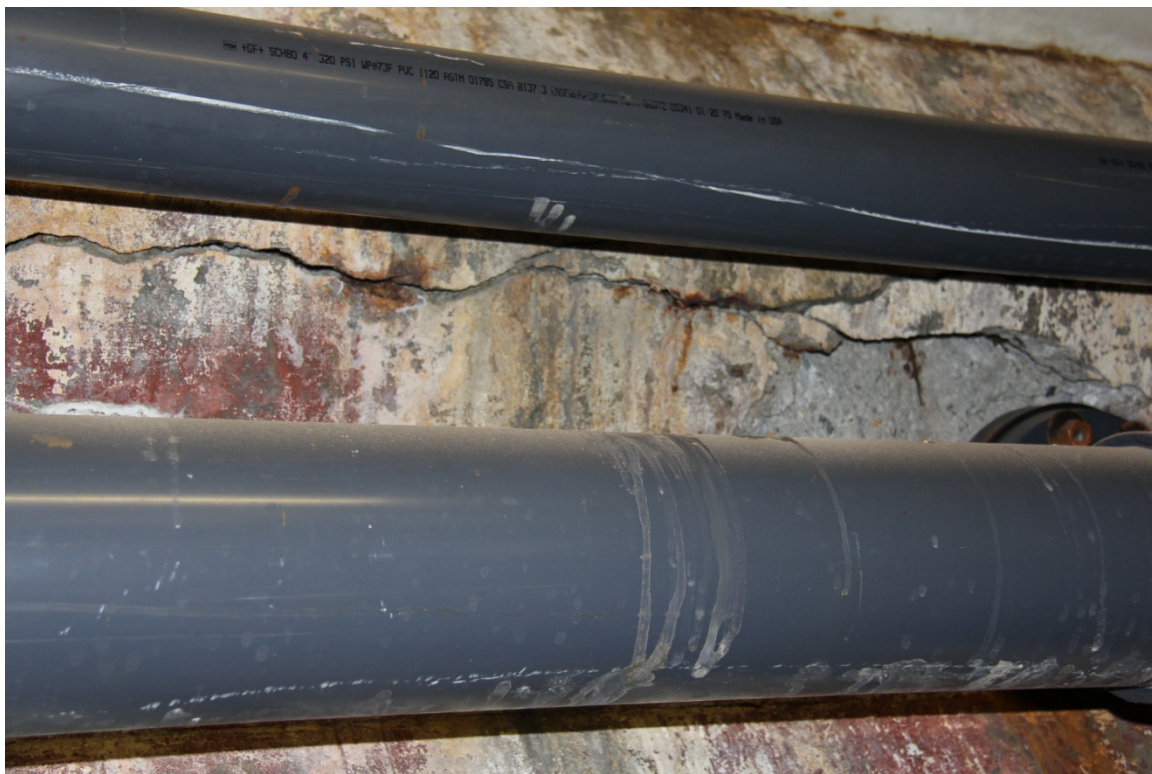
Figure 30 – Community Building, Cracks in Concrete Wall in Basement

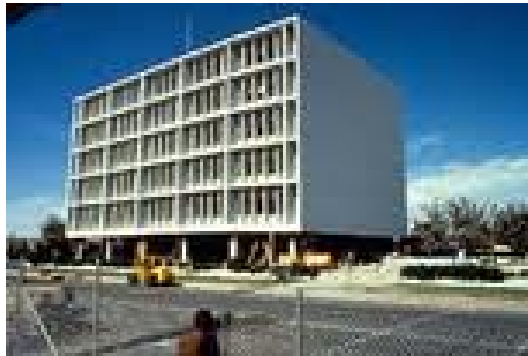
Photo 1 – Imperial County Service Building, 1979 Earthquake Damage

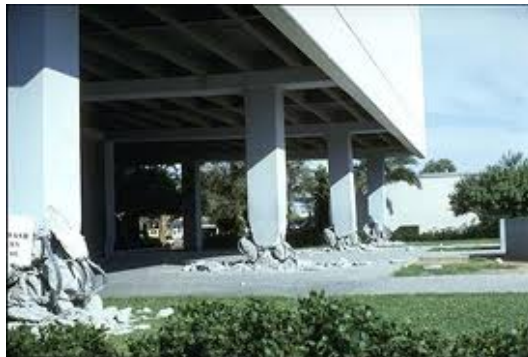
Photo 2 – Imperial County Service Building, 1979 Earthquake Damage

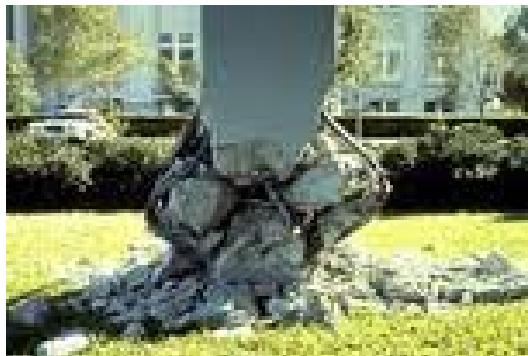
Photo 3 – Imperial County Service Building, 1979 Earthquake Damage

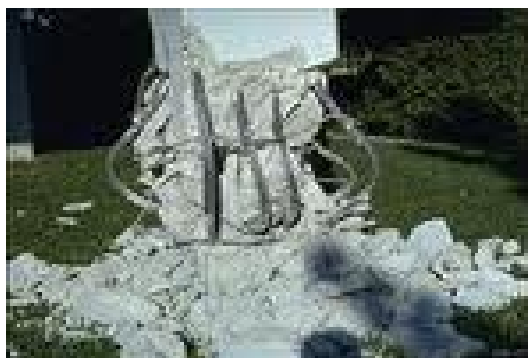
Photo 4 – Imperial County Service Building, 1979 Earthquake Damage
