Subject: Letter Report for 3801 East Fifth Street (Assessor's Parcel Number 7255-017-013),
City of Long Beach, Los Angeles County (LSA Project No. LRG1101)

3801 East Fifth Street

RE: 3801 East Fifth Street, Long Beach
Structural Assessment
NYA #11231.00

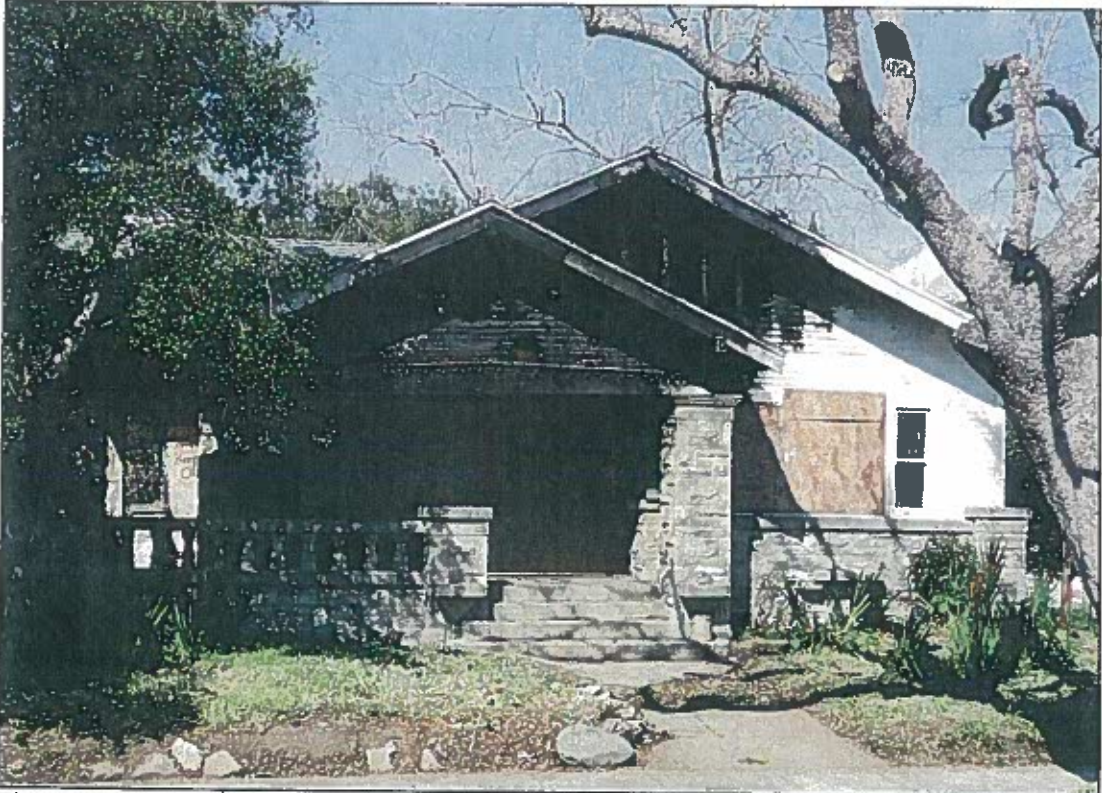
The approximately 1,530-square-foot residence is a typical Craftsman bungalow with an interior floor plan that is generally rectangular. It rests on a raised concrete foundation and is surmounted by a cross-gable roof (Attachment A, Figures 1–3). The exterior walls are sheathed with clapboard siding and there is flat wood trim around the windows. The south-facing façade is dominated by a concrete

Figure 1: 3801 East 5th Street, view to the north. (Photograph taken on 2/23/11 and provided by the owner.)

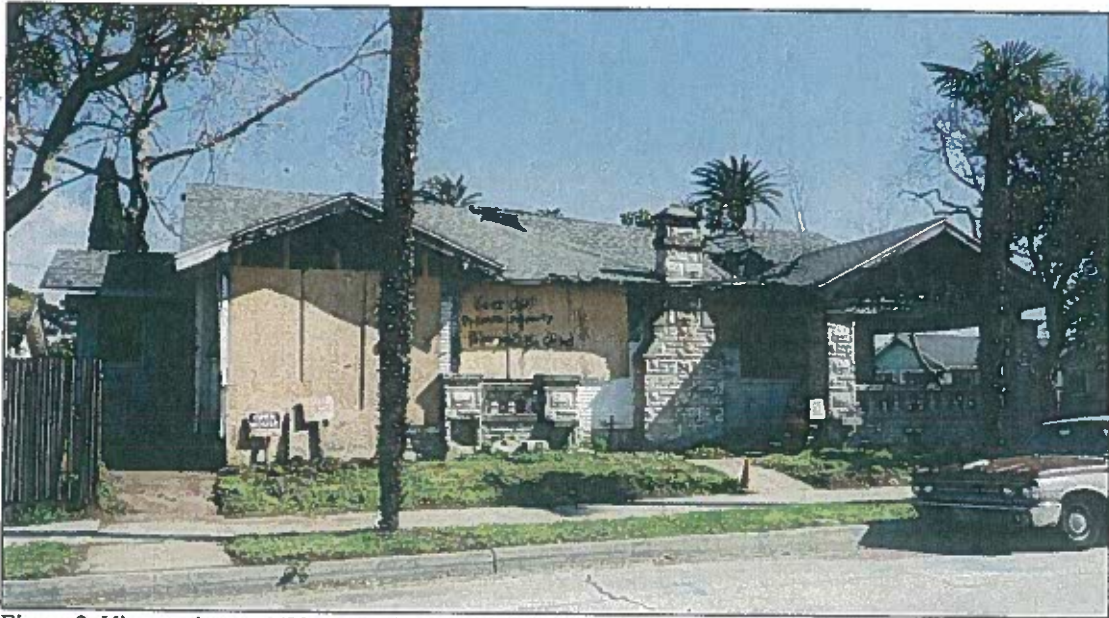
Figure 2: View to the east. (Photograph taken on 2/23/11 and provided by the owner.)

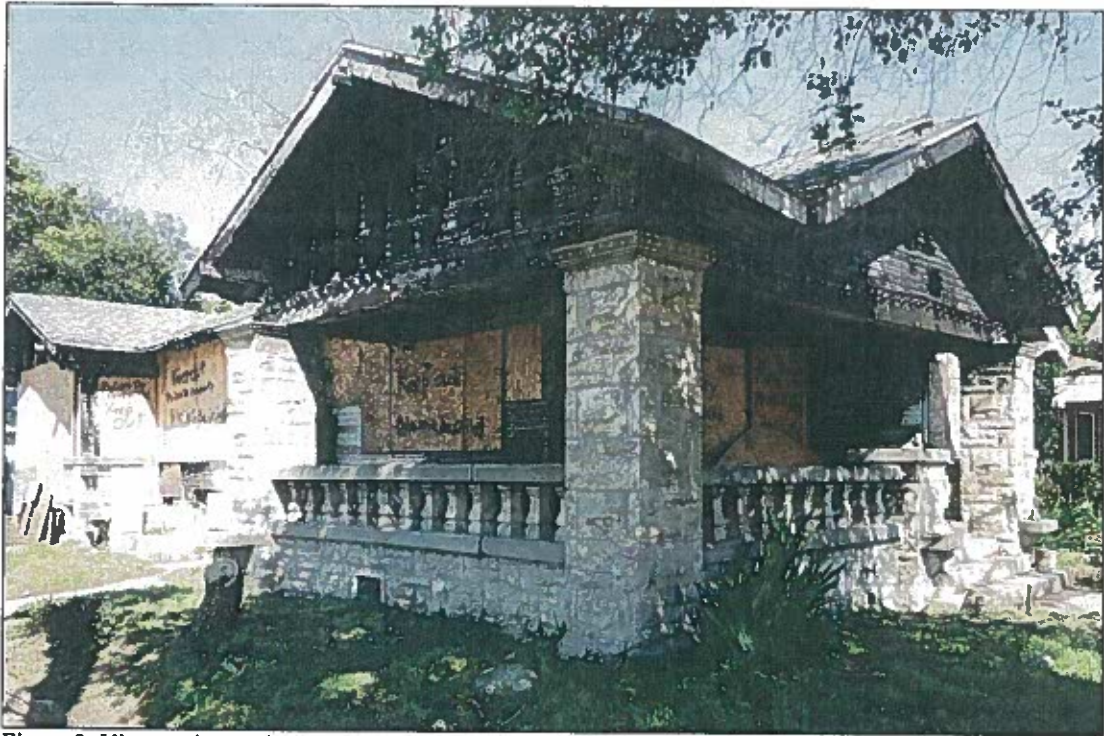
Figure 3: View to the northeast. (Photograph taken on 2/23/11 and provided by the owner.)

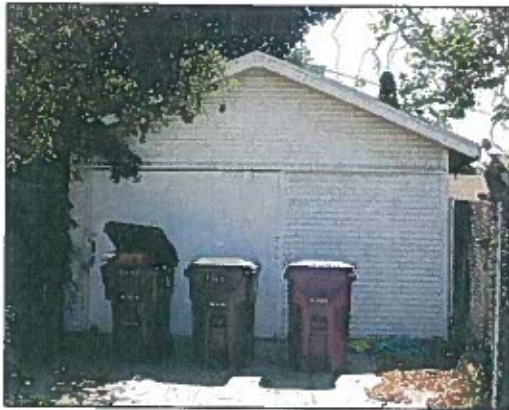
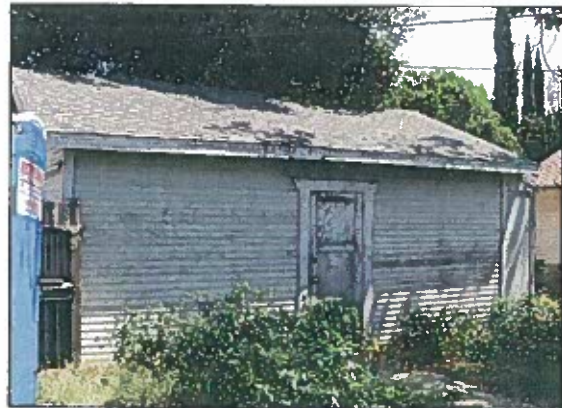
Figures 4 and 5: Detached garage located north of the residence. Views to the east and northeast (7/25/11).

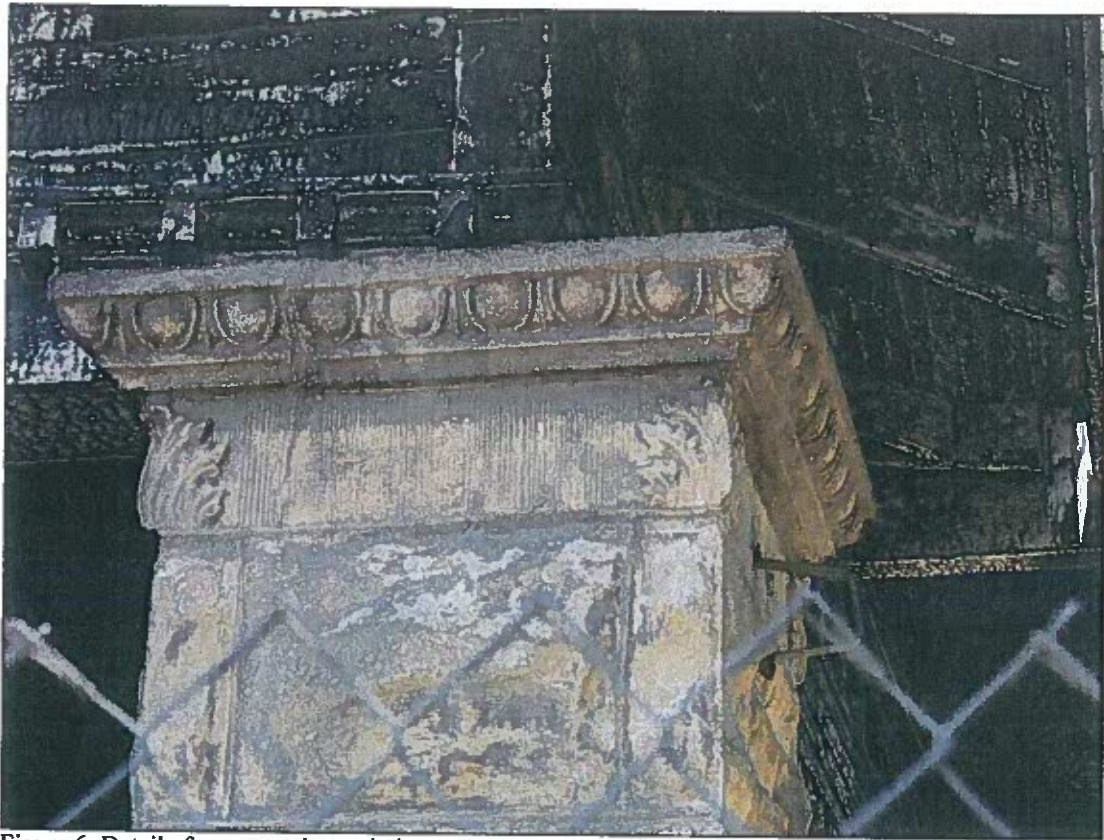
Figure 6: Detail of concrete pier capital.

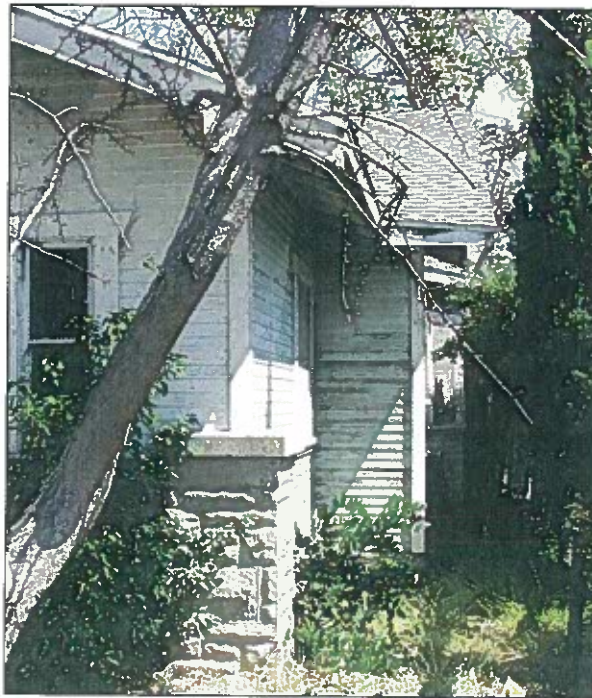
In addition to the wrap-around porch, the west side of the house includes a concrete or stone chimney flanked by projecting gables, wood-framed double-hung windows, boarded-over window and door openings, and concrete steps with a concrete balustrade and piers adjacent to concrete steps that access a south-facing door (Attachment A, Figure 2). The rear of the residence has wood-framed double-hung windows and a small, raised concrete porch with a short concrete pier at the corner (Attachment A, Figures 7 and 8). The east side of the residence has wood-framed double-hung and fixed windows and a bay window (Attachment A, Figure 9).

Figure 9: East side of residence. View to the north (7/20/11).

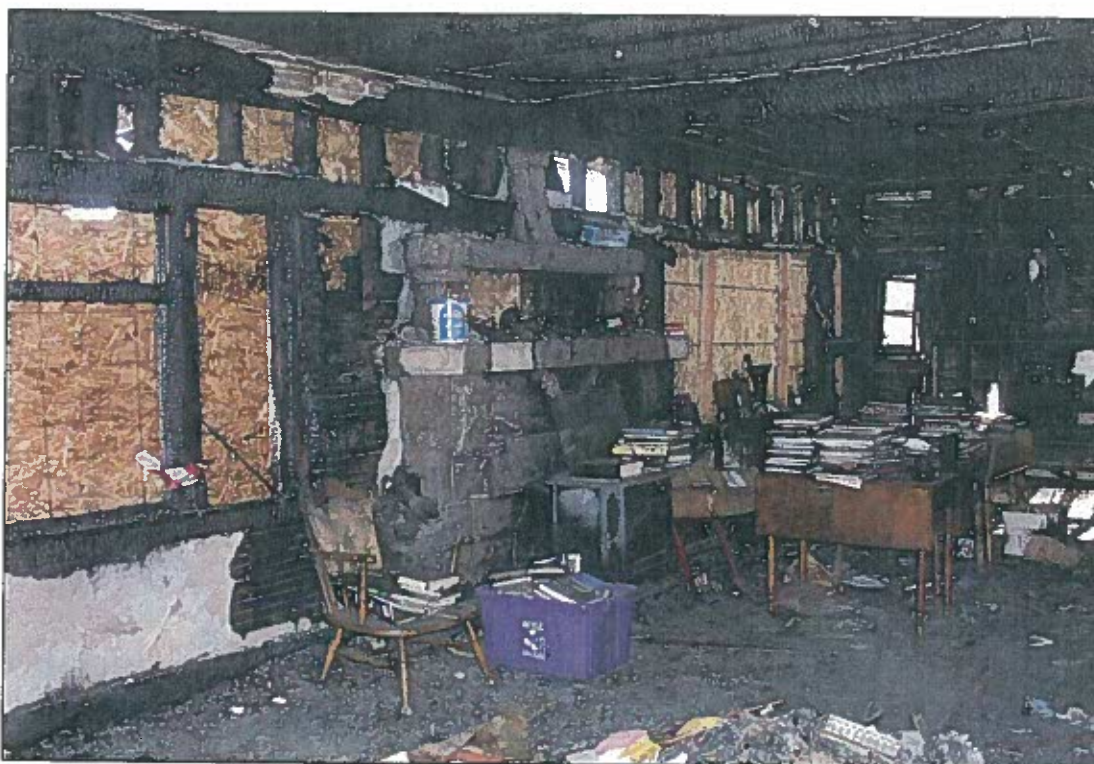
The main entrance opens into a large room that appears to be a combination living/dining room and features a fireplace on the west wall and a built-in cabinet on the north wall. The living/dining area has been significantly damaged by fire (Attachment A, Figures 10–15). The kitchen and a small room (perhaps a bedroom or den) are located behind (north of) the living/dining area and do not appear to have sustained as much fire damage as the living/dining area. A hallway on the east side of the living/dining area accesses three bedrooms and a bathroom (Attachment A, Figure 16). Of these, the hallway and front bedroom (southeast corner of the house) have sustained the most fire damage.

Figure 10: Living room and fireplace. View to the northwest (7/20/11).

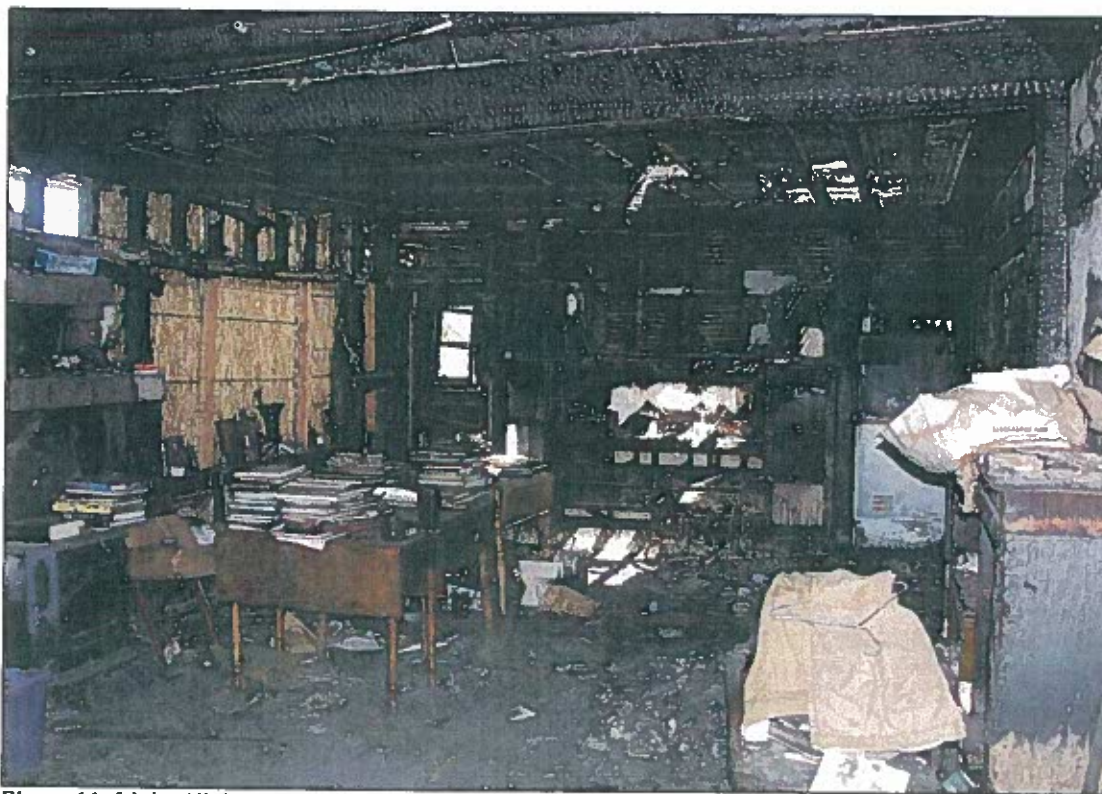
Figure 11: Living/dining room. View to the north (7/20/11).

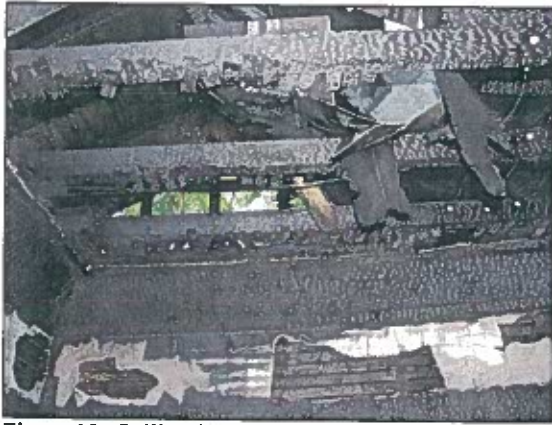
Figure 12: Ceiling in living room (7/20/11).

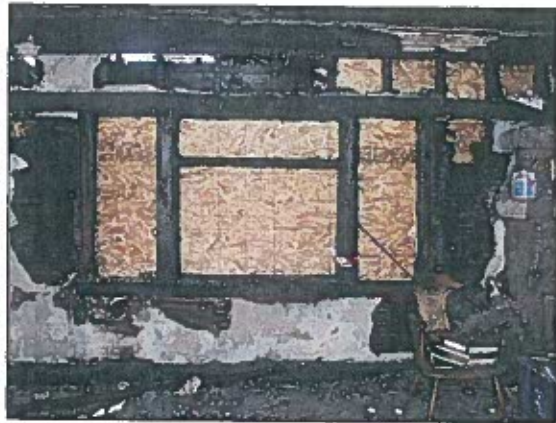
Figure 13: Window in living room (7/20/11).

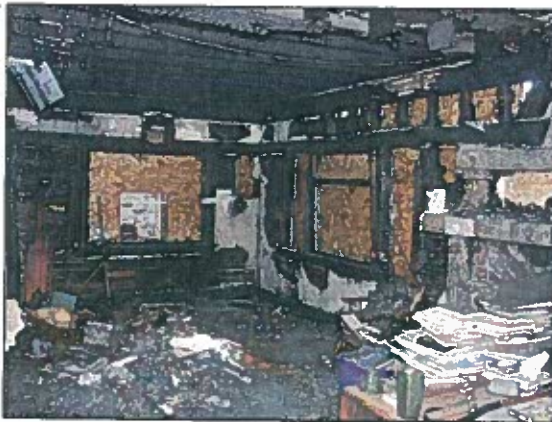
Figure 14: Southwest corner of living room (7/20/11).

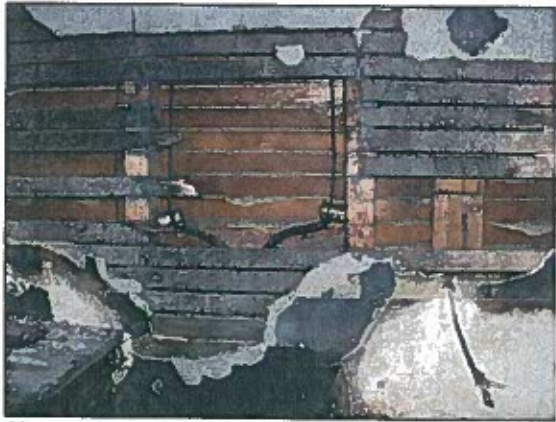
Figure 15: East wall of living room showing knob and tube wiring (7/20/11).

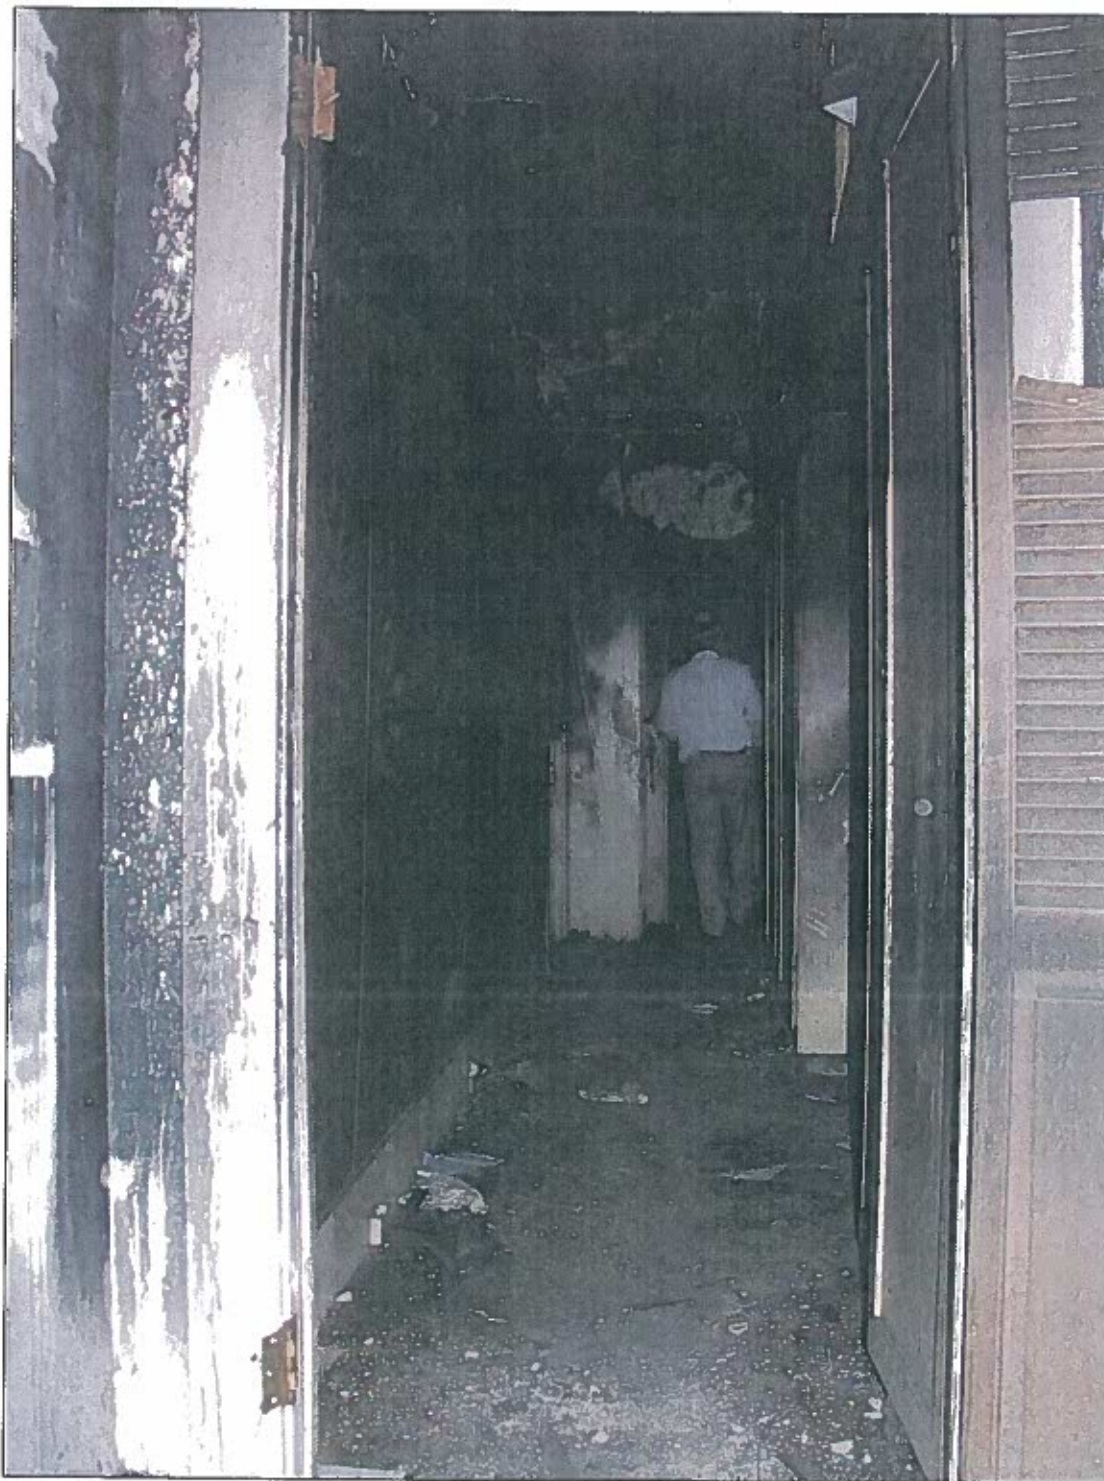
Figure 16: Hallway between living/dining area and bedrooms/bathroom (7/20/11).

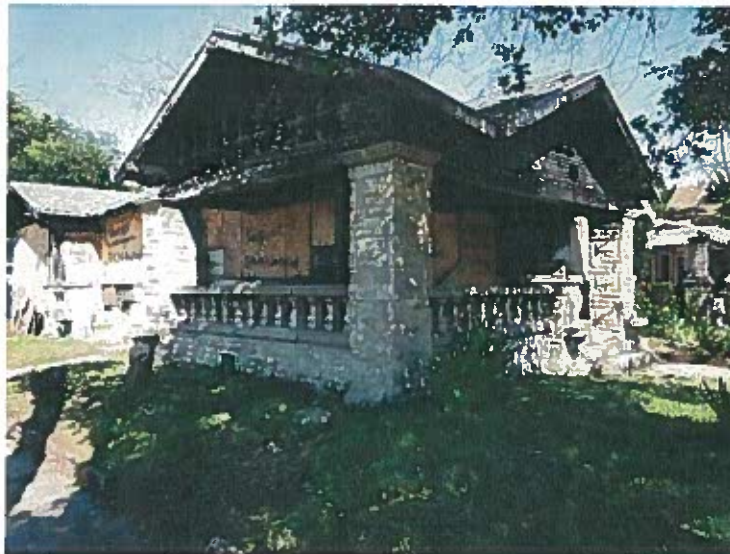
Photo 1: Exterior View from the corner of Fifth & Grand

The structure is a Type V (wood framed) single family, single-story residence, with a raised floor, originally constructed in 1920. It is approximately 1500 square feet in area. A separate wood framed garage structure is also part of the site, but is a stand alone structure separate from the main residence. The south side of the structure faces Fifth Street and the west side faces Grand Avenue. The existing building sustained damaged by fire and is currently unsafe and uninhabitable.

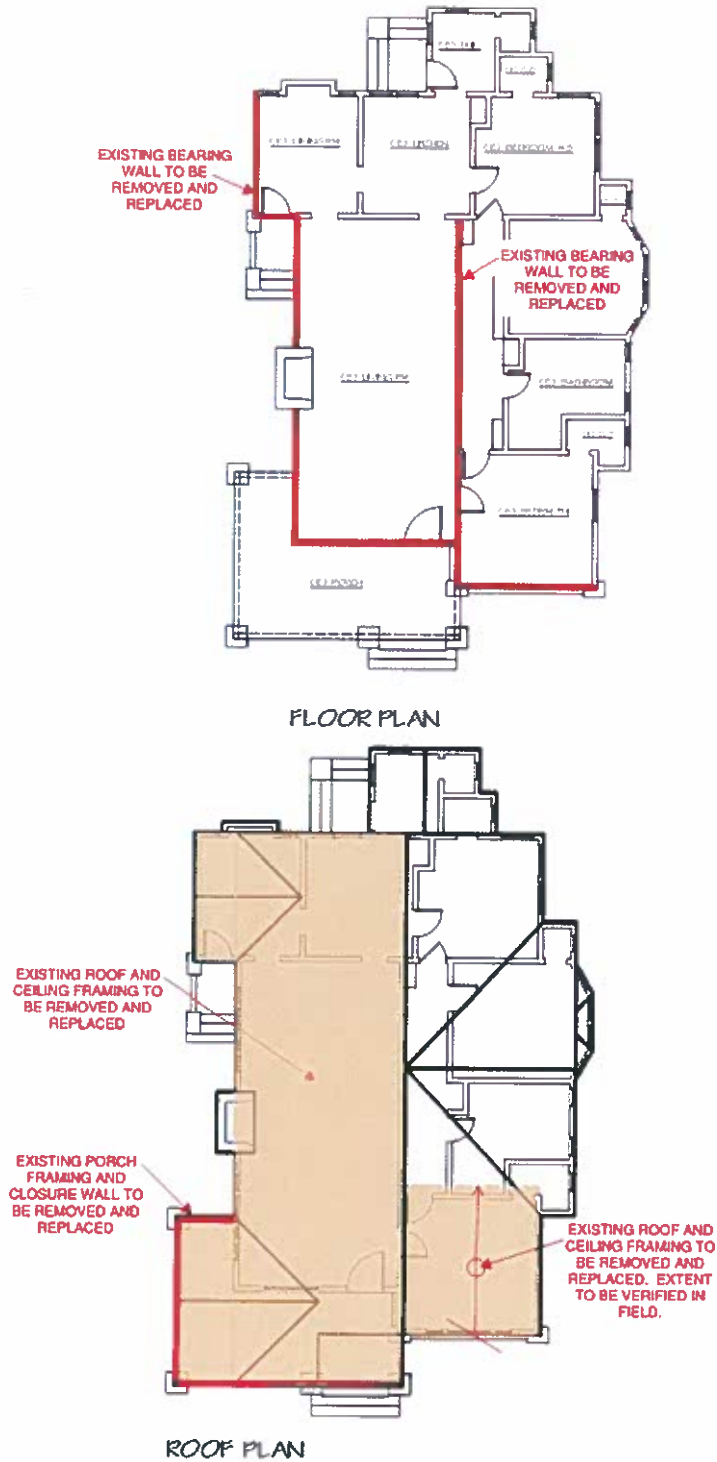
Diagram 1: Reference Plans

- The structural damage was limited to the south and west sides of the structure. Refer to Diagram 1 and Photos 2 and 3.
- The roof framing suffered most of the damage, including partial collapse over the living room. Refer to Photo 3 and 4.

Based on the results of our evaluation and expertise working with Historic Structures, due to the extent of fire damage, partial selective demolition will be required. Diagram 1 indicates the structural elements that will need to be removed and replaced. The intent of this letter is to identify the structural deficiencies. Structural design of the retrofit is not part of this scope.

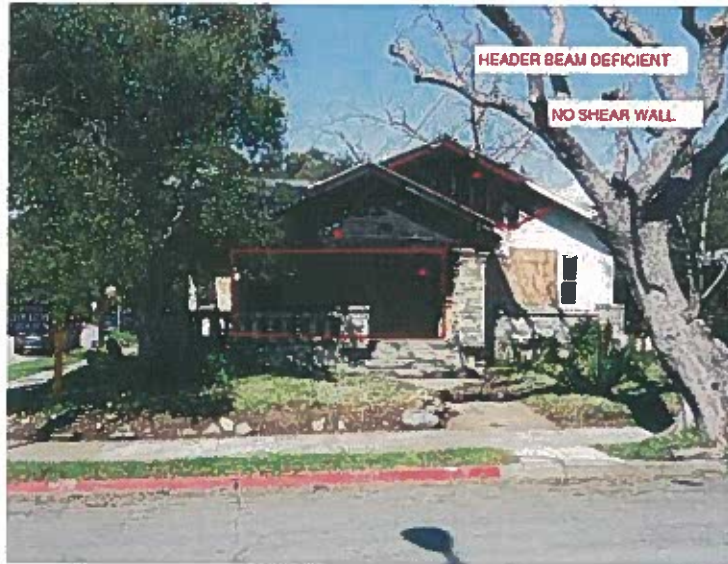
Photo 2: South Elevation – Facing Fifth Street

- At the porch, the header beam supporting the roof has a reduced cross sectional area and capacity due to extent of the fire damage. The header beam appears to be sagging and may not be able to continue to support the weight of the roof. Refer to Photos 2 and 3.

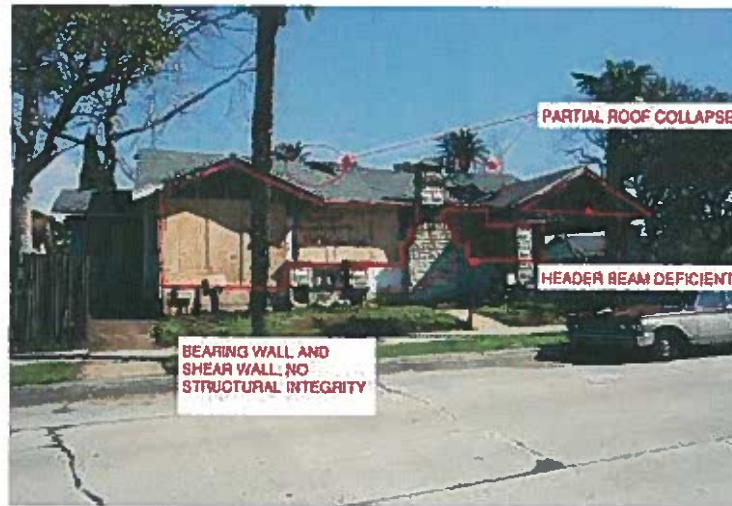
Photo 3: West Elevation – Facing Grand Avenue

- The west facing bearing wall studs have lost their essential structural attributes and engineering properties to allow them to be augmented or strengthened. Refer to Photo 3.

Our evaluation indicates that the lateral system (roof diaphragm and shear walls) will need to be repaired at a minimum to meet the same level of safety as its pre-existing condition as allowed by Chapter 34 of the California Building Code. We recommend that the roof framing, roof diaphragm, and bearing walls which were damaged by the fire be removed and replaced with materials common to Type 5 residential construction practices of today. Architectural features, such as the stone columns and fireplace, which were not damaged, can remain.

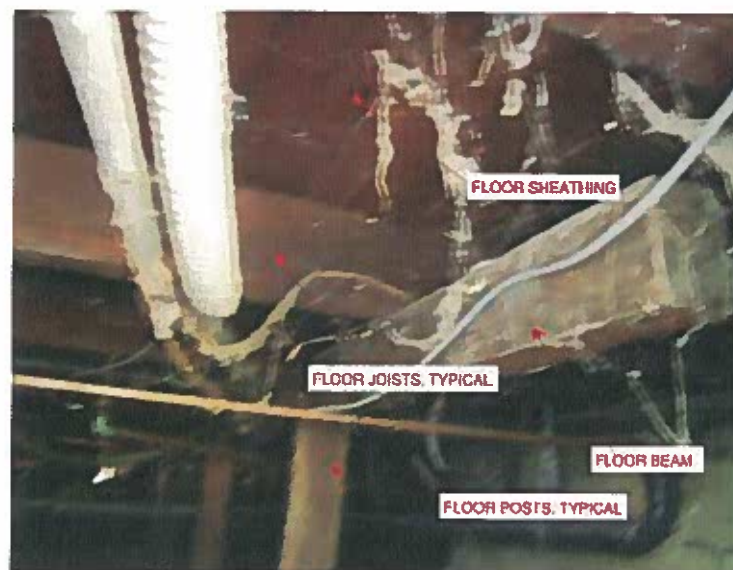
Photo 5: Floor Framing – From Crawl Space

- The floor Framing does not appear to have suffered major fire damage and may be able to be kept or strengthened to continue to support the floor loads. Refer to Photo 5.
