City of Long Beach ----- Arborist Report

Date: September 8th 2012

Location: **2nd St (Quincy Ave to Bayshore Ave)**

Purpose of report: To inspect trees that currently line 2nd Street from Quincy Ave to Bayshore Drive for tree and site conditions which include the trees current health, offsets to grates and/or sidewalk, and tree skirts. Make any recommendation concerning type of current tree in place and future problems that can arise from this species.

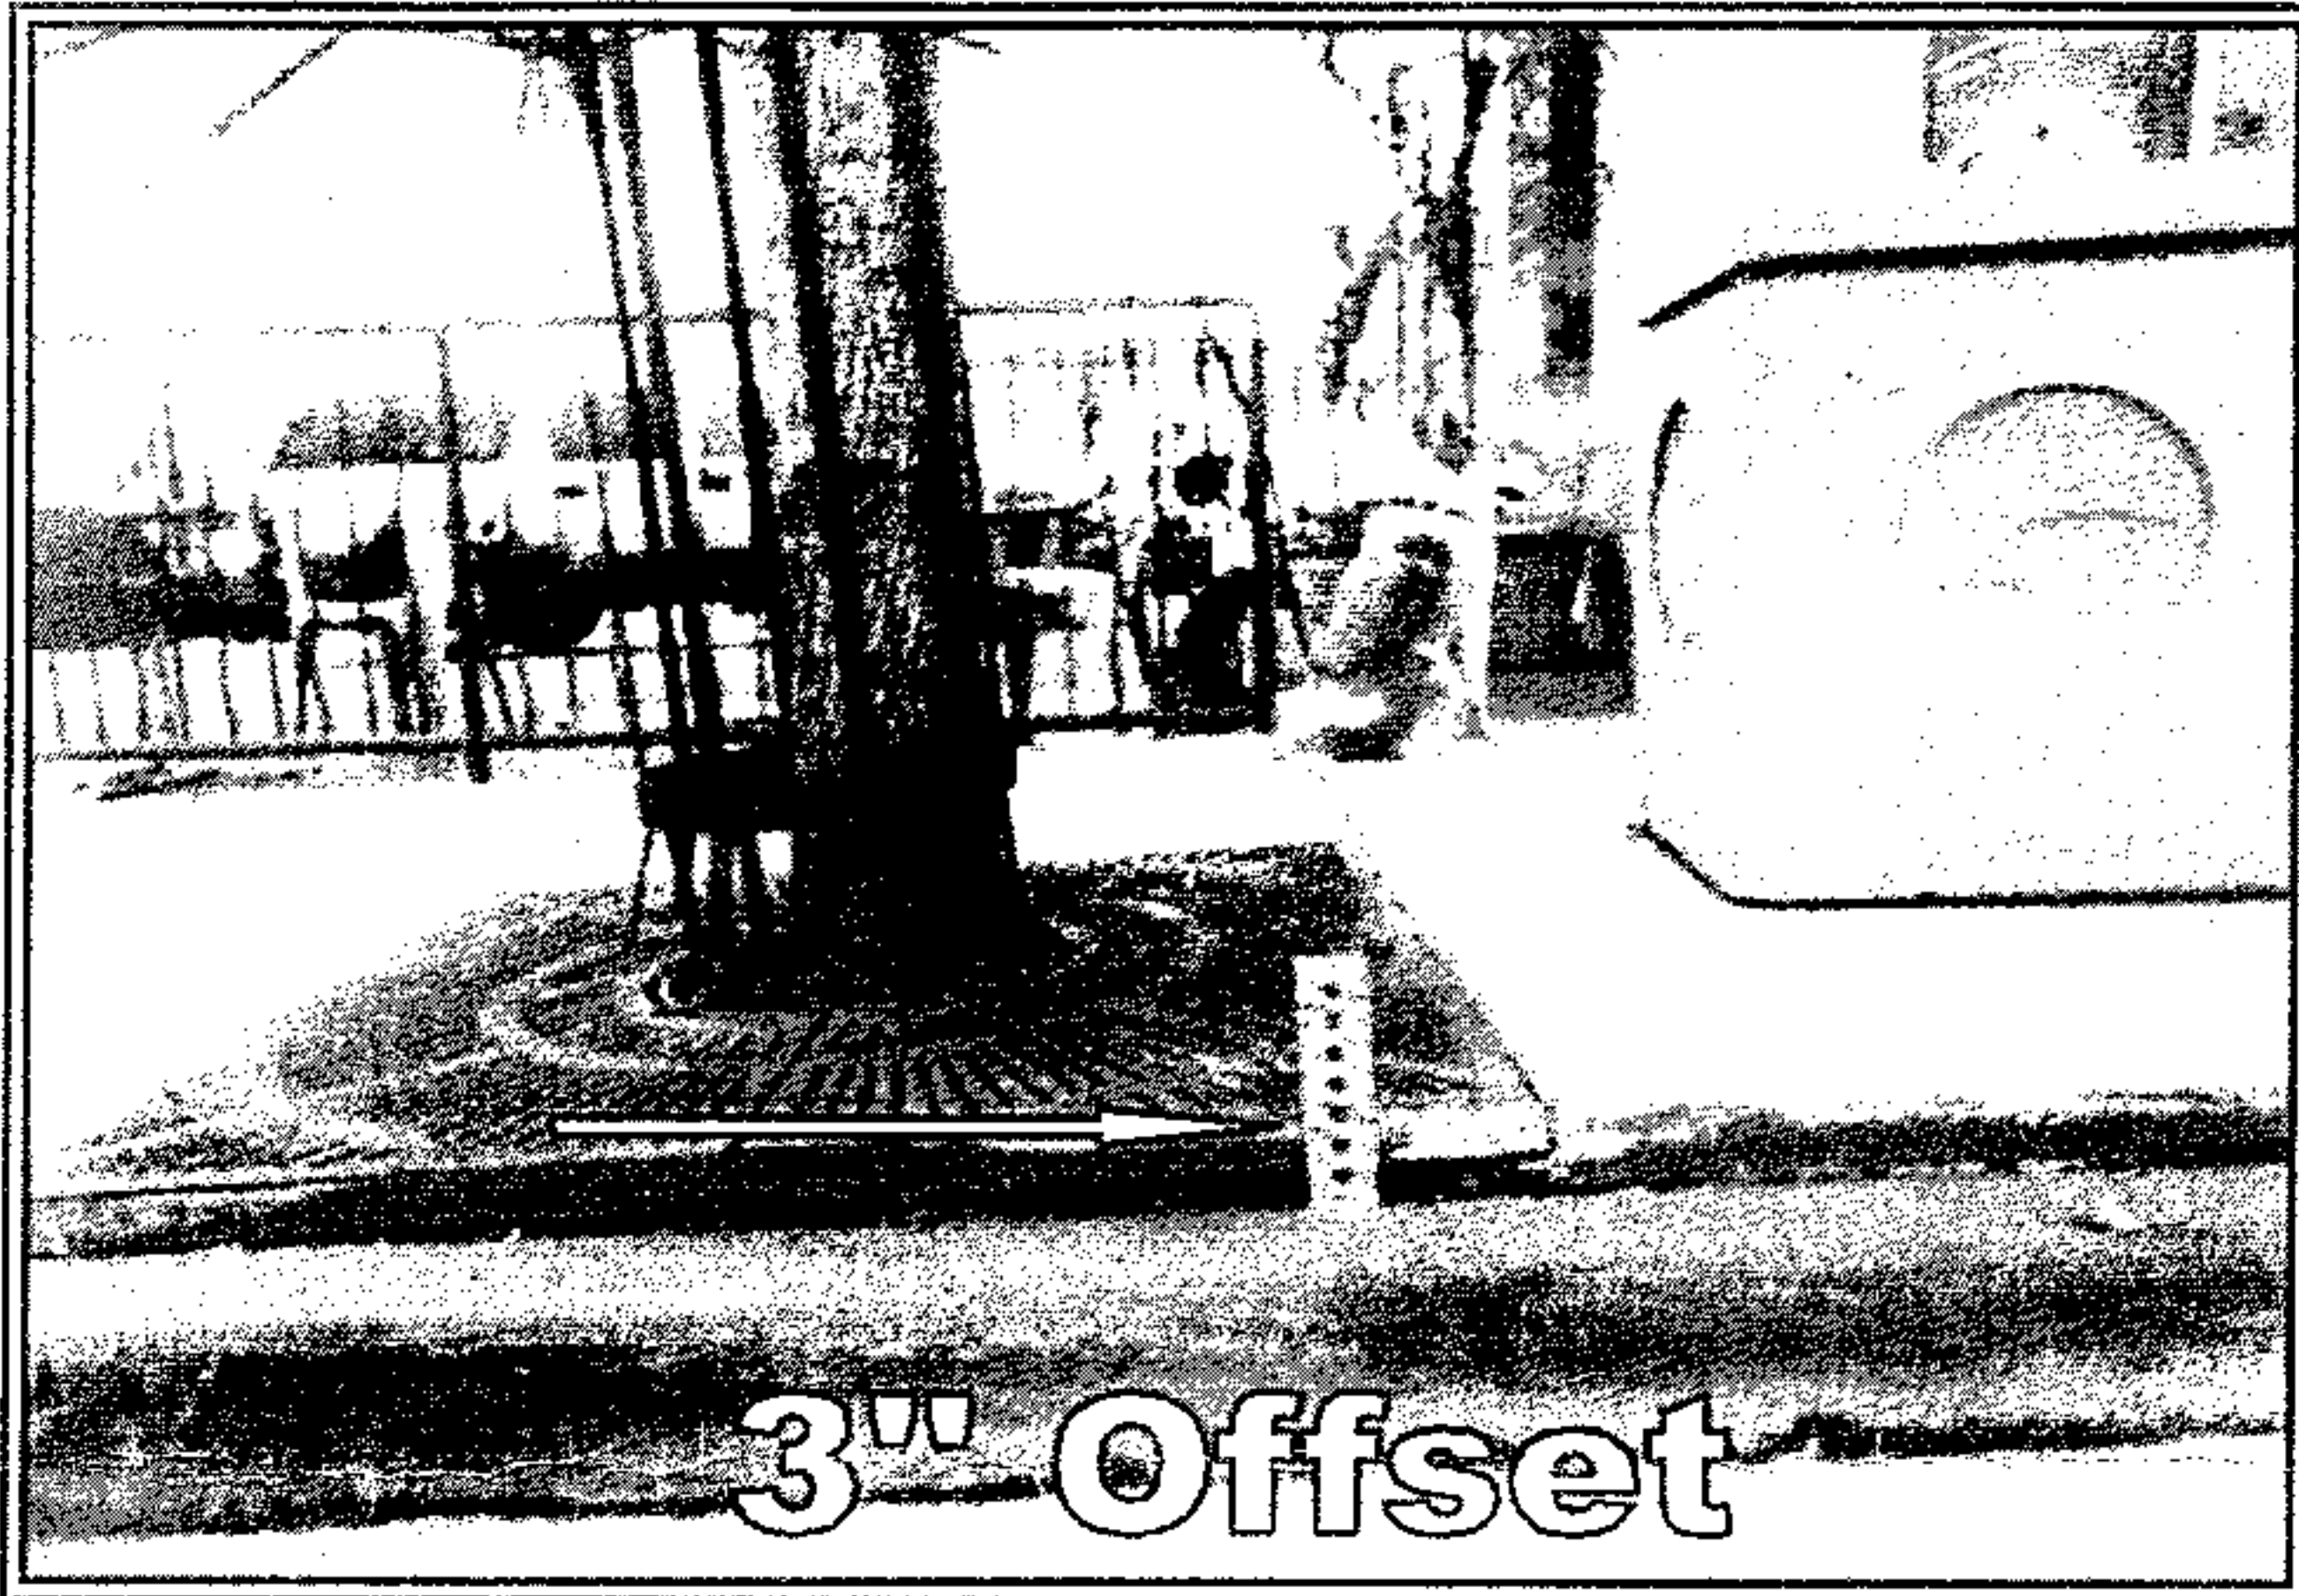
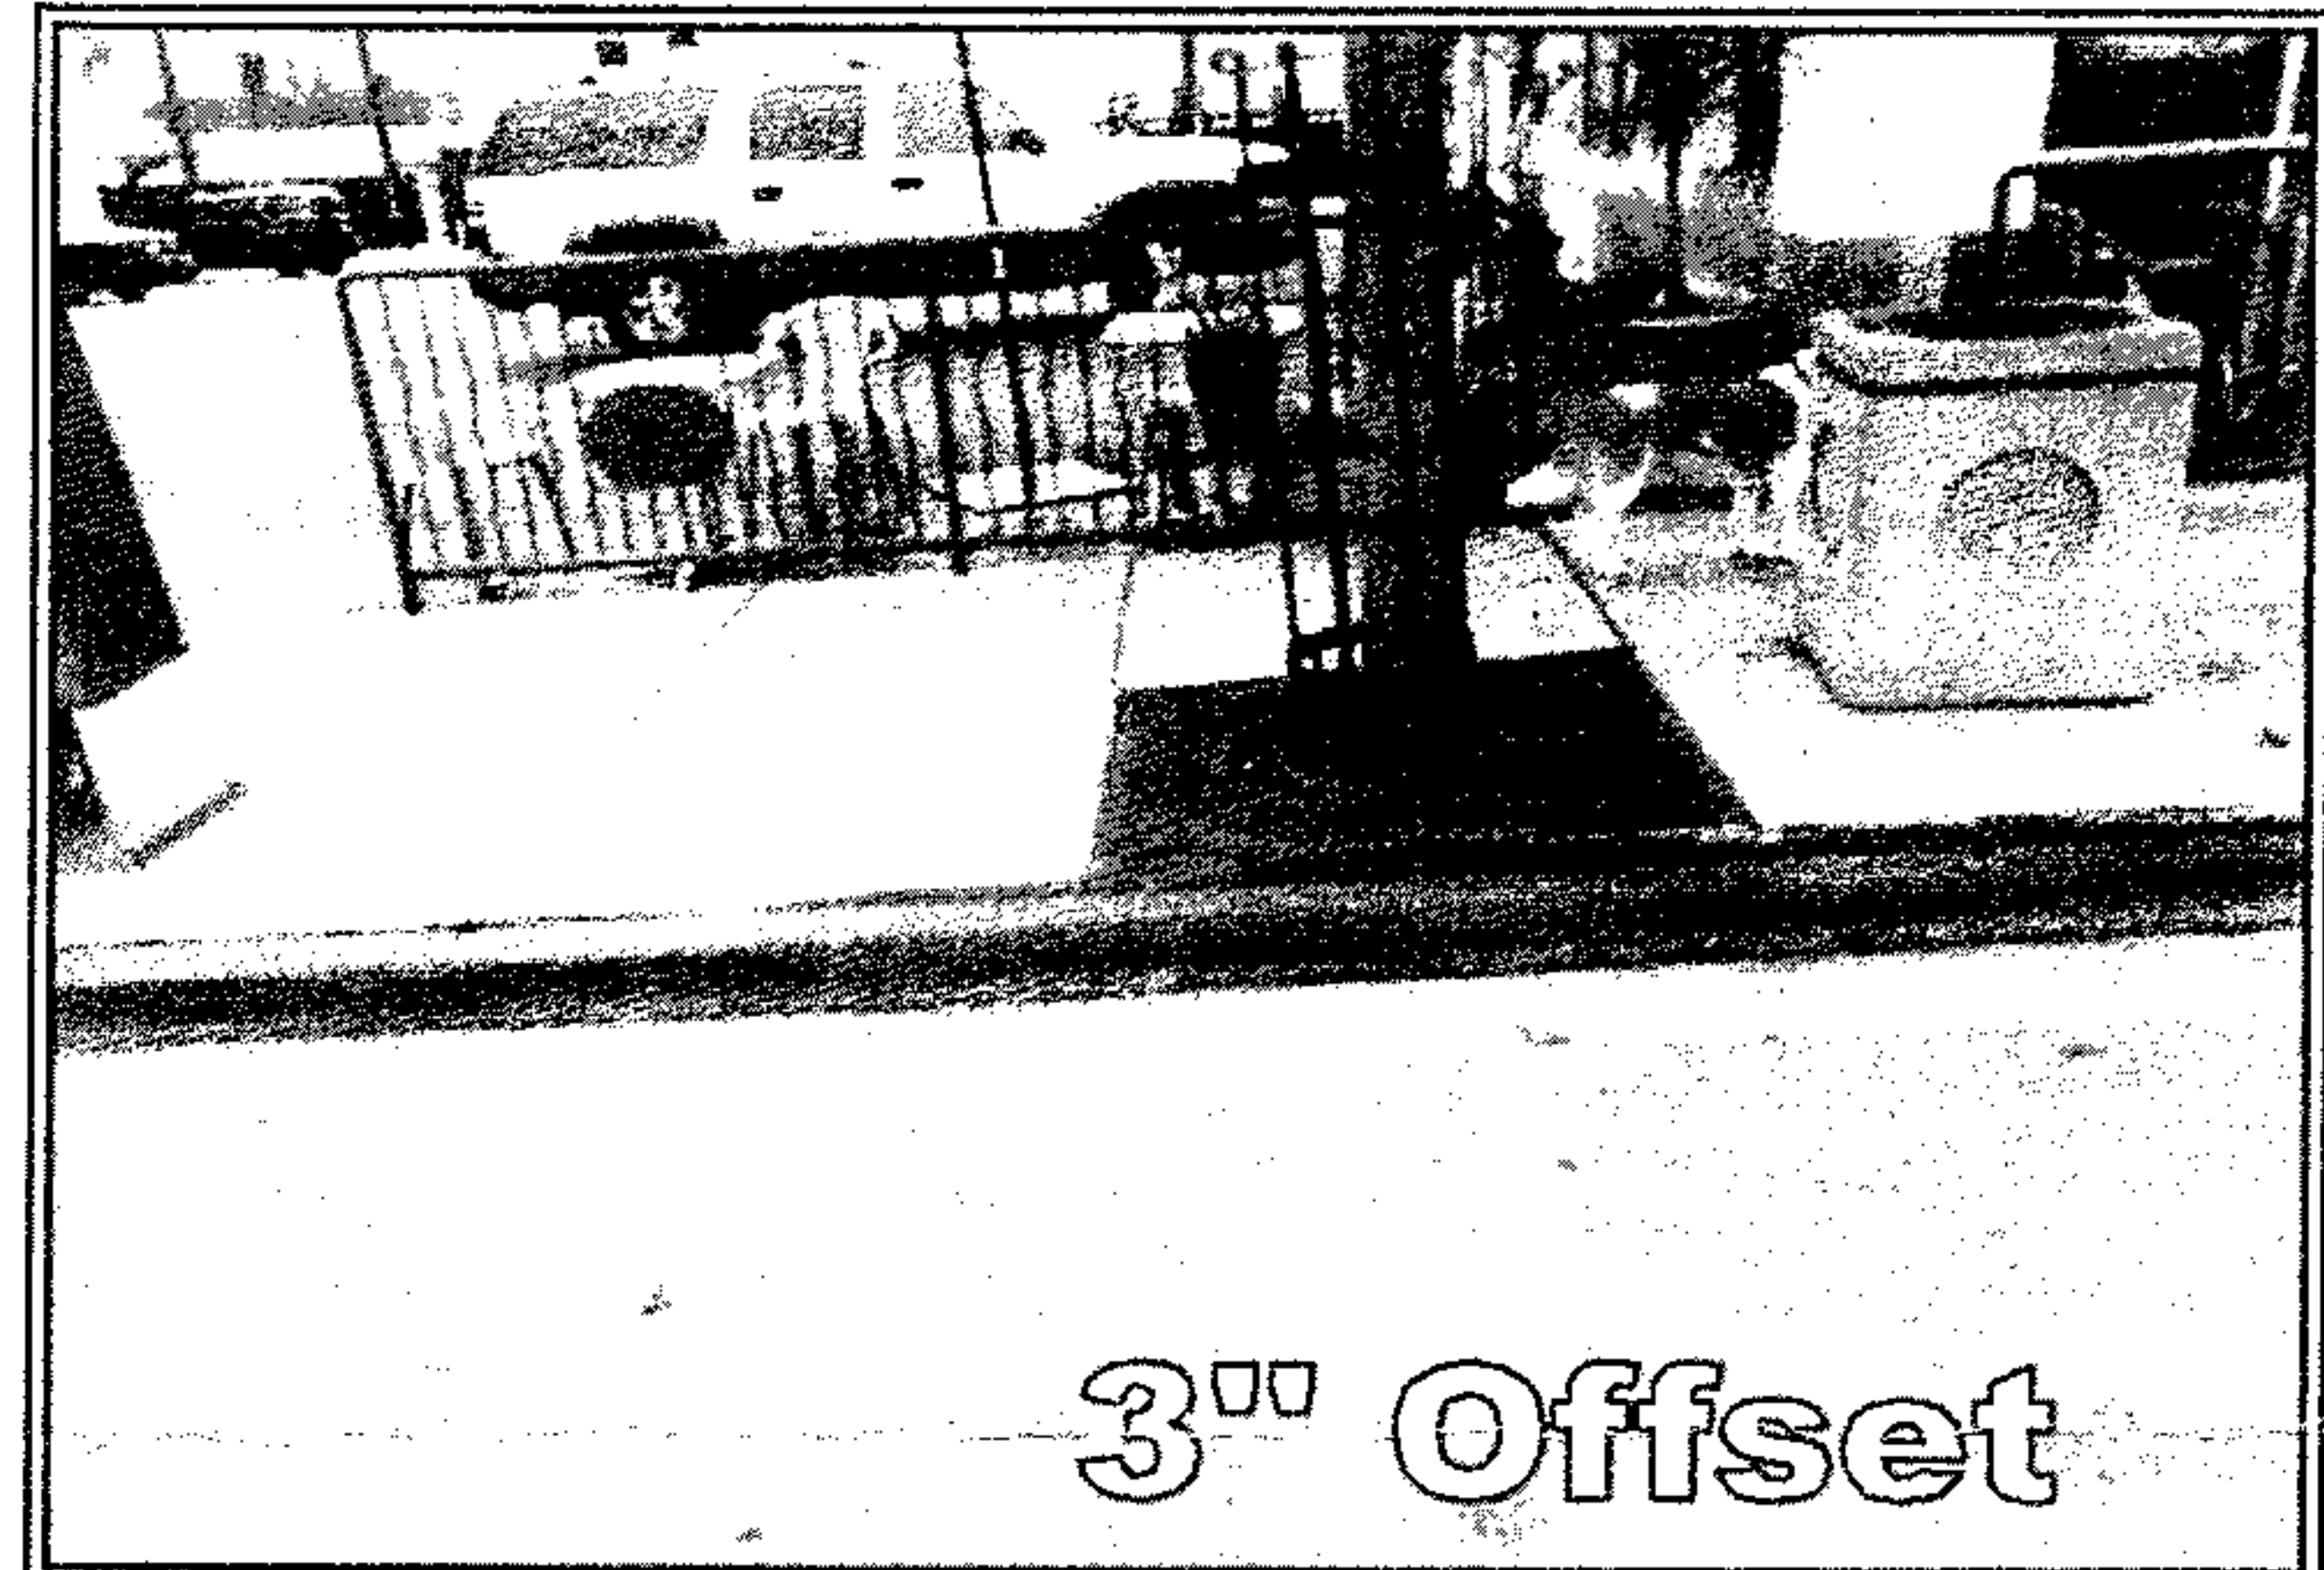
Location:	Species	Offsets	Notes
4600 E 2nd St	Bradford Pear	3"	Multiple sides of offsets
4606 E 2nd St E/Tree	Bradford Pear	2 1/2"	Multiple sides of offsets
4606 W 2nd St E/Tree	Bradford Pear	Dead	Multiple sides of offsets
4801 E 2nd St (Park Side) S/Tree	Bradford Pear	2"	Multiple sides of offsets
184 Park Ave	Bradford Pear	1"	Cracked Sidewalk
4923 E 2nd St	Bradford Pear	1 1/4"	Multiple sides of offsets
5004 E 2nd St	Bradford Pear	1 3/4"	Multiple sides of offsets
5100 E 2nd St	Bradford Pear	2 1/2"	Multiple sides of offsets
5128 E 2nd St	Bradford Pear	Dead	Multiple sides of offsets
5239 E 2nd St	Bradford Pear	1 1/2"	Multiple sides of offsets
5265 E 2nd St	Bradford Pear	1"	Multiple sides of offsets
5296 E 2nd St (Glendora Side)	Liquidambar	3 1/4"	Evasive root system
5313 E 2nd St	Bradford Pear	1 3/4"	Multiple sides of offsets
5374 E 2nd St	Bradford Pear	1 3/4"	Multiple sides of offsets

Note: Due to multiple sides of root removal, it is recommended that these trees be removed for safety reasons, removing the roots will weaken the trees structural supporting root structure and in turn could cause failure.

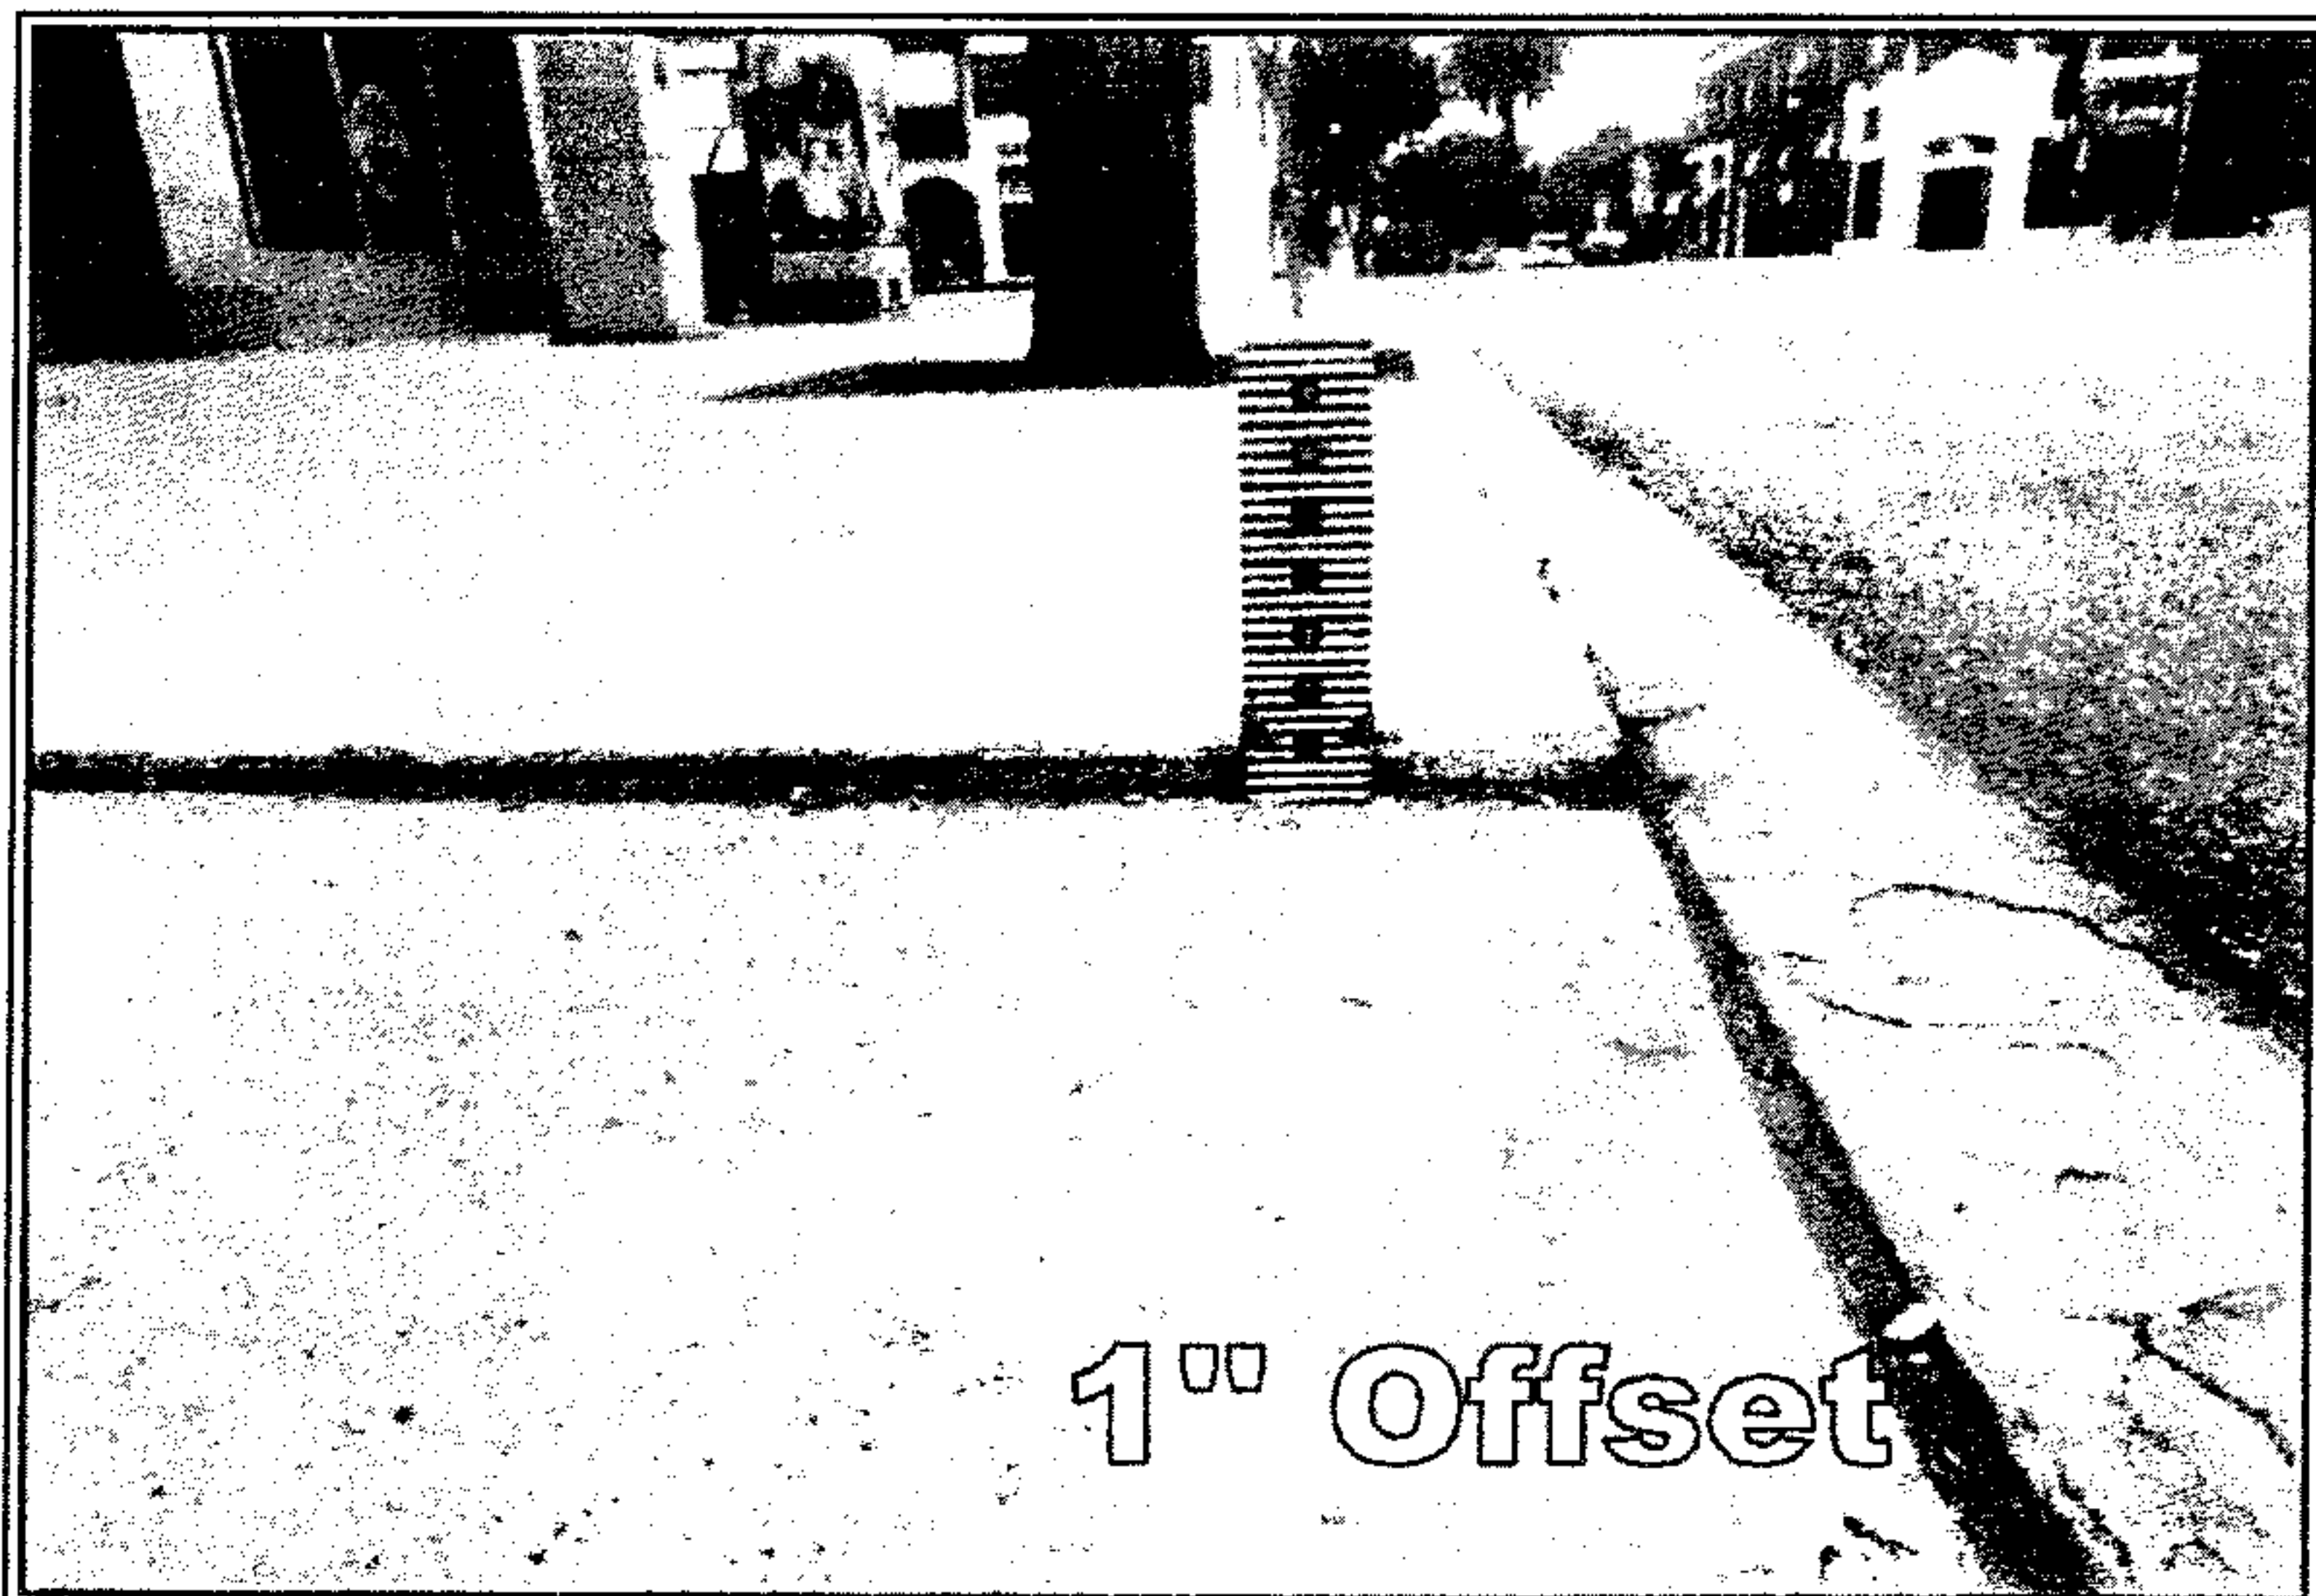
4801 E 2nd St "Park Ave Side" N/Tree

The tree at located at 480 E 2nd St (Park Side) N/Tree was marked for removal, although I found a 1" offset to the sidewalk, the repairs can be made with out removing the tree due to the offset being on one side of the tree.
