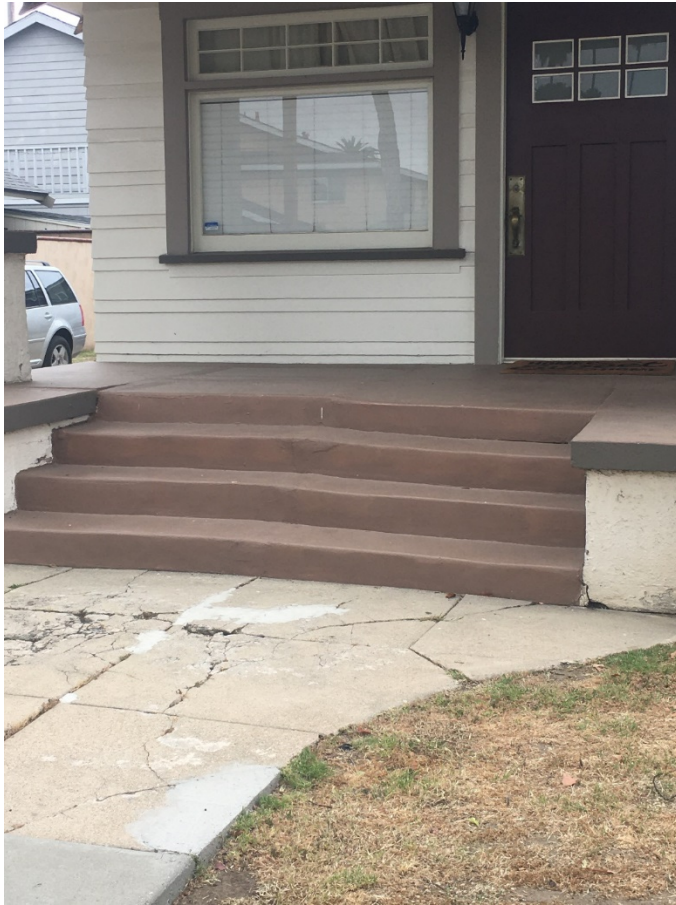
**Front Porch - foundation failing**

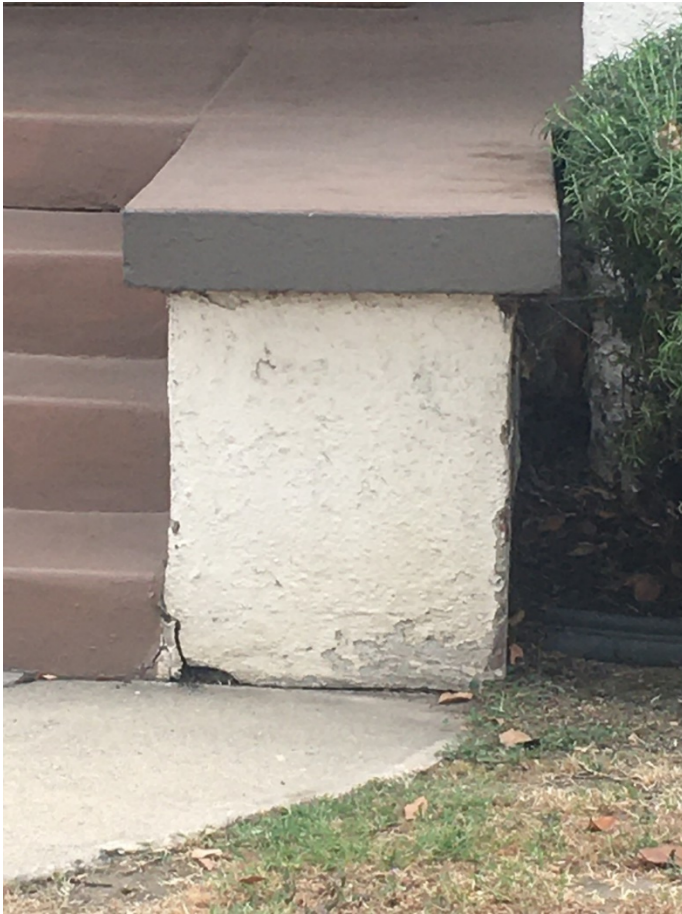
**Porch column- stucco over brick facade**

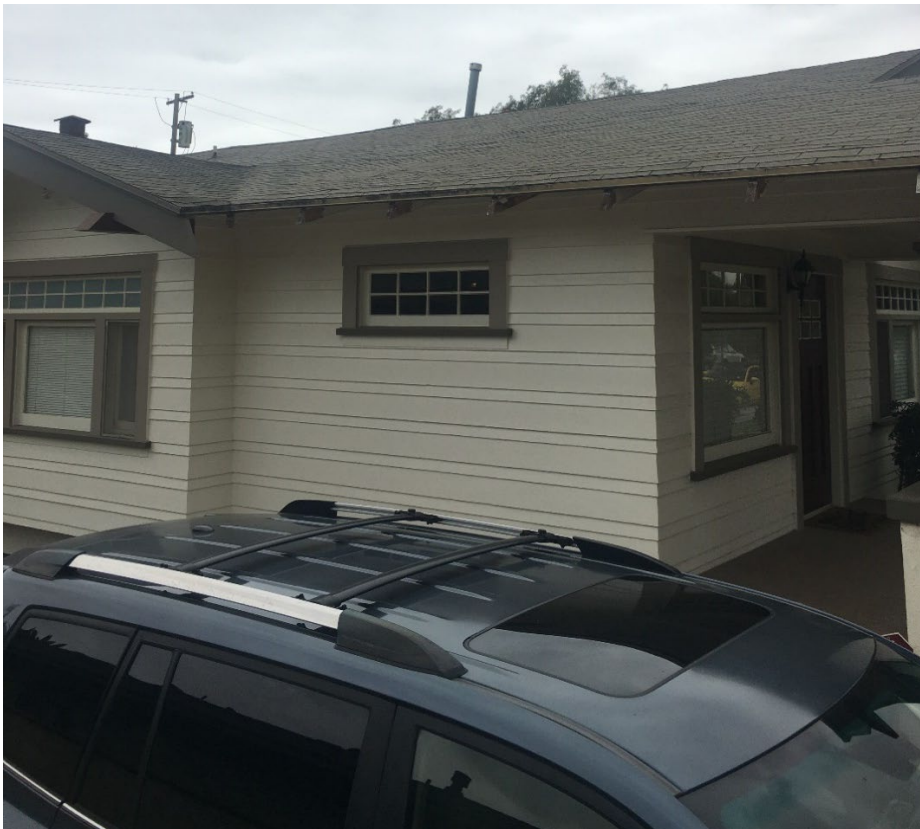
**Roof rafters failing**

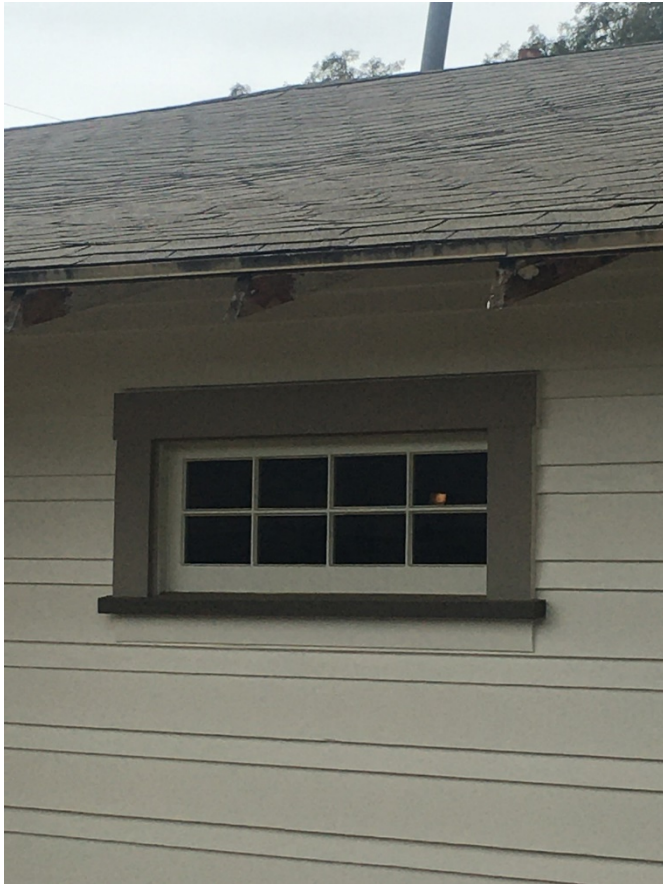
**Roof and eave deteriorated**
