City of Long Beach  
**MILLS ACT PROPERTY TAX INCENTIVE PROGRAM**

**REHABILITATION/RESTORATION/MAINTENANCE PLAN**

Property Name and Address: McDowell Property, 238 Coronado Avenue, Long Beach CA 90803

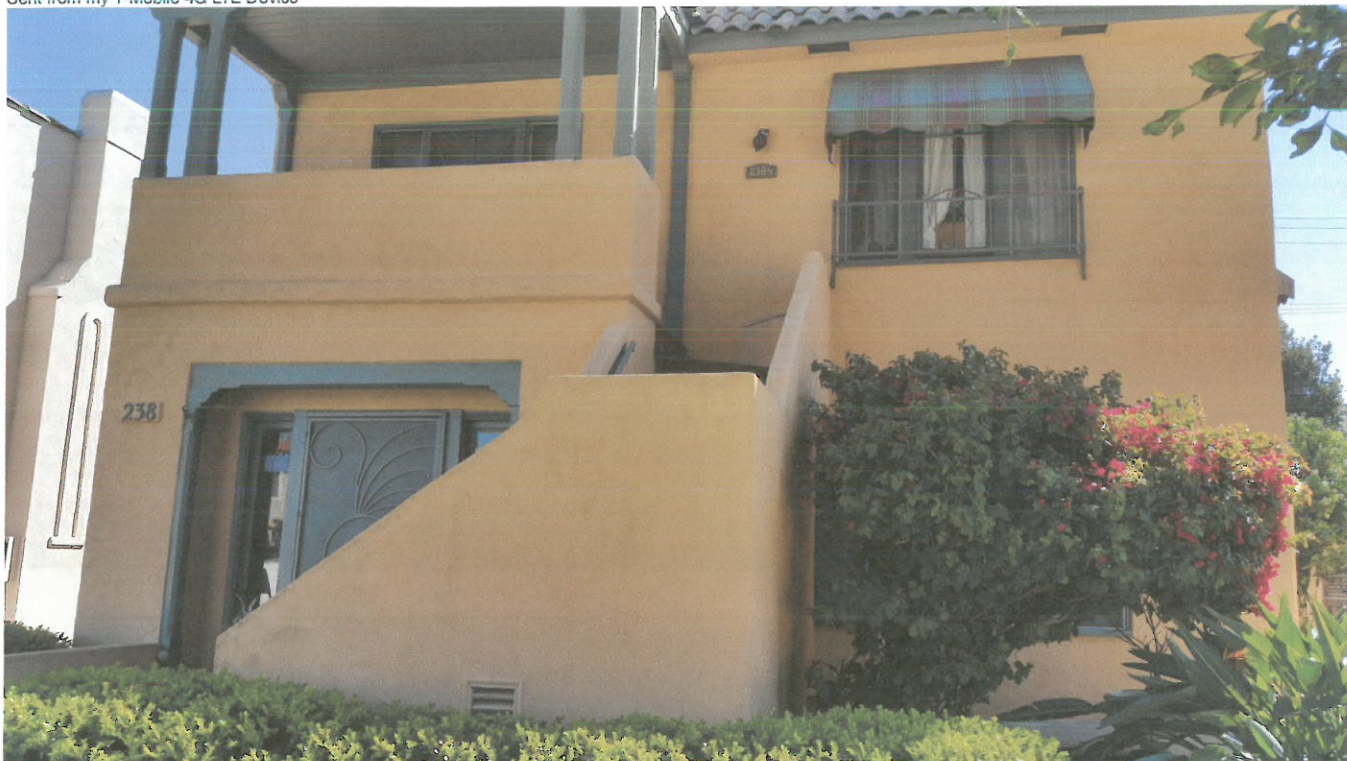
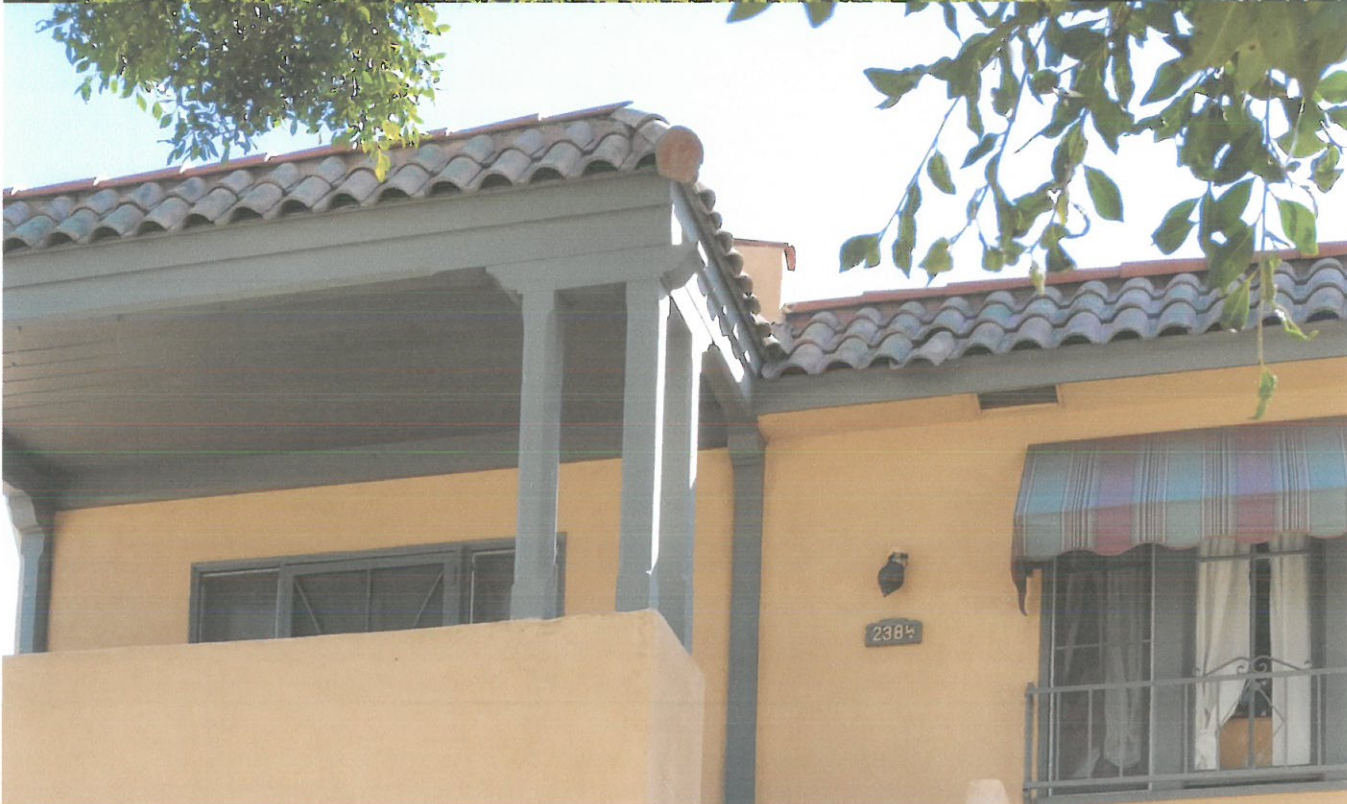
1. Clay tile roof and roof leaks

<p>Item No.: <u>1</u></p> <p>Building Feature: <u>Clay tile roof</u></p> <p>Completion Year: 20 <u>18</u></p> <p>Plan to Use Long Beach Vendors For Materials/Labor:  <input checked="" type="checkbox"/> Yes (If Yes, specify/list)    <input type="checkbox"/> No</p>	<p>Detailed description of work:                  Repair or replace broken or missing clay tiles that are of distinctive color on main elevation. Repair roof leaks to prevent further damage to historic fabric in two buildings on the property - the main building and garage building. The new tiles replacing missing tiles shall match the old in design, color, texture, and other visual qualities and, where possible, materials.</p>
<p>Item No.: <u>2</u></p> <p>Building Feature: <u>Wood windows, main elevation, side elevations.</u></p> <p>Completion Year: 20 <u>18</u></p> <p>Plan to Use Long Beach Vendors For Materials/Labor:  <input checked="" type="checkbox"/> Yes (If Yes, specify/list)    <input type="checkbox"/> No</p>	<p>Detailed description of work:                  Provide termite inspection and mitigation of wood rot in all windows. Scrape, repaint seven double-hung wood windows on main and side elevations of the house and four casement windows on side elevations of house. Repair and clean existing metal hardware. Provide termite inspection and, if necessary, termite mitigation throughout the property to prevent further damage of plaster walls and wood on windows and foundation.</p>
