REHABILITATION/RESTORATION/MAINTENANCE PLAN

Property Name and Address: The Parsonage, 326 W. 10th Street

City of Long Beach
MILLS ACT PROPERTY TAX INCENTIVE PROGRAM

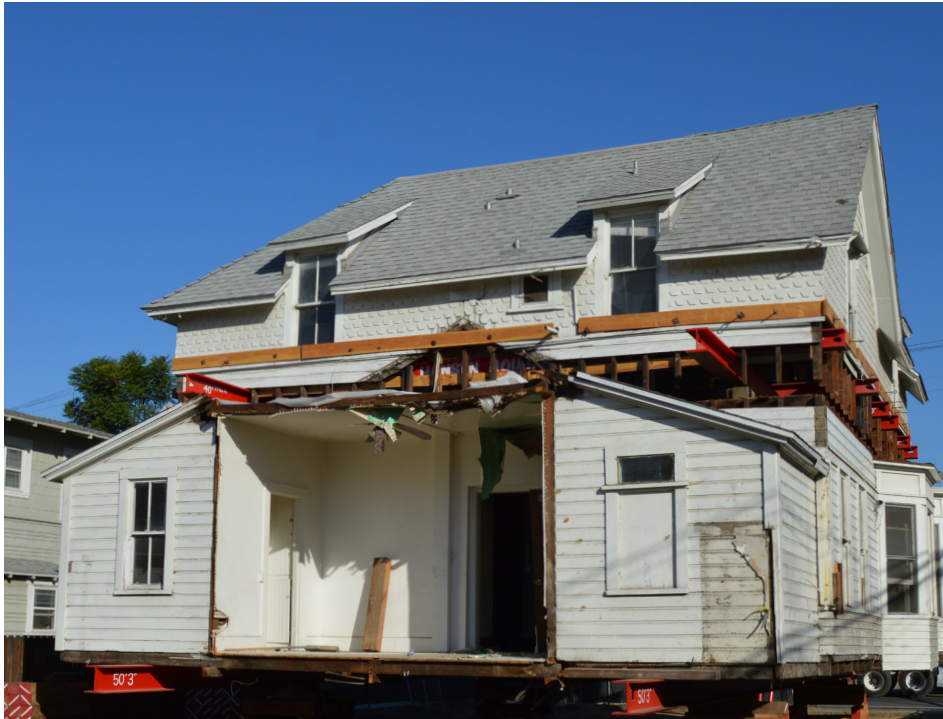
South Elevation, View Northwest (November 9, 2018)

The photograph at left of the building in its present condition documents an opening created through the removal of an addition to the building added after the period of significance, which took place prior to the building's relocation in November 2018. This elevation also retains additional character-defining features not listed in the enclosed Rehabilitation Plan including roof forms and bracketed window surrounds are shown in these photographs. The opening will be filled according to currently-approved plans, and these additional features will be repaired and restored during 2019. As such, they are not included in the Rehabilitation Plan as work completed will not take place during the applicable work period.

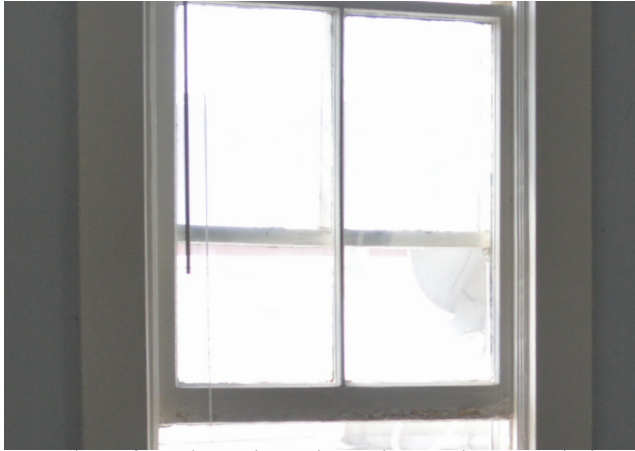
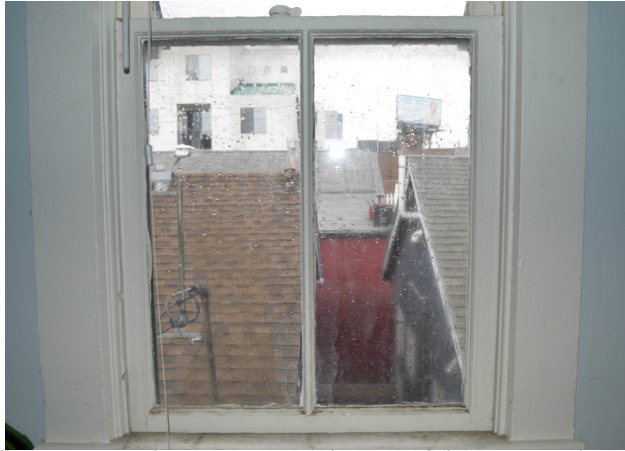
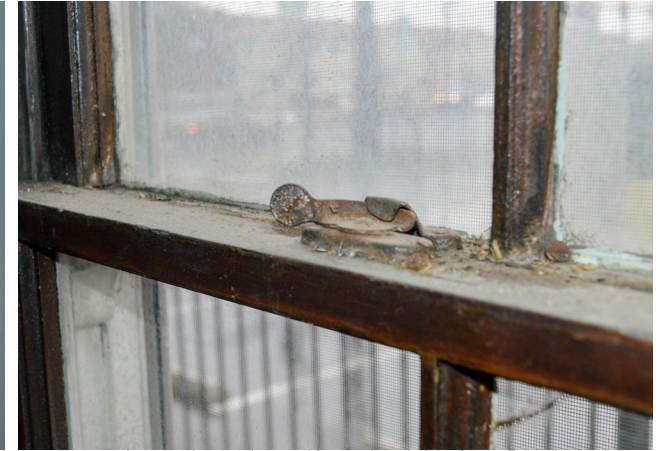
Item No. 1: Window Restoration

A number of windows throughout the residence, including all upstairs windows, are painted. Most of these painted windows are functional, and they and their hardware vary from fair to good condition.

Unpainted wood windows (found on the first floor) vary from poor to fair condition.

<p>Item No.: <u>1</u></p> <p>Building Feature: <u>Window Restoration (For this feature and all others, see Photographs submitted with this application for additional detail.)</u></p> <p>Completion Year: 20 <u>20</u></p> <p>Plan to Use Long Beach Vendors For Materials/Labor: <input checked="" type="checkbox"/> Yes (If Yes, specify/list) <input type="checkbox"/> No </p>	<p>Detailed description of work:</p> <p>Windows throughout the property will be progressively removed. While removed, each window's hardware will be removed and cleaned. Broken glass will be replaced, and each window will be carefully cleaned and lightly sanded to remove debris. Wood will be filled or patched as appropriate, following the Standards. Windows will be repainted appropriately, and reinstalled in their original position (as cataloged prior to removal.)</p>
<p>Item No.: <u>2</u></p> <p>Building Feature: <u>Diagonal Wood Siding Repair within Front Porch Area</u></p> <p>Completion Year: 20 <u>20</u></p> <p>Plan to Use Long Beach Vendors For Materials/Labor: <input type="checkbox"/> Yes (If Yes, specify/list) <input checked="" type="checkbox"/> No </p>	<p>Detailed description of work:</p> <p>Diagonal wood siding is exposed and covered in various areas throughout the building. Any intact or salvageable material will be retained and restored in accordance with the Secretary's Standards for Rehabilitation. All siding will be uncovered, carefully cleaned and lightly sanded to remove debris, and will be filled and patched as necessary. Beyond-repair material will be replaced when necessary with new material that is like in size, texture, and material.</p>

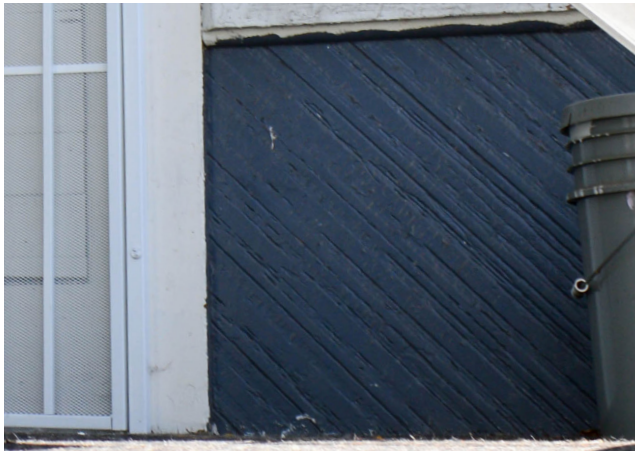
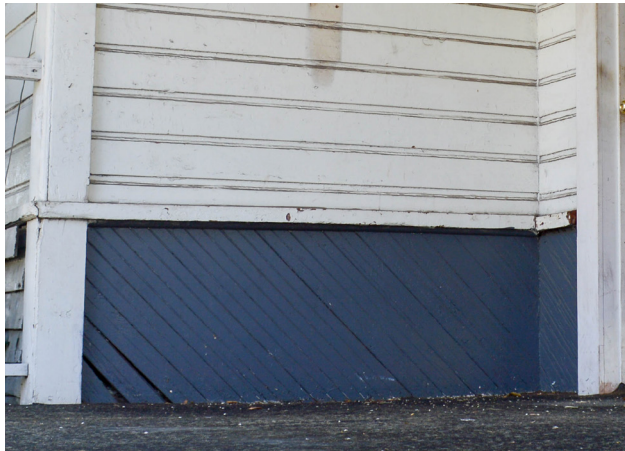
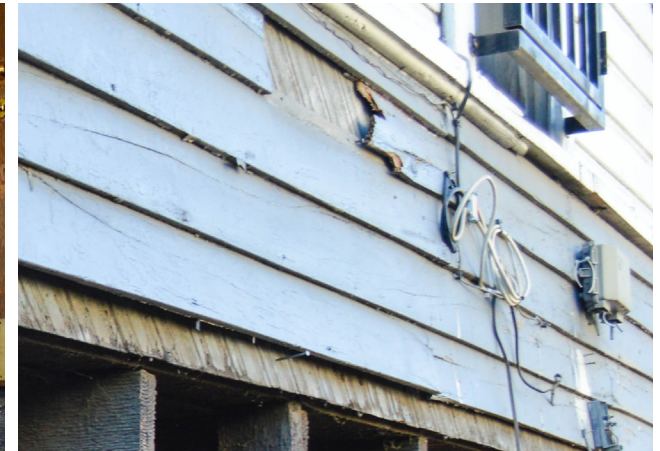
Item No. 2: Diagonal Wood Siding Repair and Restoration

Diagonal wood siding in the front porch area is exposed. This siding dates to the period of historic significance, and is in poor condition. Over the course of relocation, it was discovered that this siding continues throughout the base of the residence. It was covered when the building was painted white for the first time, as the siding retains its original gray paint coloring. This was likely after the building's most recent relocation in 1913/14 or during its 1921 conversion to a duplex. As part of this work, clapboard siding added after the period of significance will be removed, and existing diagonal wood siding hidden beneath will be repaired and restored according to the Rehabilitation Plan.

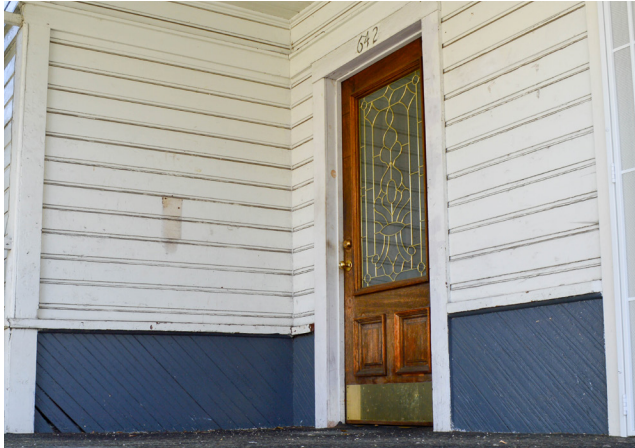
Item No. 3: Restoration of Original Entry Door/Window Opening and Entry Door

Through observation of historic photographs, it's known that the original doorway was filled with this wood door after the period of significance.

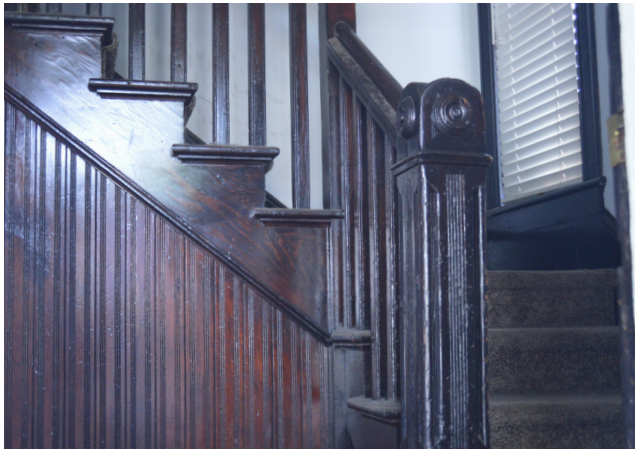
Item No. 4: Interior Staircase Repair and Restoration

The staircase banister and its supports are highly decorative, and were removed prior to relocation to ensure protection.

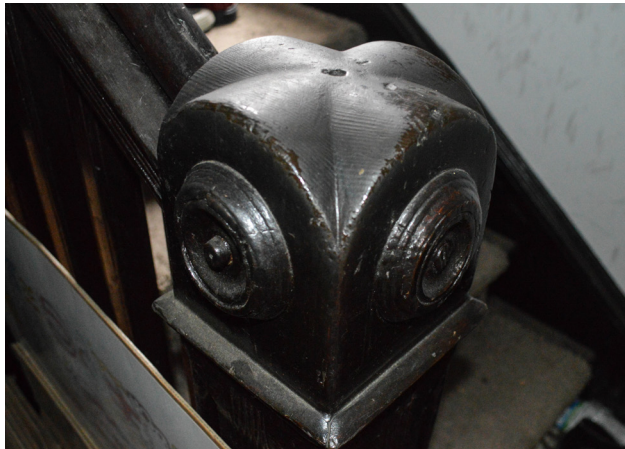
Decorative elements like this post are in good condition, and will be restored.

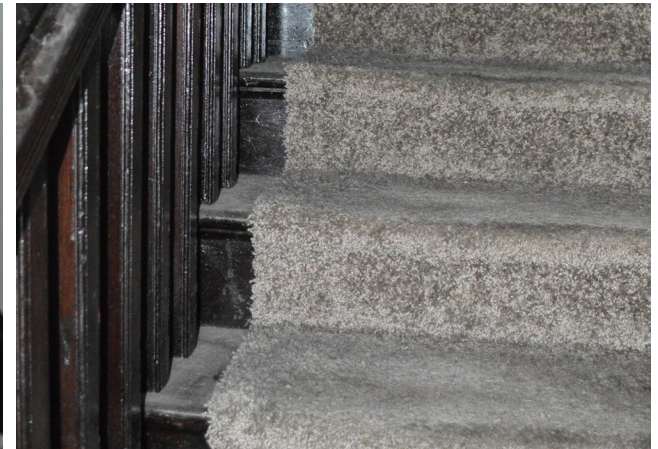
The staircase rise and run is in very poor condition, and must be replaced for safety purposes.

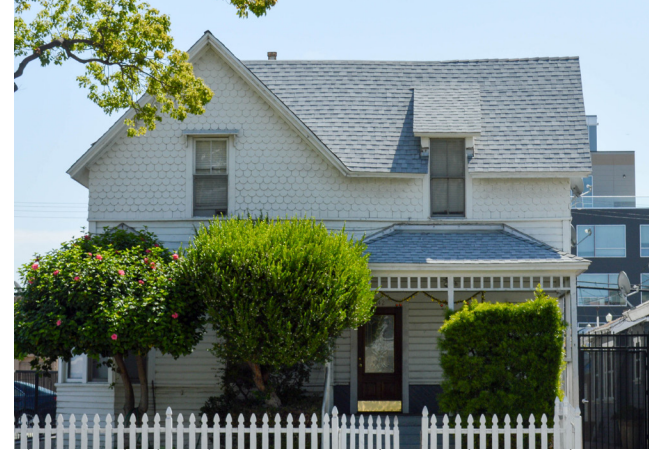
Item No. 5: Exterior Painting in Original Color Scheme Determined by Forensic Paint Analysis

The original color scheme was painted over with a monochrome cream in the 1920s, most likely. It has remained as such since.

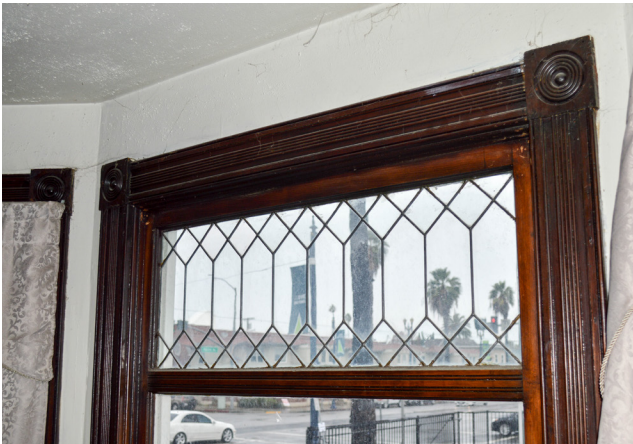
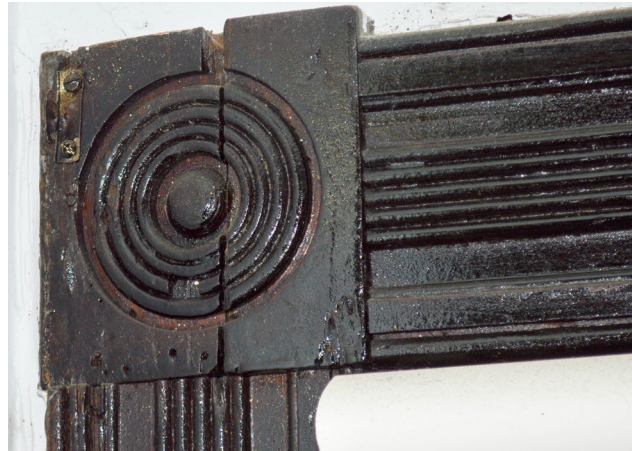
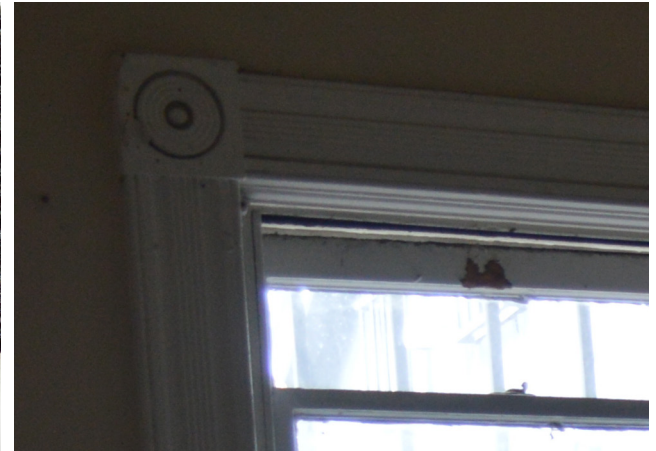
Item No. 6: Interior Window Frame Restoration

On the first level only, windows have decorative dart and other detailing in the wood window surrounds. Three of these window frames have been painted or varnished (demonstrated through the two images at right) while most are unpainted and sealed (as seen in the left-most image.)

<p>Item No.: <u>6</u></p> <p>Building Feature: <u>Interior Window Frame Restoration</u></p> <p>Completion Year: 20 <u>21</u></p> <p>Plan to Use Long Beach Vendors For Materials/Labor: <input checked="" type="checkbox"/> Yes (If Yes, specify/list) <input type="checkbox"/> No </p>	<p>Detailed description of work:</p> <p>On windows with ornamental frames (14 total,) frames will be gently cleaned and sanded to remove debris and prepare for repair. On those window frames which have been varnished/painted, that varnish/paint will be carefully removed with care to protect historic material. Holes will be filled with suitable wood filler, and wood will be lightly sanded, stained, and sealed if appropriate to the existing stain/color of preserved wood window frames.</p> <p>Specify/list: Will be completed by JR van Dijs, Inc. or by another Long Beach-based vendor</p>
<p>Item No.: <u>7</u></p> <p>Building Feature: <u>Interior Door Frame and Door Restoration</u></p> <p>Completion Year: 20 <u>21</u></p> <p>Plan to Use Long Beach Vendors For Materials/Labor: <input checked="" type="checkbox"/> Yes (If Yes, specify/list) <input type="checkbox"/> No </p>	<p>Detailed description of work:</p> <p>This work will only apply to remaining historic doors within the building (7 doors total.) Door locations will be noted and cataloged, and then doors will be progressively removed and restored, along with their hardware, to complete this work. Door frames, doors, and door hardware will be treated according to the same steps outlined in Items 1, 3, and 6 of this Rehabilitation Plan. Following work, doors will be reinstalled in their original position.</p> <p>Specify/list: Will be completed by JR van Dijs, Inc. or by another Long Beach-based vendor</p>

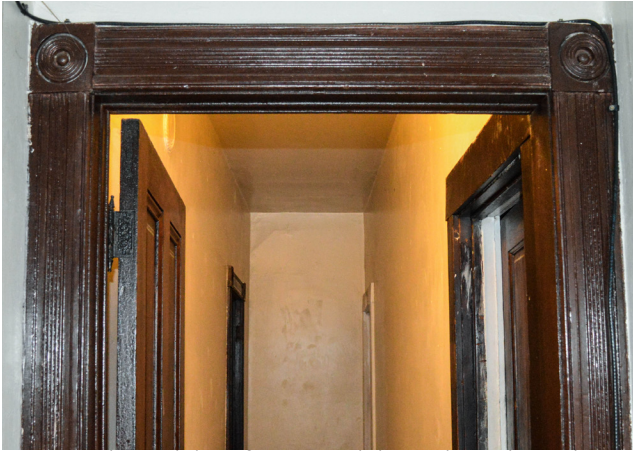
Item No. 7: Interior Door Frame and Door Restoration

Unpainted wood door frames and doors throughout the first story are in need of repair and restoration.

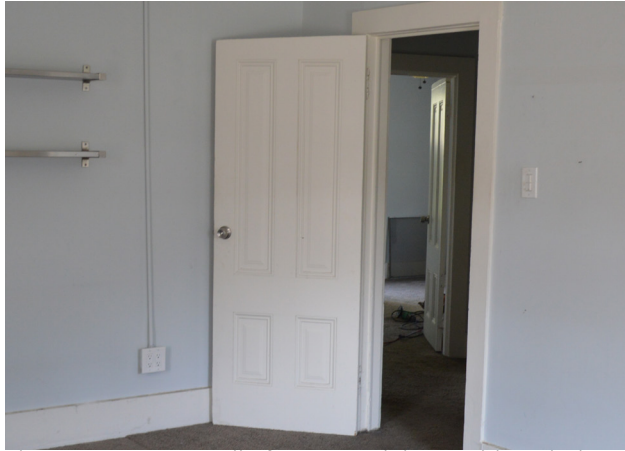
The upstairs retains all of its original doors, although they have been painted.

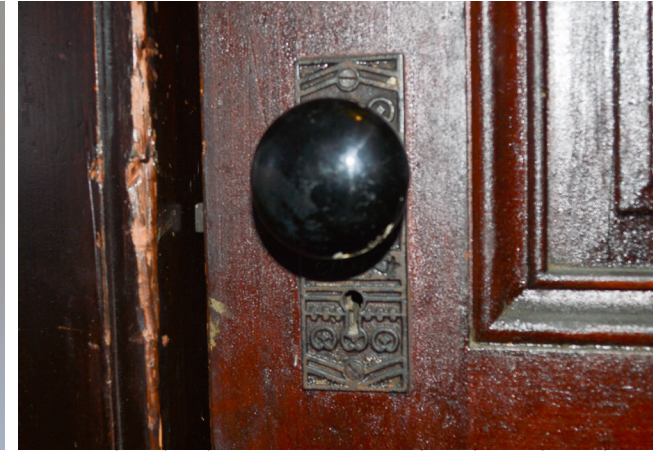
Historic door hardware remains on select doors throughout the first and second story, and will be restored.

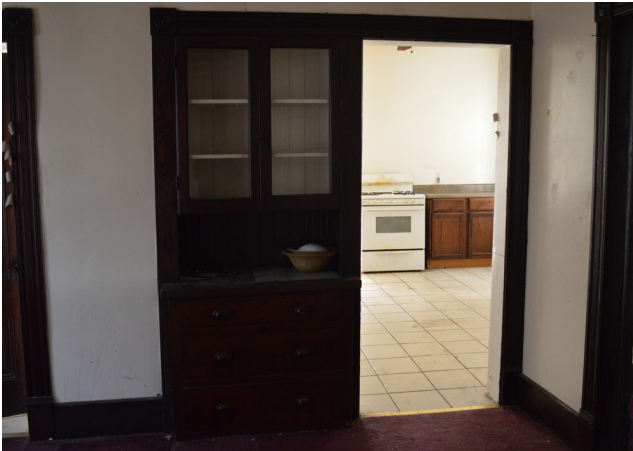
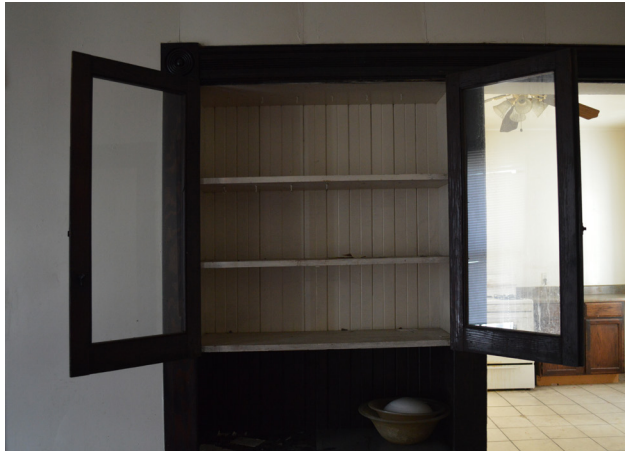
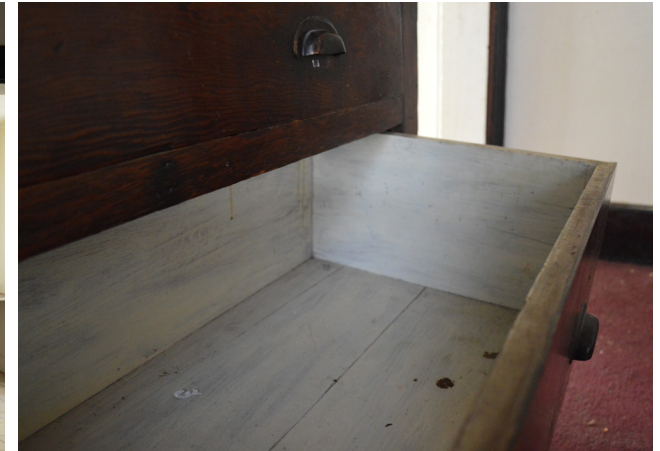
Item No. 8: Restoration of Original Built-in China Cabinet

The china cabinet dating to the building's period of historic significance remains in the dining room area. This cabinet is functioning fairly well, and is generally in good condition. Cleaning, minor hardware repair, and some drawer repair is needed to return the cabinet to full functionality.

<p>Item No.: <u>8</u></p> <p>Building Feature: <u>Restoration of Original Built-in China Cabinet</u></p> <p>Completion Year: 20 <u>22</u></p> <p>Plan to Use Long Beach Vendors For Materials/Labor: <input type="checkbox"/> Yes (If Yes, specify/list) <input checked="" type="checkbox"/> No </p>	<p>Detailed description of work:</p> <p>This cabinet dates to the building's period of historic significance. To begin work, the cabinet's drawers and doors will be cataloged and removed. All components will be gently cleaned and sanded to remove debris. Drawers and drawer tracks will be repaired to ensure proper function. The rear wall of the cabinet may be repainted appropriately. Holes will be filled with suitable wood filler, and wood will be lightly sanded, stained, and sealed as appropriate.</p> <p>Specify/list:</p>

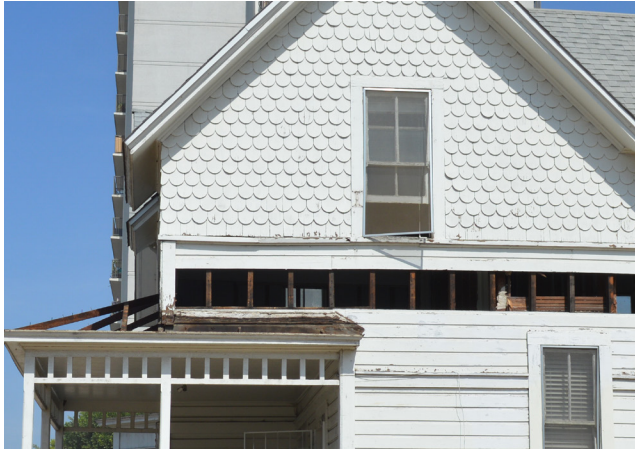
Item No. 9: Repairs to Exterior Clapboard Siding and Wood Shingle Siding

Wood siding that was removed as required for relocation will be replaced according to the Rehabilitation Plan.

Item No.: <u>9</u> Building Feature: <u>Repairs to Exterior Clapboard Siding and Wood Shingle Siding</u> Completion Year: 20 <u>29</u>	Detailed description of work: Several years after the complete restoration of the exterior, it is expected that materials will have experienced wear and tear, and that some shingles and clapboard siding may need to be repaired or replaced. Shingles and clapboard siding materials that are missing or damaged will be replaced with materials that are similar in size and material origin, and then are cut, placed, and painted to match the original.
Plan to Use Long Beach Vendors For Materials/Labor: <input type="checkbox"/> Yes (If Yes, specify/list) <input checked="" type="checkbox"/> No	Specify/list:

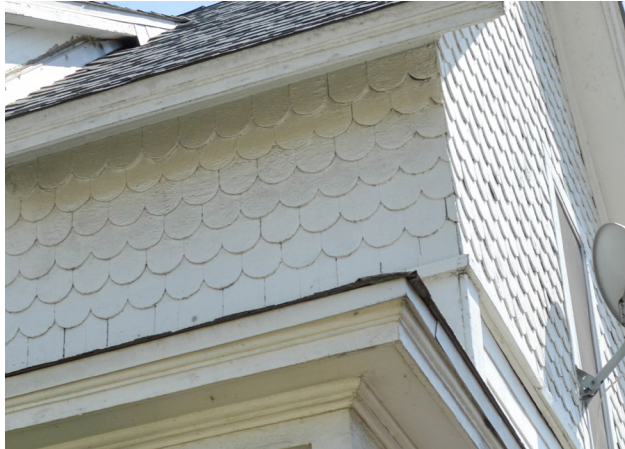
Shingle cladding will be repaired according to the Rehabilitation Plan.

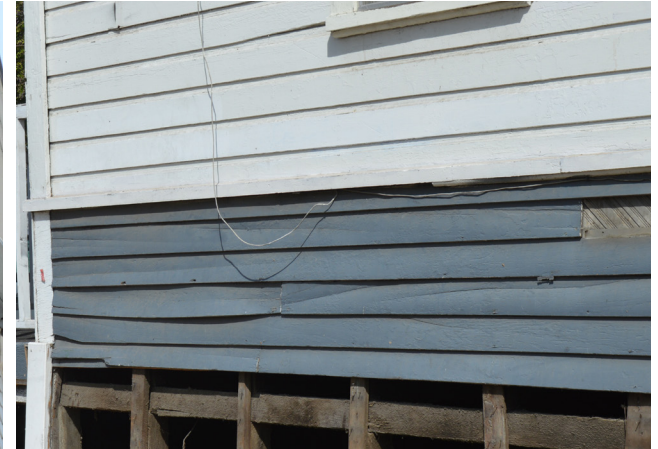
Wood clapboard siding (seen in the upper half of this image) will be repaired, while siding around the base (seen in the lower half) will be removed to restore diagonal wood siding hidden beneath it.
