# American Hotel

## Certificate of Appropriateness

November 2010

# AMERICAN HOTEL

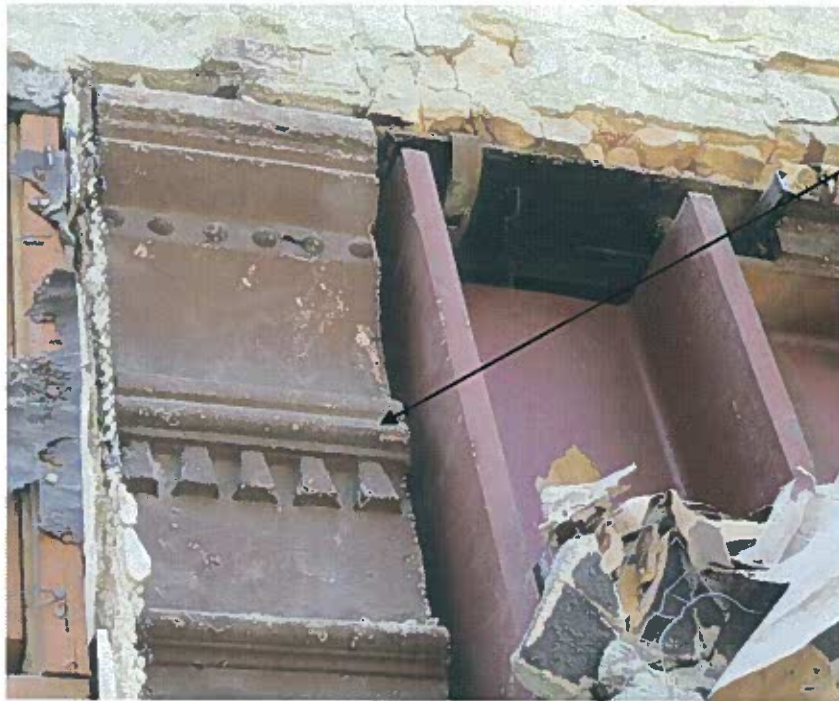
- 1 Selective demolition revealed two decorative cast iron columns bordering one of the central bays on the ground floor.
- 2 The two columns are identical in design with detail work running from top to bottom adding a unique element to the restored façade.
- 3 The original exposed facade uses a tan colored facing brick installed in a colonnade design seen here in the field, and varied relief designs surrounding the upper story windows. Also note the prominent decorative granite keystones.
- 4 Also exposed during the selective demolition was this plaster veneer stamped with a brick pattern and capped with an Ogee style cornice. Under the non-original fire escape an egg and dart cornice can also be seen.

Selective demolition of non-original exterior elements revealed two decorative cast iron columns bordering one of the central bays on the ground floor. Also exposed during the selective demolition was a plaster veneer with a brick pattern and capped with an Ogee style cornice. Under the non-original fire escape an egg and dart cornice can also be seen.

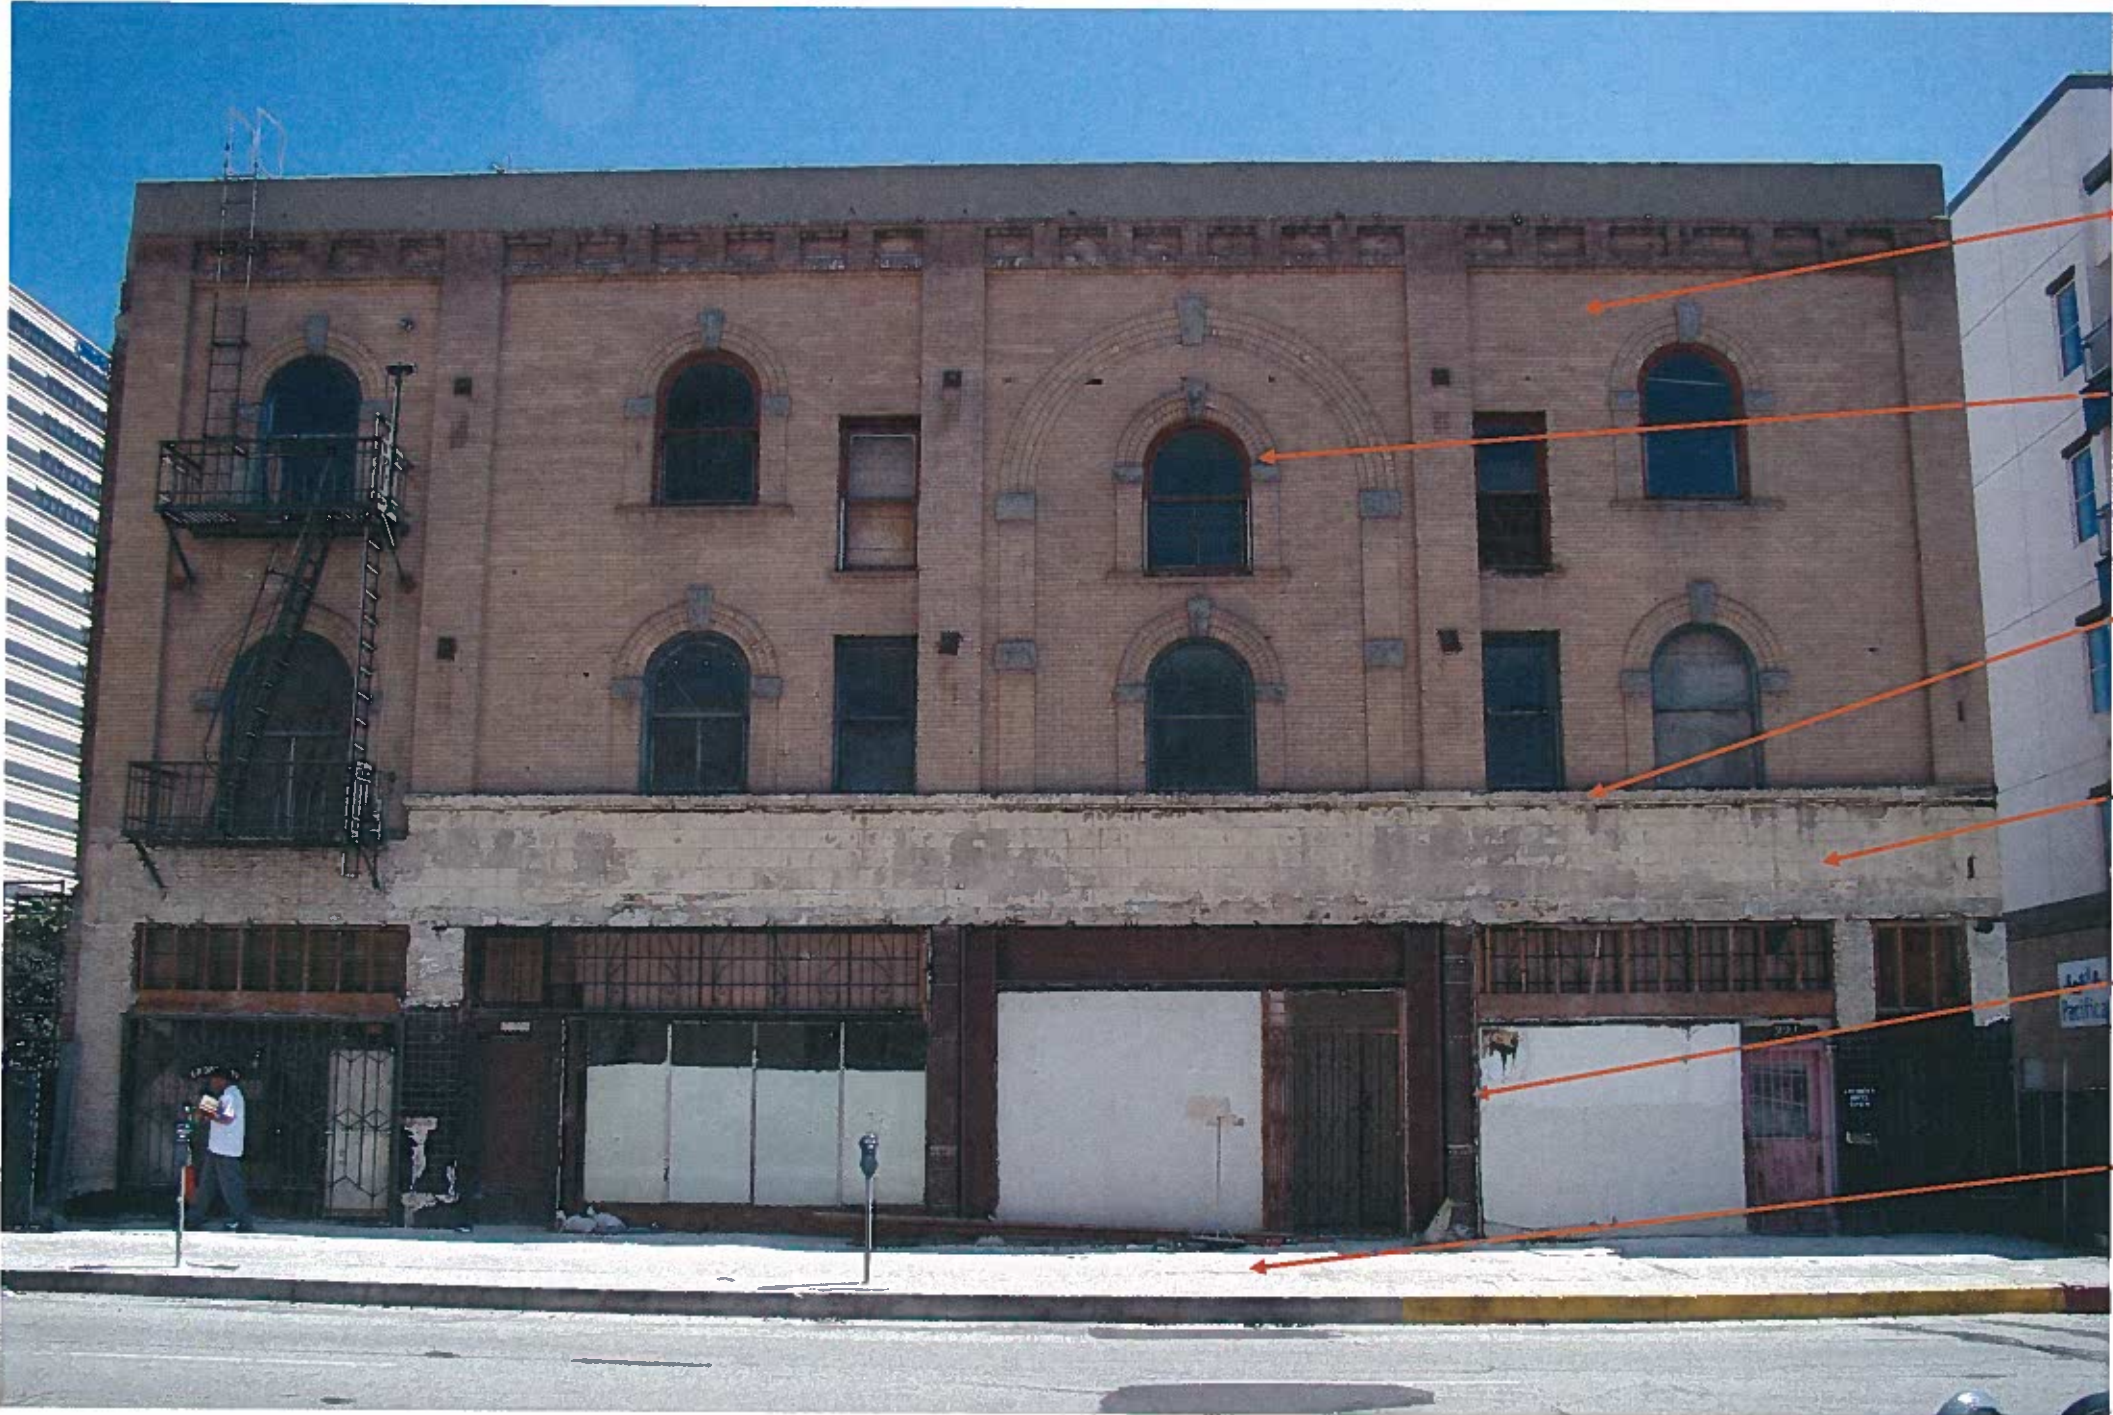
# NORTH ELEVATION

- 1 Original facing brick and stone details on 1st and 2nd floors
- 2 Existing double-hung windows on the Broadway facade
- 3 Original cornice elements between plaster and brick facade
- 4 Plaster brick pattern detailing above clerestory windows
- 5 Original cast-iron support columns
- 6 Patterned sidewalk with blue glass light-well inserts

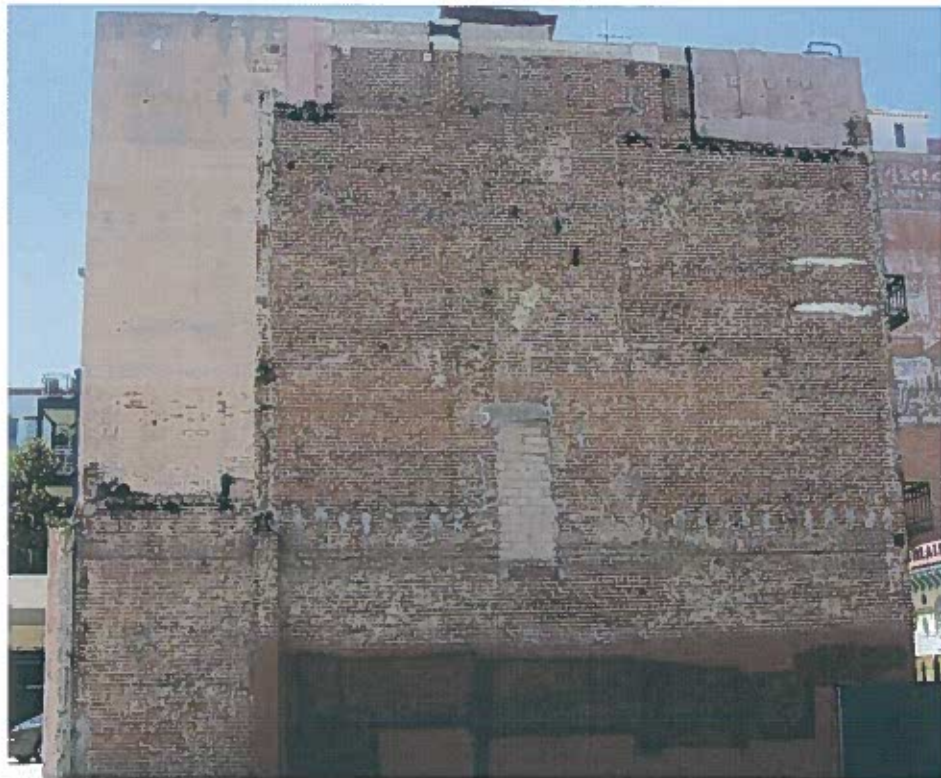
- 1 **East Elevation of Building**  
Masonry block repair to remain.
- 2 **South Elevation of Building**  
New steel exterior stairs to be installed as second point of egress.
- 3 **West Elevation of Building**  
Non-functioning vent system to be removed. Fire escape balconies to stay. Ladders to be removed.

Repair and replace deteriorated brick in kind with salvage or new brick and mortar that matches original. Clean surface using the gentlest method possible such as low pressure water and detergents using natural bristled brushes.

Remove deteriorated mortar by carefully hand raking the joints to prevent damage. Duplicate old mortar in strength, composition, color and texture.

Remove any deteriorated paint and patch concrete and plaster as needed.

All windows on East, South and West elevations to be replaced with new double hung windows.
