COLOR ANALYSIS STUDY

of the
Breakers Hotel
located at
210 East Ocean Boulevard
Long Beach, California 90802

Report prepared by
Carolyn Lehne

COLOR ANALYSIS STUDY of the exterior surfaces and interior lobby at the Breakers Hotel located at 210 East Ocean Boulevard, Long Beach, CA 90802.

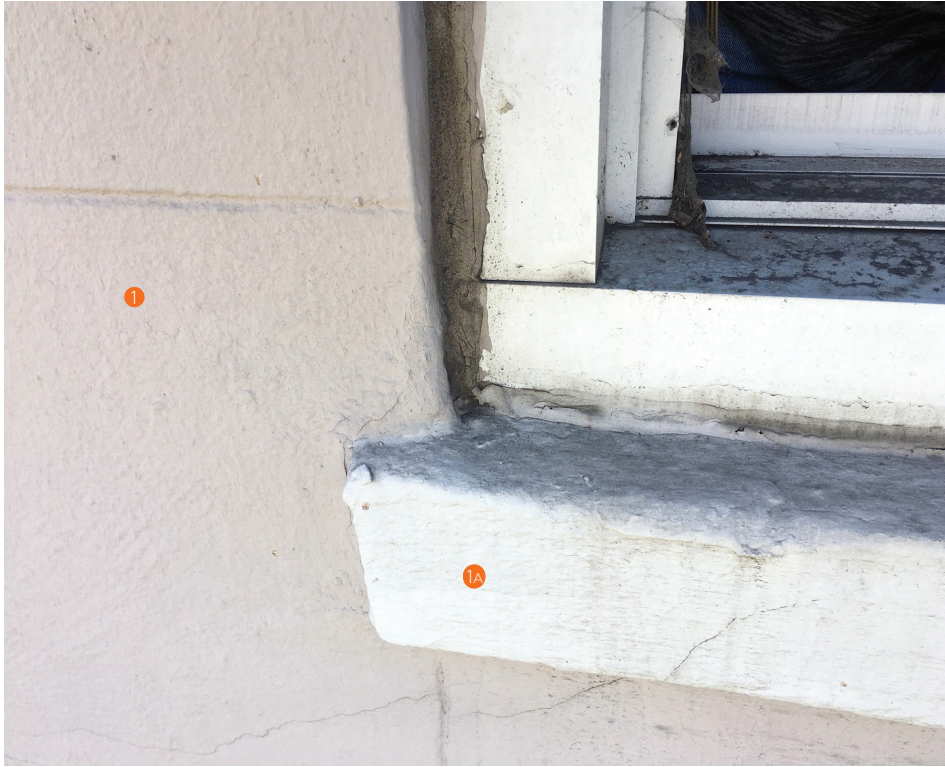
SAMPLE LOCATIONS
Exterior Windowsill

This sample was taken from the 2nd floor exterior wall. The sample has 9 layers of paint. The first is a pale peach, followed by a beige, a green, peach, white, pale yellow, white, off-white, and the current off-white layer. The original surface appears to be a pale peach color. Note: The exterior samples 1A (the 2nd floor window ledge), 1B (varied brick wall), and 1C (fire escape) are the same color and color sequence as sample #1.

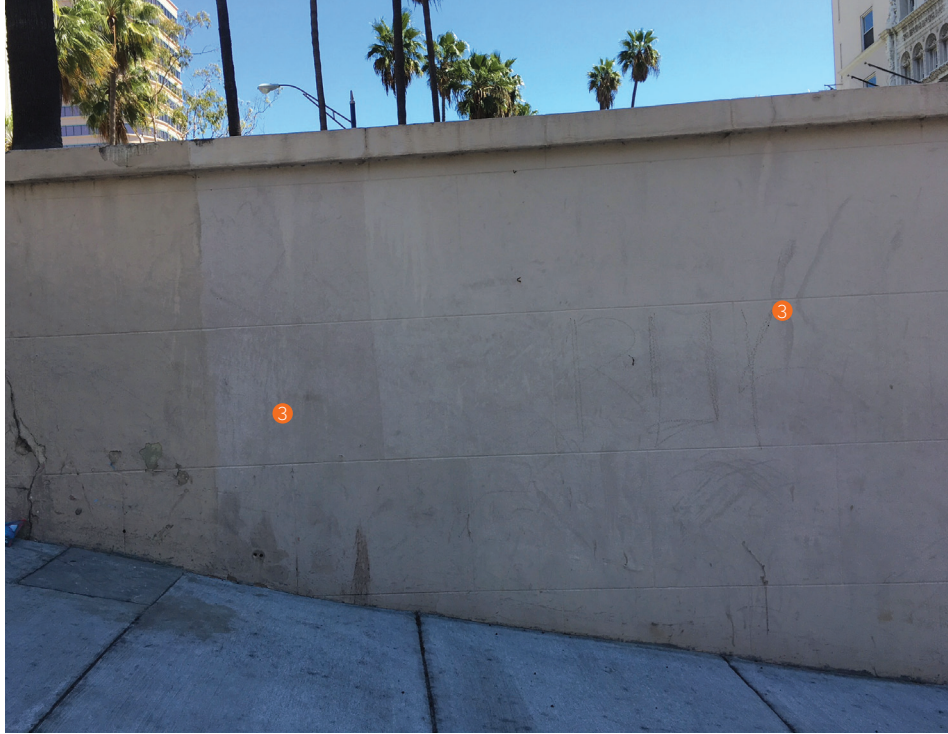
SAMPLE LOCATIONS
Exterior Property Wall

This sample was taken from the exterior wall. The sample has 13 layers of paint. The first is a green, followed by peach, pale peach, yellow ochre, off-white, beige, off-white, white, beige, off-white, beige, black, and the current off-white layer. The original color appears to be a green color. I noticed that the green color was evident in later sequence layers of exterior samples 1, 1A, 1B, AND 1C. I believe the wall may have been left unpainted originally and then painted green during the same time frame that a green paint palette was applied to rest of the building.

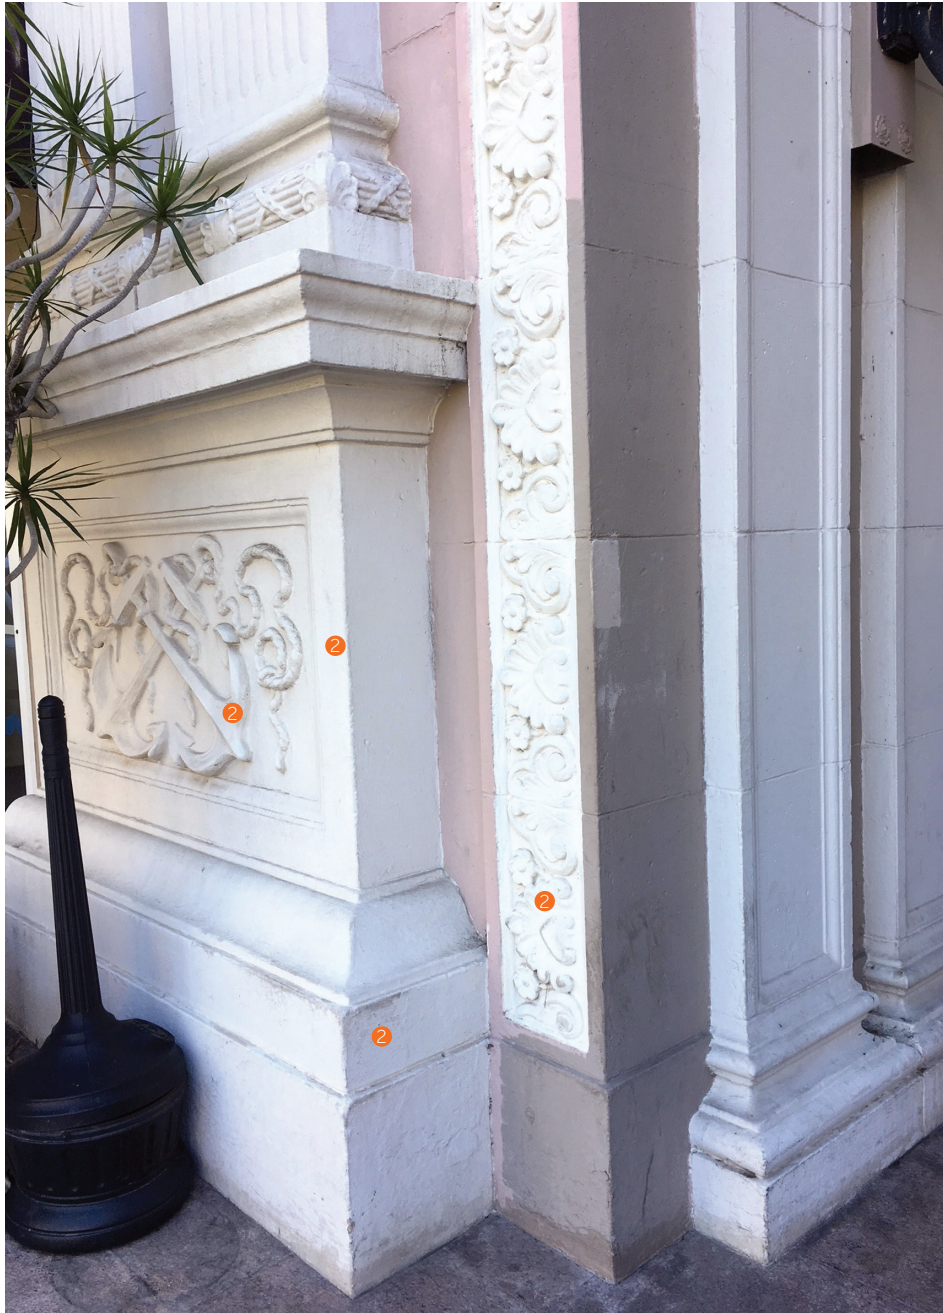
SAMPLE LOCATIONS
Terra Cotta

This sample was taken from the main entrance decorative terra cotta. The sample has 16 layers of paint plus a layer of gold leaf. The first is a medium peach, followed by a dark red, white, dark red, yellow ochre, dark red, off-white, blue, white, gold leaf, warm grey, beige, dusty rose, dark red, yellow ochre, white, and the current off-white layer. The original surface appears to be a medium peach color. The gold leaf layer and previous thin color layers suggest that the surface was glazed and possibly decoratively painted to enhance the decorative details.

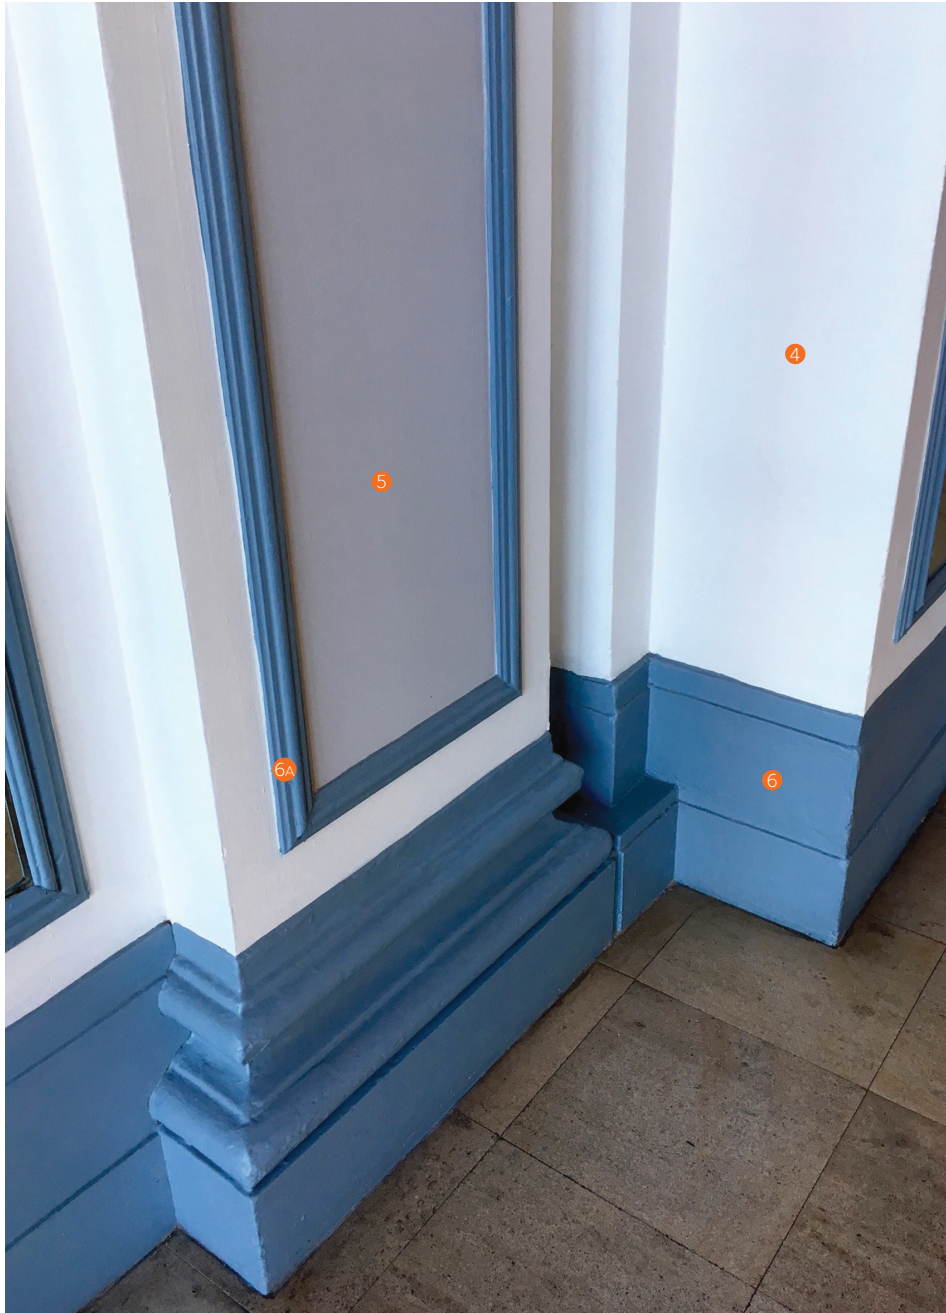
SAMPLE LOCATIONS
Interior Entry Lobby

This sample was taken from the interior wall. The sample has 6 layers of paint. The first is a pale yellow, followed by a yellow, off-white, off-white, off-white, and the current off-white layer. The original surface appears to be a pale yellow color.

This sample was taken from the inset panel. The sample has 6 layers. The first is a yellow color, followed by a pale yellow, pale peach, cream, beige and the current off-white layer. The original surface appears to be a yellow color.

This sample was taken from the interior base molding. The sample has 8 layers of paint. The first is a pale yellow, followed by a yellow layer, off-white, off-white, off-white, off-white, off-white and the current blue layer. The original surface appears to be a pale yellow color. Note: Sample 6A (decorative panel frame) is the same color and color sequence as sample #6.

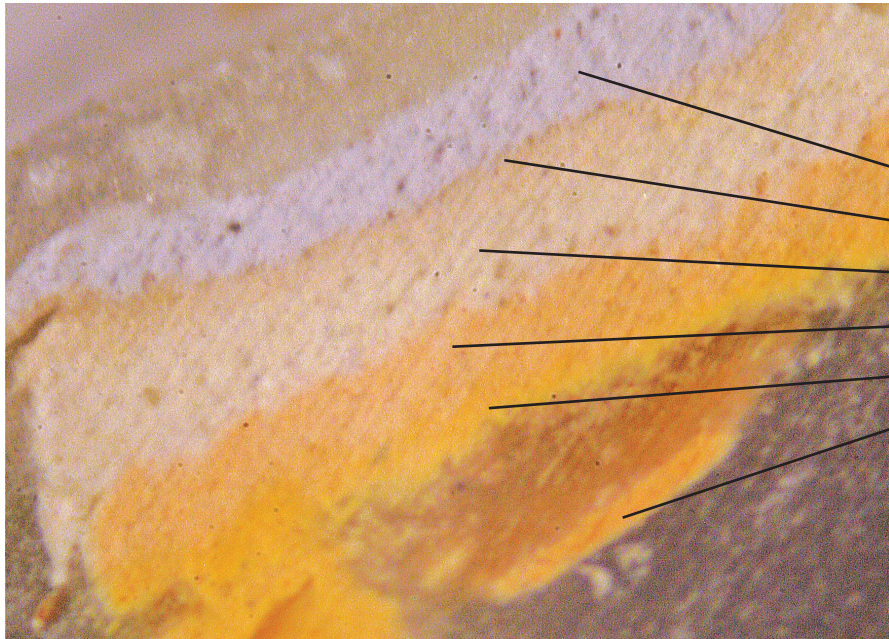
SAMPLE #5 Interior Entry Inset Panel

sixth layer
fifth layer
fourth layer
third layer
second layer
original paint layer

hue = 3.19Y
value = 8.7
chroma = 5.0

Light Reflection Value 72

Dunn Edwards DE5352 Sun Kissed
