Receive information and provide direction relative to the geotechnical analysis peer-review report for the Ocean Boulevard (Bluff) Erosion and Enhancement Phase 2 Project. (District 3)

**PEER REVIEW REPORT
OCEAN BOULEVARD EROSION AND ENHANCEMENT
PHASE 2 PROJECT
CITY OF LONG BEACH, CALIFORNIA**

**CITY OF LONG BEACH
Tidelands Capital Improvement Division**

June 23, 2014

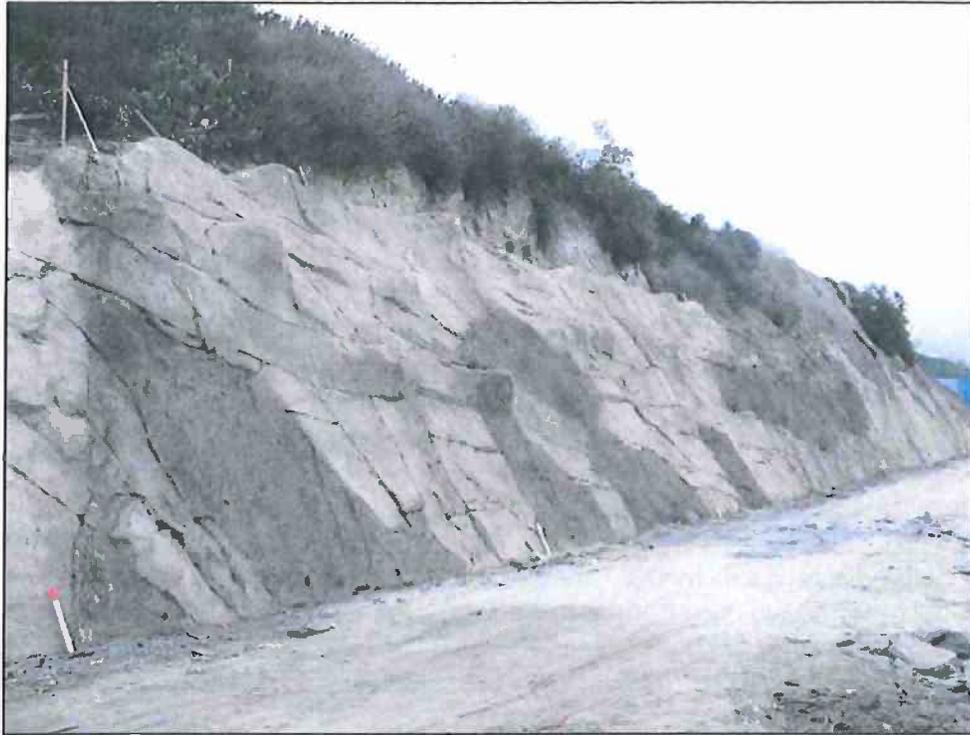
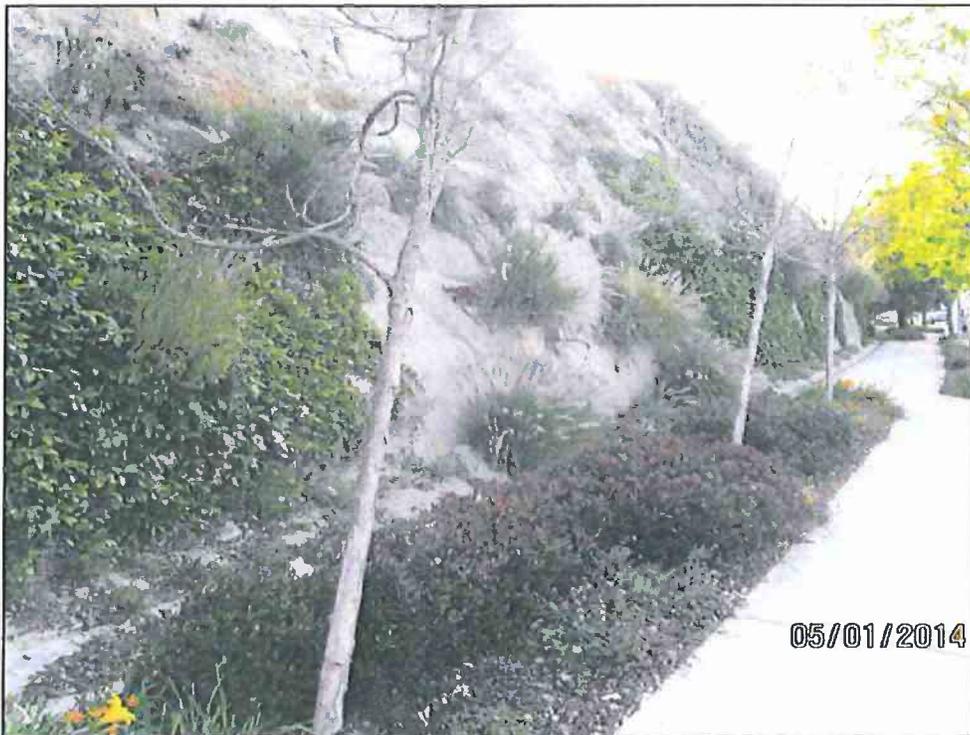
Before & After—Dana Point

Before (2002)

After (2014)

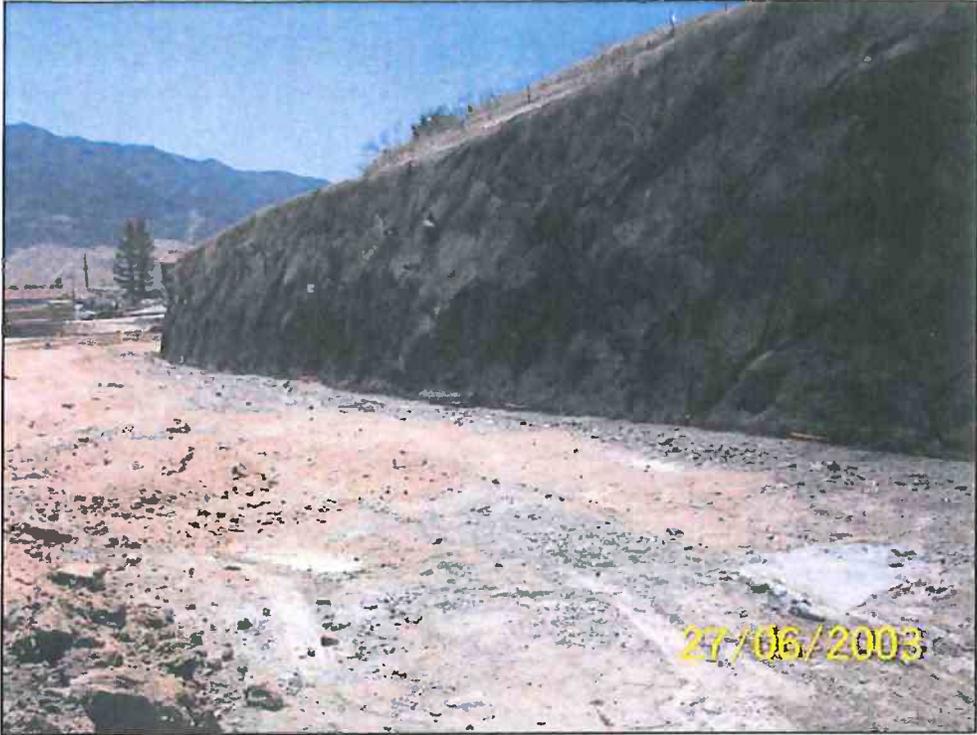
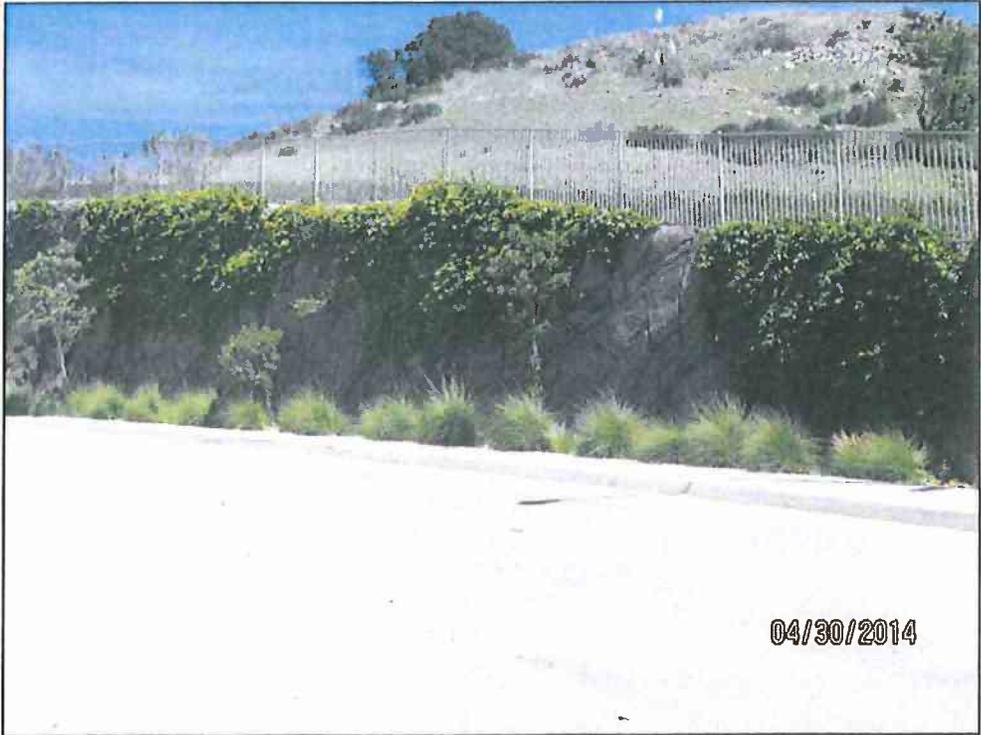
Before & After—Agoura Hills

Before (2003)

After (2014)

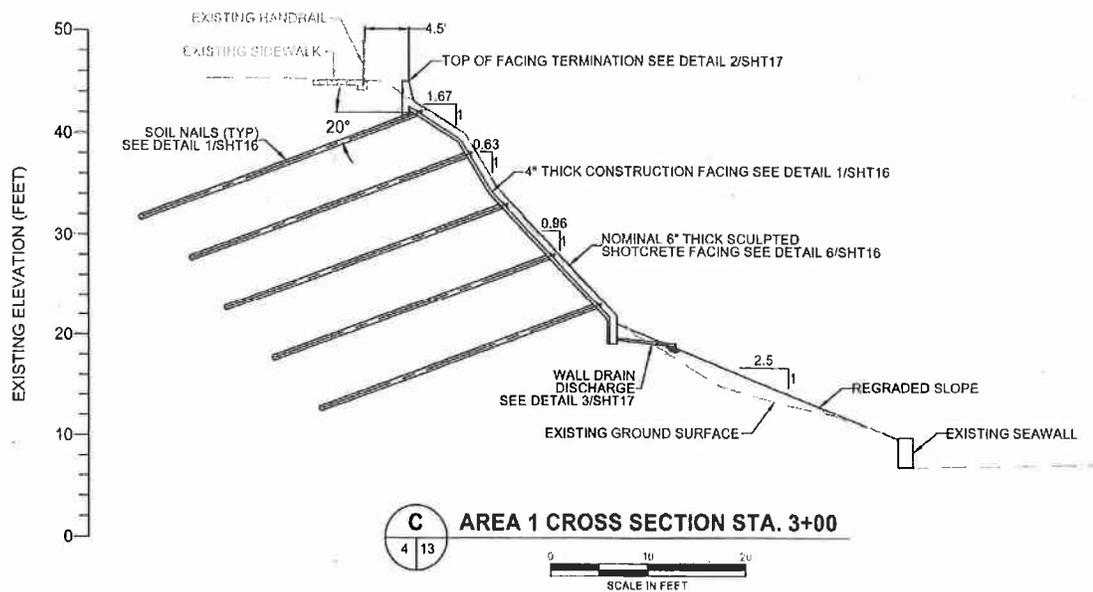
Figure 1 - Design Cross-Section of Soil Nailing

- Soil nails that enhance the deep-seated stability of the bluff under static and dynamic conditions (Figure 1) and locally support portions of the sidewalk; and
- A shotcrete facing (Figure 1) that protects the slope surface from weathering and erosion caused by surface water, and enhances the surficial stability.

The shotcrete facing will be sculpted to blend in with the surrounding landscape. At specific locations, the shotcrete facing has planter pockets that allow vegetation to grow on the slope and with time will partially cover the shotcrete surface, as exemplified in Figure 2. The design contemplates having open-bottom planters that allow infiltration into the slope. Failure of sprinklers and/or the irrigation pipes may result in a concentrated influx of water directly into the slope which is undesirable. The design includes irrigation PVC pipes embedded into the shotcrete to drain excess irrigation water.

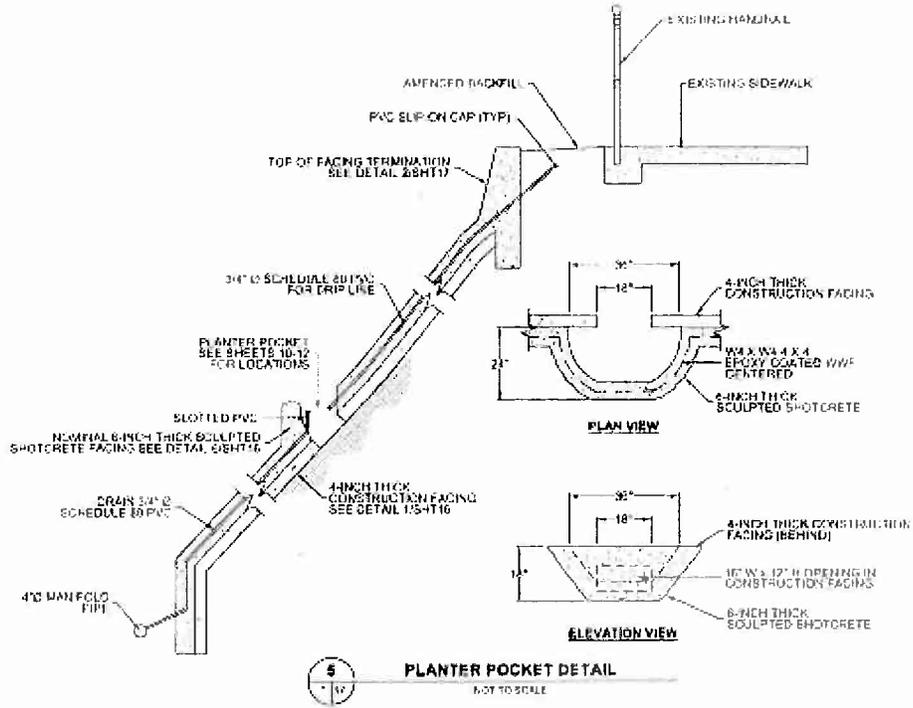
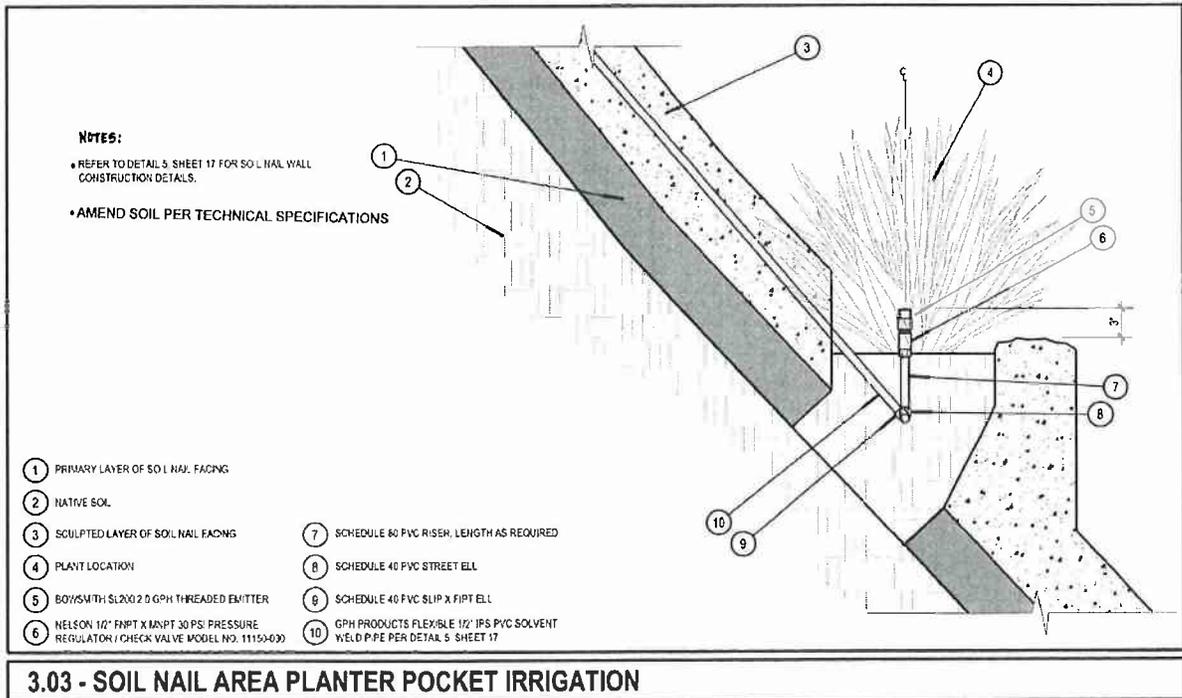
Figure 2 - Planter Details

3.03 - SOIL NAIL AREA PLANTER POCKET IRRIGATION

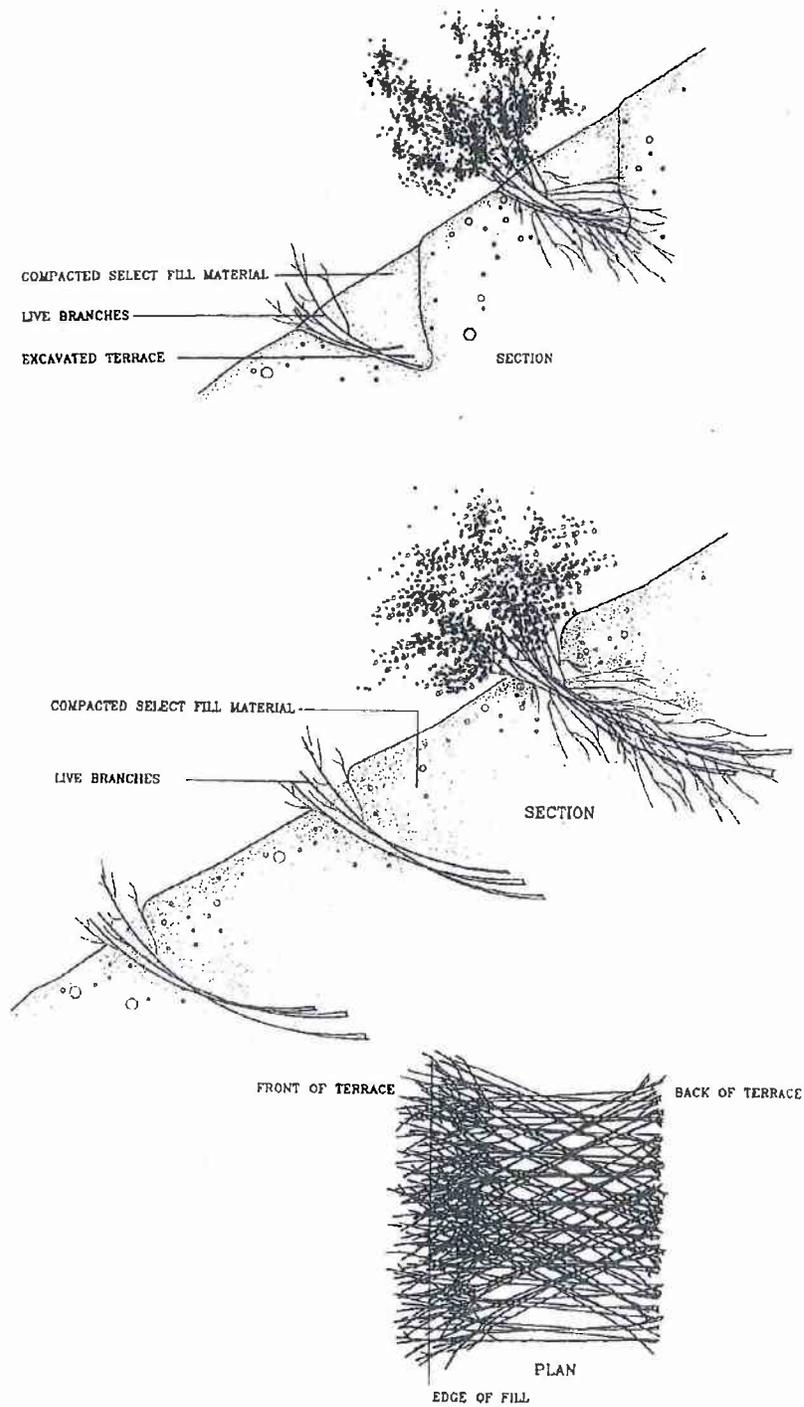
Figure 3 – Example of Deep-Rooted Vegetation

Figure 7-21. Schematic diagram of an established growing *fill slope* brushlayer installation showing alternating layers of live cut brush inserted between lifts of soil.

- Deep rooted vegetation as depicted in Figure 3;
- Deep rooted vegetation in combination with geogrid or timber grid used to hold topsoil and slope plantings as shown in Figure 4; and
- Live slope grating where a lattice-like array of vertical and horizontal timbers are fastened or anchored to a steep slope and the openings in the structure are filled with suitable backfill material and layers of live branch cuttings (see Figure 5).

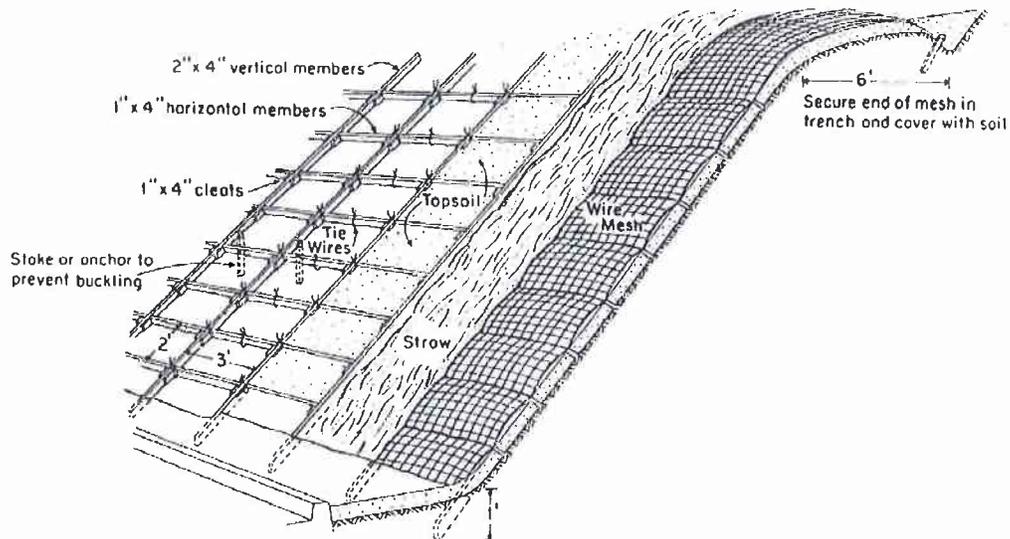
Figure 4 – Example of Deep-Rooted Vegetation with Timber Grid

Figure 8-18. Anchored timber grid used to hold topsoil and slope plantings.

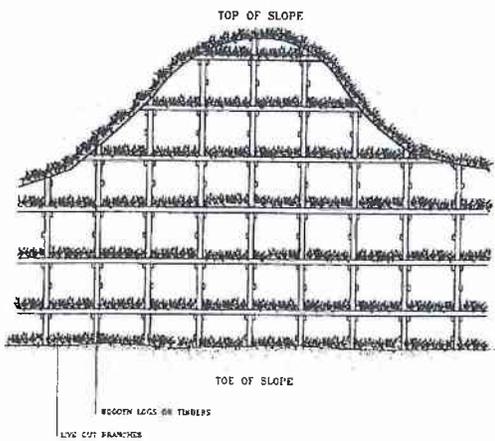
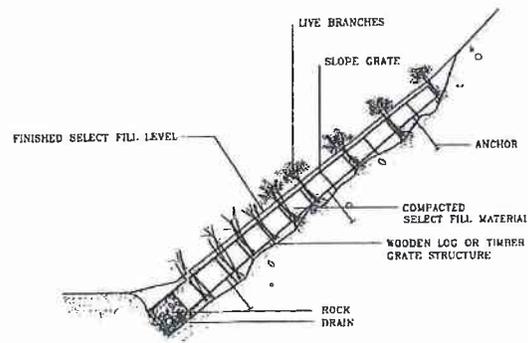
Figure 5 – Example of Live Slope Grating

Figure 7-36. Schematic illustration, frontal view, of live slope grating consisting of lattice-like array or grid of horizontal and vertical timbers that are anchored to a steep slope.

Figure 7-37. Profile view of an established growth slope grating system showing placement of live cuttings or branches in box-like compartments in the grating.
