The Walker Building HOA

Attached are the necessary components of The Walker Building HOA's application for a Certificate of Appropriateness with regard to proposed historic sign restoration at 401 Pine Ave

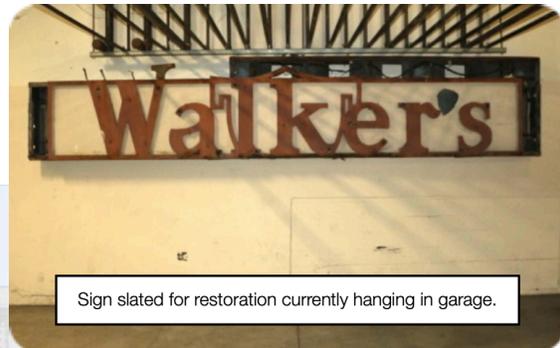
Photo below captured during condo-conversion showing neon sign mounted to the east-facing Pine Avenue awning before it was removed and stored. May 31, 2001

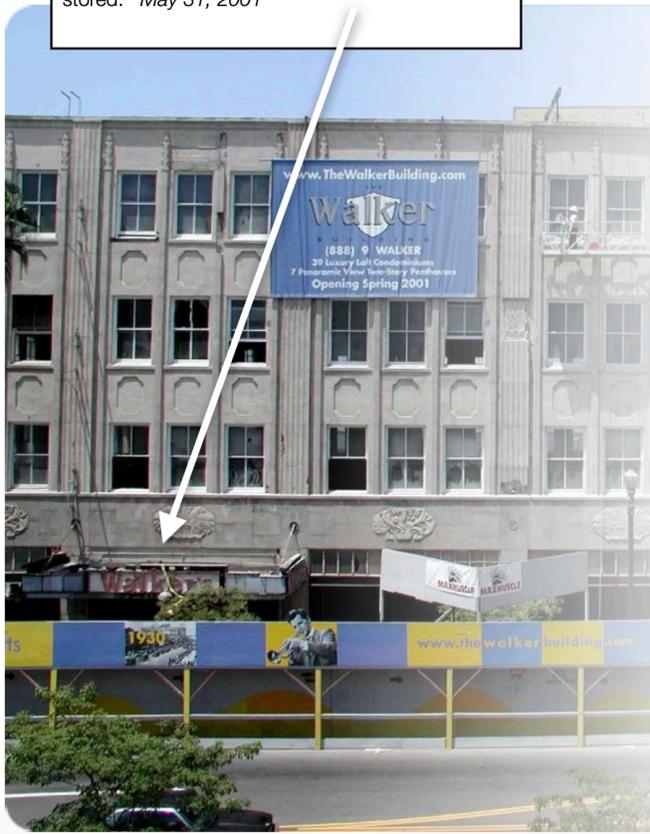
Sign slated for restoration currently hanging in garage.

There are holes present in the current sign. They will be patched with a similar alloy and the entire sign repainted in light color. The majority of the sign will remain intact. Minimal replacement of structural components is expected.

The sign is to be cleaned using the gentlest method first, which is hand scraping and wire brushing. If the first method is ineffective additional steps may be taken. Metal to be repainted in a light color based on photo in the first section and the neon sign reproduced in violet which was the original color used in 1934.

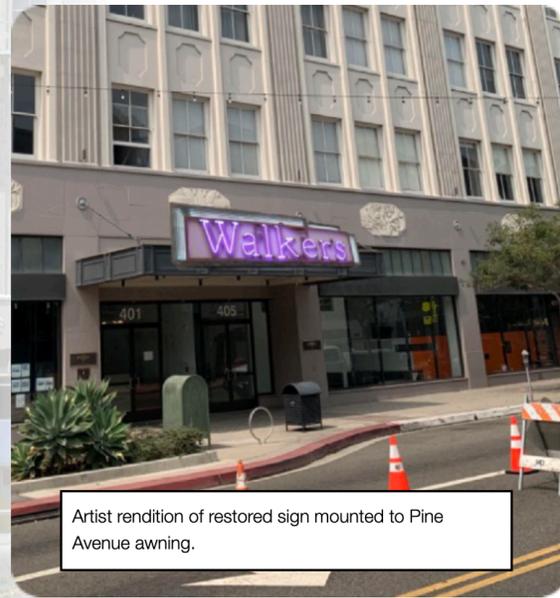
Artist rendition of restored sign mounted to Pine Avenue awning.

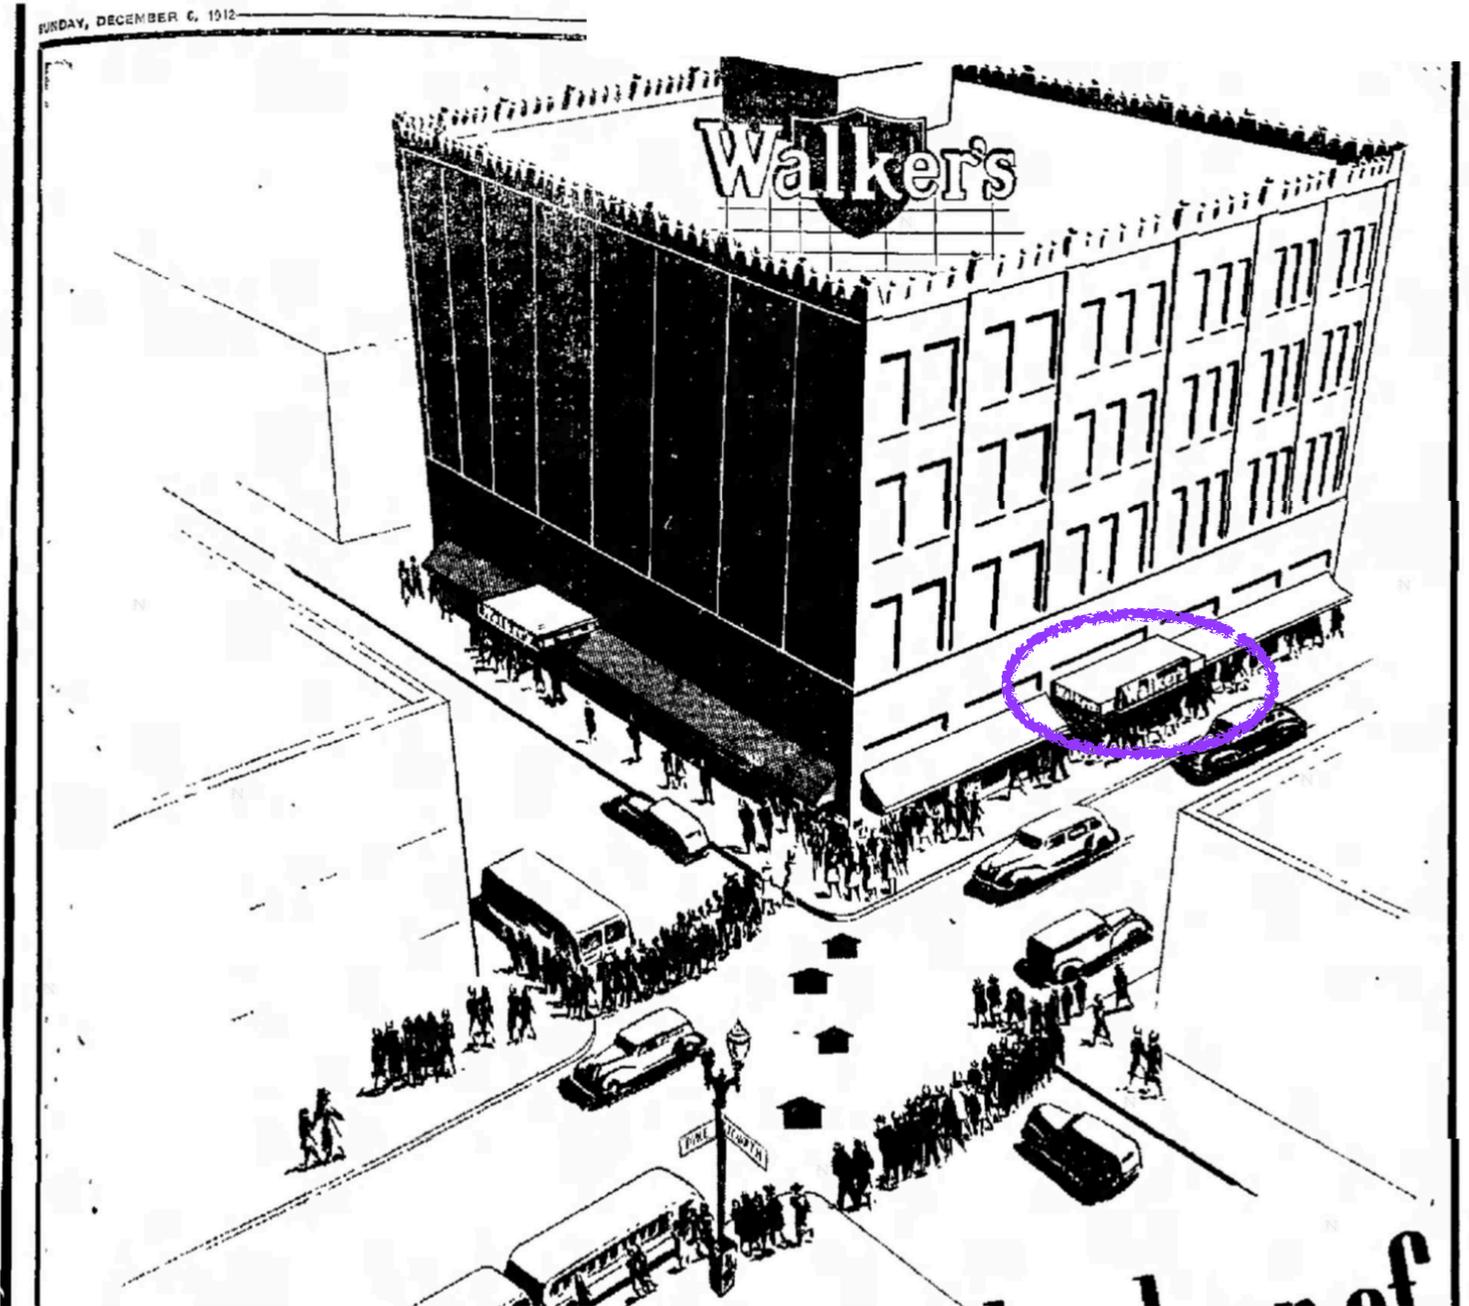
Sunday, December 6, 1942 newspaper advertisement showing *Walker's* sign hanging on Pine Avenue awning. *Long Beach Press-Telegram*.

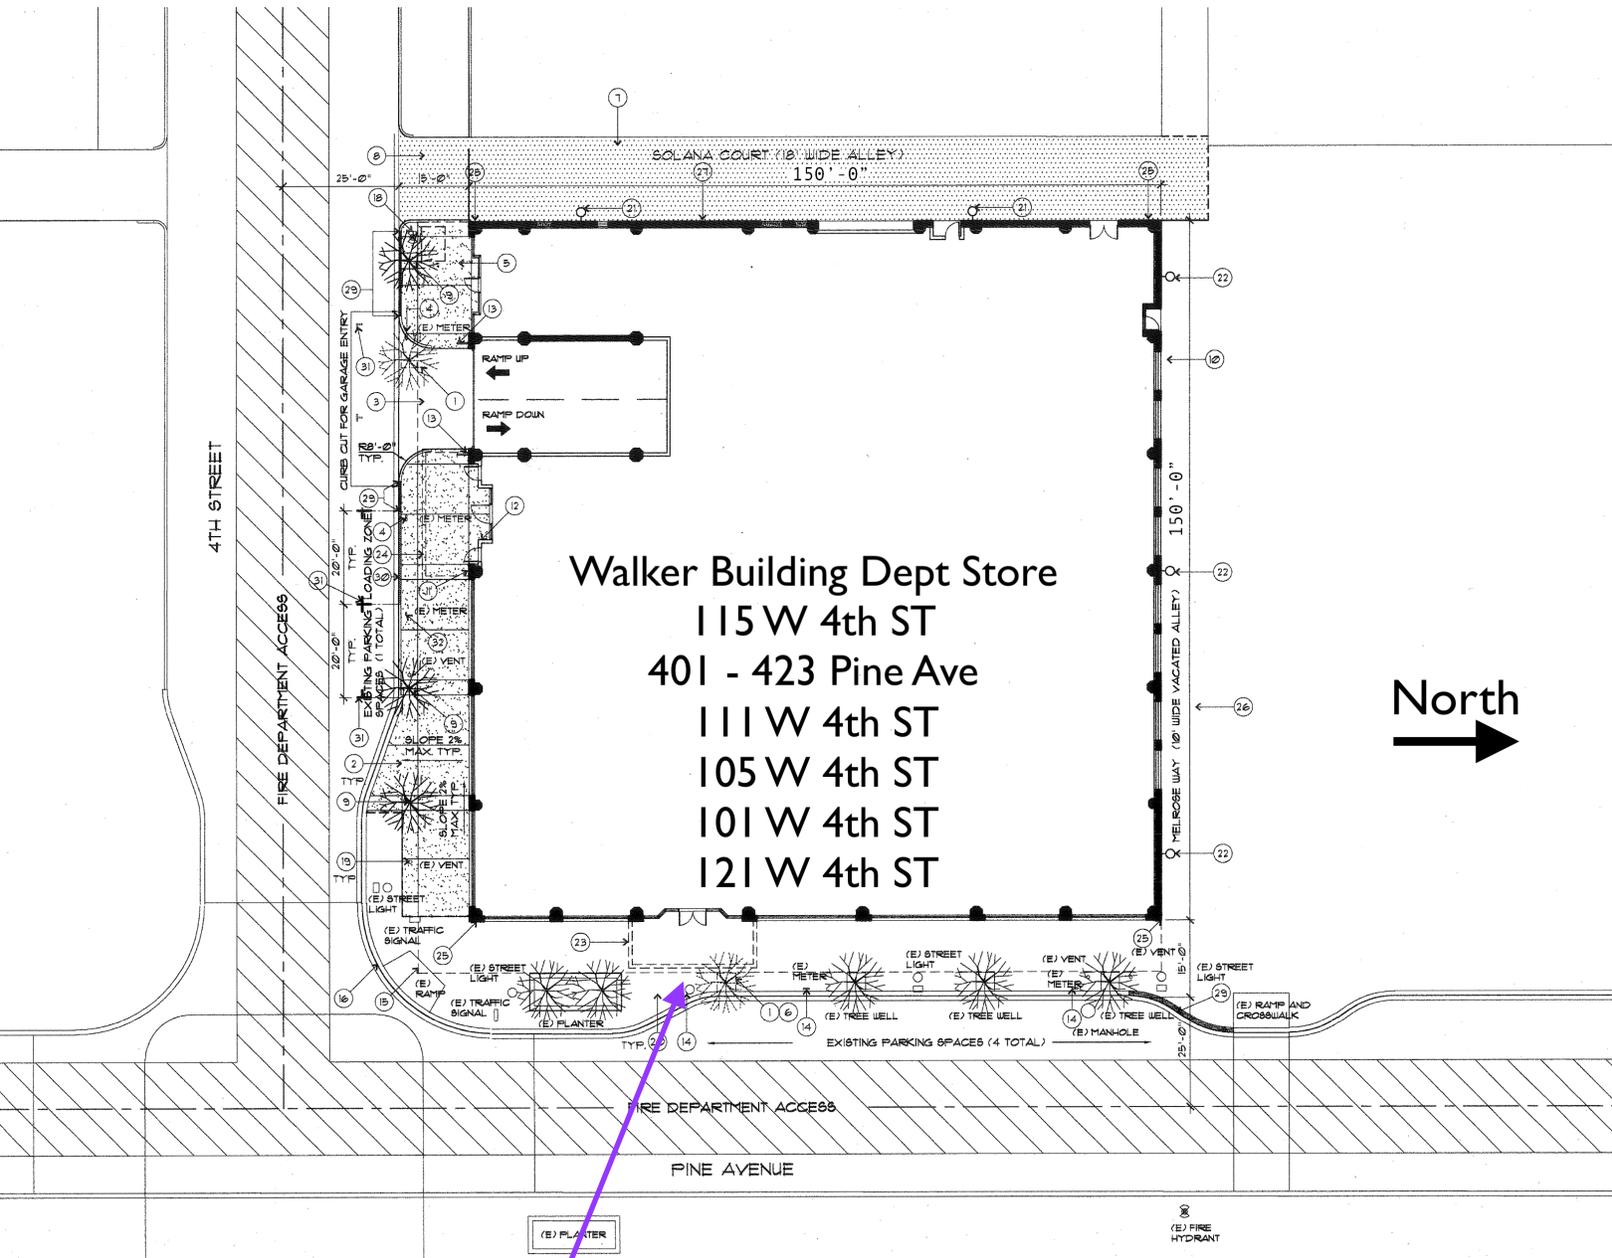
Site Plan:

Sign to be mounted here

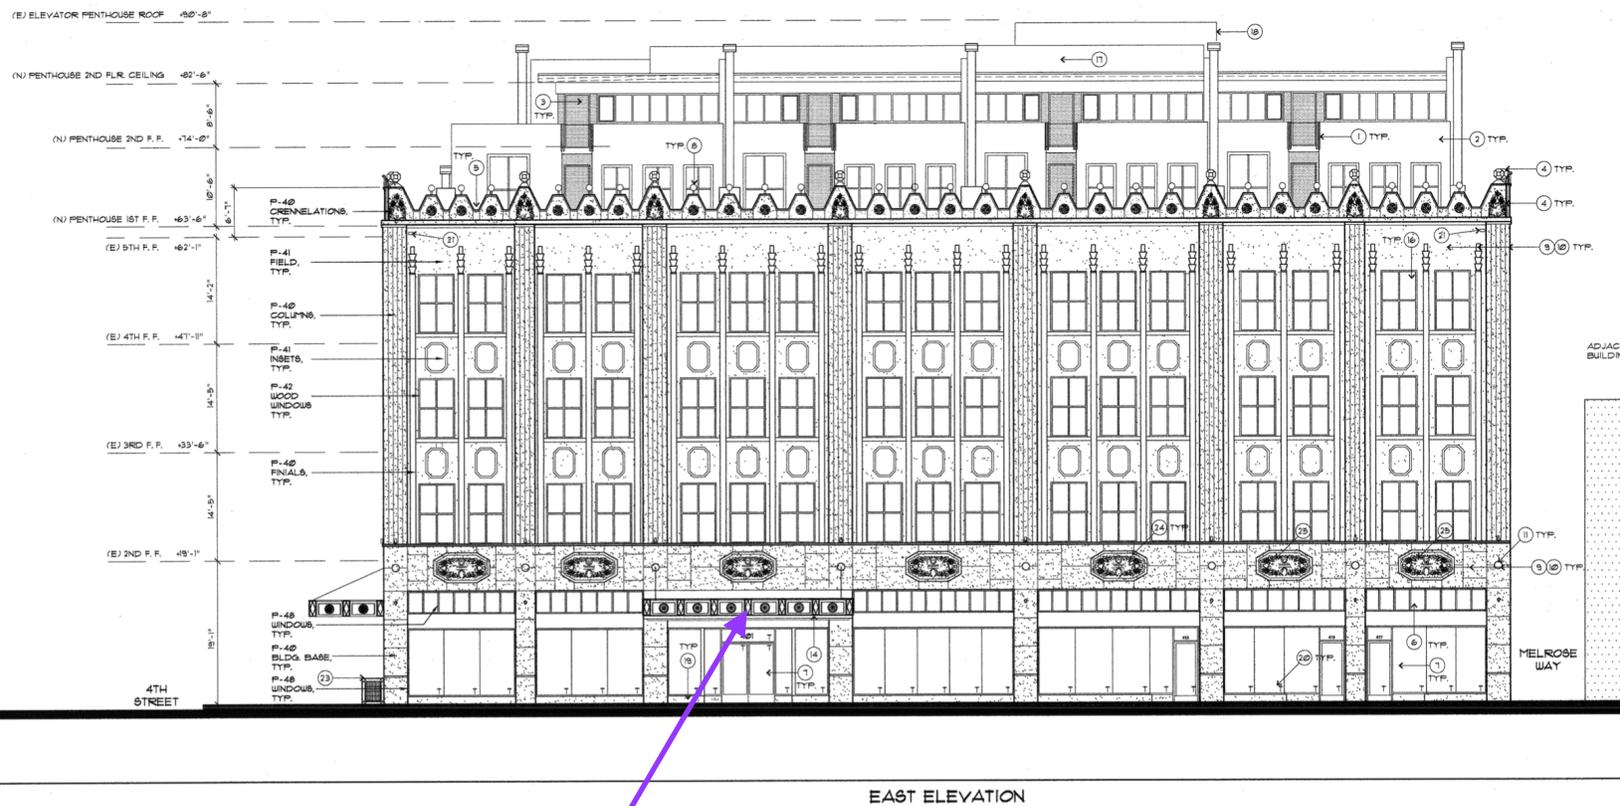
Exterior Elevations:

Sign to be mounted here

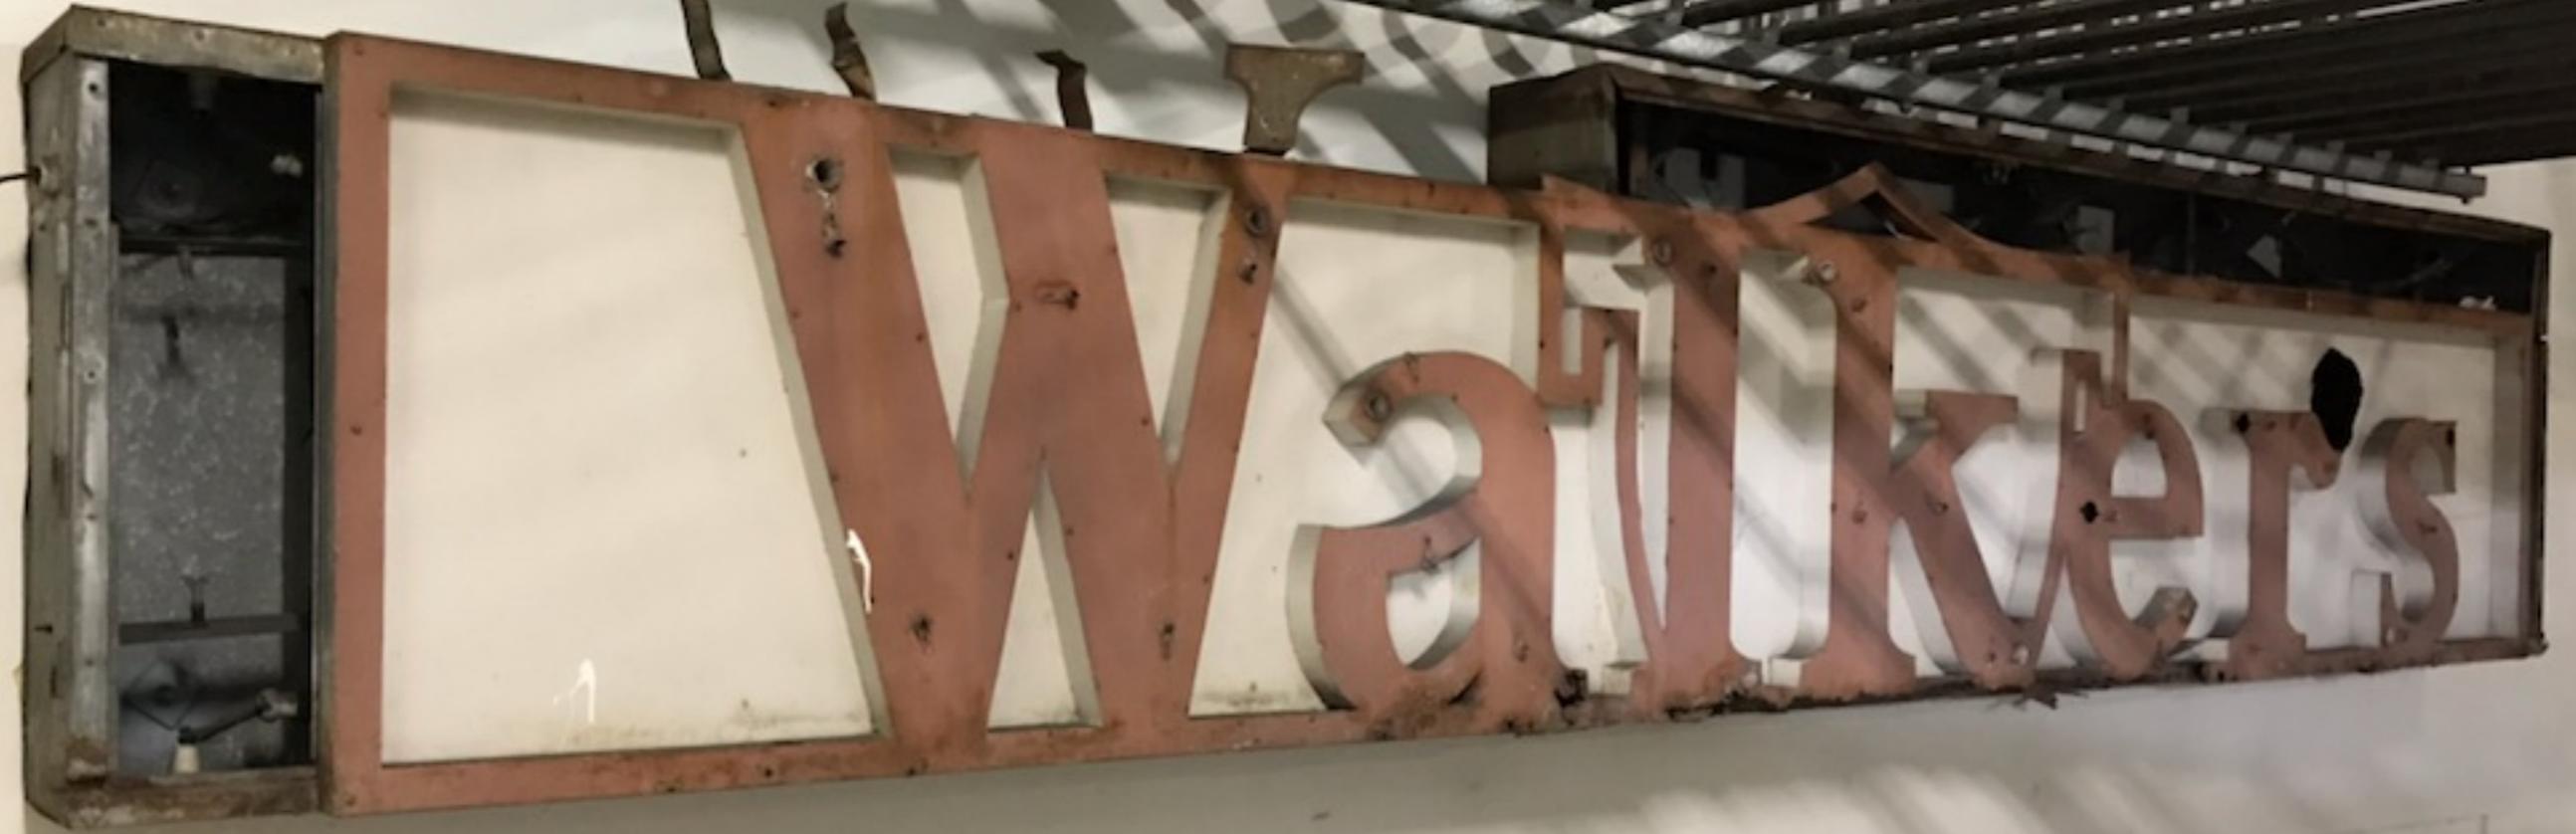
ORIGINAL WALKERS
DEPARTMENT STORE SIGN

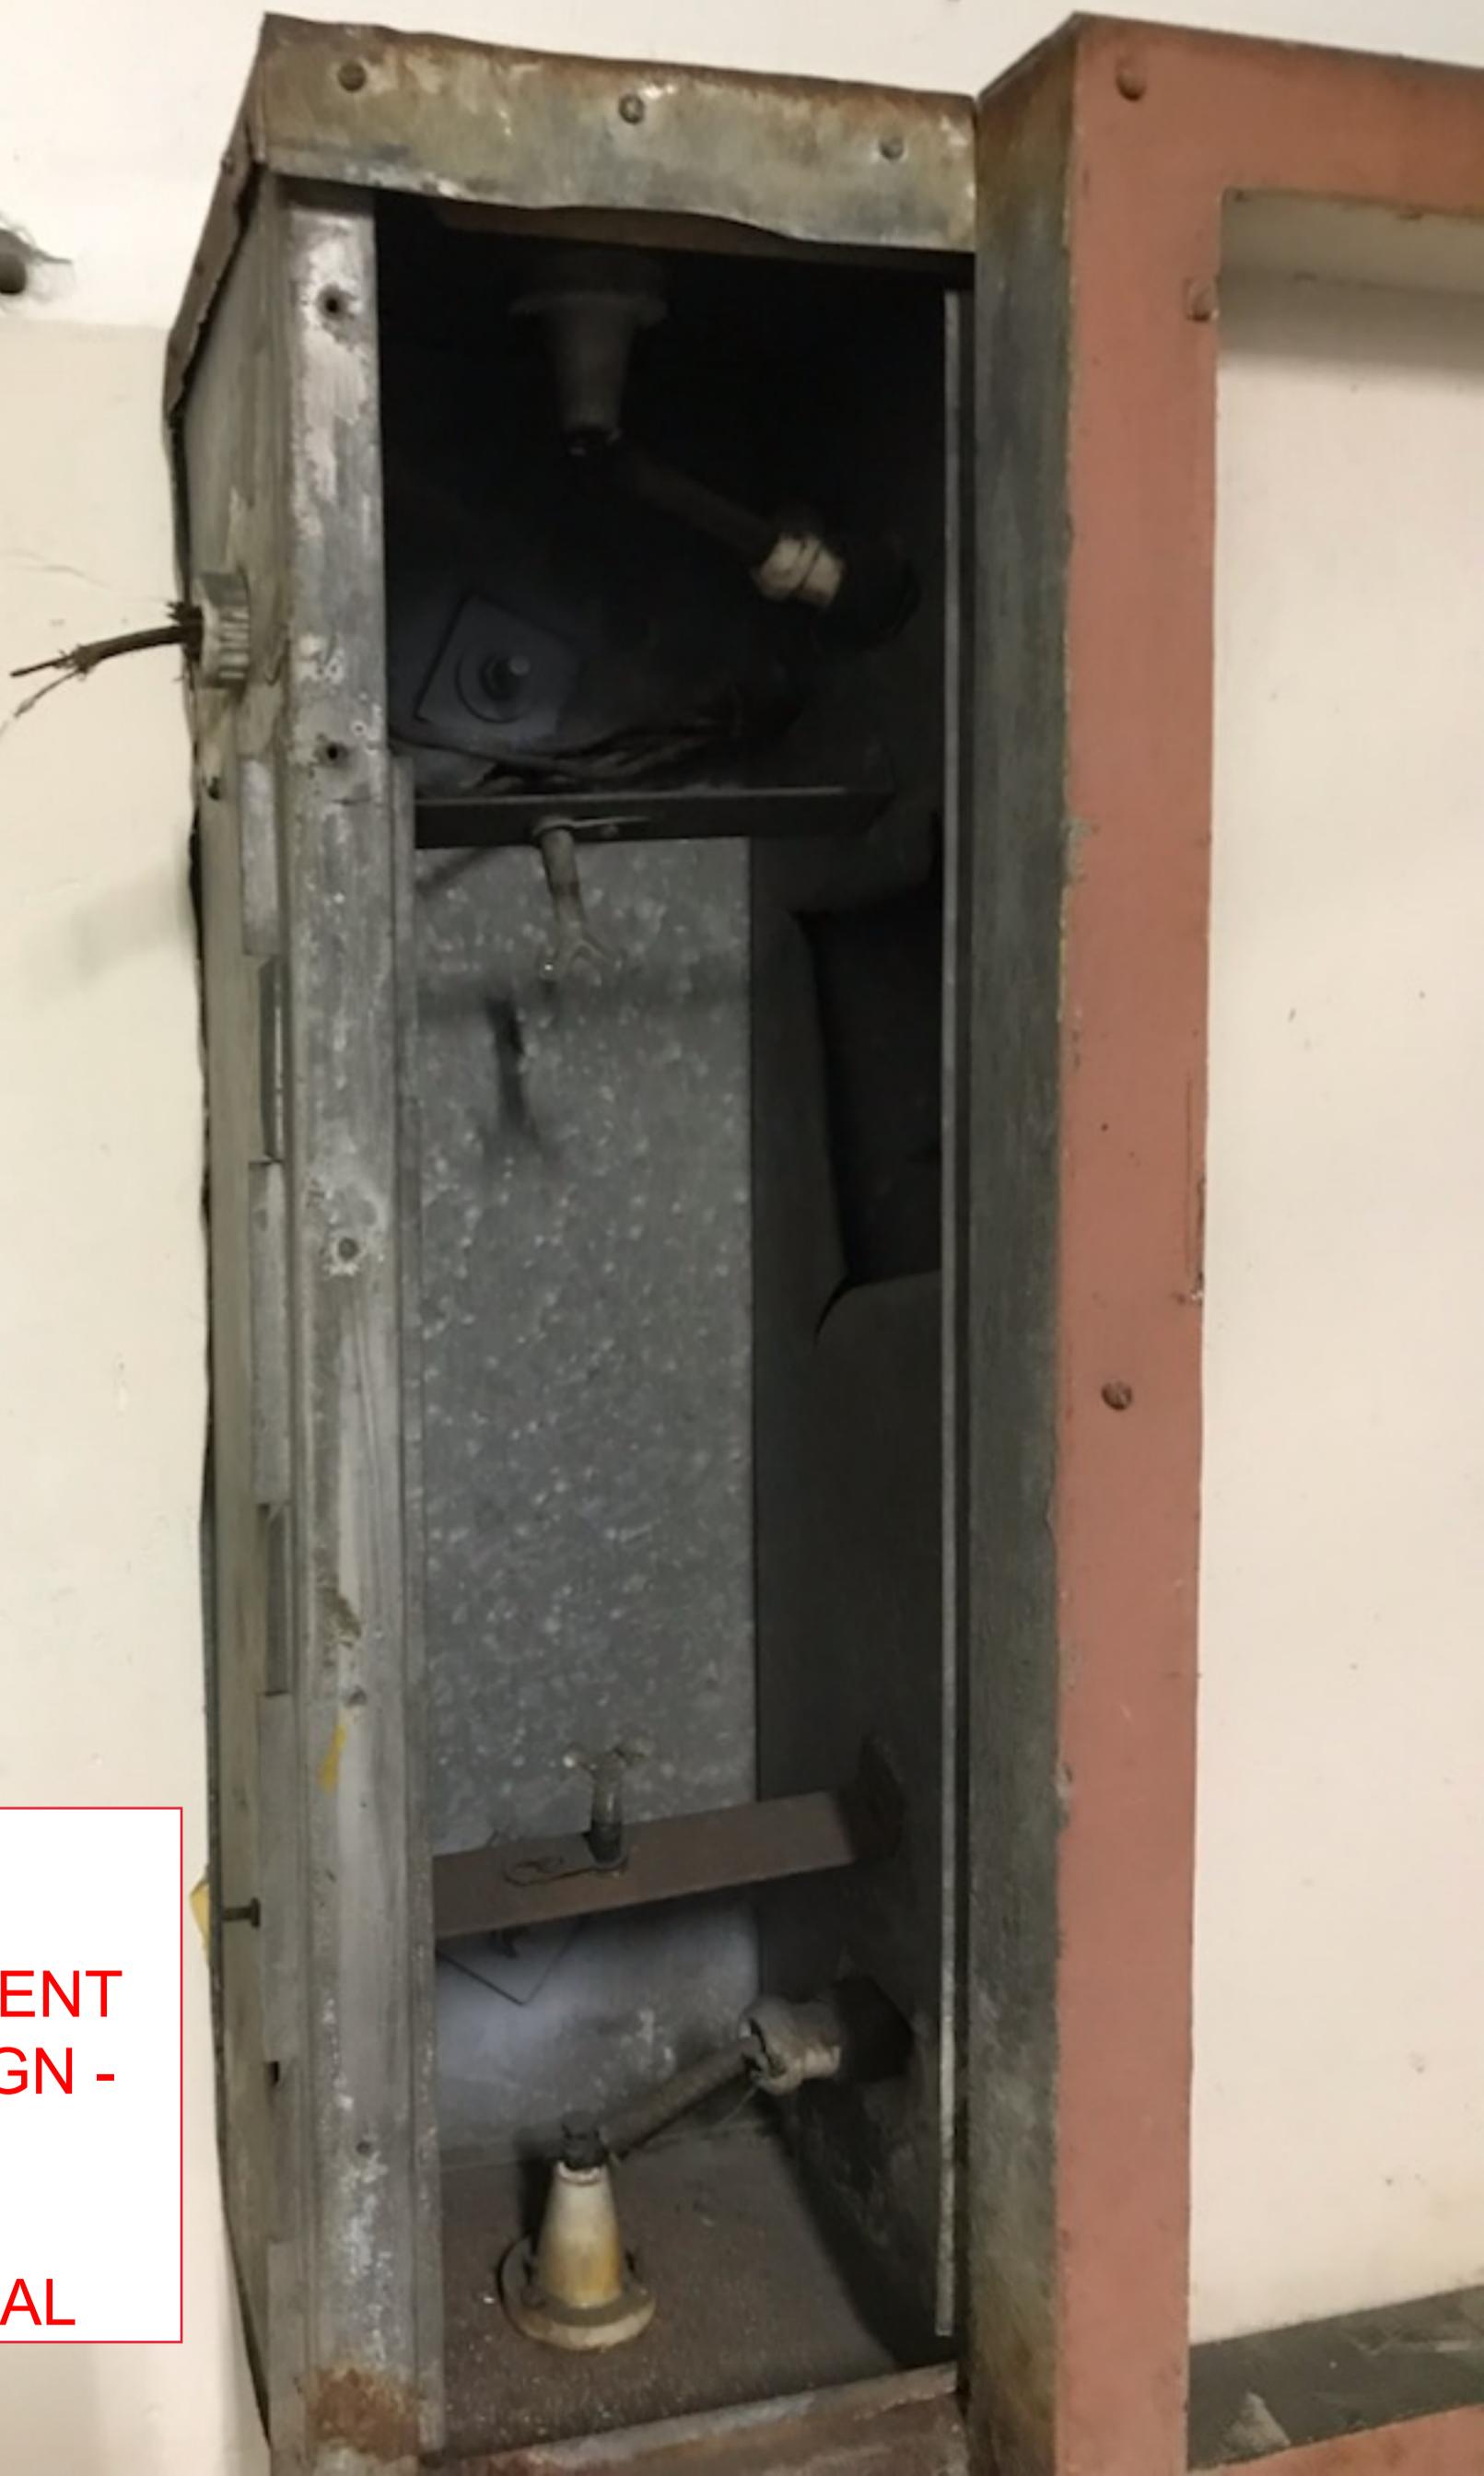
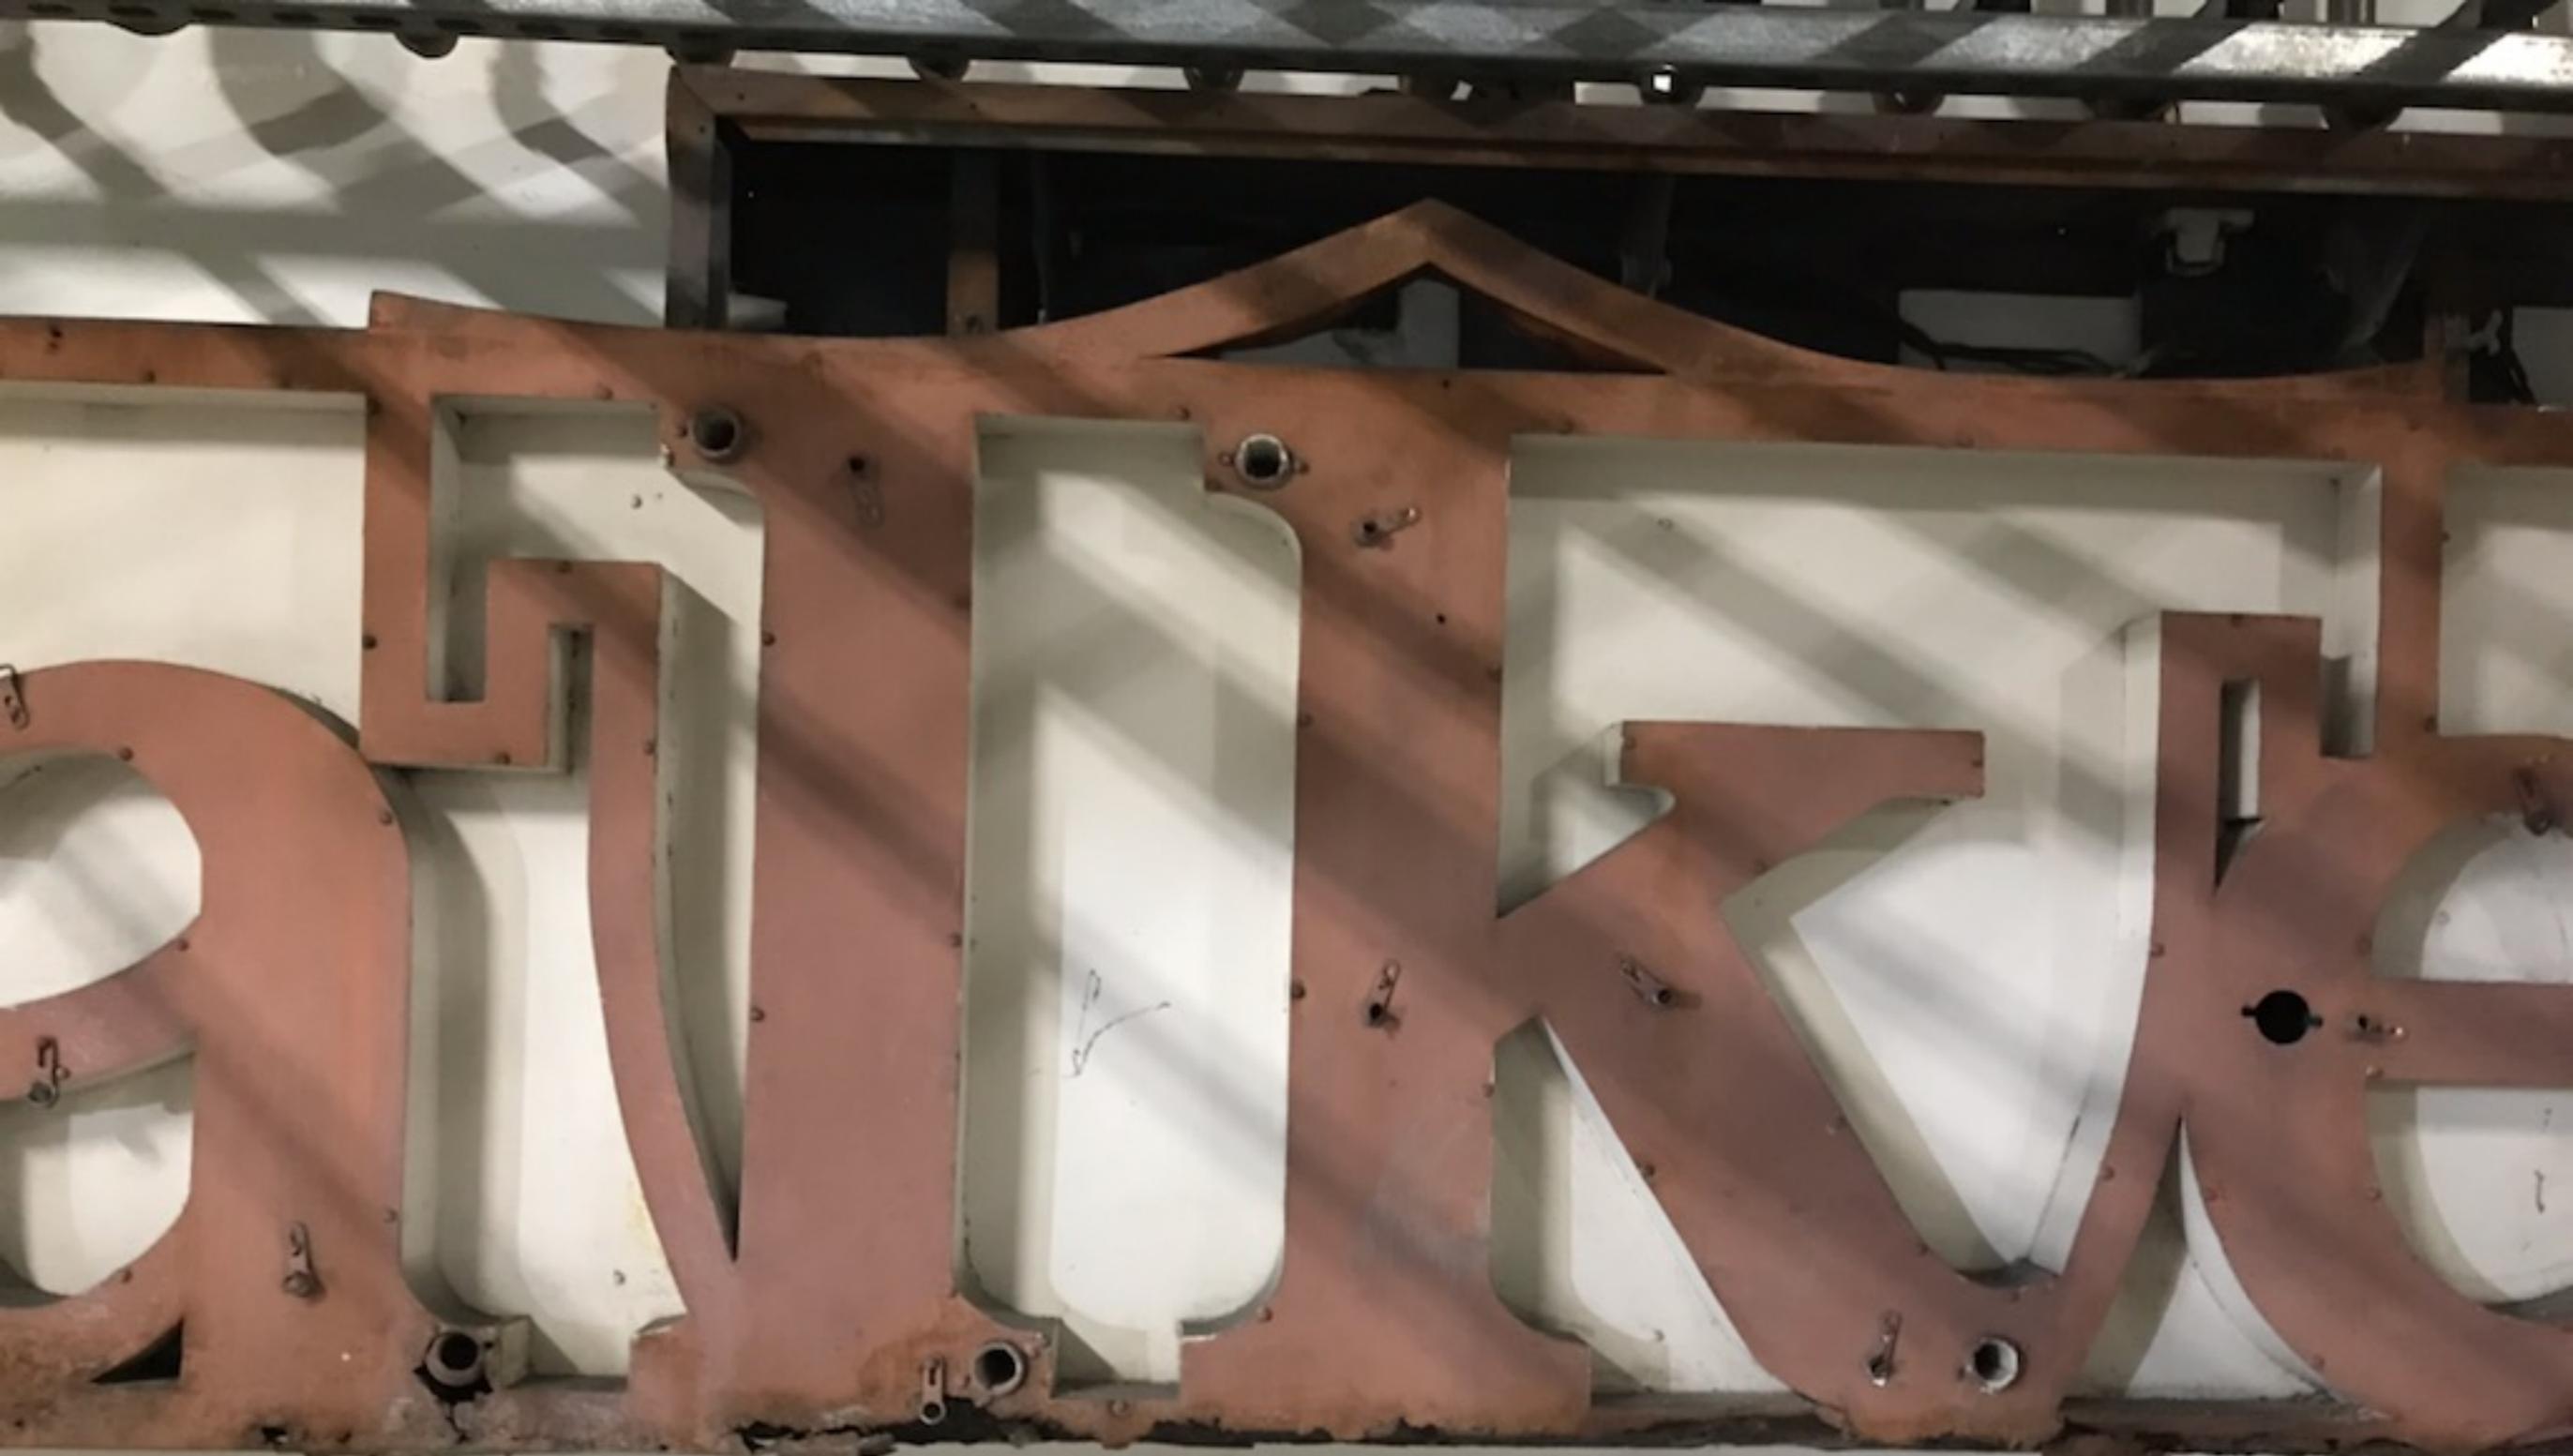
**ORIGINAL
WALKERS
DEPARTMENT
STORE SIGN -
EXPOSED
INTERIOR
ELECTRICAL**

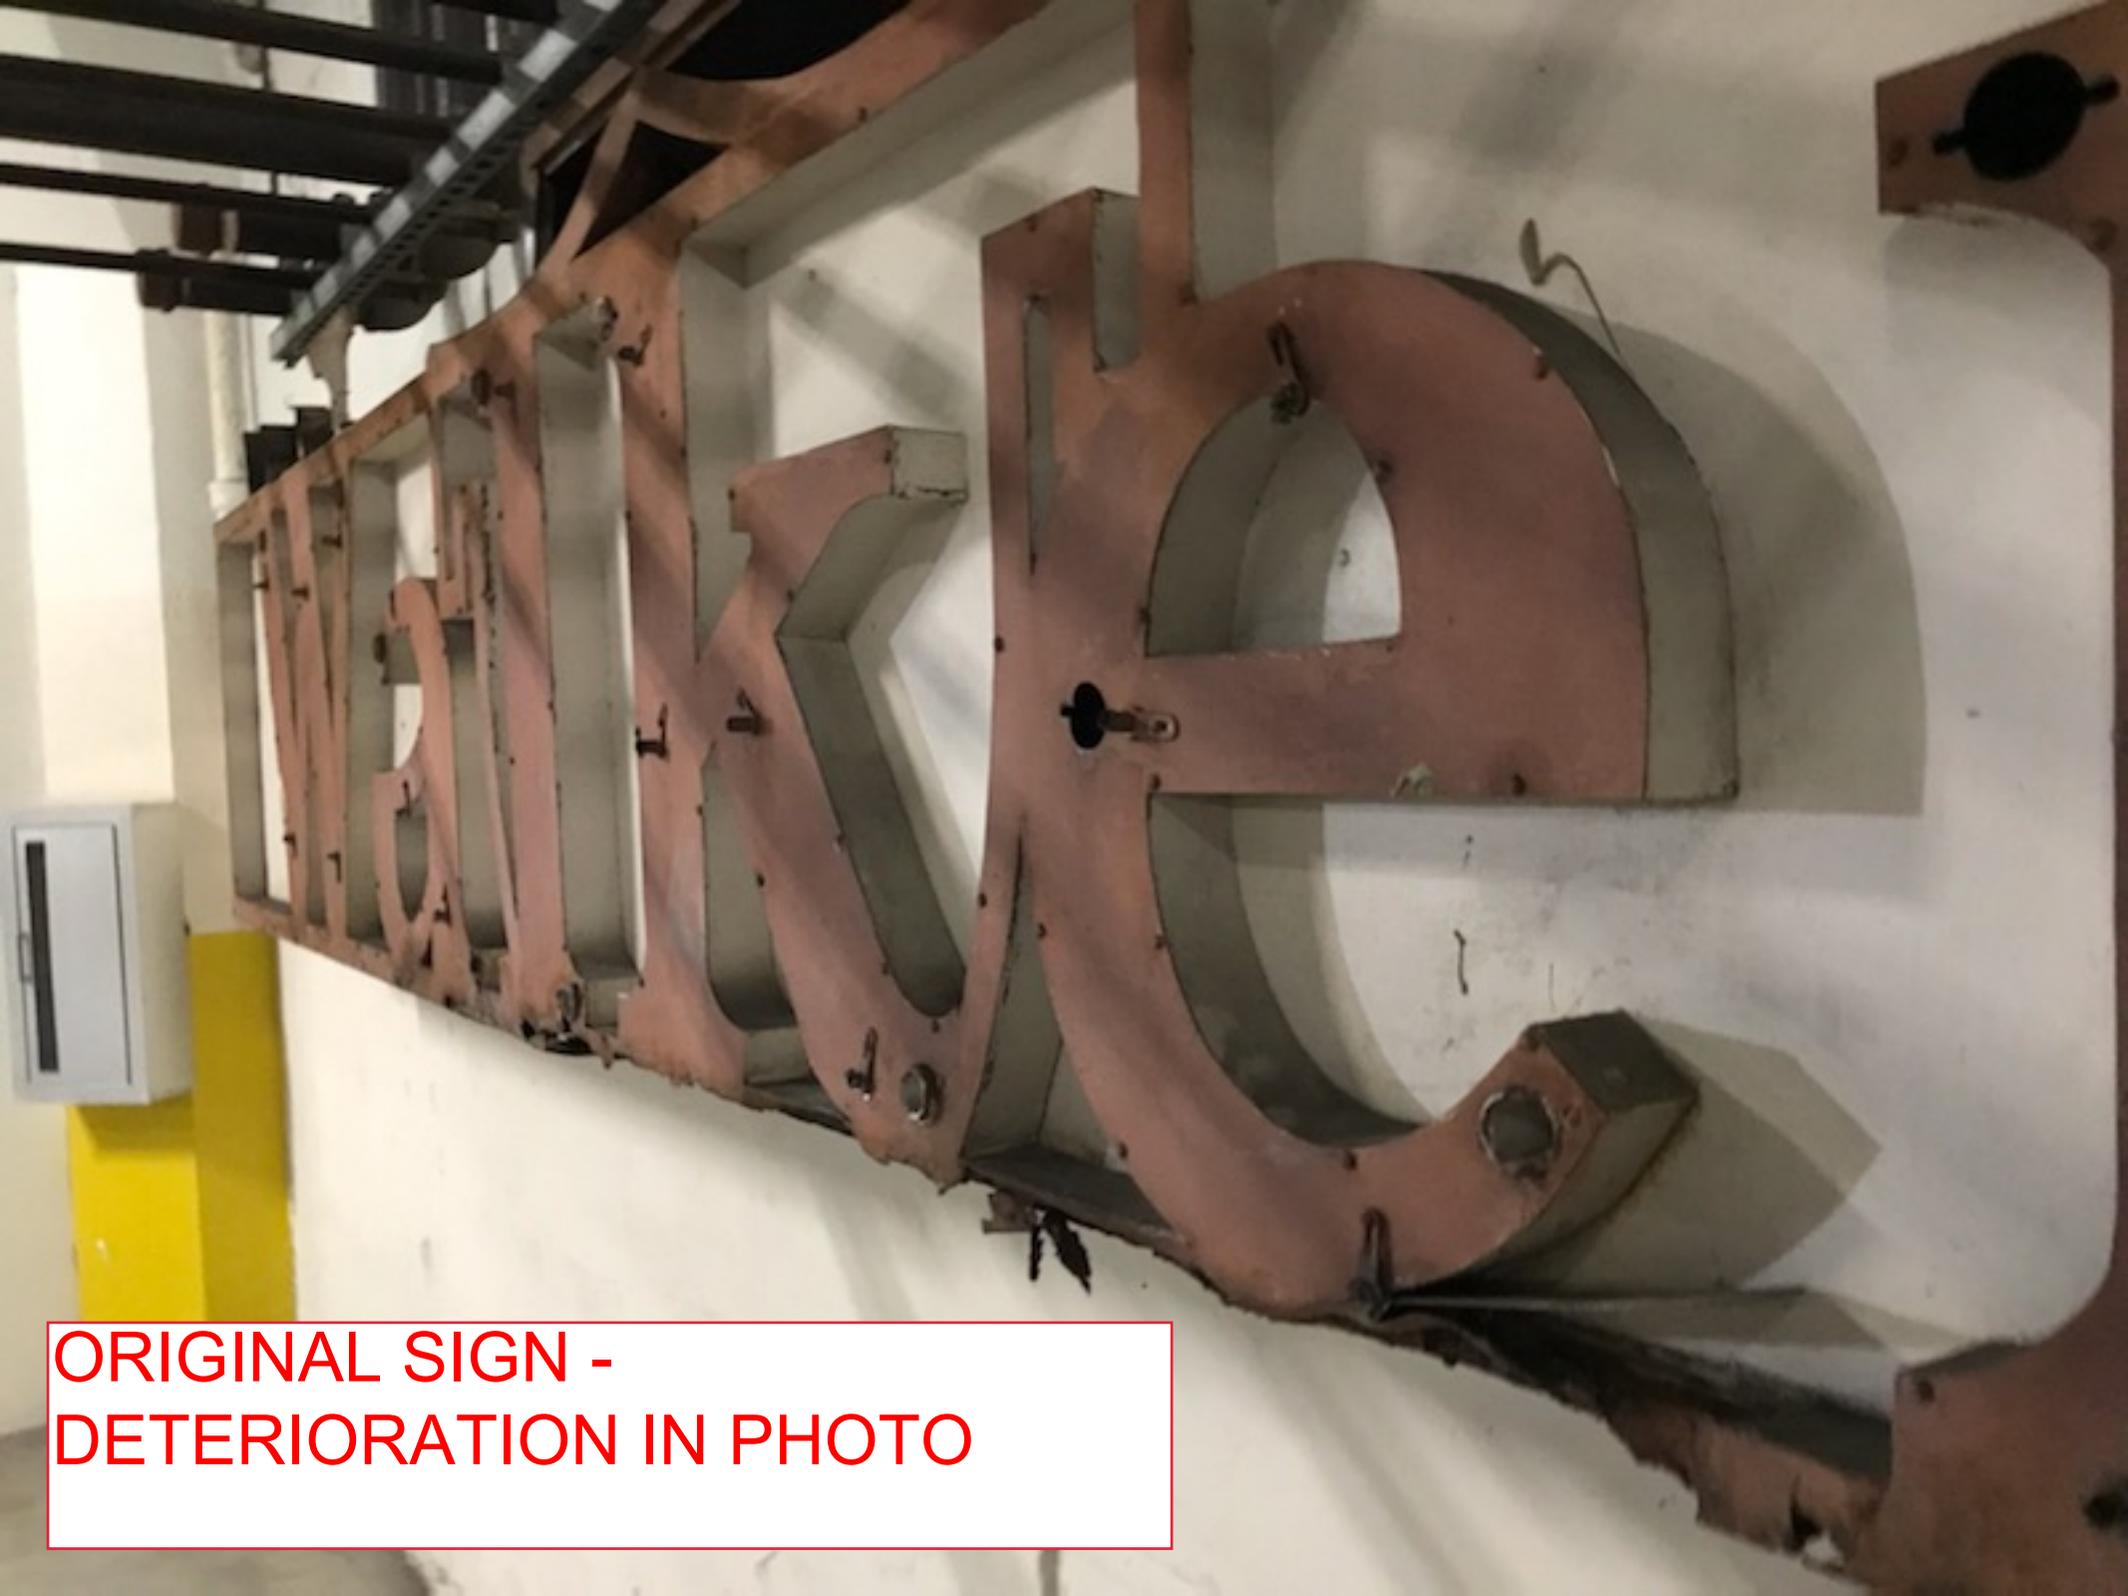
**ORIGINAL WALKERS DEPARTMENT STORE SIGN -
VISIBLE DAMAGE DETERIORATION & SHIELD LOGO**
