# Riverwalk Residential Development Project

## Cultural Resources Study

## Riverwalk Residential Development Project

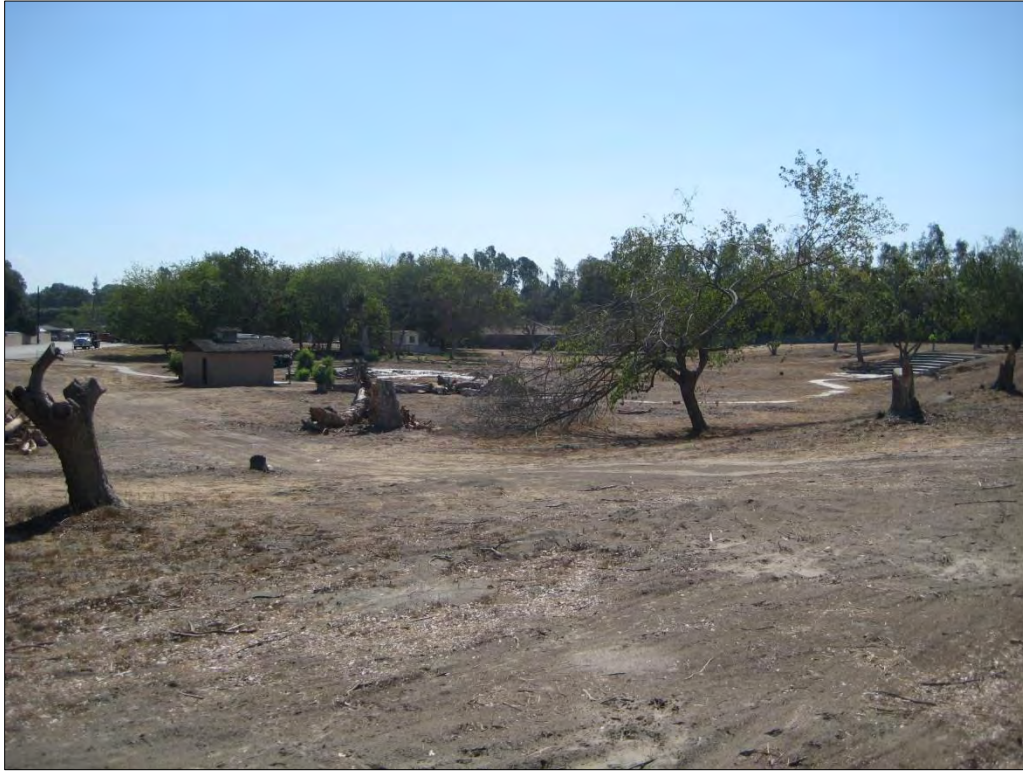
Photograph 1. Project site overview, facing southeast.

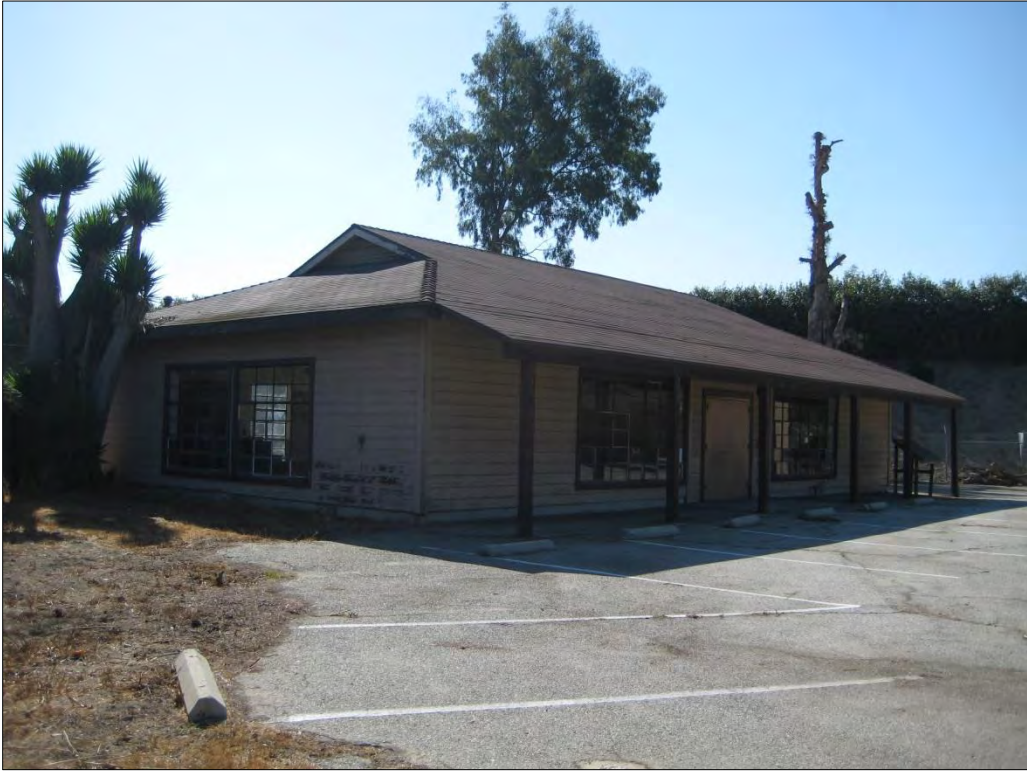
Photograph 3. Assembly Hall, facing southeast.

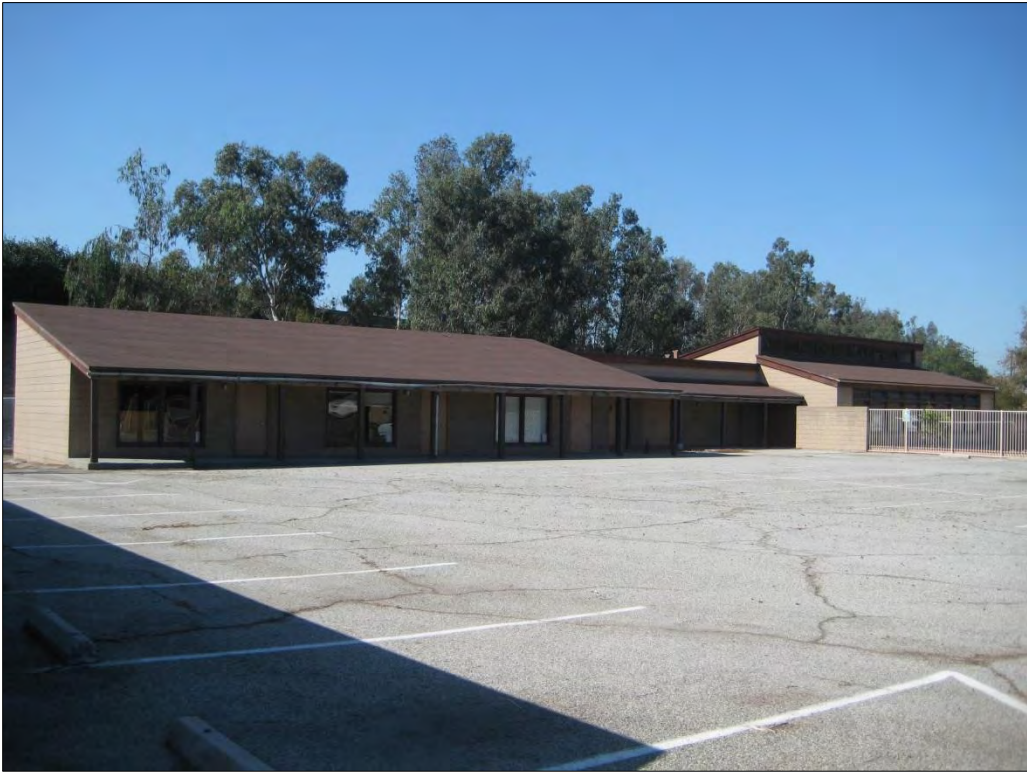
Photograph 4. Training Center, facing south.

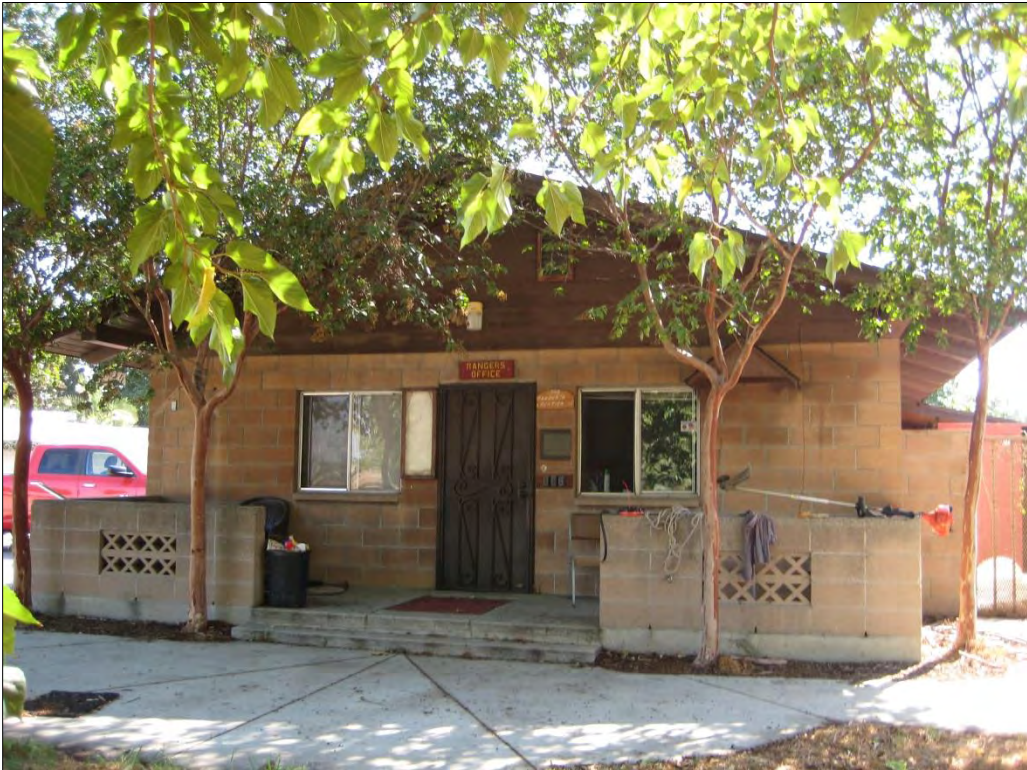
Photograph 5. Ranger's Office building, facing east.

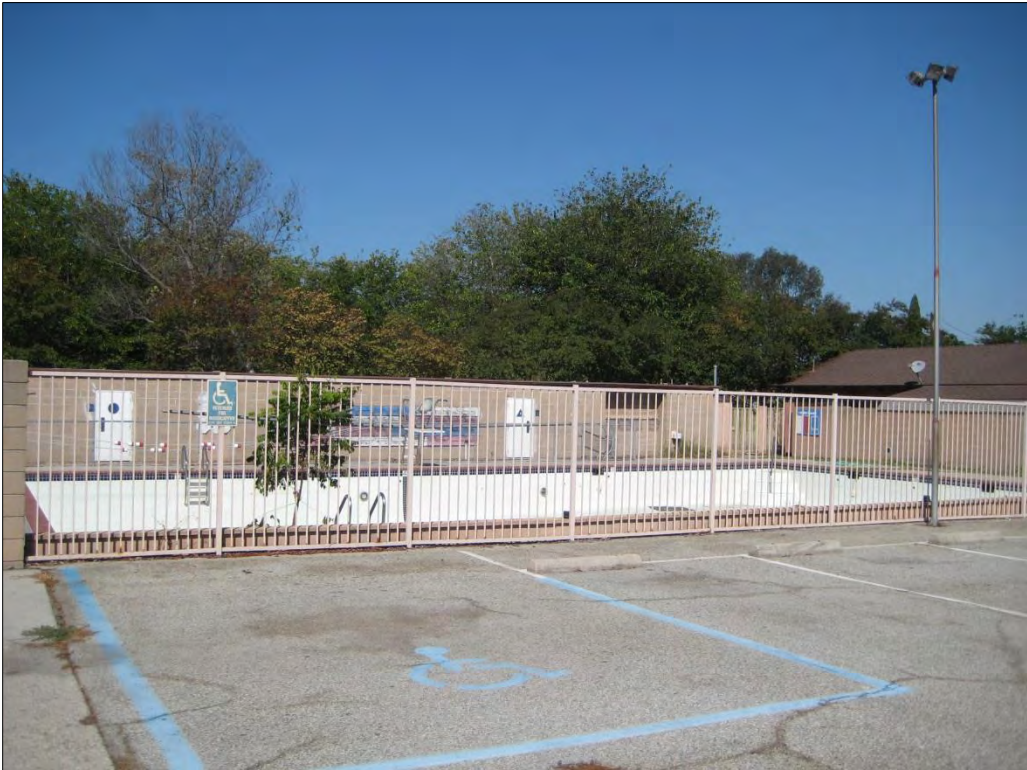
Photograph 6. Swimming Pool, facing west.

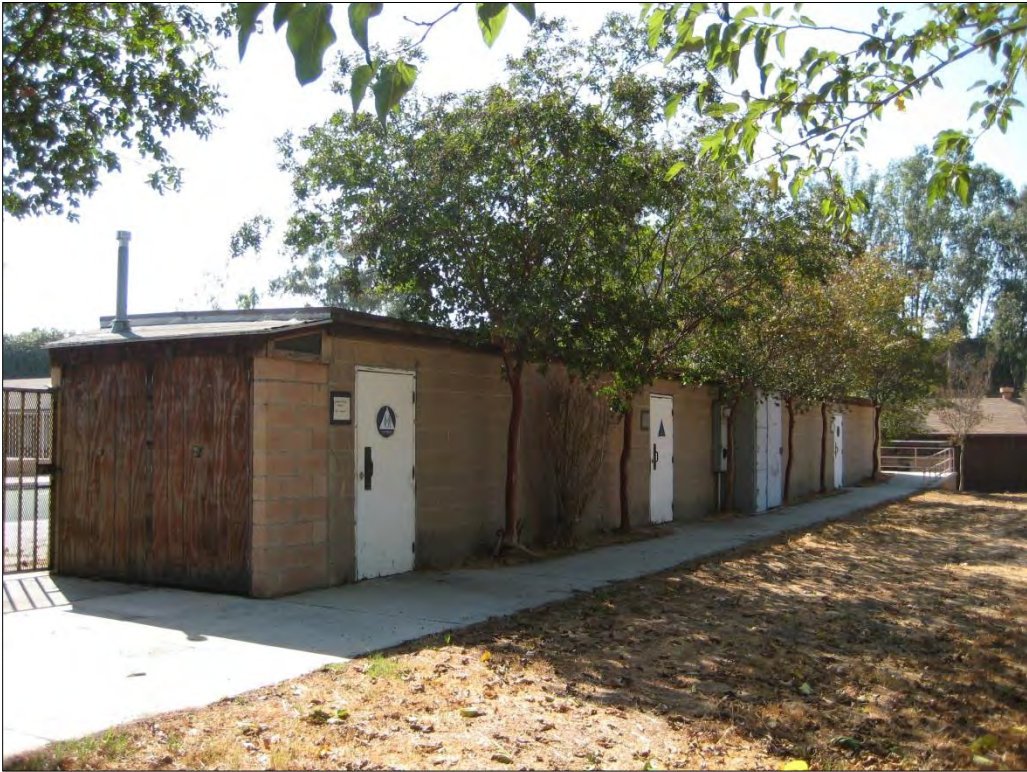
Photograph 7. Changing Rooms, facing southeast.

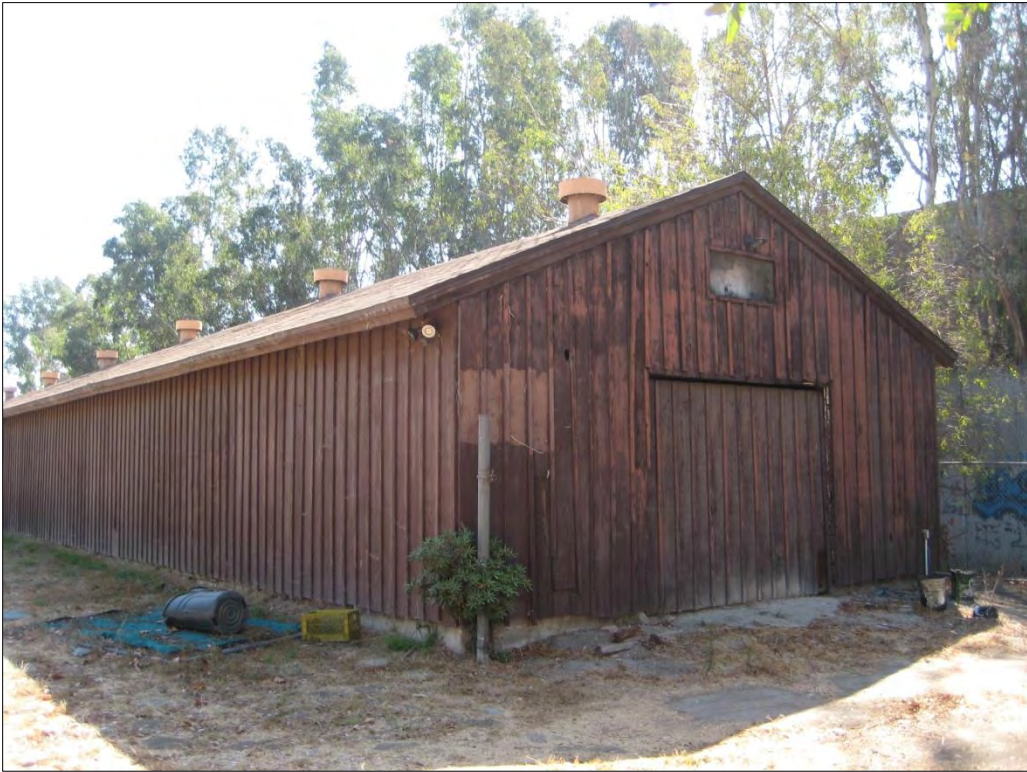
Photograph 8. Storage Building, facing southeast.

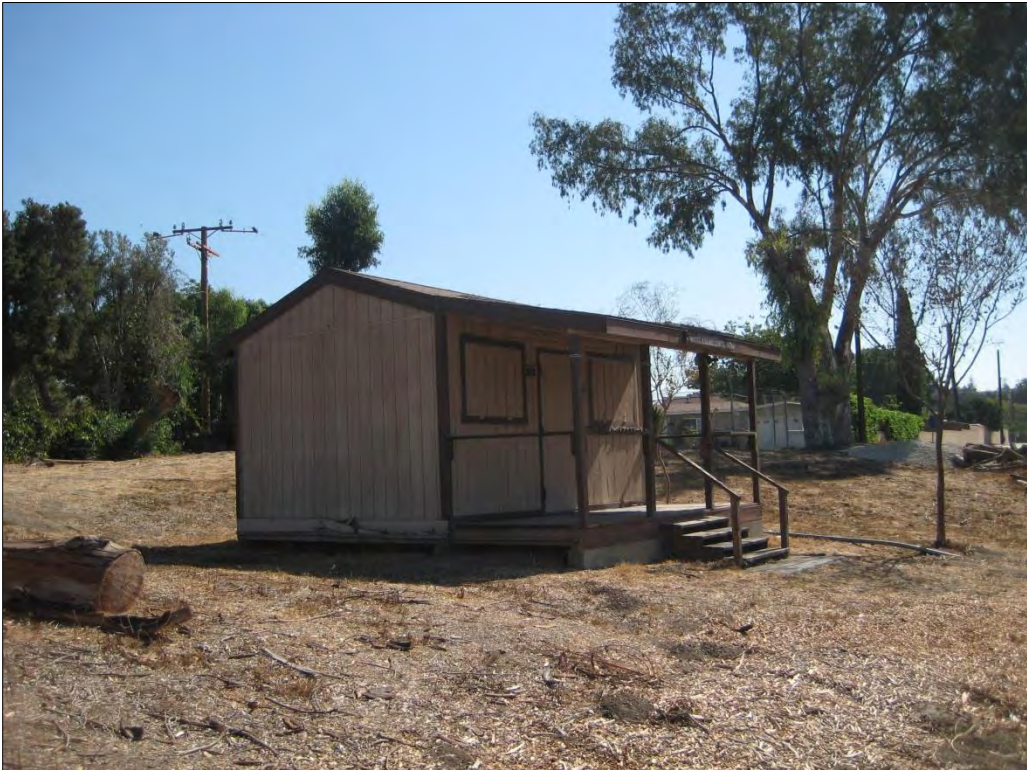
Photograph 9. Camp Master building, facing northeast.
