COLOR ANALYSIS STUDY

Exterior
of the
KOFFEE POT BUILDING
located at
957 East 4TH Street
Long Beach, California 90802

Report prepared by
Carolyn Lehne

July 7, 2015

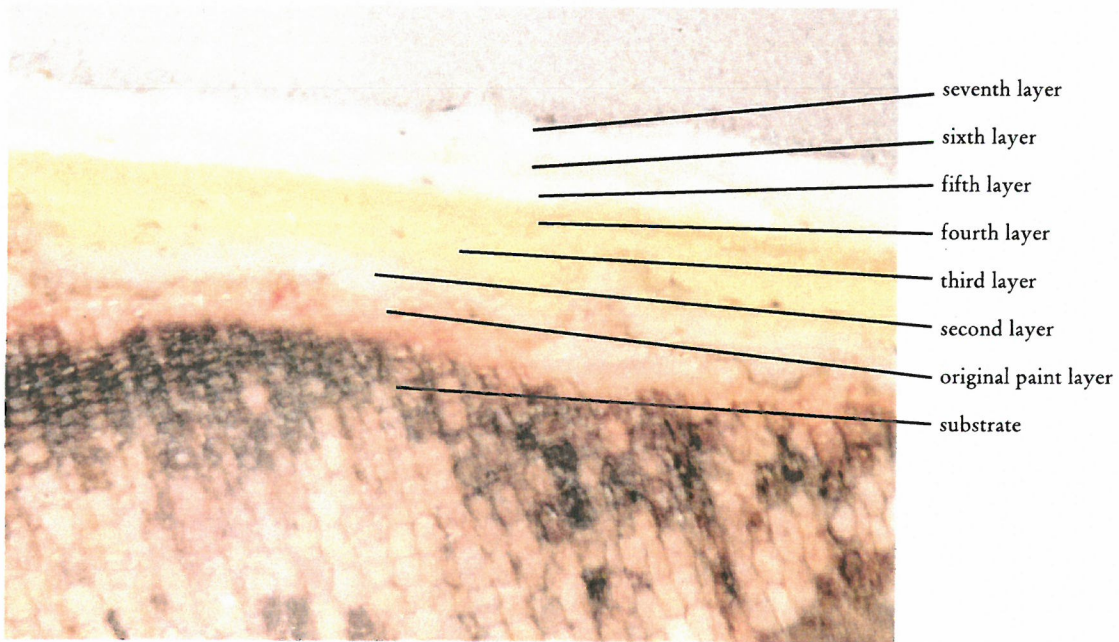
SAMPLE #2 WEST ELEVATION SIDING

The wood siding (SAMPLE #2) located on the west elevation consists of six paint layers. The first layer is a soft beige rose color, followed by a cream, two yellows, and and cream/off whites. One of the four samples has an irregular color pallete consisting of 15 colors. It is believed this was a section of wood siding that had been salvaged from an unknown source and replaced the original siding.

hue = .79YR

value = 7.0

chroma = 4.4
