# CITY OF LONG BEACH

Receive report and provide direction to staff on the options addressing biotechnical and various other alternatives for the Ocean Boulevard (Bluff) Erosion and Enhancement Phase 2 Project. (District 3)

AREA 1 - OPTION 1 - TECCO MESH/HYDROSEED/SHRUB/VINE CUT OUTS  
**OCEAN BOULEVARD BLUFFS EROSION AND ENHANCEMENT PROJECT**  
**BIO-TECHNICAL SLOPE STABILIZATION**  
 CITY OF LONG BEACH, CALIFORNIA

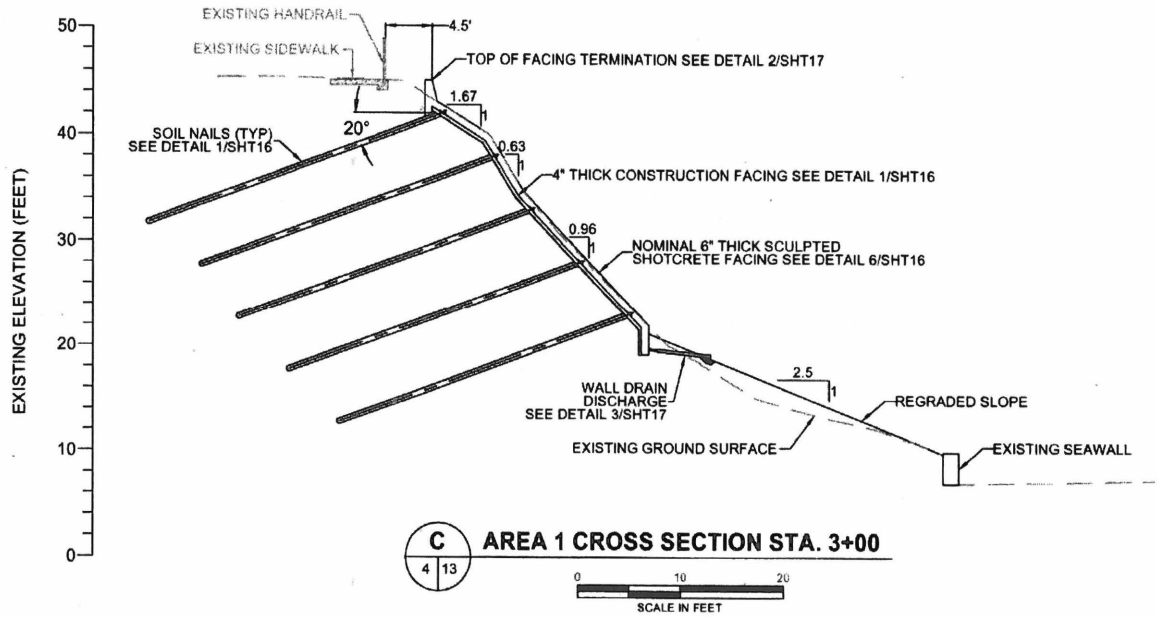
Figure 1 - Design Cross-Section of Soil Nailing

- Soil nails that enhance the deep-seated stability of the bluff under static and dynamic conditions (Figure 1) and locally support portions of the sidewalk; and
- A shotcrete facing (Figure 1) that protects the slope surface from weathering and erosion caused by surface water, and enhances the surficial stability.

The shotcrete facing will be sculpted to blend in with the surrounding landscape. At specific locations, the shotcrete facing has planter pockets that allow vegetation to grow on the slope and with time will partially cover the shotcrete surface, as exemplified in Figure 2. The design contemplates having open-bottom planters that allow infiltration into the slope. Failure of sprinklers and/or the irrigation pipes may result in a concentrated influx of water directly into the slope which is undesirable. The design includes irrigation PVC pipes embedded into the shotcrete to drain excess irrigation water.

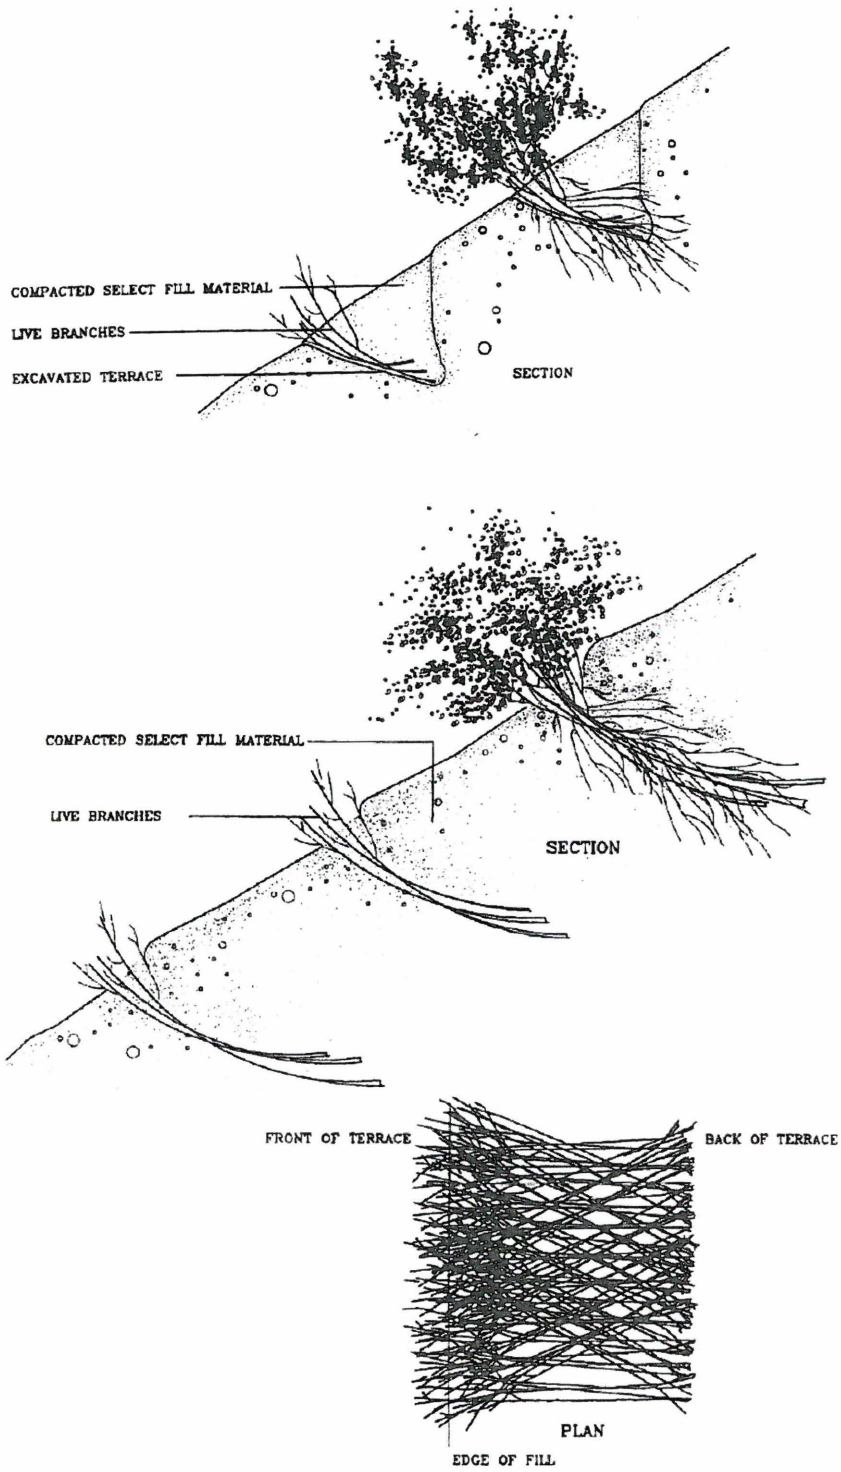
Figure 3 – Example of Deep-Rooted Vegetation

Figure 7-21. Schematic diagram of an established growing *fill slope* brushlayer installation showing alternating layers of live cut brush inserted between lifts of soil.

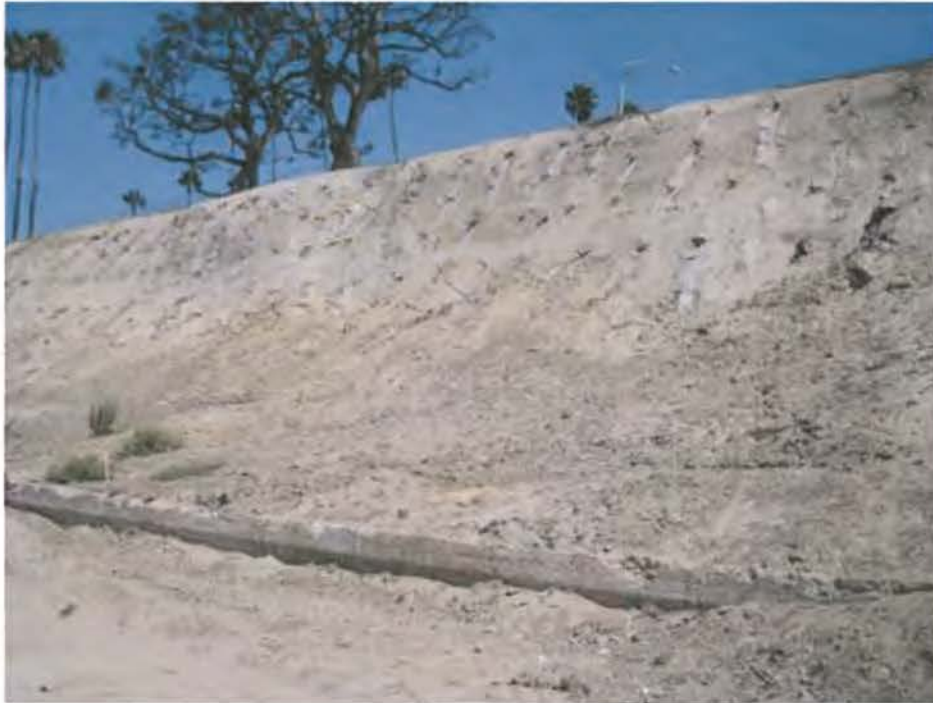
Figure 1 – Existing Slope Condition in Area 1

The existing bluff in Area 1 is up to approximately 37 feet high with an inclination varied from approximately 0.6H: 1.0V (horizontal to vertical) in the upper portion to approximately 2.5H: 1.0V at the toe of the slope. A system of soil nails, up to 30 feet long, was recently installed in a grid, approximately 6 feet by 6 feet, to improve global stability of the bluff slope and reduce potential for future deep-seated sliding, particularly during or following a strong seismic event. The existing present conditions are shown in Figure 1.

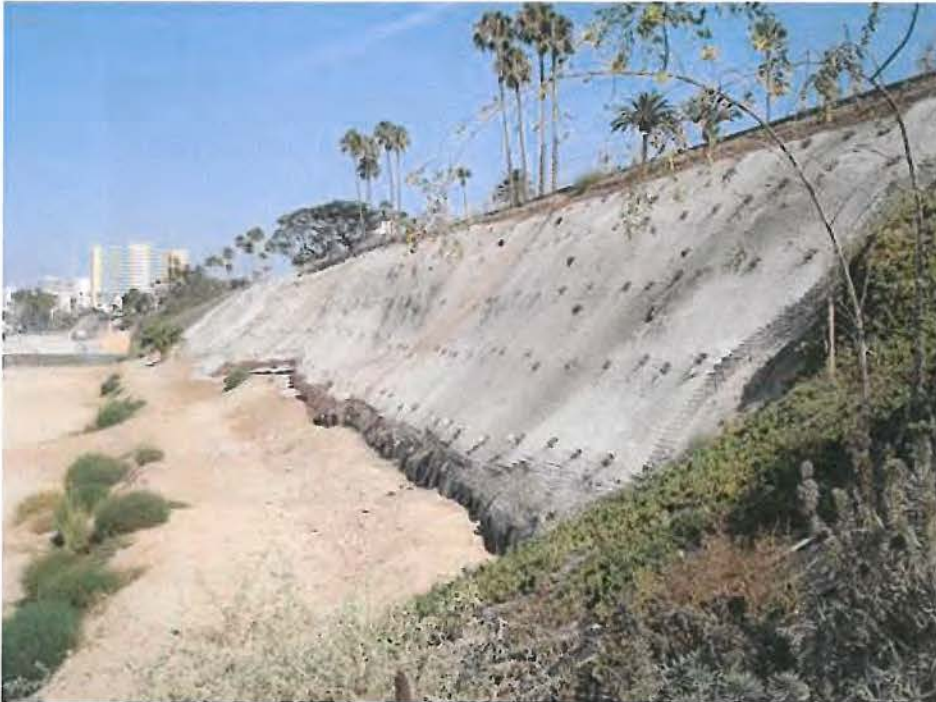
Figure 2 – Initial Layer of Shotcrete in Central/Eastern Portion of Area 2

completely constructed by installing soil nails with a layer of sculpted shotcrete (total shotcrete thickness of about 10 inches) and planter pockets. The central and eastern portion of the bluff between stations 15+75 and 19+25 has been partially constructed by installation of soil nails with an initial layer of shotcrete, approximately 4 to 5 inches thick. Pictures showing the existing conditions are shown in Figures 2 and 3.

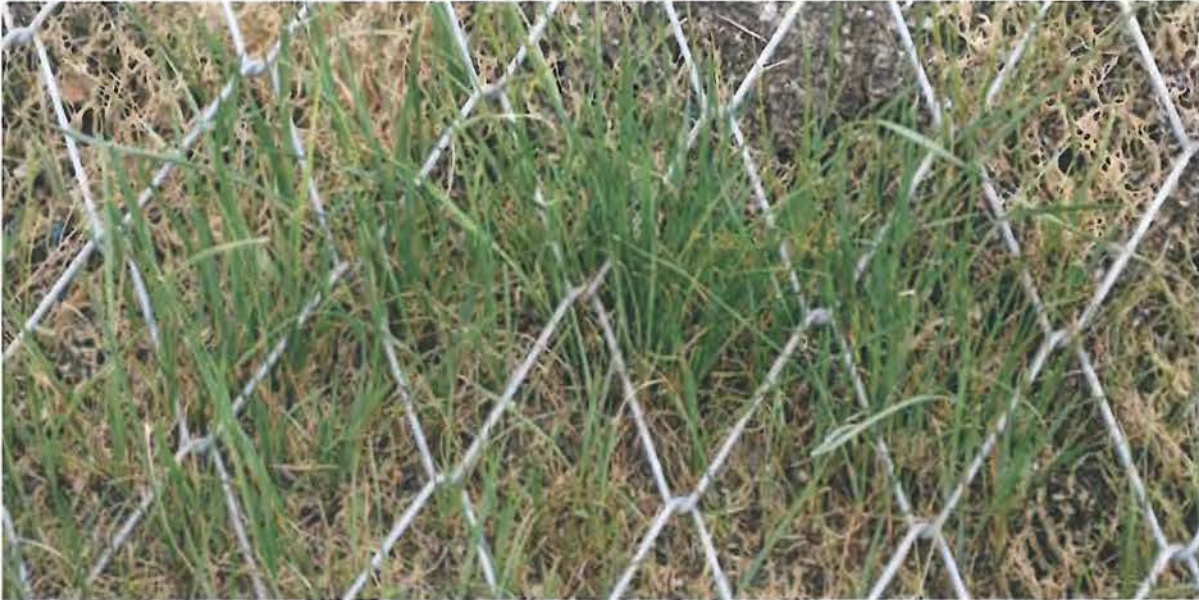
Figure 4 – TECCO Mesh

TECCO® Mesh is a high-grade slope protection and stabilization system which consists of high-tensile steel wire and associated spike plates and nails. An example of TECCO mesh is shown in Figure 4.

It is feasible to use TECCO Mesh on the existing slope in Area 1 where mesh can be installed on the slope and fasten to the already installed soil nails in a square pattern of approximately 6 x 6 feet. The slope must be suitably prepared before the TECCO® system is put in place. It should include clearing and cleaning of the slope as well as some localized leveling and removal of loose materials. A cross section prepared by RJM Design Group showing implementation of this alternative is included in Appendix A. Details about vegetation establishment were prepared by Tidal Influence and are discussed in Appendix B.

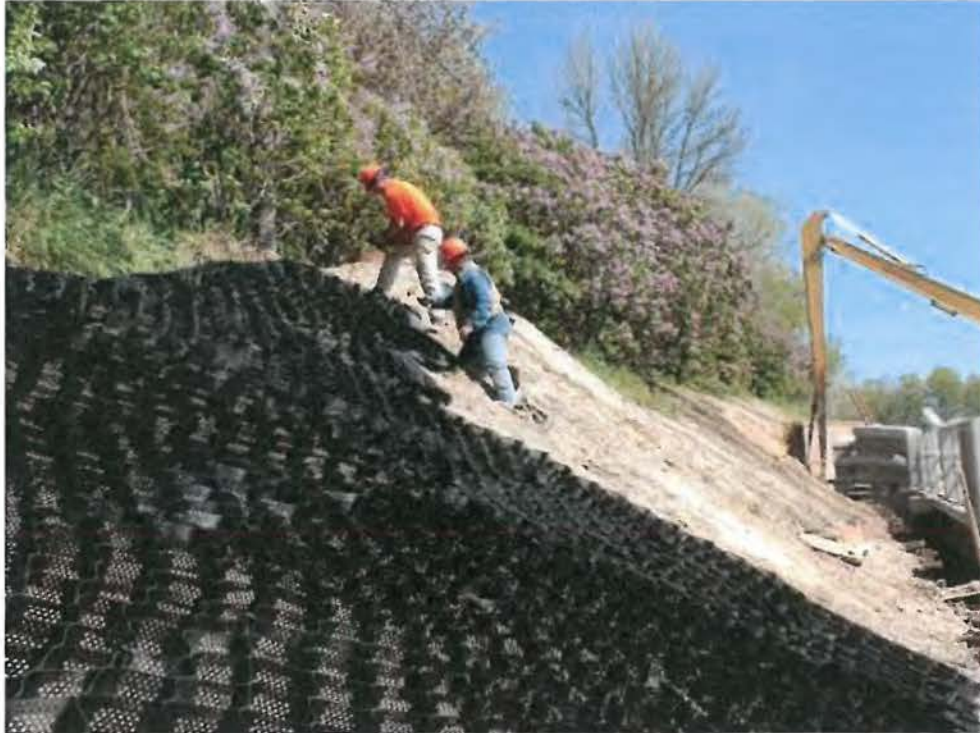
Figure 5 – Cellular Confinement System - GEOWEB®

This option includes import of top soil and re-grading of the existing slope in Area 1 at a uniform inclination of approximately 1.4H: 1V. A layer of high strength steel reinforcement mesh (TECCO® mesh or similar) is attached to the already installed soil nails and torque tensioned onto the slope. A cellular confinement system composed of synthetic material such as GEOWEB® system that forms cells is placed on the reinforcement mesh and is fastened to the slope with anchor pins. These cells are backfilled with compacted topsoil, “overfilled” at least 1-inch above cells, and are vegetated. Since these cells are typically 4 – 8-inches deep, a greater volume of soil is

provided compared to traditional hydroseeding. An example of cellular confinement system (synthetic) is shown in Figure 5.

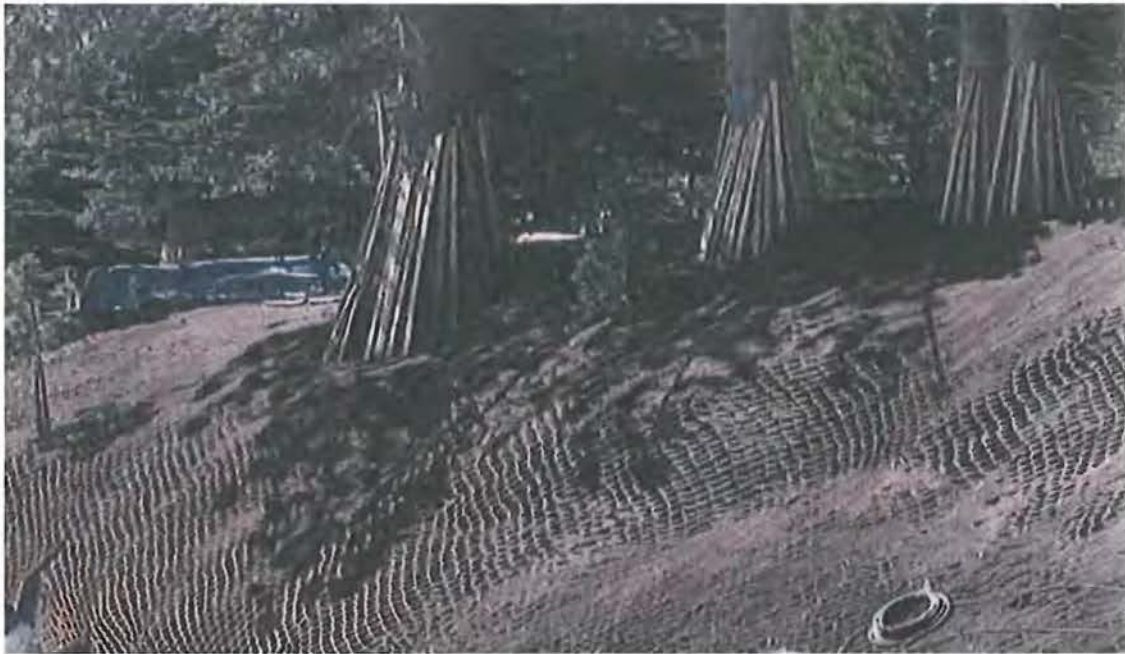
Figure 6 – Cellular Confinement System - CellScape™

As an alternative option to synthetic confinement system is to use organic, biodegradable enhancements such as CellScape™ which are attached to the high strength steel wire mesh and filled with a custom blend of soil and mulch prior to hydroseeding and planting. An example of cellular confinement system (biodegradable) is shown in Figure 6. A conceptual cross section is shown in Appendix A. The feasibility of vegetation establishment is discussed in Appendix B.

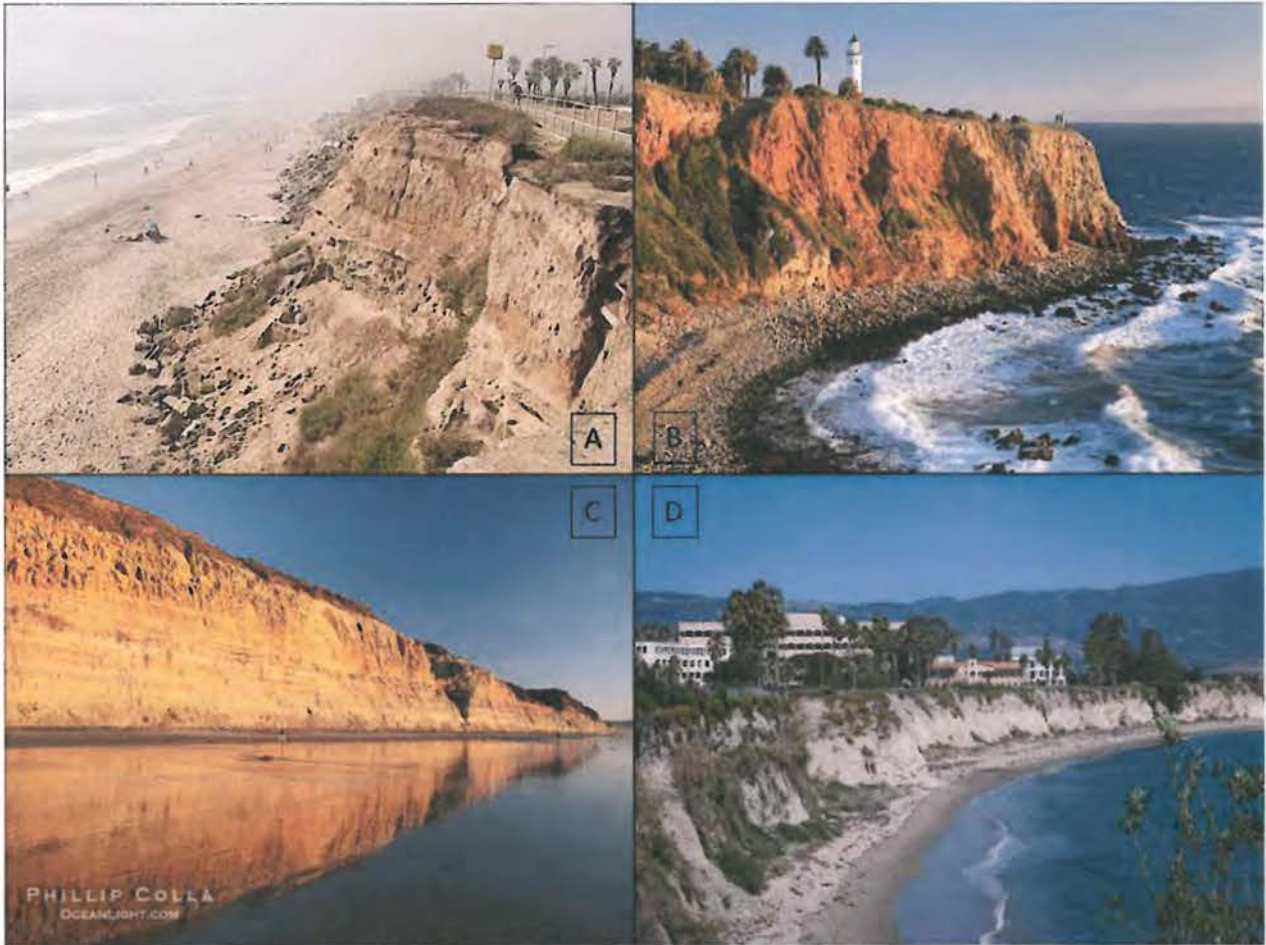
Figure 1. Southern California natural coastal bluff systems. A. Huntington Beach; B. Palos Verdes Peninsula (Pointe Vicente); Del Mar (Torrey Pines State Beach); D. Goleta (UCSB campus)

It is important to recognize how the Long Beach Bluffs were formed originally. They are composed of sandstone that likely was once a raised sea terrace that became exposed when sea level dropped during the most recent ice age a millions of years ago. These sea terraces remain exposed presently and the sandstone that composes them naturally erodes due to the forces of rain and gravity. This erosion is exacerbated by human disturbance from the construction of recreational/access facilities, climbing, digging, and installation of improper vegetation. These compounding erosion pressures lead to the bluff faces being steep in grade. This steep grade makes it a challenge for vegetation to naturally establish itself. Figure 1 shows photographs of four southern California natural bluff systems and the apparent depravity of vegetation where slopes are steep.

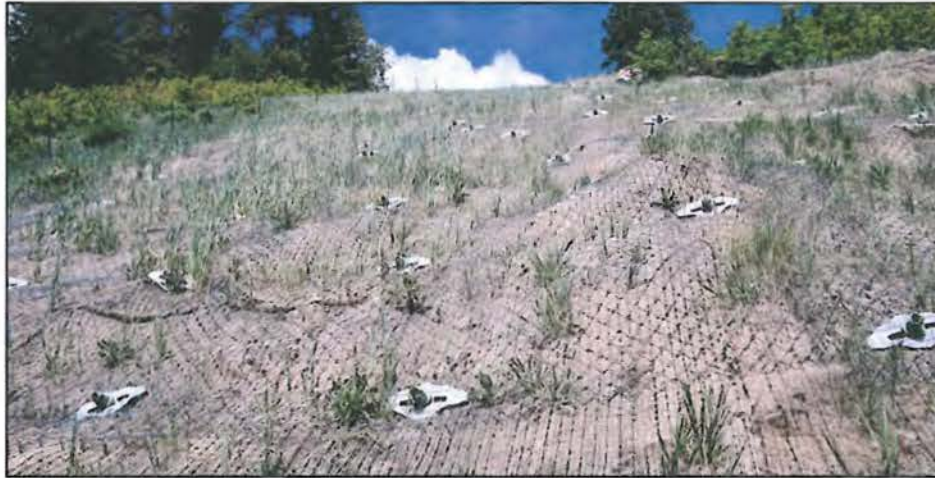
Figure 2. Photo of vegetation growing through Tecco mesh. Source: geostablization.com

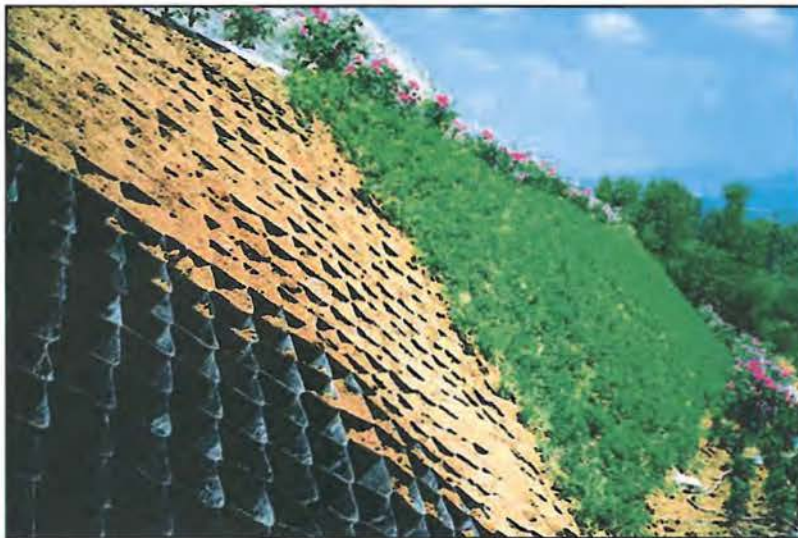
Figure 3. Photo of vegetation growing in a cellular confinement grid. Source: geosolutionsinc.com

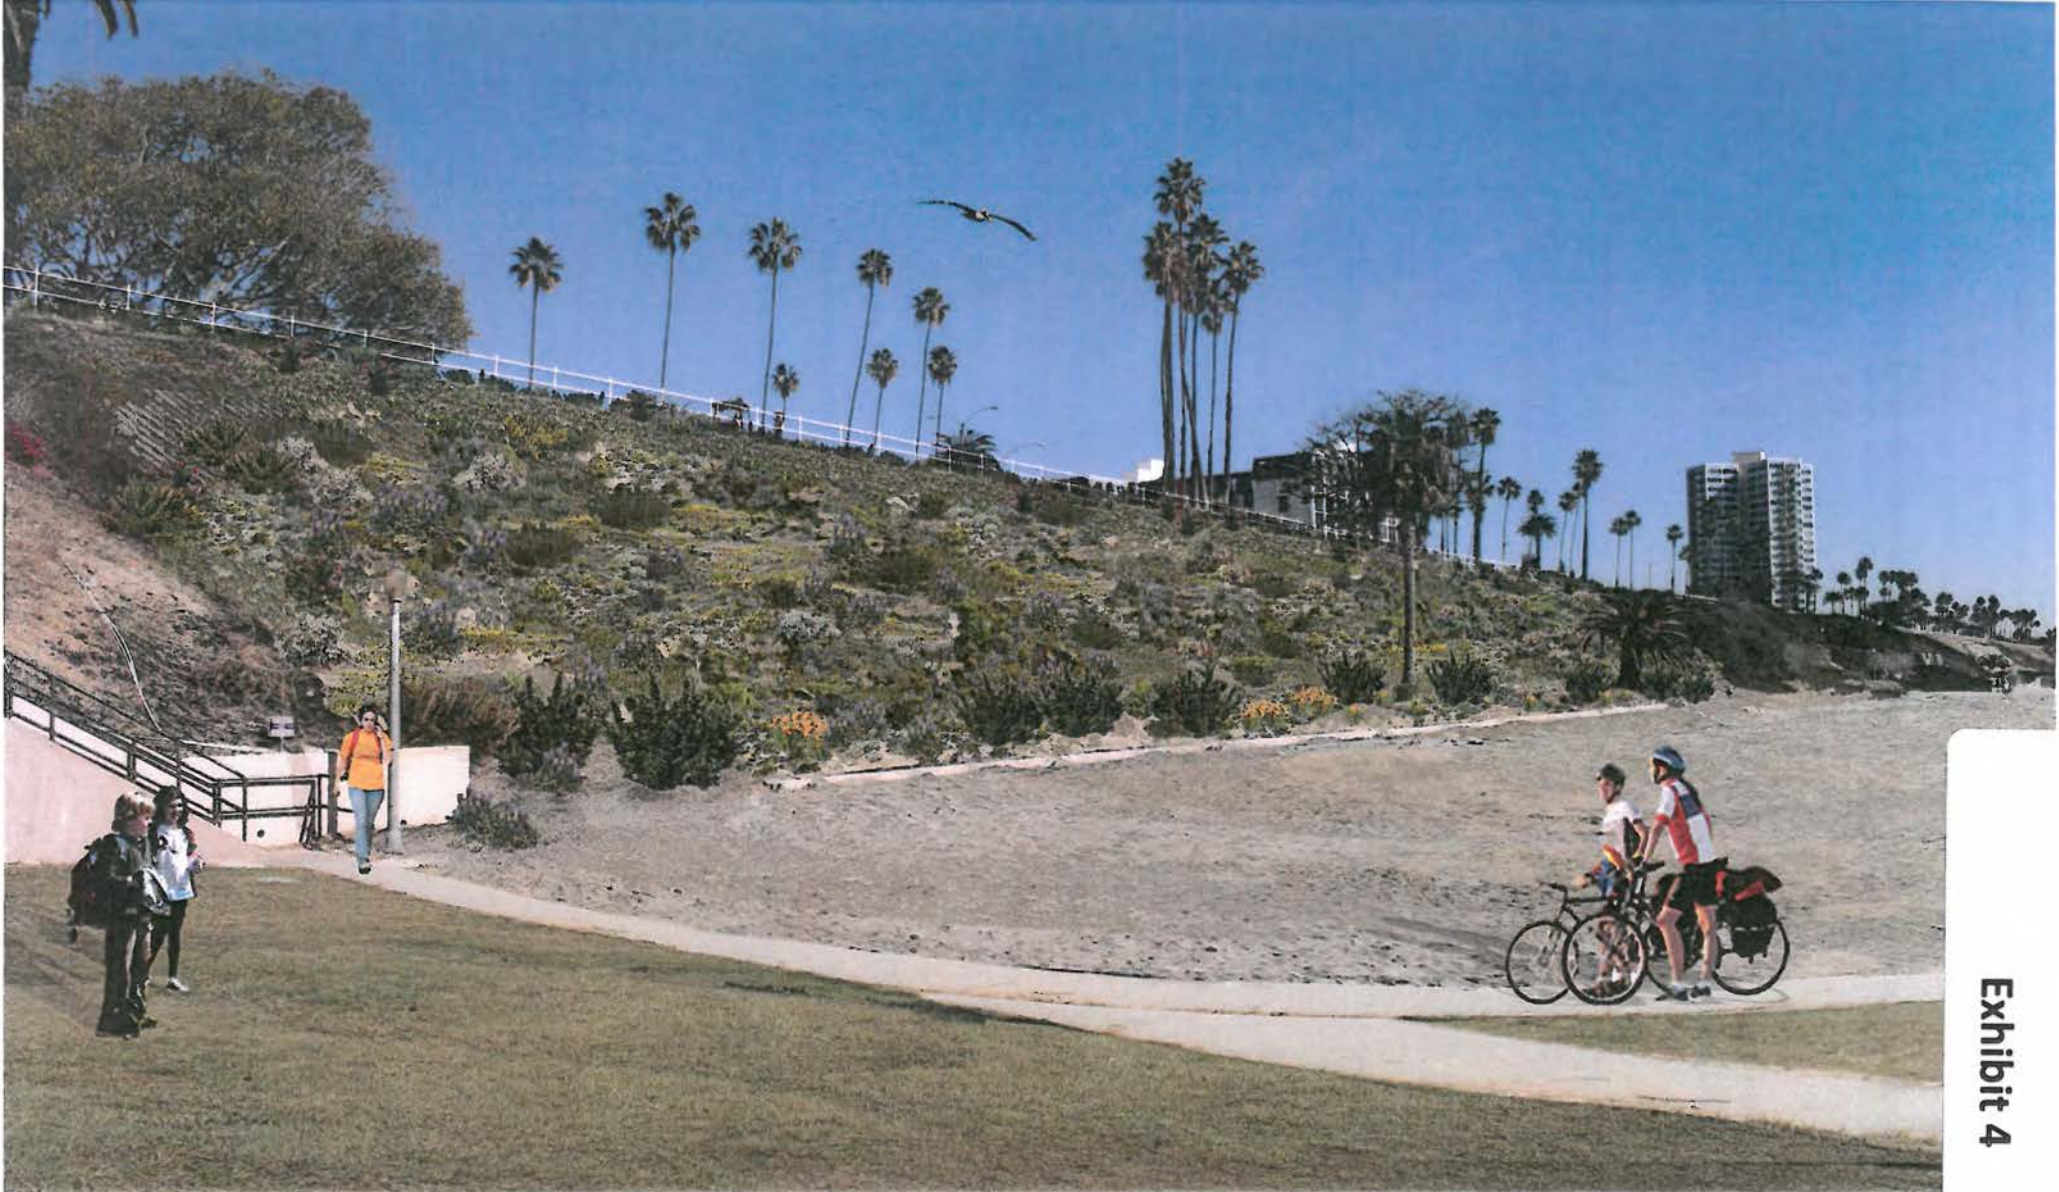
**Exhibit 4**

- **Option 2 (Area 1):** Option 2 would involve some regrading to create less steep slopes. A steel mesh would also be used as in Option 1, but a cellular confinement system (honeycomb-like vegetative cells composed of synthetic or biodegradable material) would be pinned to the mesh. These cells would be filled with 4 - 8 inches of high quality top soil, which would allow a greater diversity of plants to establish. This option would be more aesthetically pleasing and would provide greater erosion control than the first option, but would also be significantly more expensive than Option 1. The less steep slope would also require less maintenance and is expected to have lower failure rates. A conceptual rendering for this option has been prepared (Exhibit 4).
