# Ocean Blvd. (Bluff) Erosion and Enhancement Project, Phase 2

December 16, 2014

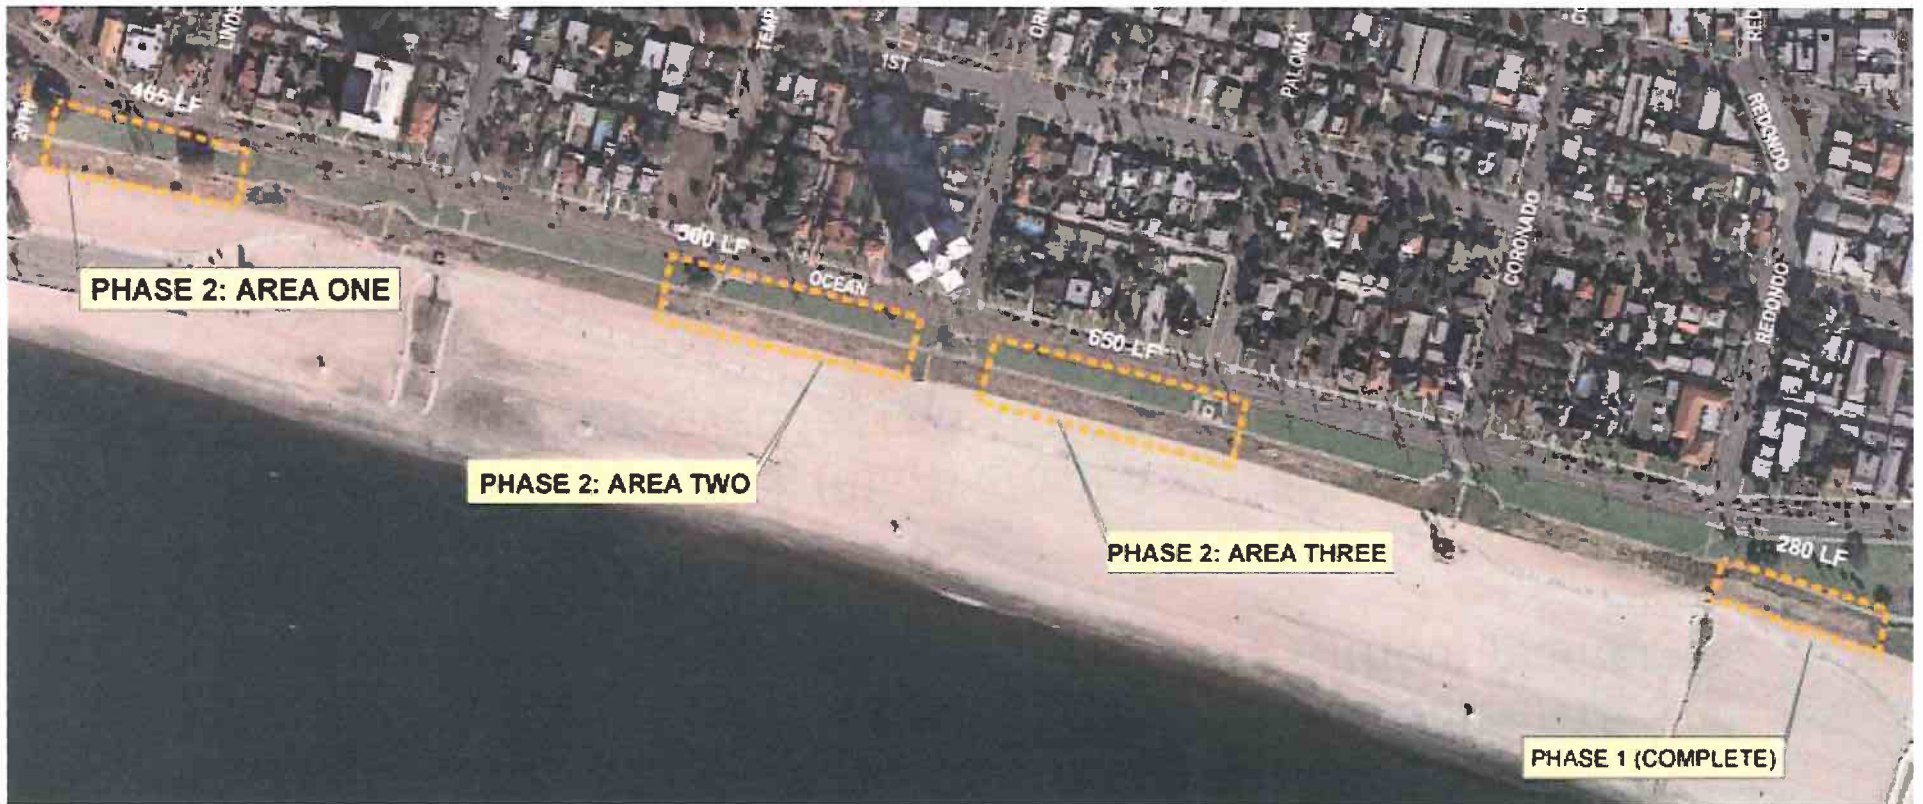
# Site Map

Phase 1 completed in  
2011

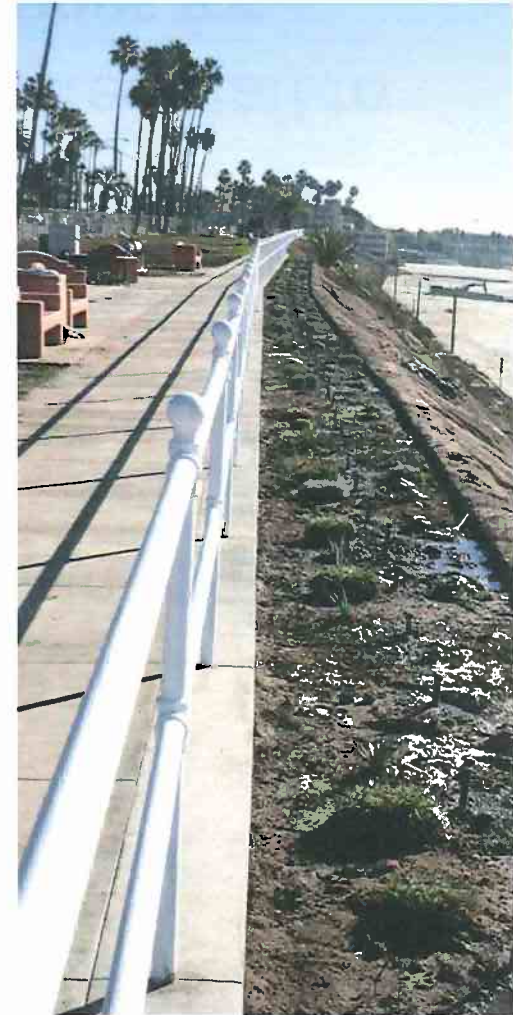
# Construction Progress

- 3700 feet of new sidewalk and historical railing have been fully installed in Bluff Park.
- The railing is made of galvanized steel and is guaranteed to last at least 25 years.

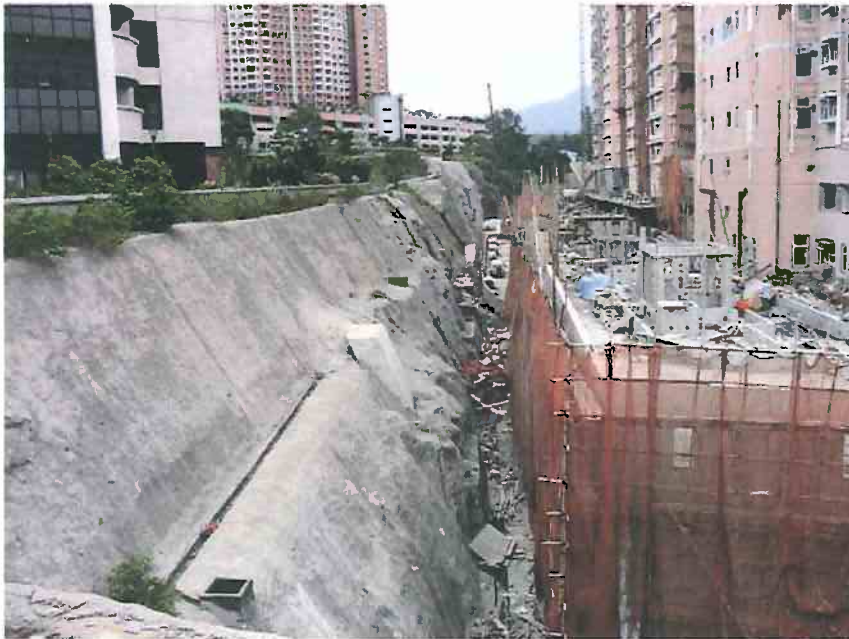
**During construction**

# Examples of Shotcrete

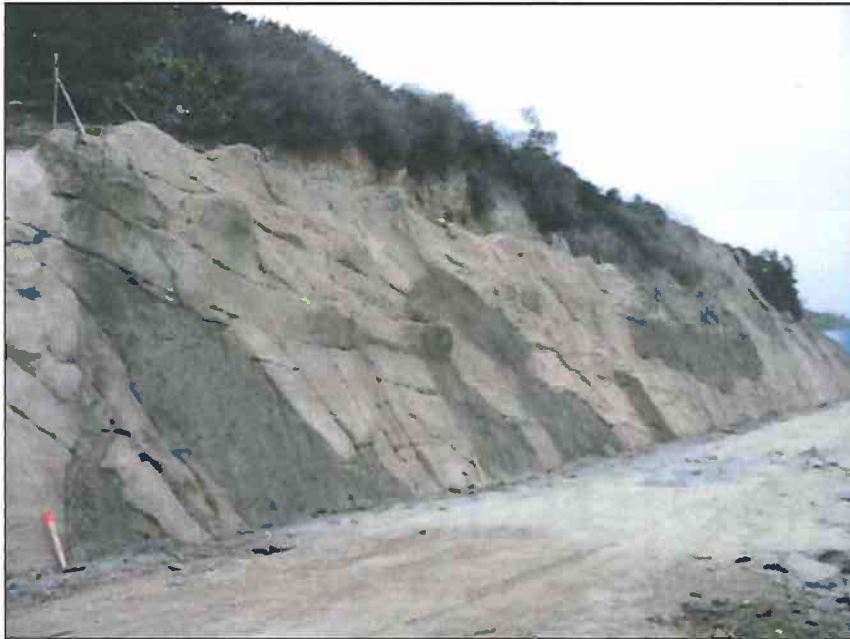
**During construction**

# Examples of Shotcrete

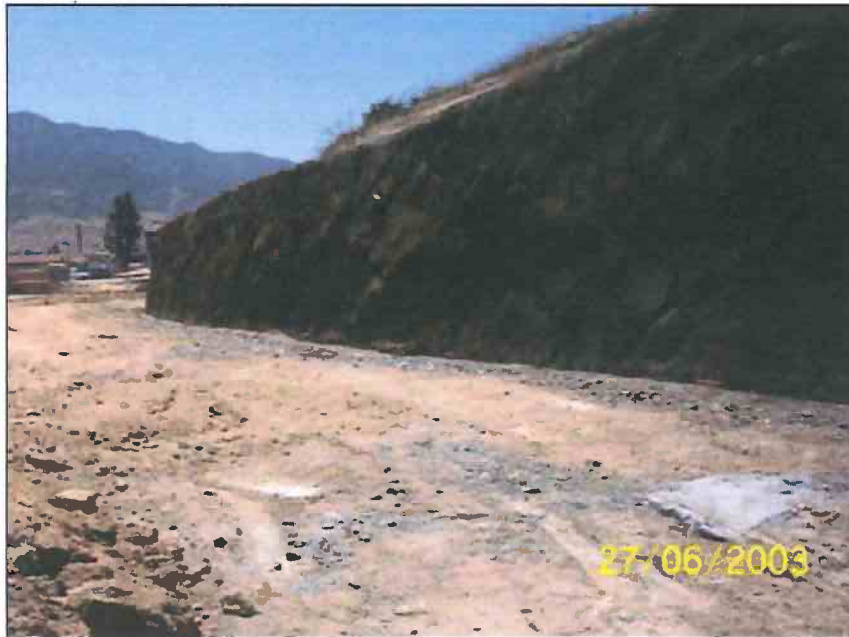
During construction

# Examples of Shotcrete

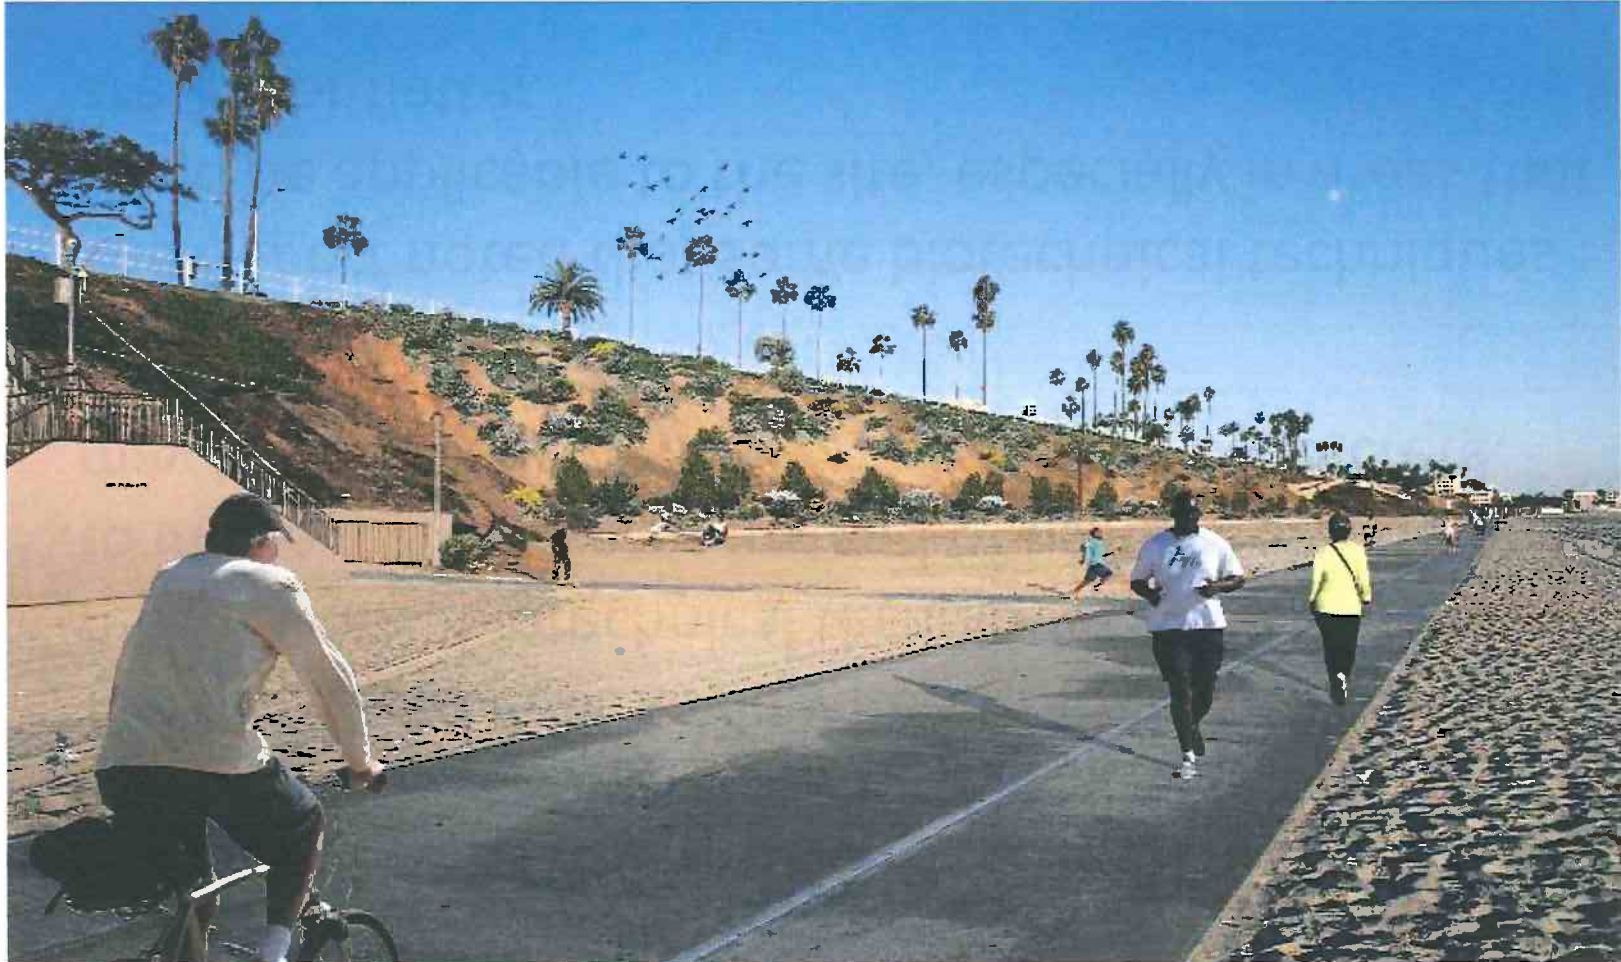
# Option 1 After Construction

- Three independent geotechnical engineers confirmed that soil nails and shotcrete are an appropriate solution for the Project (June 23, 2014 Peer Review)
- Most cost effective option with at least 75 year effective lifespan requiring minimal annual maintenance
- Vegetation will cover shotcrete as it grows and fully establishes itself and is expected to achieve greater Bluff coverage than in similar natural urban coastal bluffs

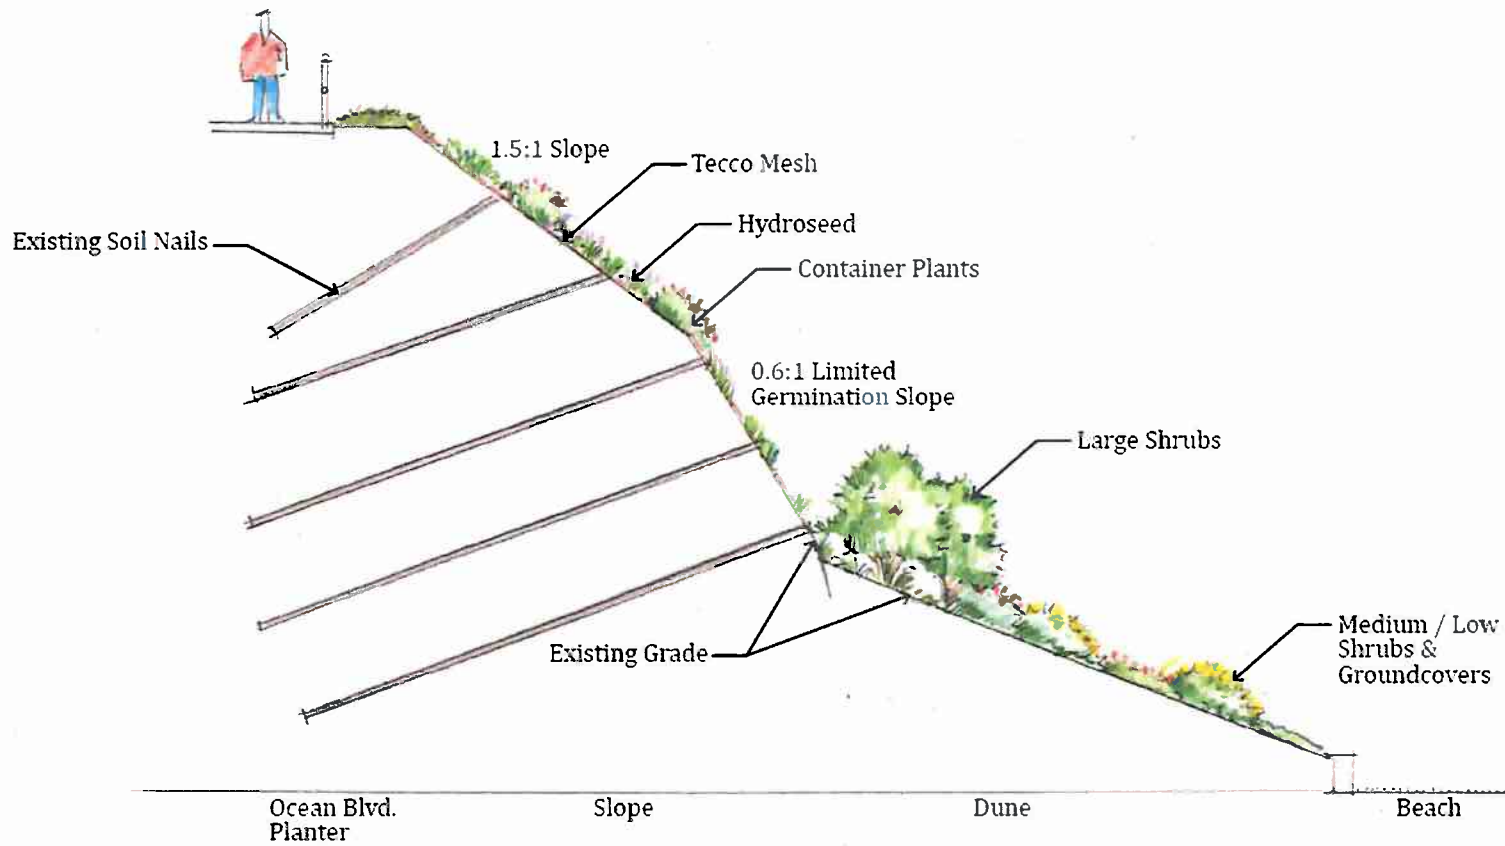
# Cross Section of Biotechnical Option 1

- A high-tensile steel wire mesh would be laid down and anchored to the soil nails.
- The slope would be hydroseeded with grasses and flowers, and cutouts would be made in the mesh to allow for small shrubs to be planted.
- At least 15 year effective lifespan with intensive annual maintenance, including repeated hydroseeding and top soil replacement.
- Plant failure anticipated to be high and will require significant maintenance to replace.
