PARSONAGE RESIDENCE  
640 PACIFIC AVENUE  
LONG BEACH, CALIFORNIA 90813

**HISTORIC STRUCTURE REPORT**

Katie Rispoli Keotamai  
*Master of Heritage Conservation*  
on behalf of  
KEAOTAMAI, LLC  
June 6, 2018

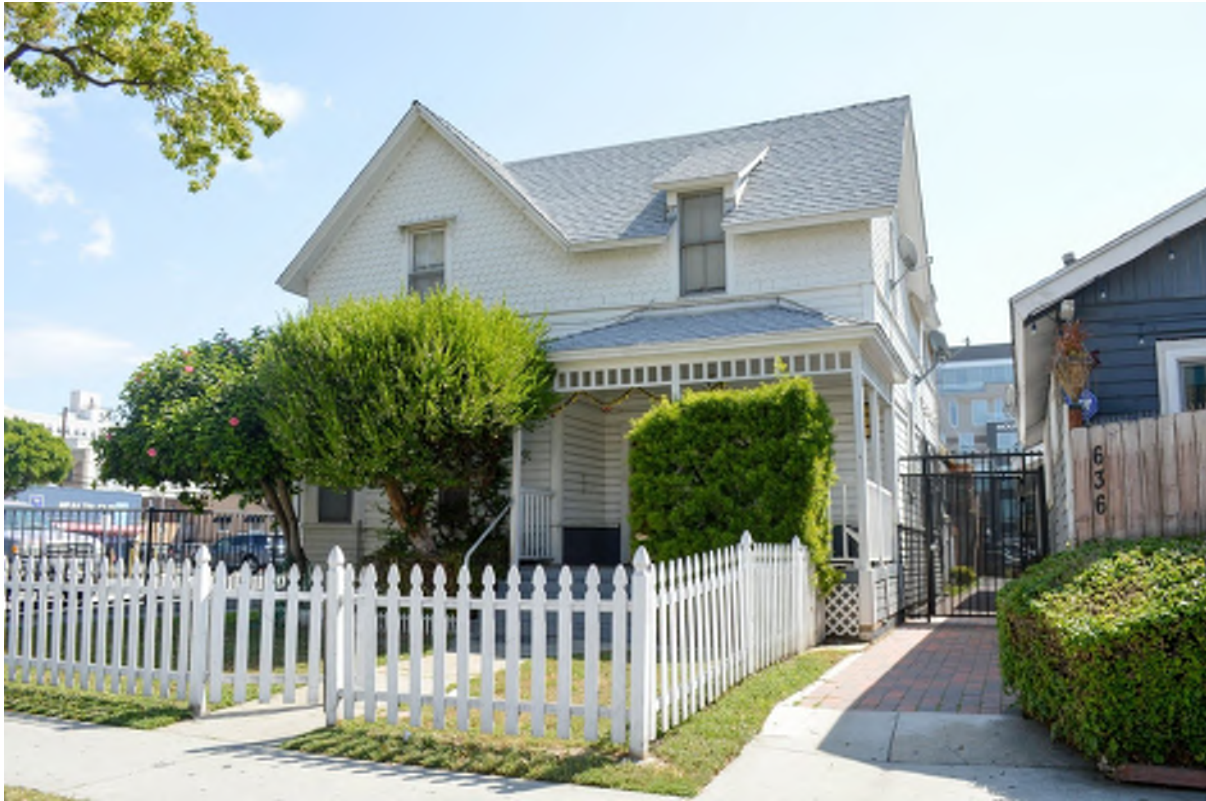
The Parsonage residence in its current condition, 2017.

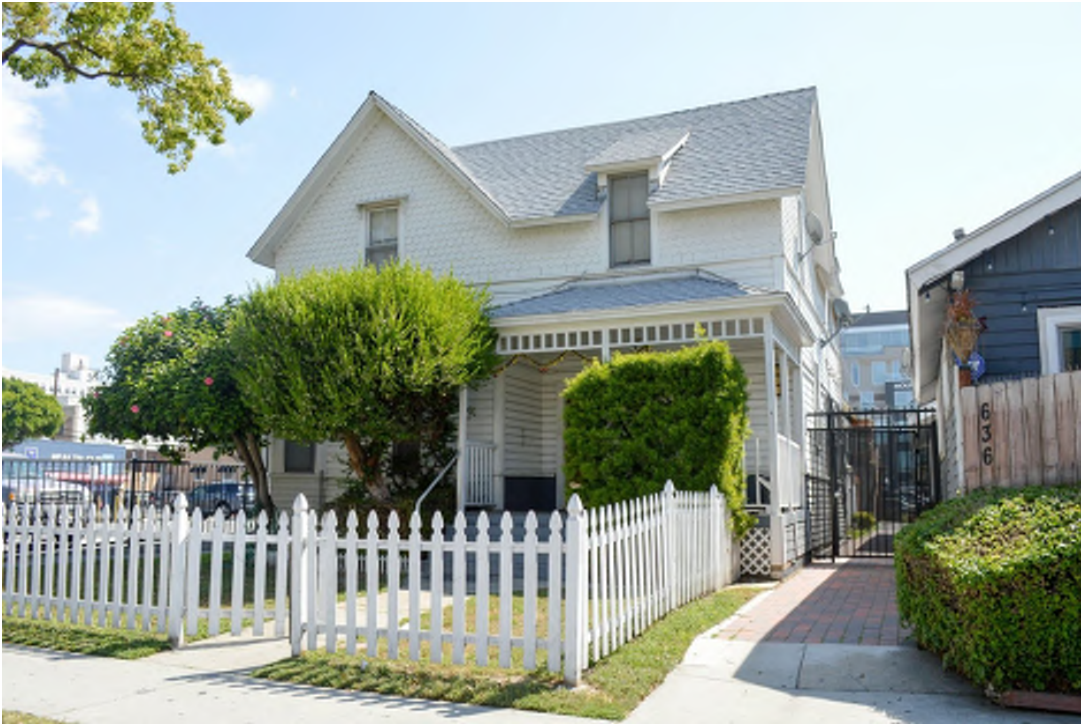
**A. Primary (West) Elevation**

*Parsonage Residence, Primary Elevation, View Northeast, Photo: 2017.*

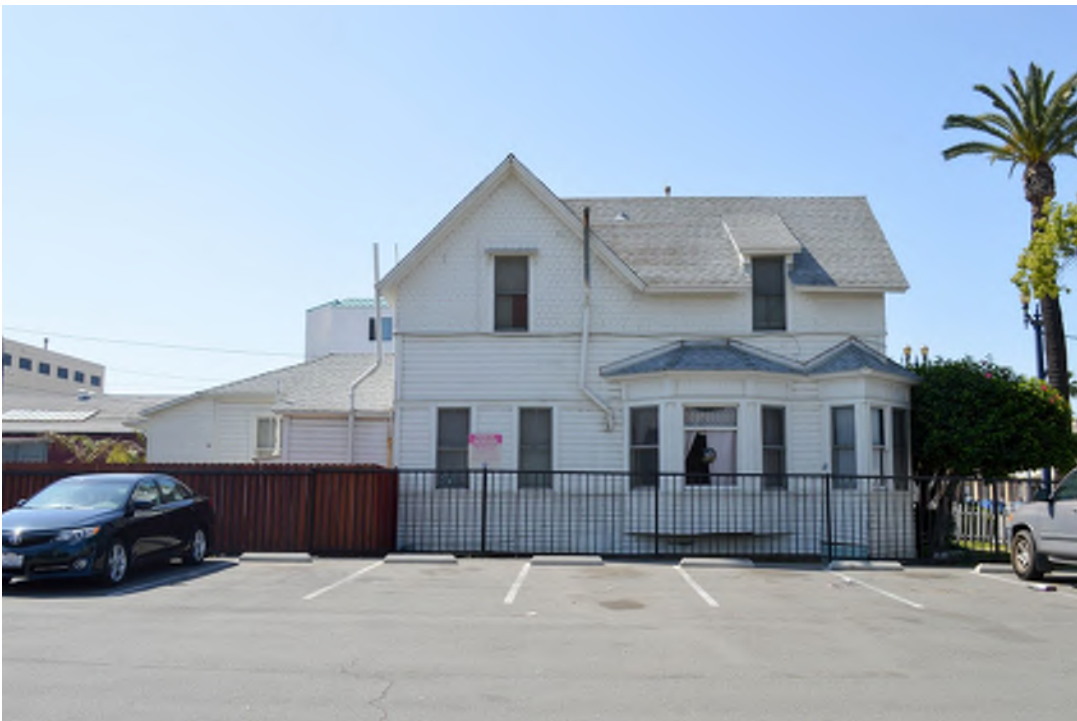
**B. North Elevation**

*Parsonage Residence, North Elevation, View South, Photo: 2017.*

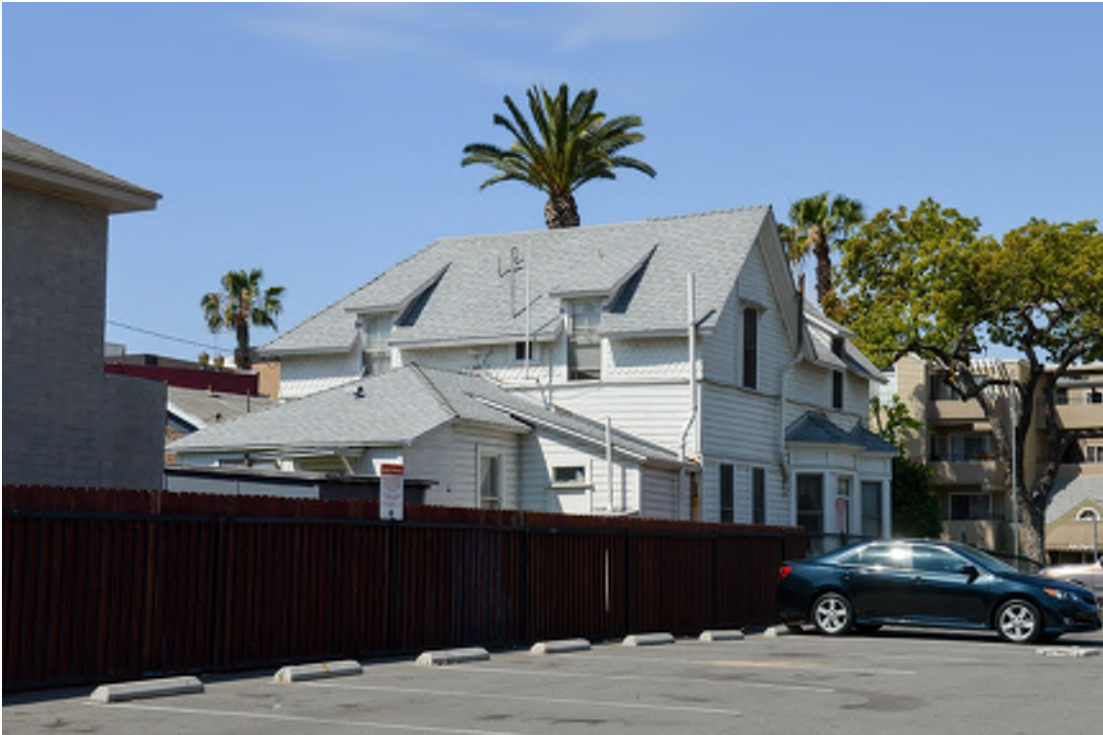
**C. East Elevation**

*Parsonage Residence, East Elevation, View Southwest, Photo: 2017.*

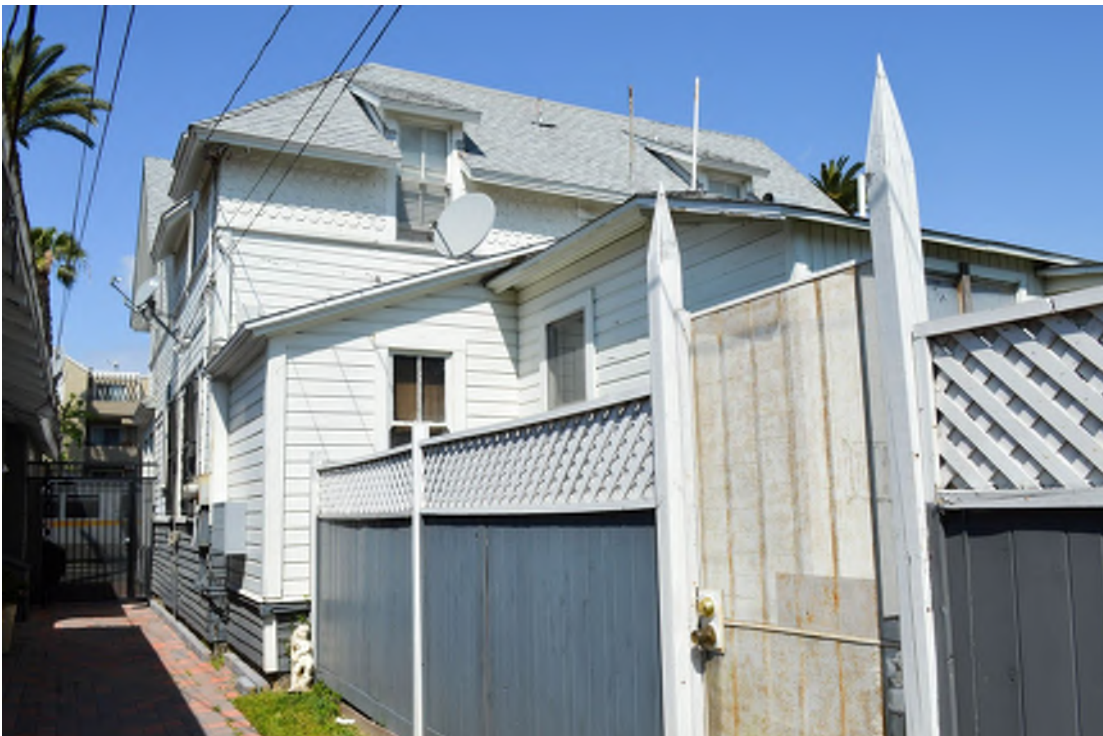
**D. South Elevation**

*Parsonage Residence, South Elevation, View Northwest, Photo: 2017.*

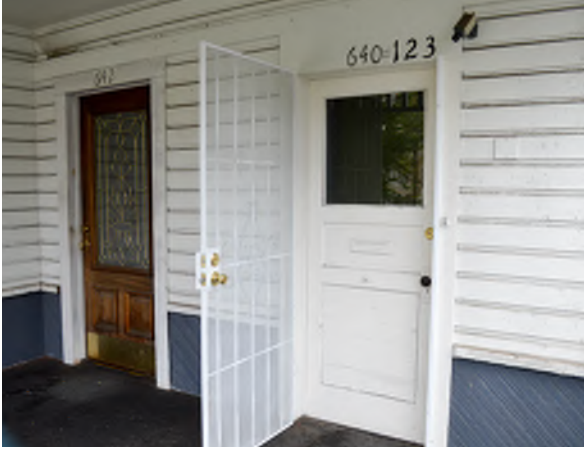
<p>Door Leading to Stairwell (Right,) View Northwest</p>	<p>The door which leads to the stairwell and second story unit is likely original to the building. The hardware on this door matches hardware from the period of historic significance identified throughout the interior of the building. In addition, period hardware and weathering on the door indicate its age.</p>	<p>Relocation Preparation</p> <p>Reassembly</p> <p>Rehabilitation</p>	<p>The door will be removed prior to relocation and safely brought to the future site. Both doors will be removed and their openings framed prior to relocation. Following relocation, the original door should be reinstalled in the leftmost door frame, and a fixed, single-lite window installed in the current location of the door as observed in the historic photograph. Hardware of the original door should be removed, and its paint carefully removed under safe conditions. The door will be painted to match its original color as determined by a forensic analysis.</p>	<p>Following the Secretary's Standards for Rehabilitation, damaged wood components of this feature will be repaired rather than replaced when possible. Lost aspects of the feature will not be replaced using conjecture. As a result, the glass within the door will remain single-lite as not to assume a design or texture of original glass. The same approach will be taken for the future window, since these details cannot be seen in the historic photograph.</p>

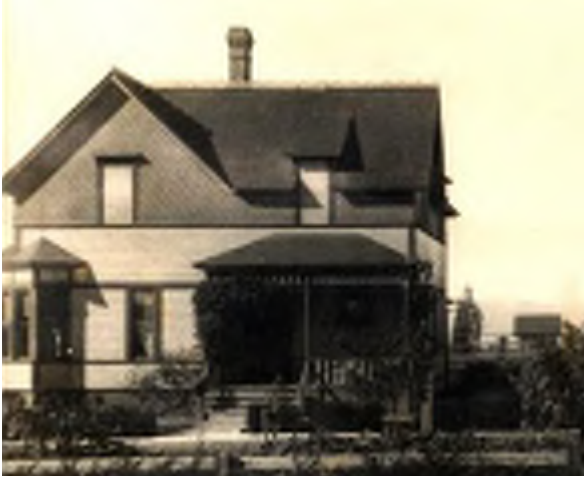
<p><b>Original Color Scheme</b></p> <p><b>Location:</b></p> <ul style="list-style-type: none"> <li>N/A</li> </ul>	<p>Lost Feature</p>

<p>Color Scheme Demonstrated in Historic Photograph</p>	<p>The building has been repainted a number of times throughout the course of its history. Exterior historic character-defining features, such as the horizontal and vertical bands dividing the first and second story, rely on a differentiated color scheme to convey their prominence and the building's historic design. Currently these features are difficult to discern due to the monochromatic palette of the building.</p>	<p>Rehabilitation</p>	<p>A forensic paint analysis will be performed to determine the color palette in the period of historic significance. The property owner will follow this color palette to repaint the building's trim, shingles, siding, and decorative components in these colors.</p>	<p>The Secretary of the Interior's Standards for Rehabilitation require that the replacement of missing features be substantiated based upon documentary, physical, or pictorial evidence. A forensic paint analysis will be performed to ensure that colors selected for the building are based upon a demonstrated record of use of those colors in the building's history. Additionally, colors will be dated using certain evidence to select a color scheme used during the period of historic significance.</p>

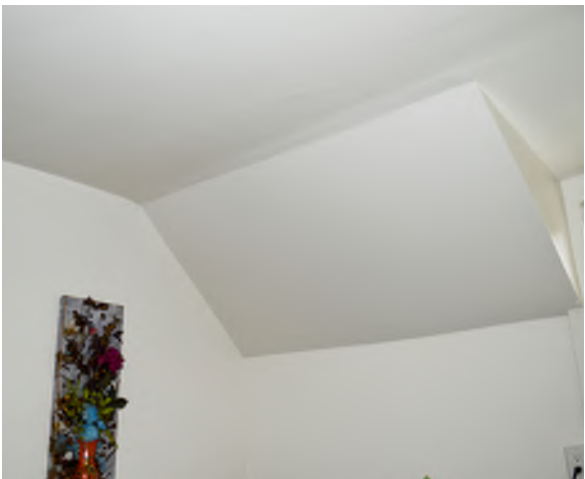
<p><b>Interior Roof Forms</b></p> <p><b>Location:</b></p> <ul style="list-style-type: none"> <li>All second-story rooms</li> </ul>	<p>Historic Character-Defining Feature</p>

<p>Interior Roof Forms Throughout Second Story</p>	<p>Interior roof forms throughout the second story of the building are a result of the exterior shape of the roof and bracketed window formations. In most occurrences, these forms are steeply pitched, and plaster around them is rounded at the intersection of the form and the ceiling.</p>	<p>Relocation Preparation</p> <p>Rehabilitation</p>	<p>If forms are undisturbed after relocation, it is suggested they be retained. Any remaining lath may be re-plastered, or drywall may be used to re-frame the shapes after relocation. If plaster forms are entirely lost as a result of relocation, they should not be reconstructed in order to provide evidence of the current era and avoid the creation of a false historical narrative.</p>	<p>Following the Secretary's Standards for Rehabilitation, damaged components of this feature will be repaired rather than replaced when possible. When replaced, the new materials will match the original in design, color, and texture. Replaced materials will be painted to match existing.</p>

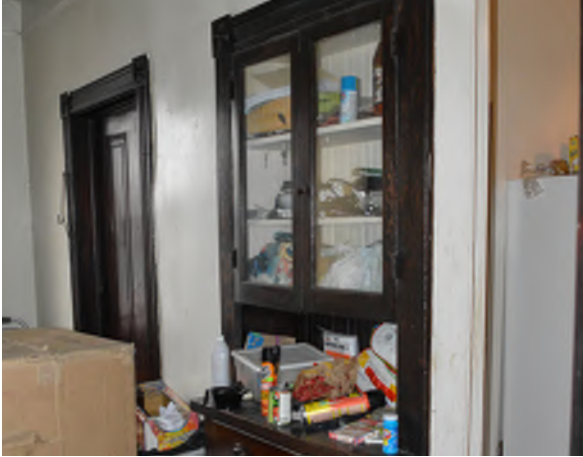
<p>Photo Description</p>	<p>A built-in china cabinet is located in the original dining room of the residence on the first story. This china cabinet would have been used to store silverware, linens, and dishes for use by ministers and guests dining at the Parsonage. The cabinet is unpainted wood, with painted 2 inch vertical wood paneling on its interior. The outer edge of the cabinet continues to form the door frame of the door to its right, and is ornamented with dart detailing.</p>	<p>Relocation Preparation</p> <p>Relocation</p> <p>Reassembly</p> <p>Rehabilitation</p>	<p>If cuts must be made near the base of the cabinet in order to prepare the lower portion of the building for relocation, the cabinet must be relocated to preserve its materials. If moving with the building, the cabinet will be wood-framed for protection. If it is removed, it will be appropriately relocated and reinstalled following relocation. It will not be painted. Unpainted wood portions will be stripped of finishing with care not to damage historic fabric. Holes will be filled with wood filler, and wood should be lightly sanded, stained, and sealed to match current stain.</p>	<p>Following the Secretary's Standards for Rehabilitation, any work completed in regards to the cabinet will be completed without the use of abrasive agents or agents which may damage the historic material.</p>

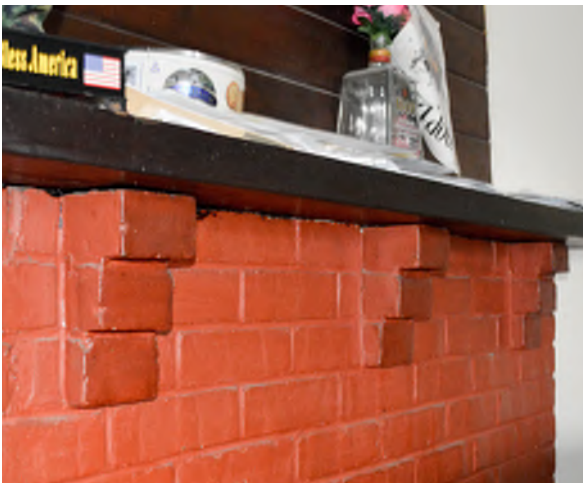
<p><b>Fireplace</b></p> <p><b>Location:</b></p> <ul style="list-style-type: none"> <li>• First Floor Living Room</li> </ul>	<p>Historic Character-Defining Feature</p>

<p>Fireplace in First Floor Entertaining Area</p>	<p>A brick fireplace is located in the parlor of the residence on the first floor. The fireplace is nonfunctional - its ventilation system was removed in a prior renovation of the building. The fireplace bricks are arranged in horizontal bands. Its opening is square with an angled body of bricks blocking access to the ventilation area. The fireplace has a wood mantle, which is supported by bricks placed vertically into the body of the fireplace, which escalate in their level of protrusion. The fireplace has been painted.</p>	<p>Relocation Preparation</p> <p>Rehabilitation</p>	<p>Relocation of the fireplace will be difficult and will pose a real challenge to the present relocation plan, due to its size and weight. The project proposes to remove the fireplace prior to relocation, and to replace the fireplace at the future site in the rehabilitation process. A new gel fireplace will be used in its place.</p>	<p>The removal and replacement of the fireplace as part of the project is not in accordance with the Secretary's Standards for Rehabilitation. To comply will require the removal of the fireplace prior to relocation, its separate transport or potential deconstruction, and re-installation or reconstruction within the living room at the future site. Undertaking of this action is financially infeasible as part of the proposed project.</p>
