COLOR ANALYSIS STUDY

Exterior
of the
8TH AND PINE BUILDING
located at
118 East 8TH Street
Long Beach, California 90802

Report prepared by
Carolyn Lehne

August 17, 2015

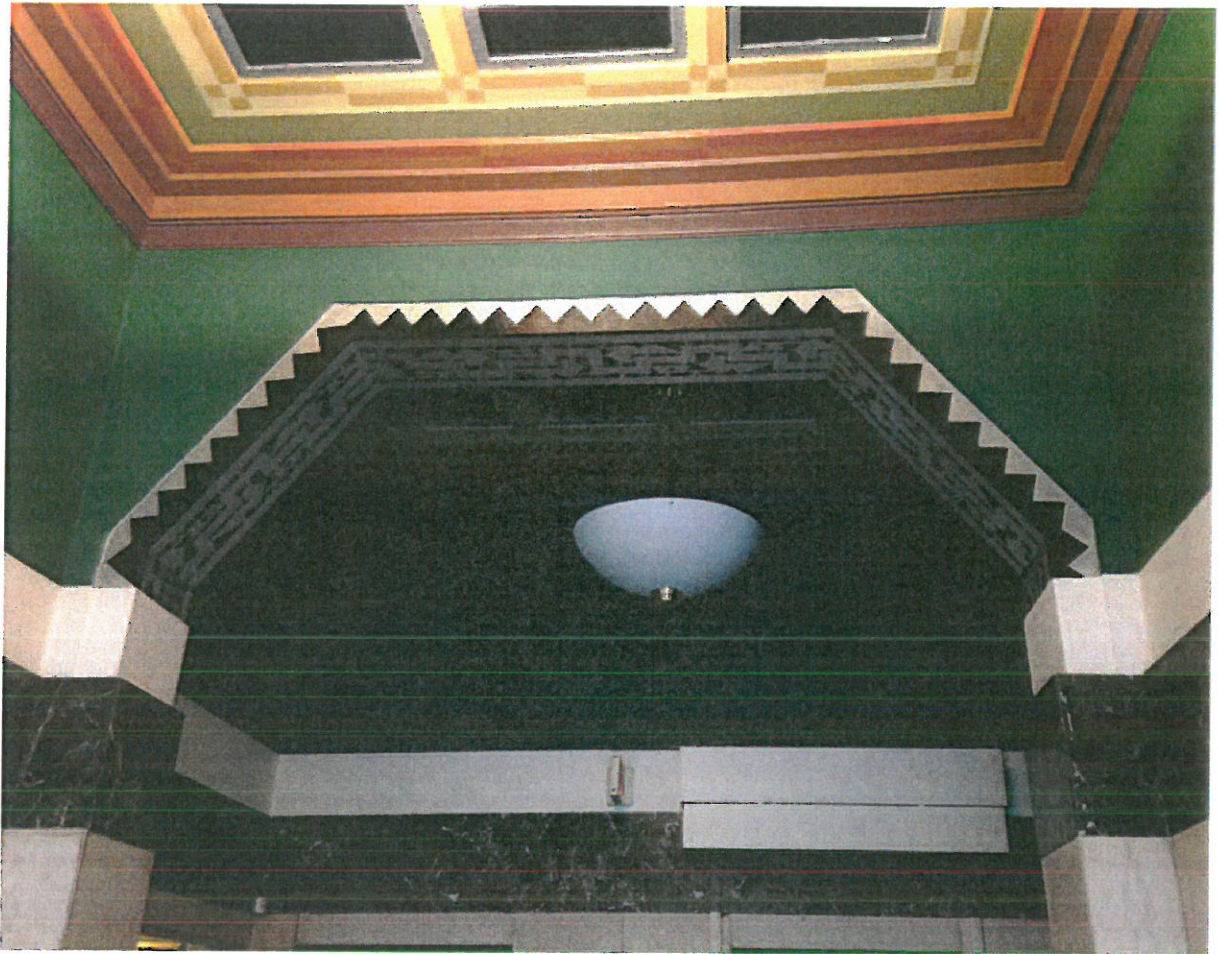
The white band (SAMPLE #4) had several layers similar in color to the walls. The first color found was a taupe/grey, then a beige, deep green, white, green, and the exposed white. The white and the colors that followed have a finer pigment consistency which is typical of modern paints.
