From: Miyoko Sakashita [mailto:miyoko@biologicaldiversity.org]
Sent: Tuesday, March 21, 2023 3:28 PM
To: CityClerk <CityClerk@longbeach.gov>
Subject: CBD Sources Part 1.5

REPORT OF OCCURRENCE

Subject: Cause and Prevention Plan for Surface Event SE 2011-8-8
Berry Petroleum Company, Project #46400390
Southwestern Lease, Section 2, T31S, R22E, MDBM
Midway Sunset Field
Kern County, CA

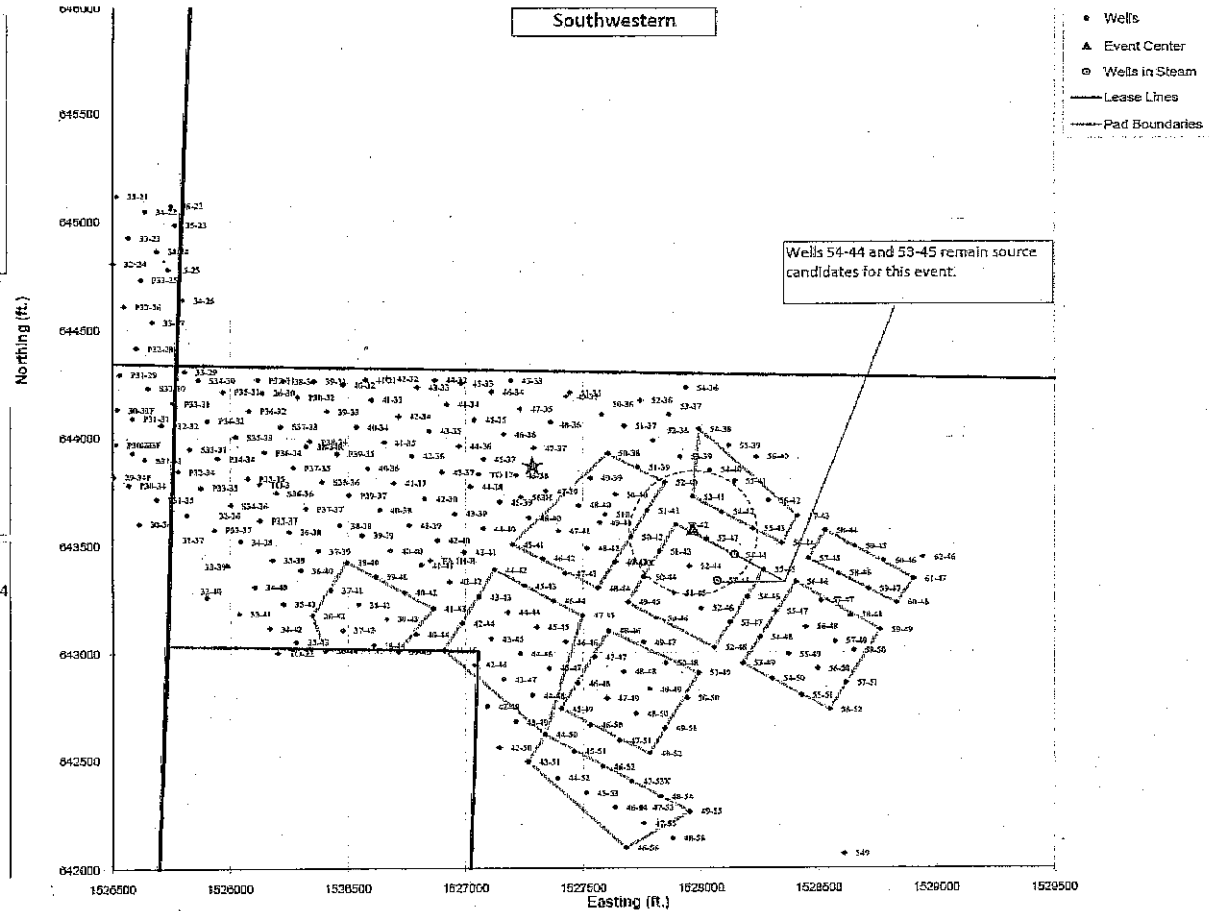
Event Fracture Parameters

Fracture Strike Azimuth = 85 deg.

Fracture Dip = 20 deg. SE

Estimated Fracture Diameter = 590 ft.

According to daily injection information, this event began and ended concurrently with the steam and soak times for nearby SW wells 54-44 and 53-45. Both wells remain source candidates for this event. This analysis supersedes previously reported results.

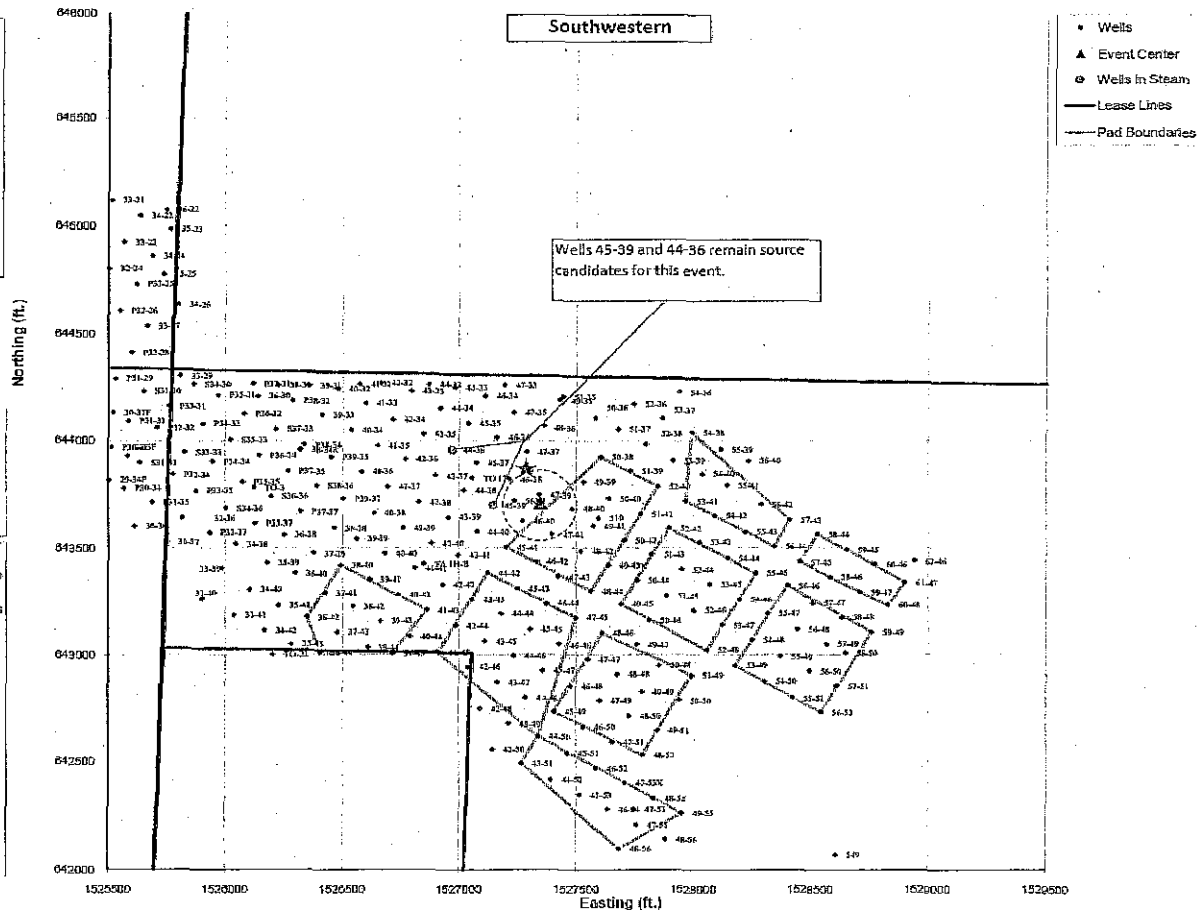
EVENT START: 08/02/2011 09:45 hrs
 EVENT END: 08/04/2011 09:00 hrs
 Event Fracture Parameters
 Depth = 415 ft. Top Dixomite = 514 ft Difference = +99 ft
 Error Bounds = 345' to 480'
 Fracture Strike Azimuth = 202 deg.
 Fracture Dip = 17 deg. NW
 Estimated Fracture Diameter = 340 ft.
 Growth Center Coordinates
 NAD27 Easting = 1527345 Northing = 643707
 NAD83 Easting = 6088737 Northing = 2284134

According to daily injection information, this event began one and two days after the steam start times for nearby SW wells 44-36 and 45-39. Event ended shortly prior to the soak times for these wells. Both wells remain source candidates for this event. This analysis supersedes previously reported results.

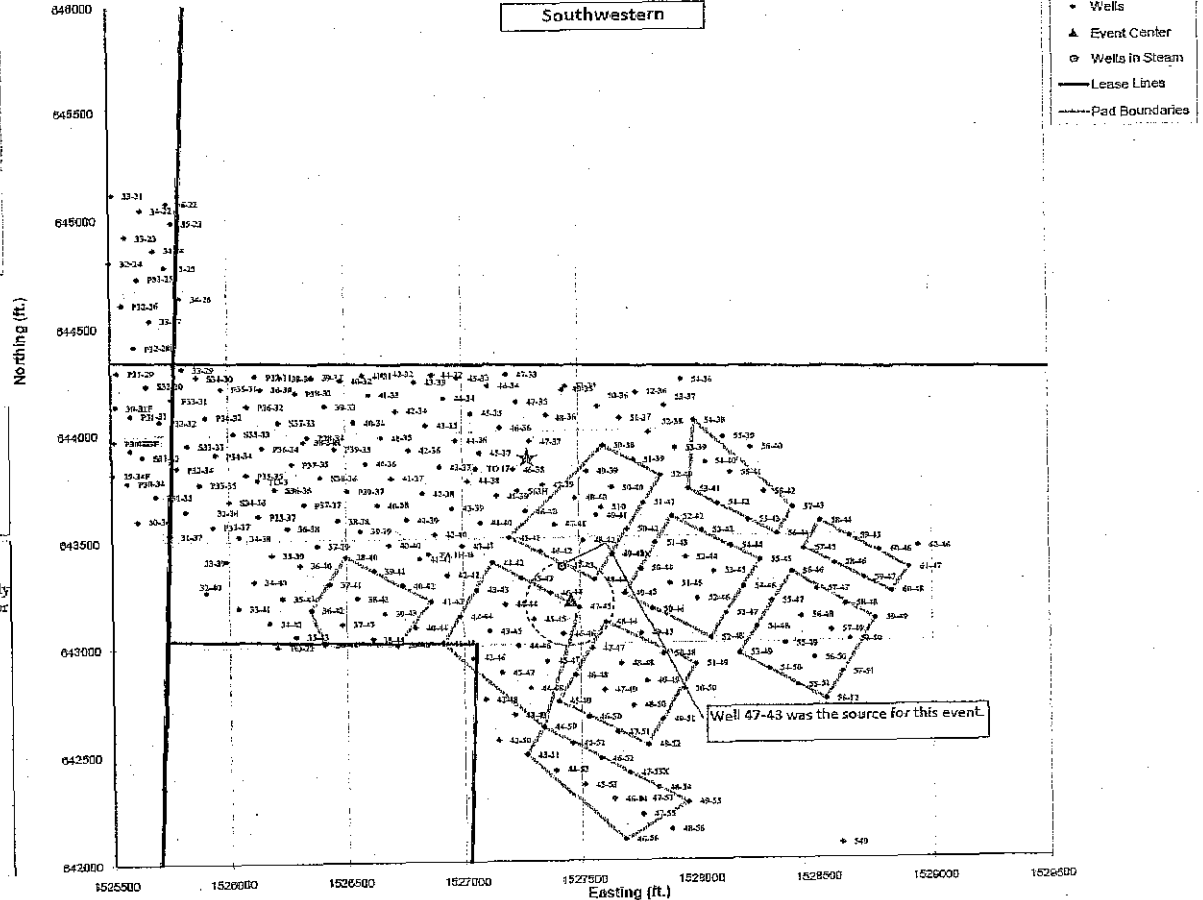
**Berry Southwestern Lease
Reservoir Monitoring Event Locator**

EVENT START: 08/02/2011 09:45 hrs
EVENT END: 08/04/2011 09:00 hrs

Event Fracture Parameters
Depth = 540 ft. Top Diatomite = 629 ft Difference = +89 ft
Error Bounds = 450' to 660'
Fracture Strike Azimuth = 29 deg.
Fracture Dip = 18 deg. SE

Estimated Fracture Diameter = 410 ft.

According to daily injection information, this event began two days after the steam start time for nearby well 47-43 and ended concurrently with the soak time for this well. This well was therefore the source for this event. This analysis supersedes previously reported results.

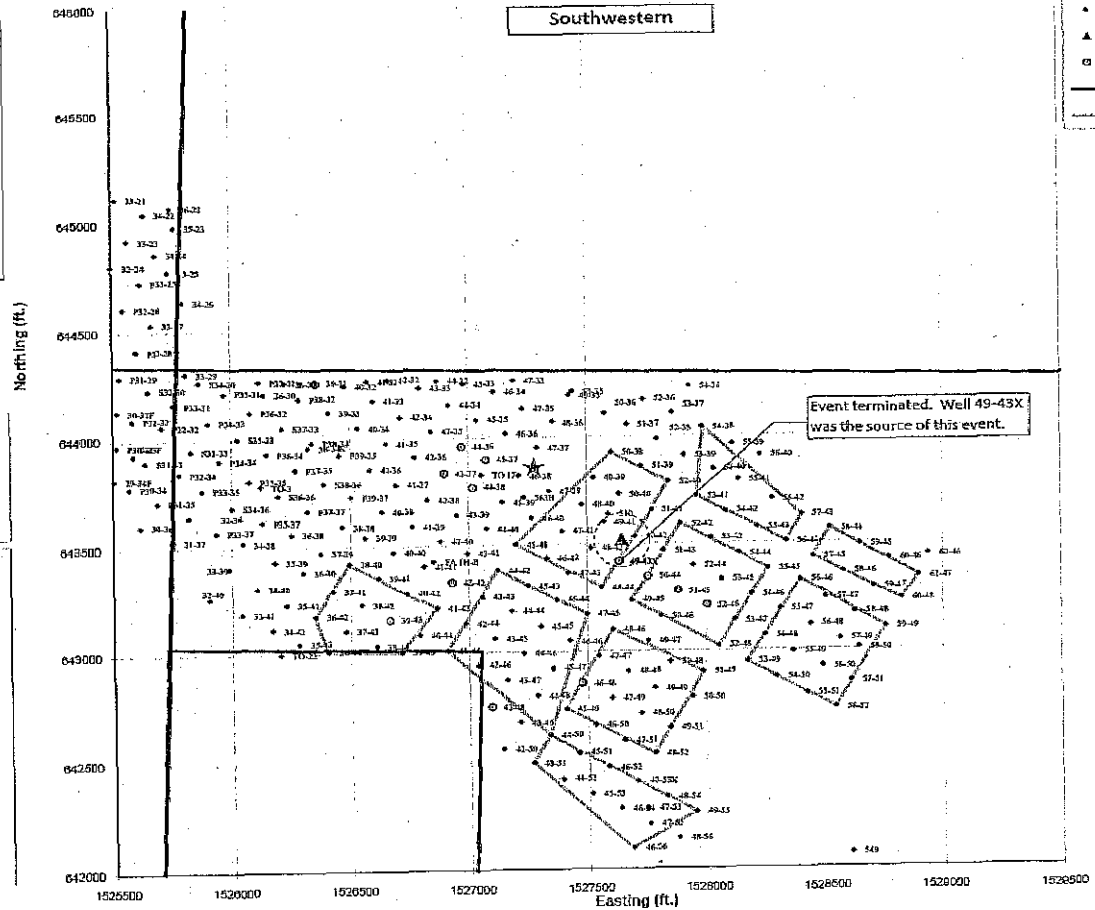
Berry Southwestern Lease

Fracture Strike Azimuth = 140 deg.

Fracture Dip = 23 deg. SW

Estimated Fracture Diameter = 225 ft.

Event 2011/08/04A terminated at 08:20 hrs on August 8, 2011. This event started shortly after the steam start time of nearby well 49-43X and event end correlated with the steam end time of this same well. SW 49-43X was the source of this event. This report supersedes previously reported results.

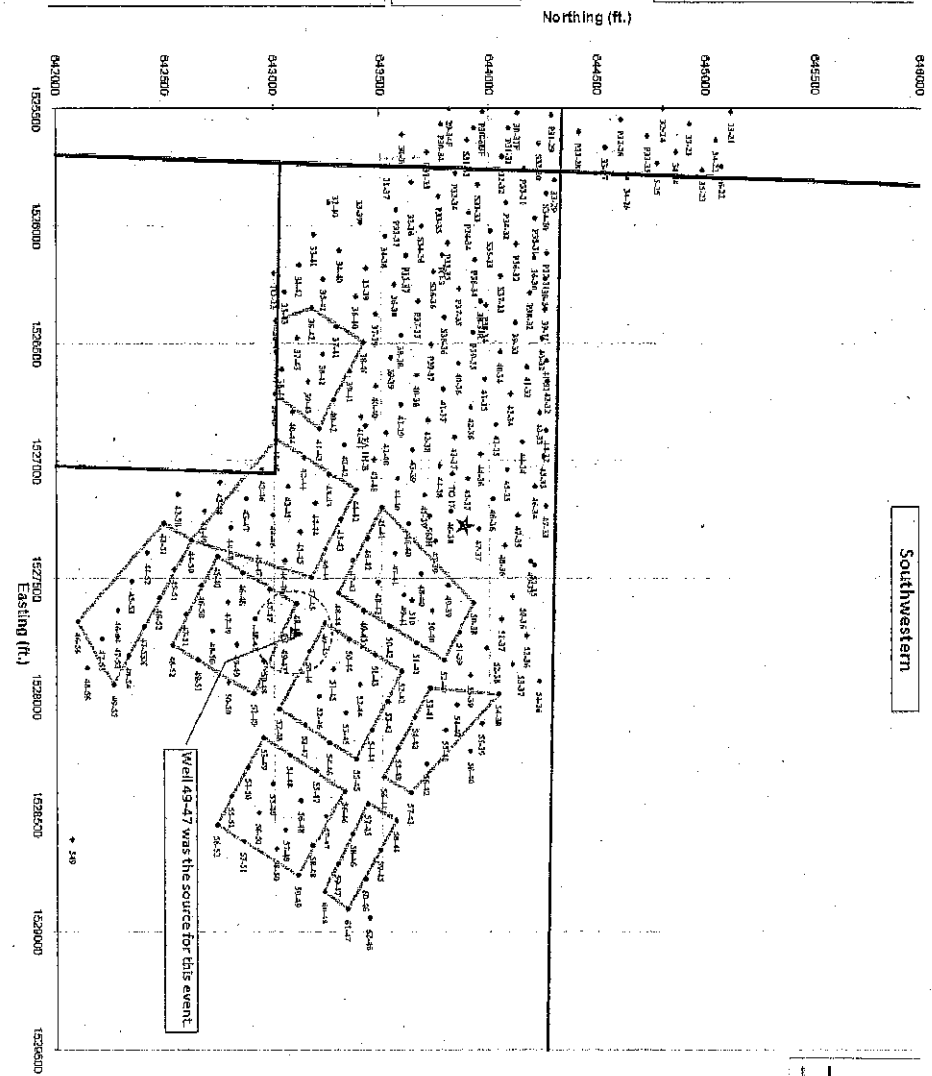
Berry Southwestern Lease

EVENT START: 08/04/2011 09:10 hrs
 EVENT END: 08/05/2011 10:30 hrs
 Event Fracture Parameters
 Depth = 610 ft, Top Diatomite = 591 A Difference = .19 A
 Error Bounds = 510 to 730
 Fracture Strike Azimuth = 119 deg
 Fracture Dip = 18 deg, STV
 Estimated Fracture Diameter = 380 A
 Grovell Center Coordinates
 NAD83 Easting = 1327735 Northing = 643100
 NAD83 Easting = 6089127 Northing = 238326

NOTES:
 According to daily injection information, this event began and ended concurrently with the steam and soak times for nearby well 49-17. This well was therefore the source for this event. This analysis supersedes previously reported results.

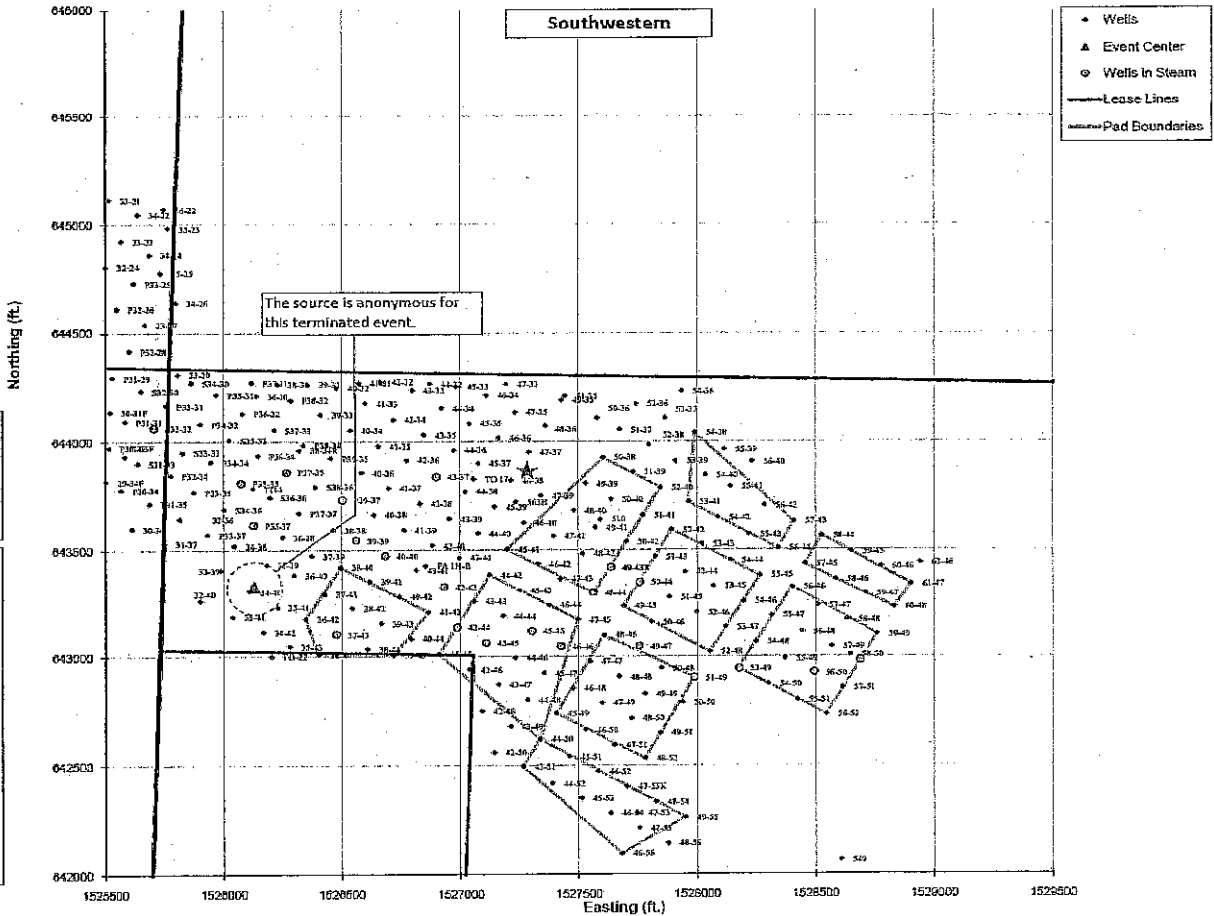
Berry Southwestern Lease
Reservoir Monitoring Event Locator
 EVENT START: 08/04/2011 05:43 hrs
 EVENT END: 08/04/2011 17:40 hrs
 Event Fracture Parameters
 Depth = 680 ft. Top Diatomite = 870 ft. Difference = +190 ft
 Error Bounds = 610' to 760'
 Fracture Strike Azimuth = 12 deg.
 Fracture Dip = 18 deg. SE
 Estimated Fracture Diameter = 220 ft
 Growth Center Coordinates
 NAD27 Easting = 1526128 Northing = 643329
 NAD83 Easting = 6087520 Northing = 2283755

Notes:
 Event 2011/08/04C began and ended on August 4, 2011. Reported injection information did not correlate with the occurrence of this event. A source has not been identified for this terminated event. We will continue to monitor this area for any signs of re-inflation.

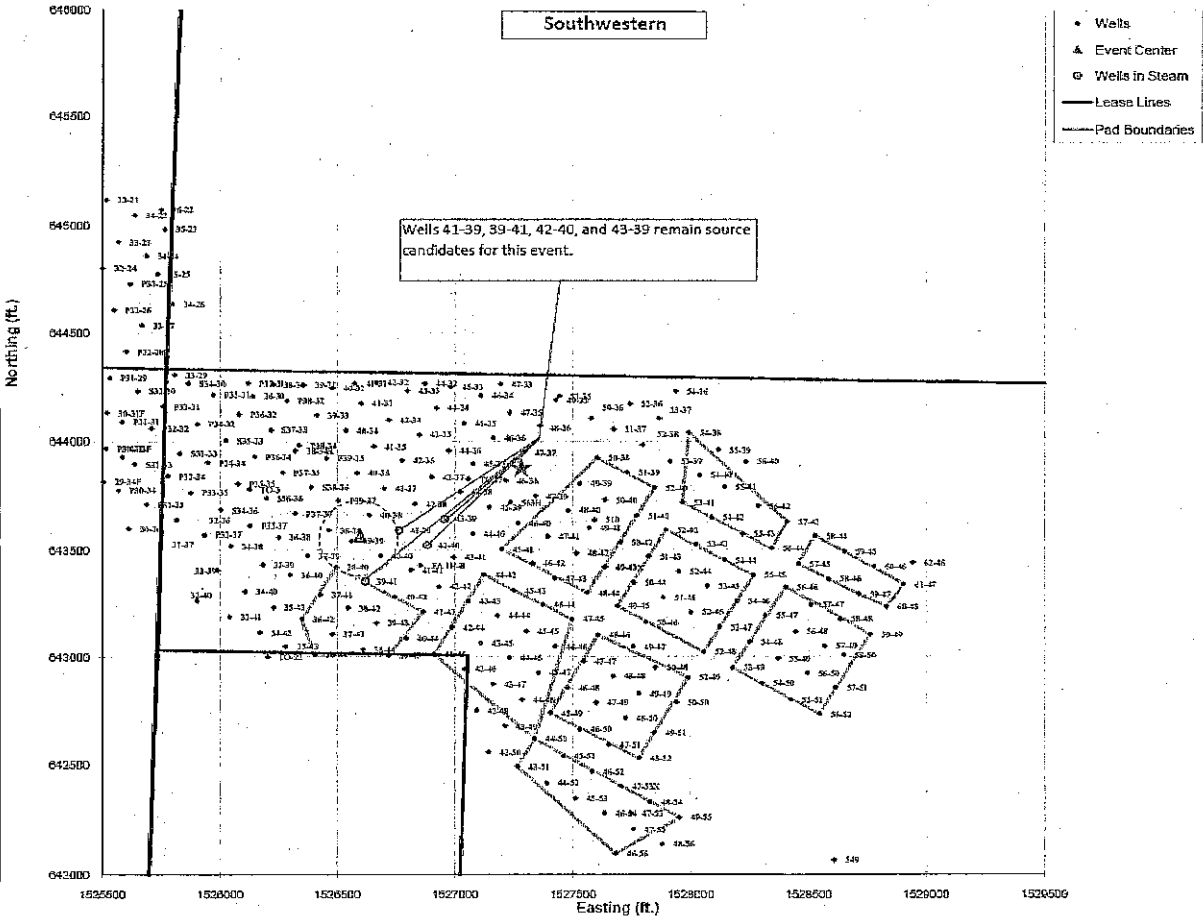
Berry Southwestern Lease
Reservoir Monitoring Event Locator
 EVENT START: 08/06/2011 09:15 hrs
 EVENT END: 08/07/2011 22:00 hrs
 Event Fracture Parameters
 Depth = 660 ft, Top Diatomite = 700 ft Difference = +40 ft
 Error Bounds = 560' to 820'
 Fracture Strike Azimuth = 22 deg.
 Fracture Dip = 17 deg. SE
 Estimated Fracture Diameter = 360 ft.
 Growth Center Coordinates
 NAD27 Easting = 1526597 Northing = 643566
 NAD83 Easting = 6087989 Northing = 2283992

Notes:
 Event 20110806A terminated at 22:00 hrs on August 7, 2011.
 According to daily injection information, this event began concurrently with the steam start time for nearby wells 41-39 and 39-41 and one day after nearby wells 42-40 and 43-39 were switched in. These wells were still in steam during event termination and remain source candidates for this event. This analysis supersedes previously reported results.

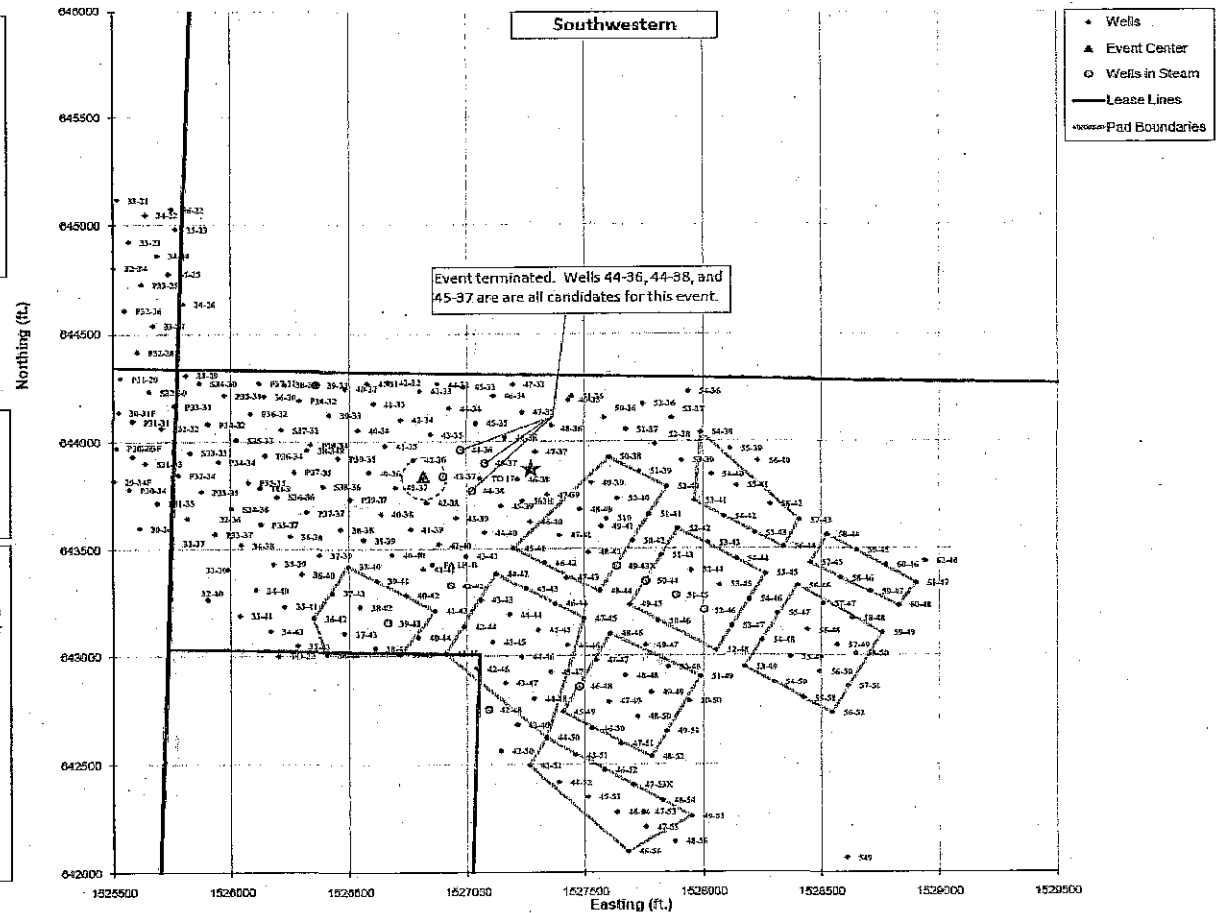
Berry Southwestern Lease

Fracture Strike Azimuth = 32 deg.

Fracture Dip = 1 deg. SE

Estimated Fracture Diameter = 170 ft.

Event 2011/08/07A terminated at 11:30 hrs on August 8, 2011 after several subsidence/re-inflation cycles. Previously named source candidates remained in steam. Based on injection data, event appears to be related to the steaming of nearby SW wells 44-36, 44-38, and/or 45-37. These wells were removed from steam approximately 2 hours after event initiation. This report supersedes previously reported results.

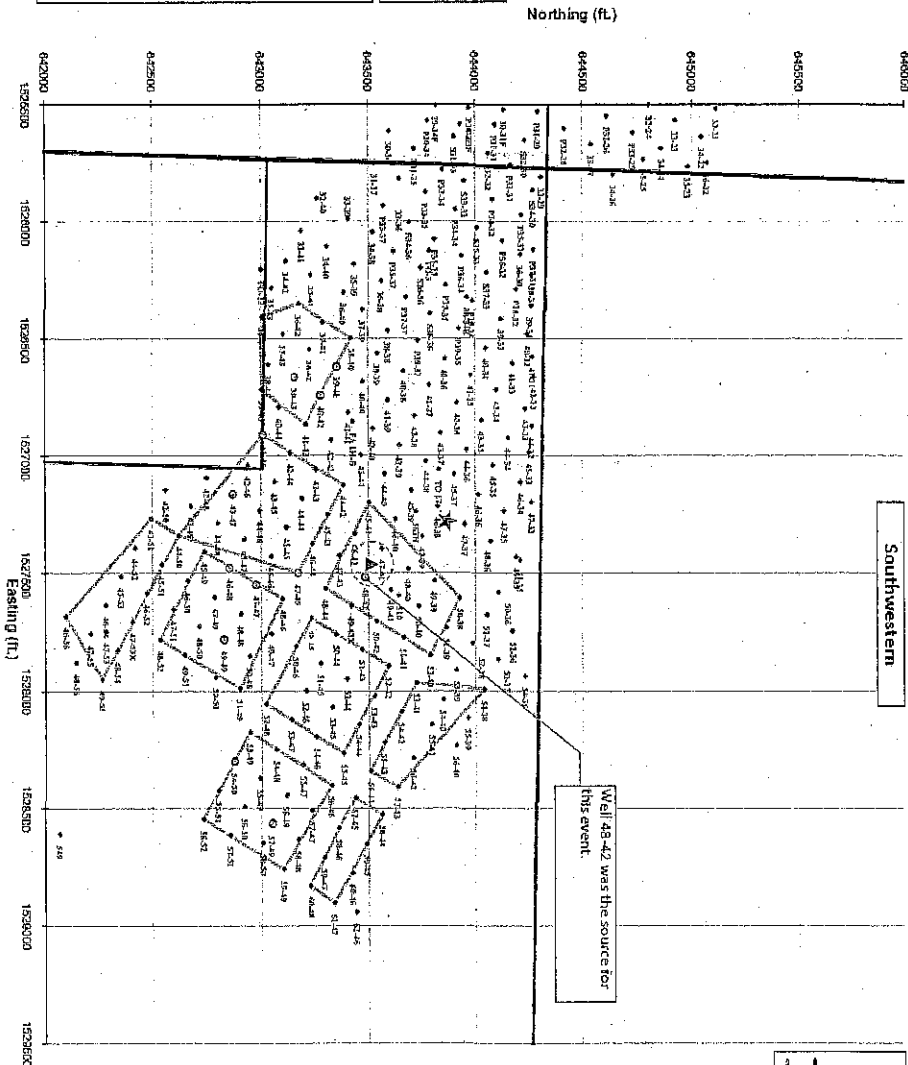
**Berry Southwestern Lease
Reservoir Monitoring Event Locator**

EVENT START: 08/08/2011 08:45 hrs
 EVENT END: 08/10/2011 15:30 hrs
 Event Fracture Parameters
 Depth = 1651 ft. Top Datum = 521 ft Difference = +156 ft
 Event Borehole = 1407 to 1875
 Fracture Strike Azimuth = 330 deg.
 Fracture Dip = 23 deg. NE
 Estimated Fracture Diameter = 200 ft.
 Growth Center Coordinates
 NAD 83 Easting = 1227401 Northing = 643314
 NAD 83 Easting = 0088331 Northing = 2283940

Notes:
 According to daily injection information, this event began shortly after the steam start time for nearby well 48-42 and ended concurrent to the cool down for this well. Therefore, well 48-42 was the source for this event. This analysis supersedes previously reported results.

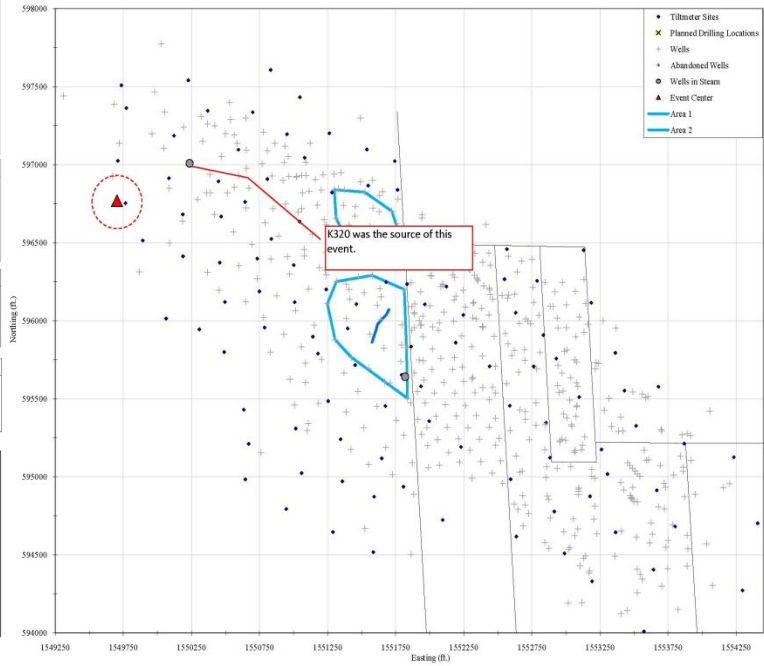
MWSS EVENT LOCATOR
 EVENT START: 06/17/11 9:00 hrs
 EVENT END: 06/19/11 8:50 hrs
Event Fracture Parameters
 Depth = 1020 ft. Top Diatomite = 779 ft. Difference = -241 ft
 Error Bounds = 970' to 1110'
 Fracture Strike Azimuth = 266 deg.
 Fracture Dip = 8 deg. NW
 Estimated Fracture Diameter = 360 ft.
Growth Center Coordinates
 NAD27 Easting = 1549703 Northing = 596768
 NAD83 Easting = 6111094 Northing = 2237193

Notes:
 This event began and ended concurrently with the steam start and soak times for nearby well K320. This well was therefore the source of this event. This report supersedes previously reported results.

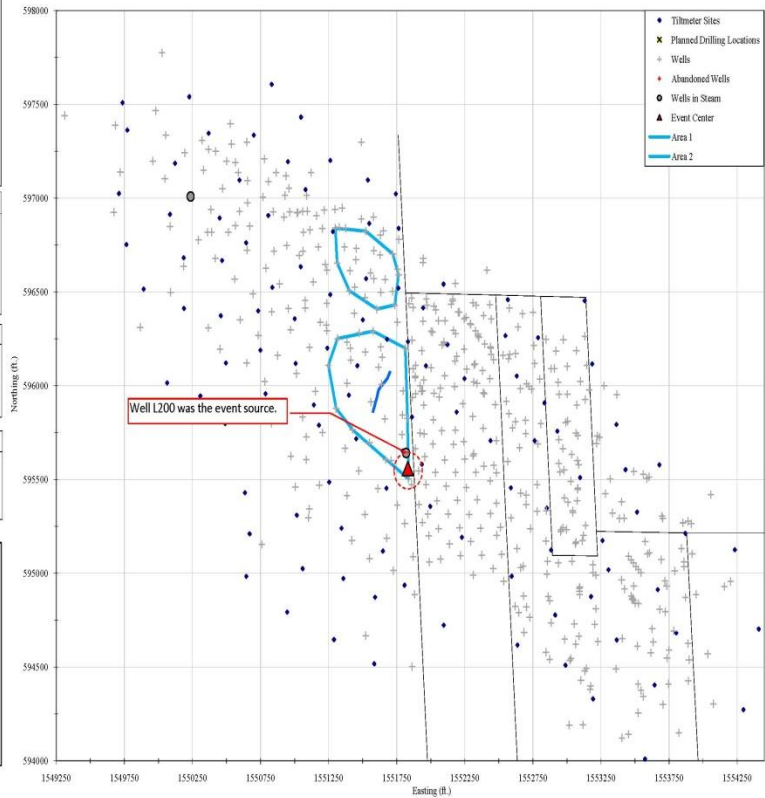
Notes:
 Event 2011.06.18A terminated at 15:35 hrs on June 19, 2011, concurrent with the steam end time of nearby well L200. This well was the event source. This report supersedes previously reported results.

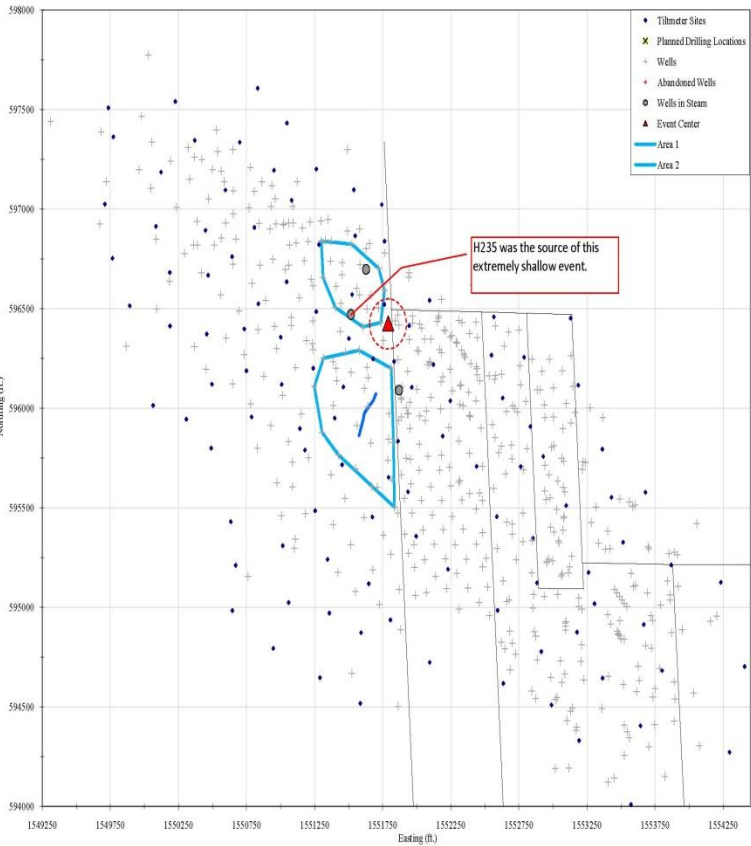
MWSS EVENT LOCATOR

Notes:
 Event termination was observed at 1:25 AM on June 21, 2011.
 Presumably, no steam changes took place at this time. A re-inflation of this event occurred at 7:55 AM with ultimate termination at 8:50 AM. This time correlates to the removal of H235 from steam. This well remains the best candidate as the source of this event. Chevron well G240 and TRC Birch-8R2 remain possible contributors to event growth. This report supersedes previously reported results.

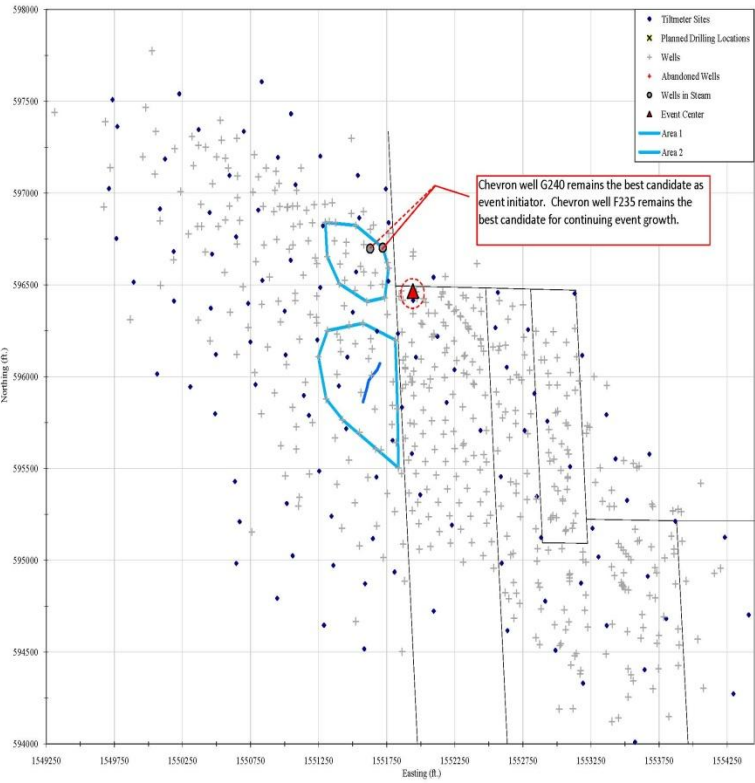
MWSS EVENT LOCATOR
EVENT START: 06/22/11 13:45 hrs
EVENT END: 06/24/11 14:30 hrs
Event Fracture Parameters
 Depth = 275 ft.
 Error Bounds = 260' to 305'
 Fracture Strike Azimuth = 68 deg.
 Fracture Dip = 18 deg. SE
 Estimated Fracture Diameter = 160 ft.
Growth Center Coordinates
 NAD27 Easting = 1551942 Northing = 596466
 NAD83 Easting = 6113334 Northing = 2236892

Notes:
 According to daily injection information, this event began two days after the steam start time for Chevron well G240. This well was removed from steam on 6/23 and remains the best candidate as event initiator. Chevron well F235 was switched into steam on 6/23 and was removed from steam on 6/26. This well remains the best candidate for continuing event growth. This analysis supersedes previously reported results.

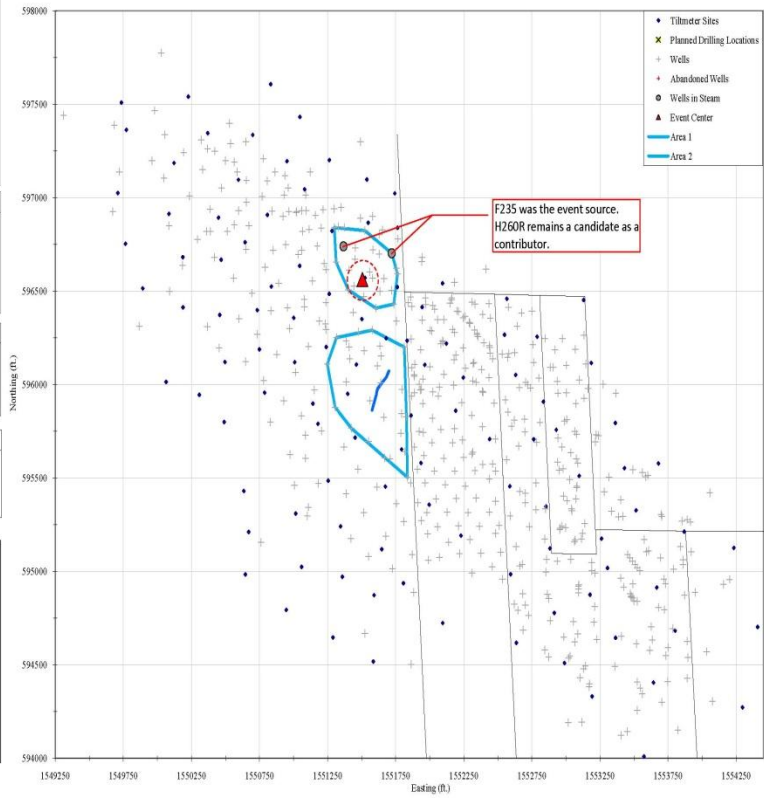
MWSS EVENT LOCATOR
 EVENT START: 06/24/11 14:30 hrs
 EVENT END: 06/26/11 9:55 hrs
Event Fracture Parameters
 Depth = 675 ft. Top Diatomite = 356 ft Difference = -319 ft
 Error Bounds = 60° to 78°
 Fracture Strike Azimuth = 187 deg.
 Fracture Dip = 19 deg. NW
 Estimated Fracture Diameter = 195 ft.
Growth Center Coordinates
 NAD27 Easting = 1551505 Northing = 596561
 NAD83 Easting = 6112896 Northing = 2236986

Notes:
 This event began one day after nearby Chevron well F235 was switched into steam and ended concurrently with the soak time for this well. F235 was therefore the source of this event. H260R remains a candidate as a contributor to event growth. This report supersedes previously reported results.

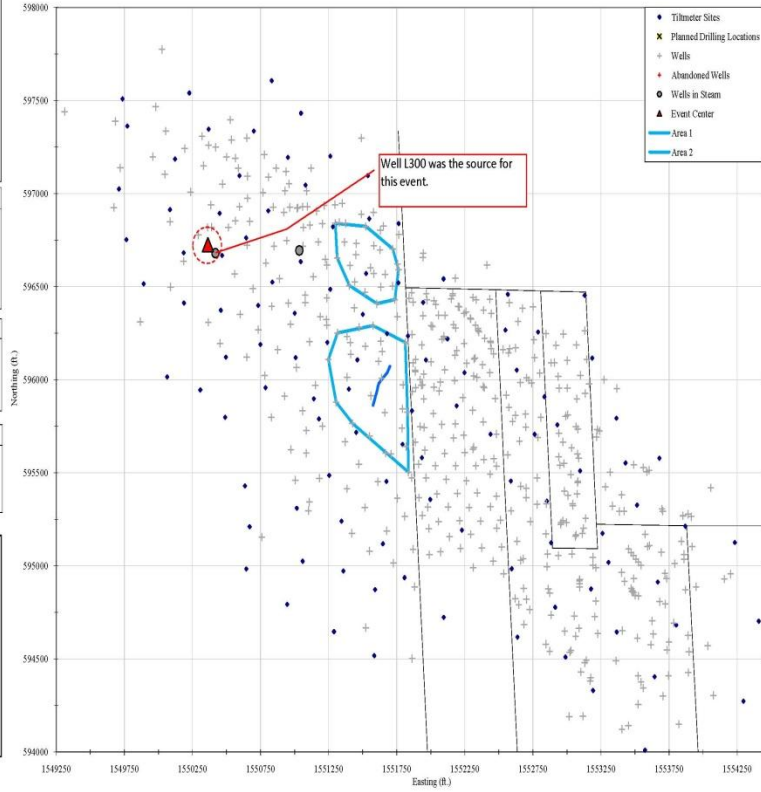
MWSS EVENT LOCATOR

Notes:
 According to daily injection information, this event began shortly after nearby Chevron well L300 was put into steam and ended concurrent to the soak time for this well. Therefore, well L300 was there source for this event. This analysis supersedes previously reported results.
