**DRAFT
ARCHITECTURAL BUDGET COST MODEL
OF**

**5870-5874 ATLANTIC AVENUE
LONG BEACH, CALIFORNIA**

**THE CITY OF LONG BEACH
REDEVELOPMENT AGENCY**

**File No. 110018
April 2010**

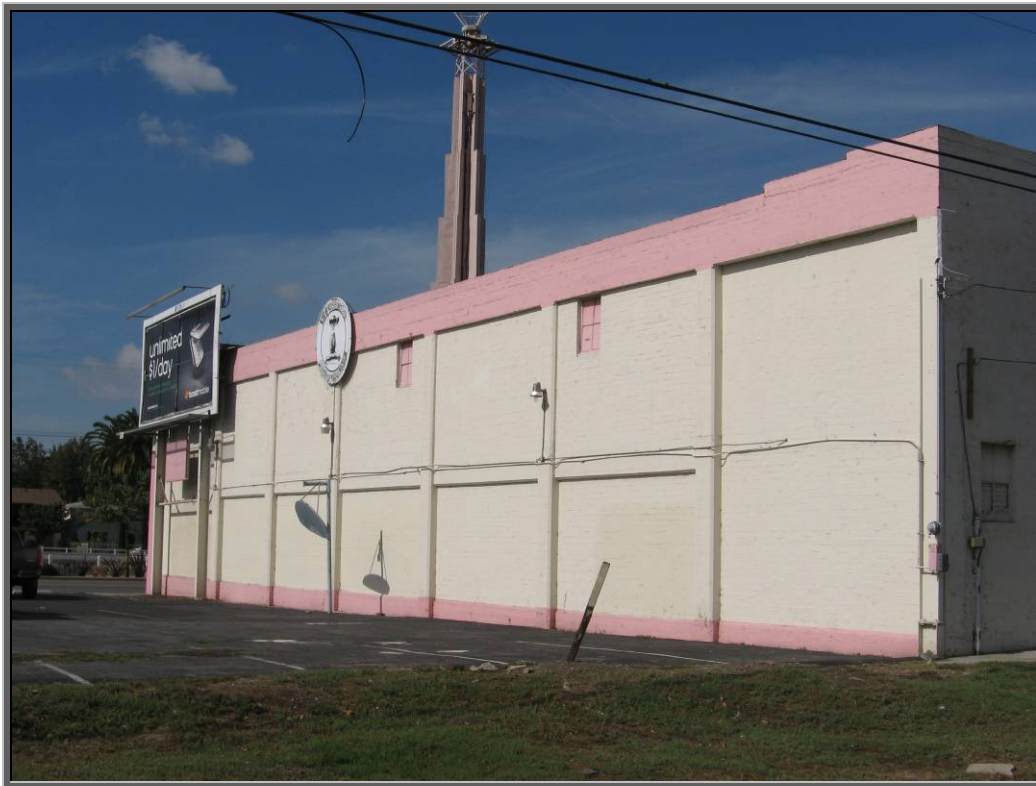
Photo 2: Brick infilled concrete frame at south elevation.

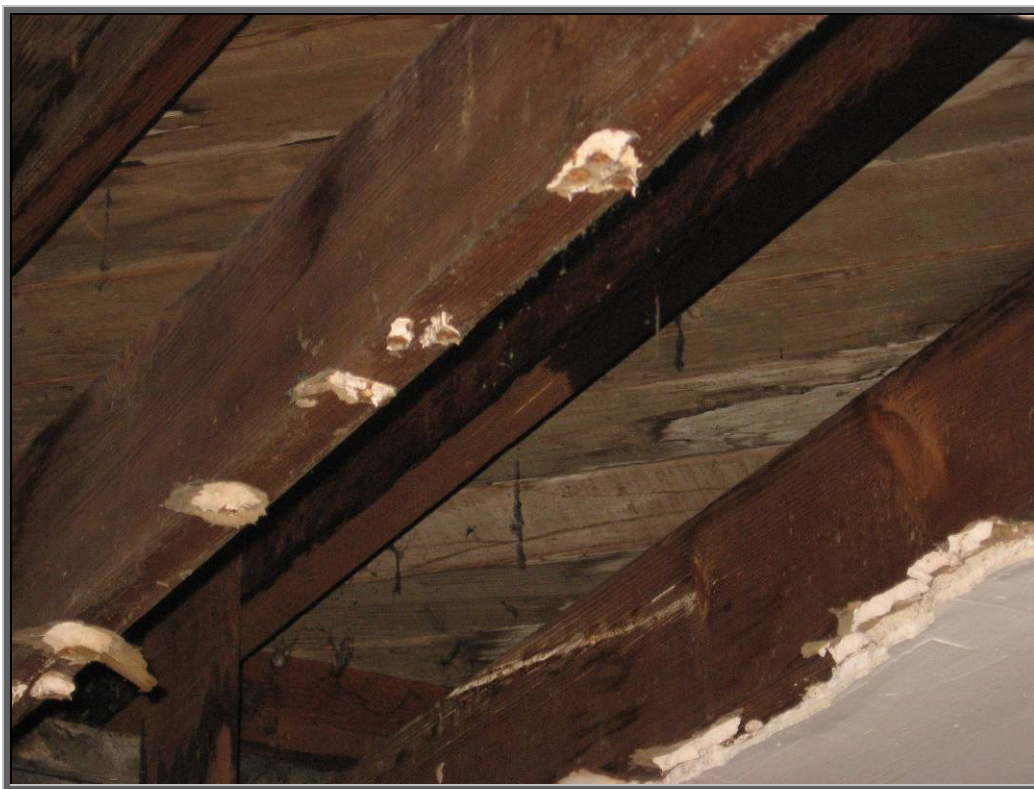
Photo 4: Typical diagonal roof sheathing.

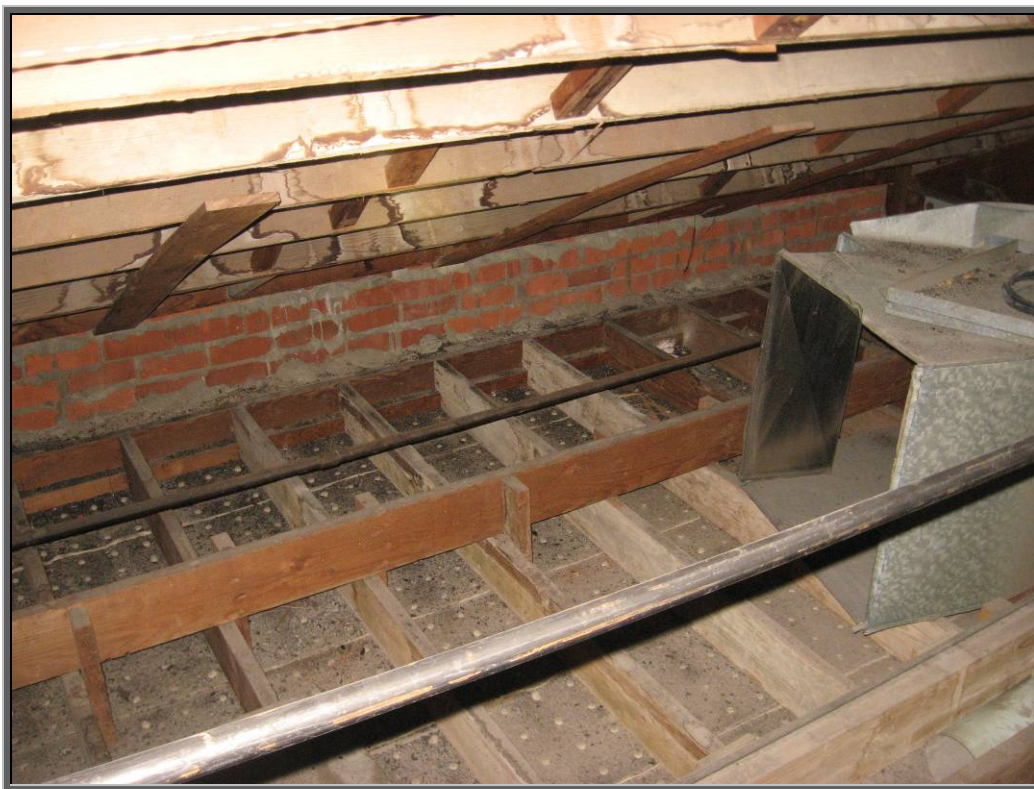
Photo 6: Typical plaster ceiling framing.

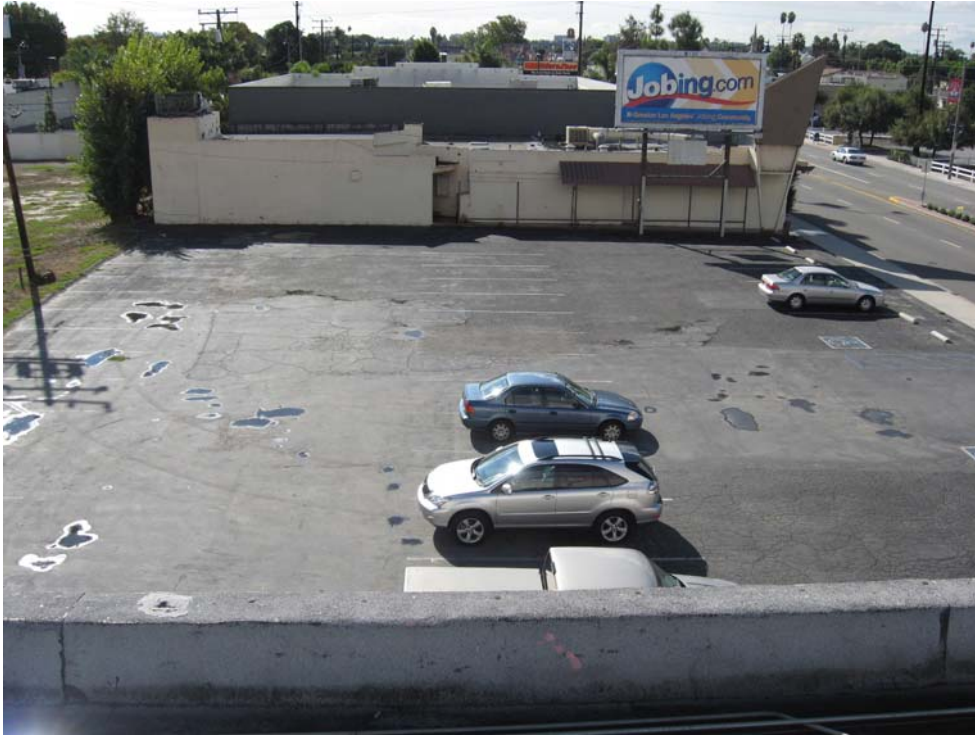
11

The asphalt paving in the parking lot is in very poor condition. Resurfacing the parking lot with another layer of asphalt could be completed but based on the age of the paving, the very poor condition and the number of cracks in the asphalt a complete removable and replacement is highly recommended. There are 46 striped parking stalls including two accessible parking stalls.

11. Overall view of the parking lot.

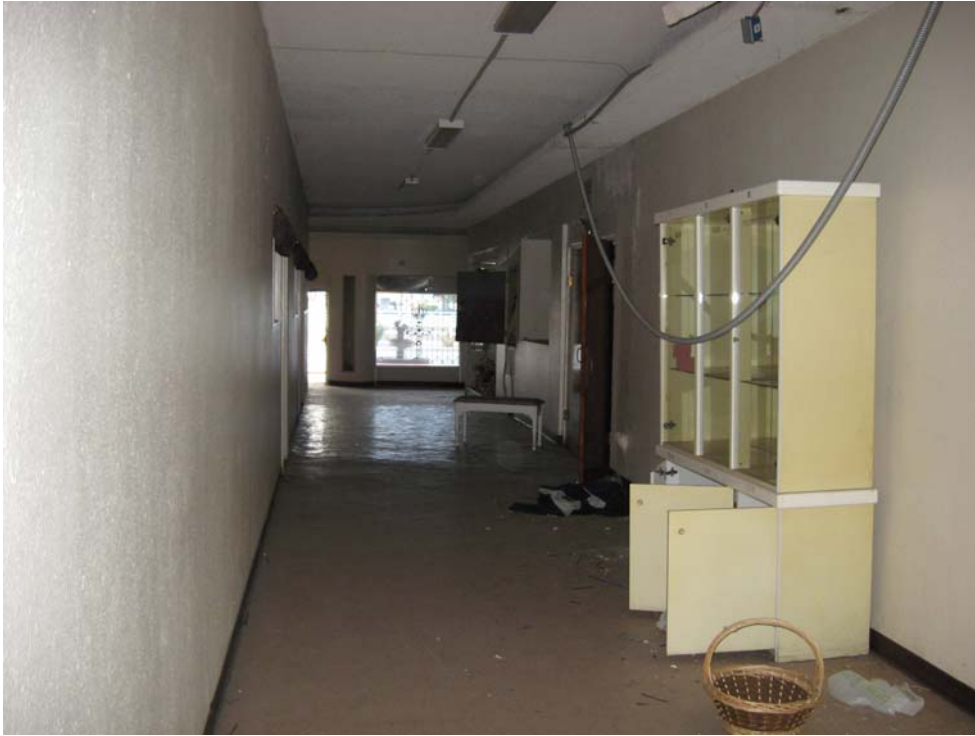
15

The interior finishes in the former church common areas consist of vinyl or carpeted floors, painted lath and plaster walls and ceilings. The building has been vacant for five years and the finishes are in poor condition with vandalism observed throughout. The interior finishes in the former furniture store consist of commercial grade carpeting and painted lath and plaster walls and ceilings. The interior finishes in the former furniture store are in poor condition and need to be replaced. Wide spread damage of the ceiling and exterior walls from roof leaks was observed during the March 2010 site visit.

15. Interior finishes at the former church main hallway.

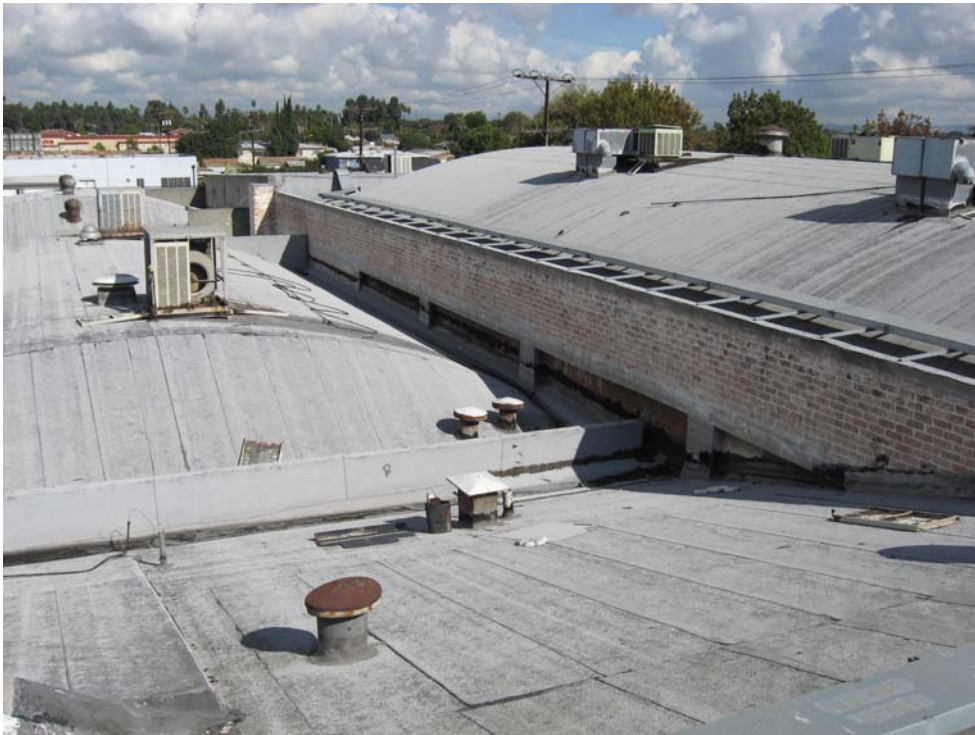
26

Access to the roof was not available during the March 2010 site visit. The roofing system consists of a built-up membrane with mineral faced capsheet. During the March 2010 site visit numerous active roof leaks were observed throughout the building. In several locations the plaster ceilings have collapsed and mold was visible on wall and ceilings. The membrane is in poor condition and needs to be replaced.

26. View of the different roof areas.

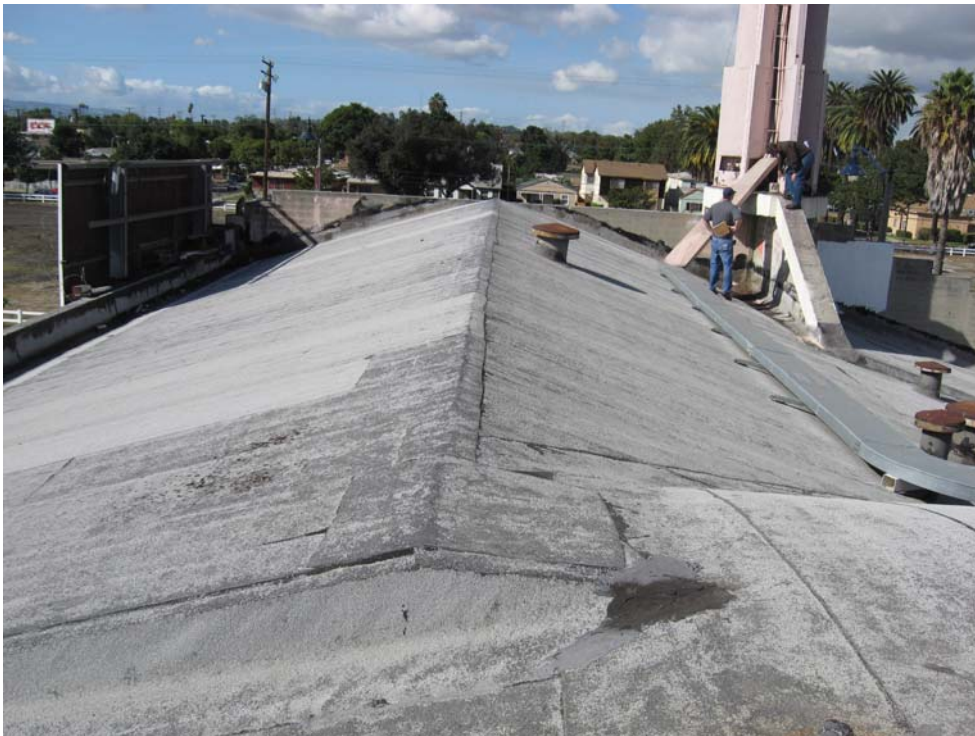
28

28. Section of the roof over the former church.

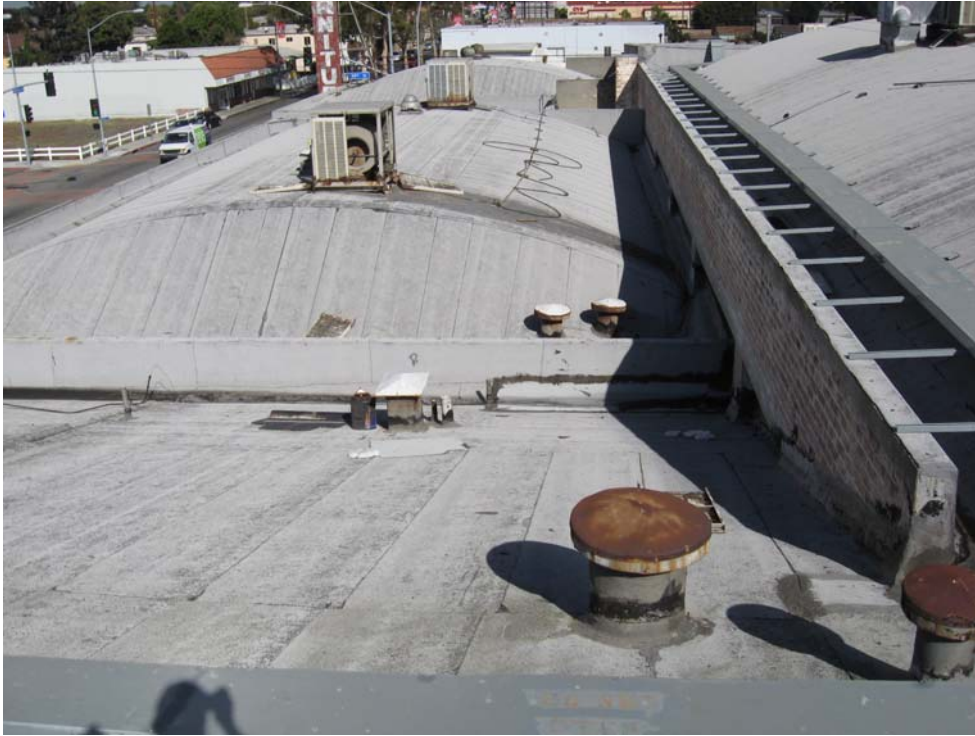
29

29. Section of the roof over the former furniture store.

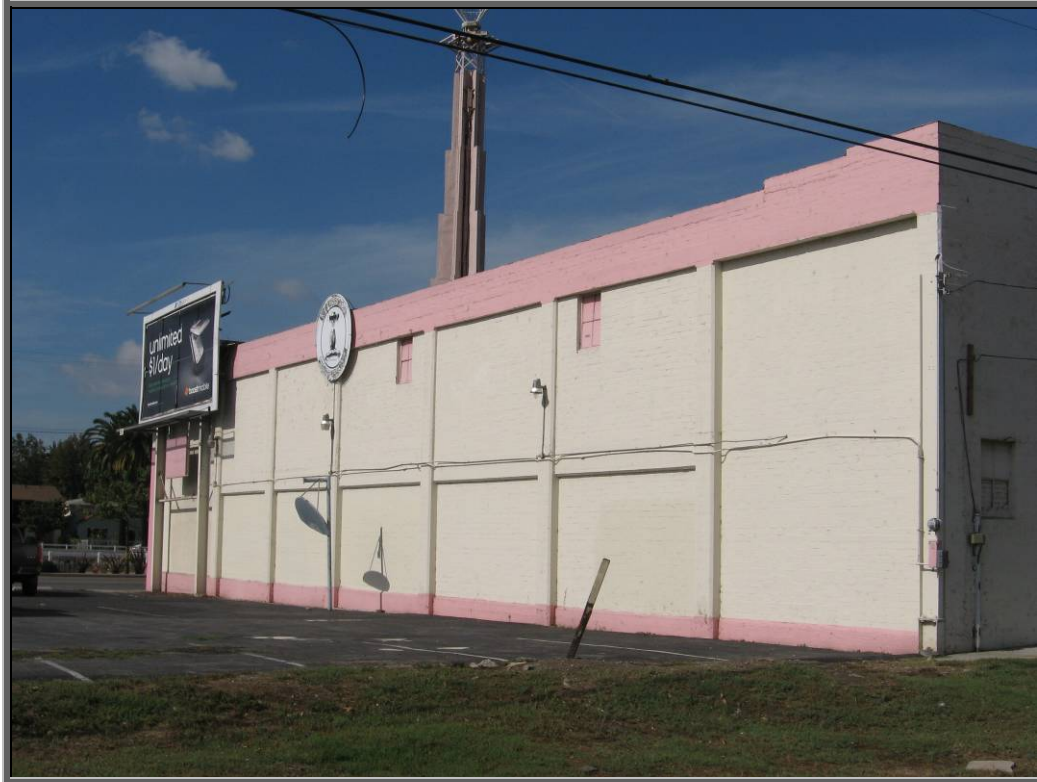
Photo 2: Typical brick infilled concrete frame.

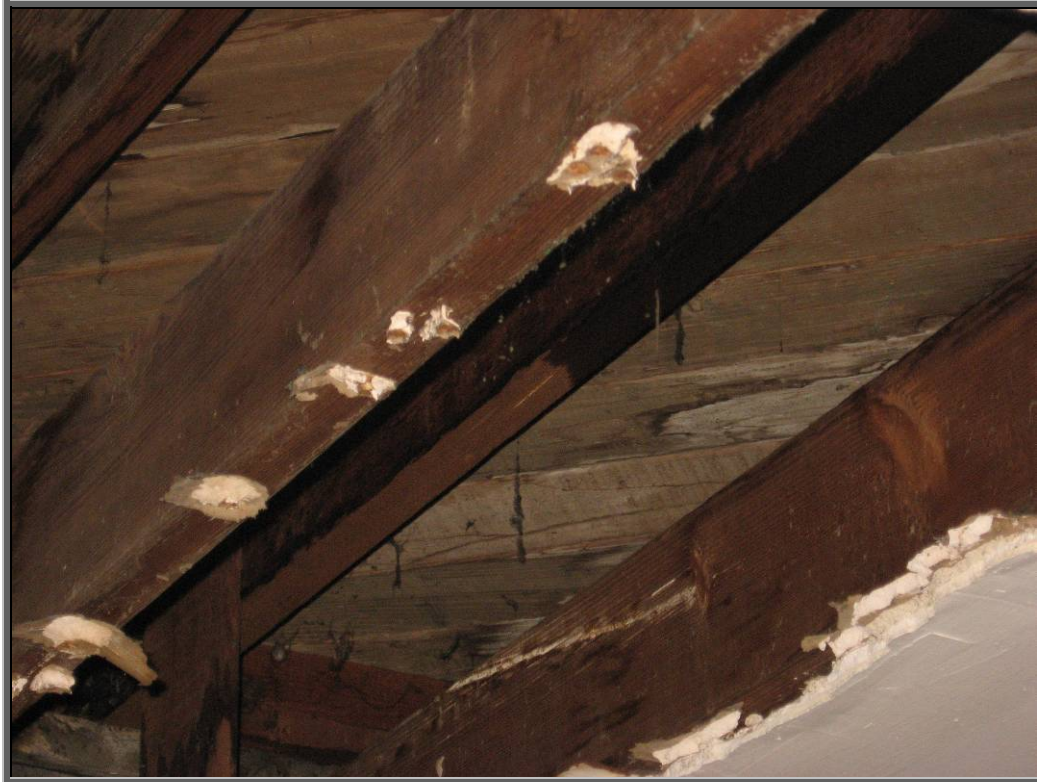
Photo 4: Typical diagonal roof sheathing.

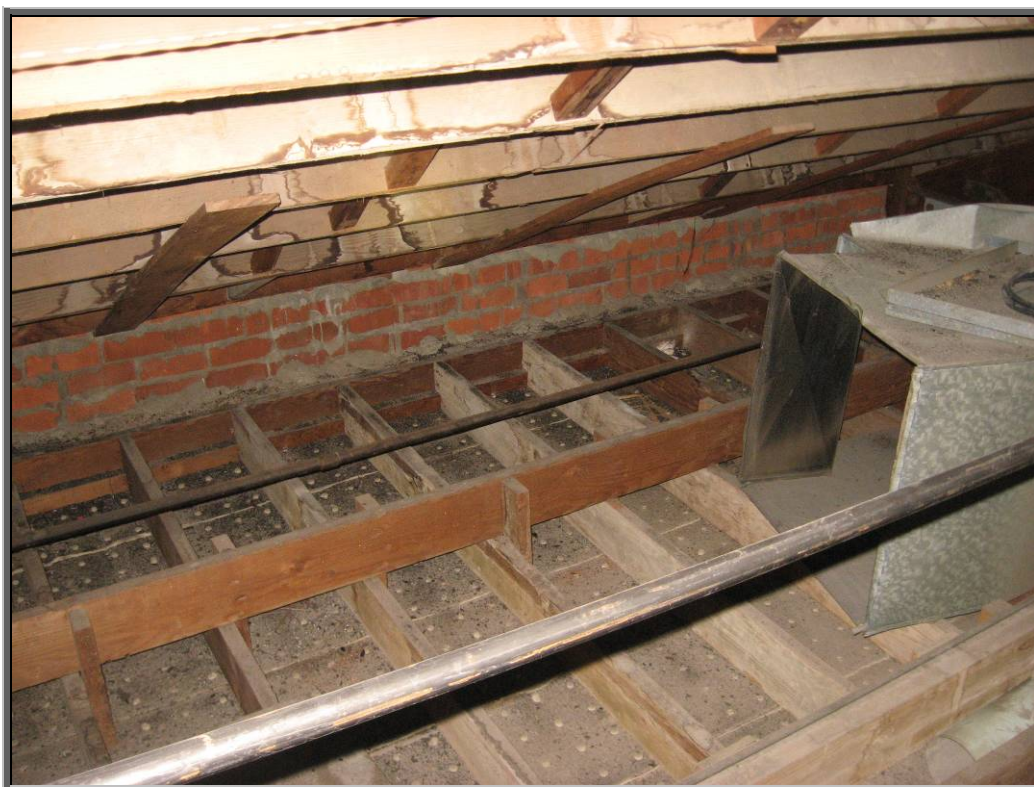
Photo 6: Typical plaster ceiling system.
