PARSONAGE RESIDENCE
640 PACIFIC AVENUE
LONG BEACH, CALIFORNIA 90813

HISTORIC STRUCTURE REPORT

Katie Rispoli Keaotamai
Master of Heritage Conservation
on behalf of
KEAOTAMAI, LLC
July 12, 2018

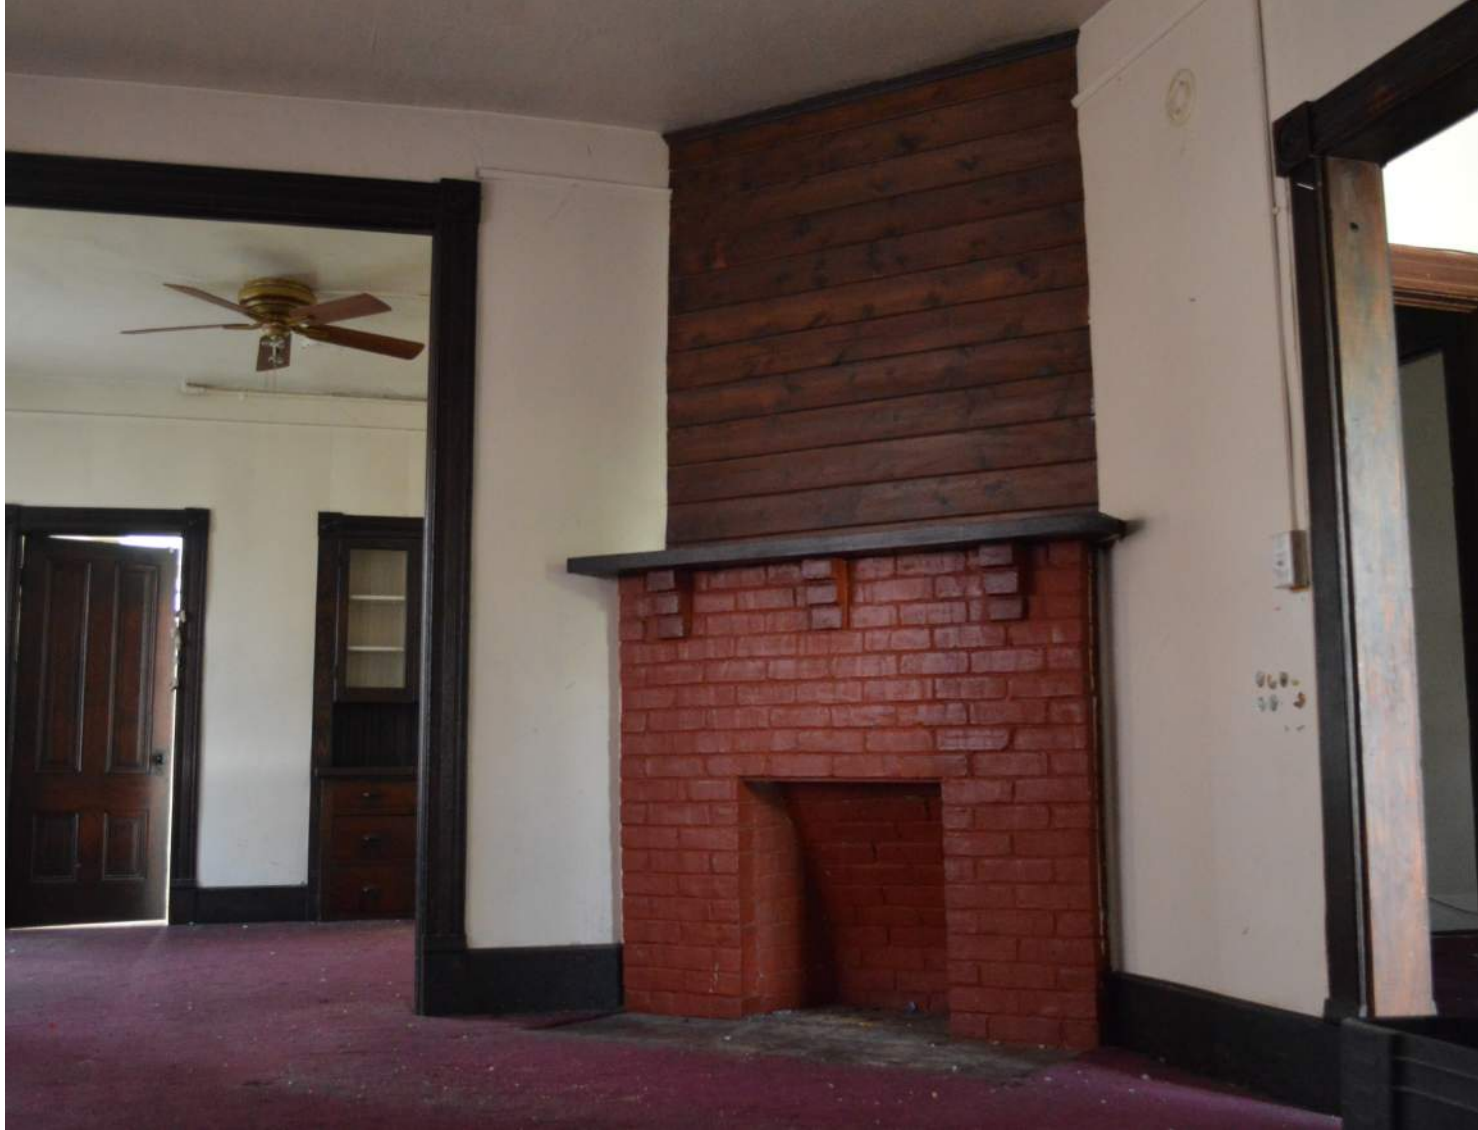
Fireplace and wood trim in Parsonage living room, First Floor, View Southeast (existing condition)
Photo: June 2018

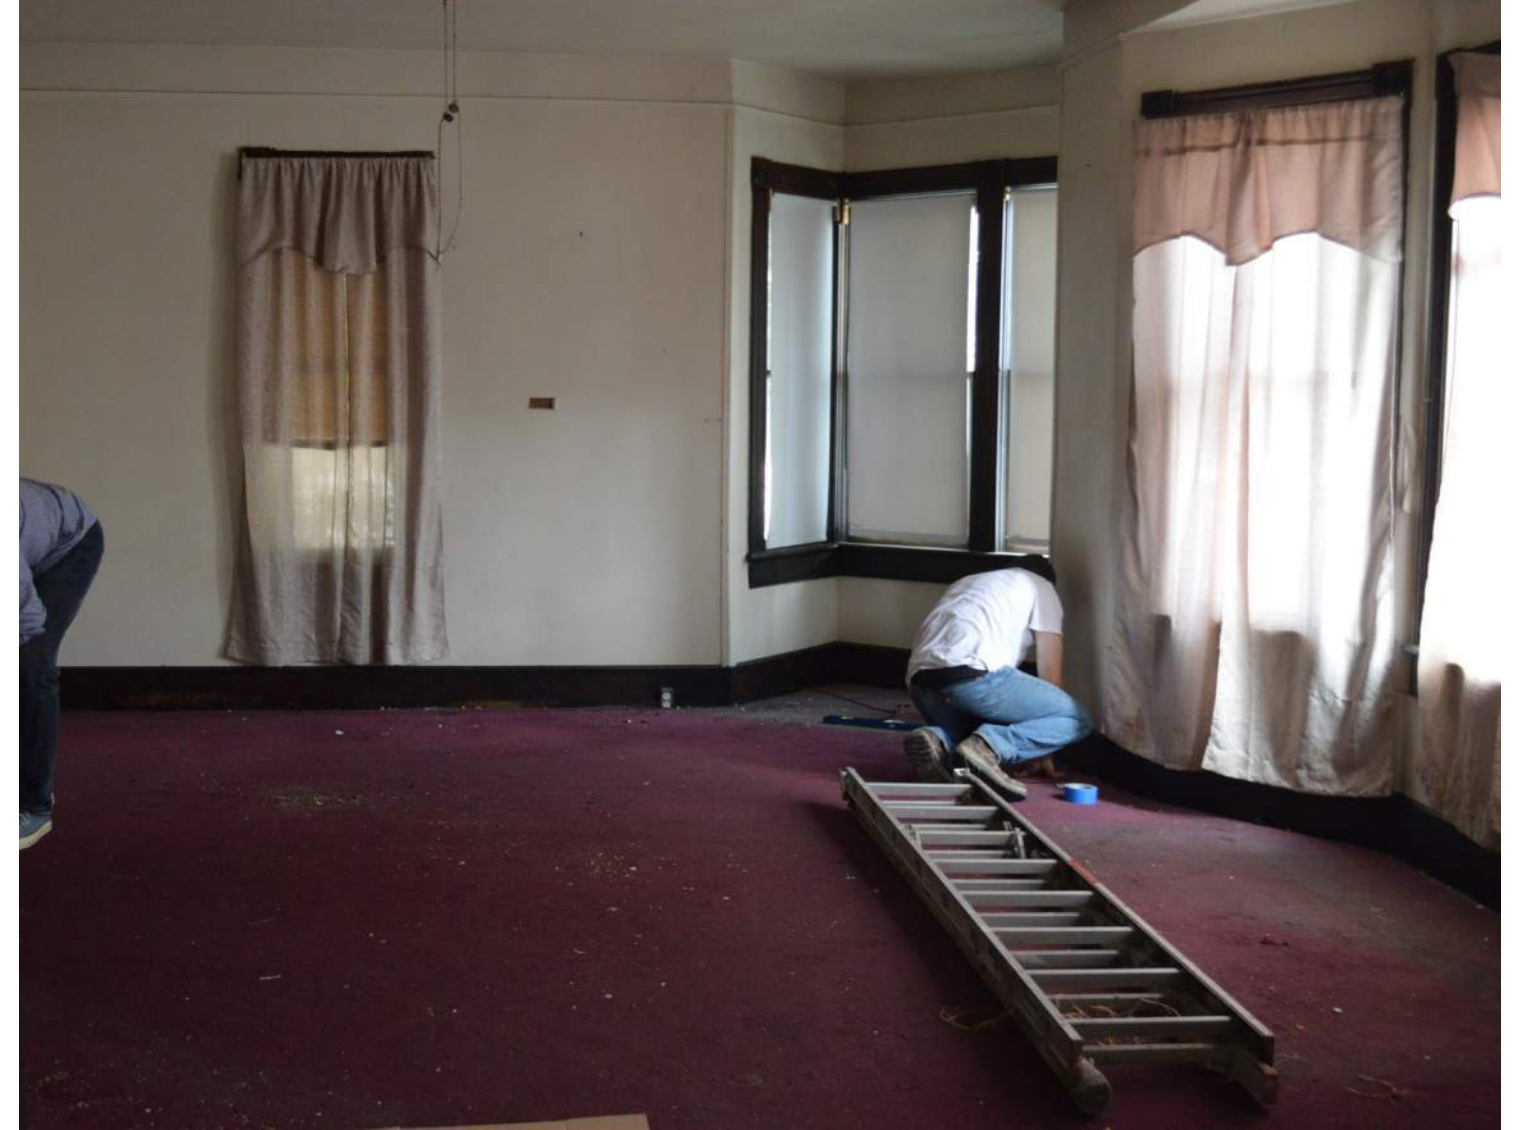
Living room area in Parsonage, First Floor, View West (existing condition)
Photo: June 2018

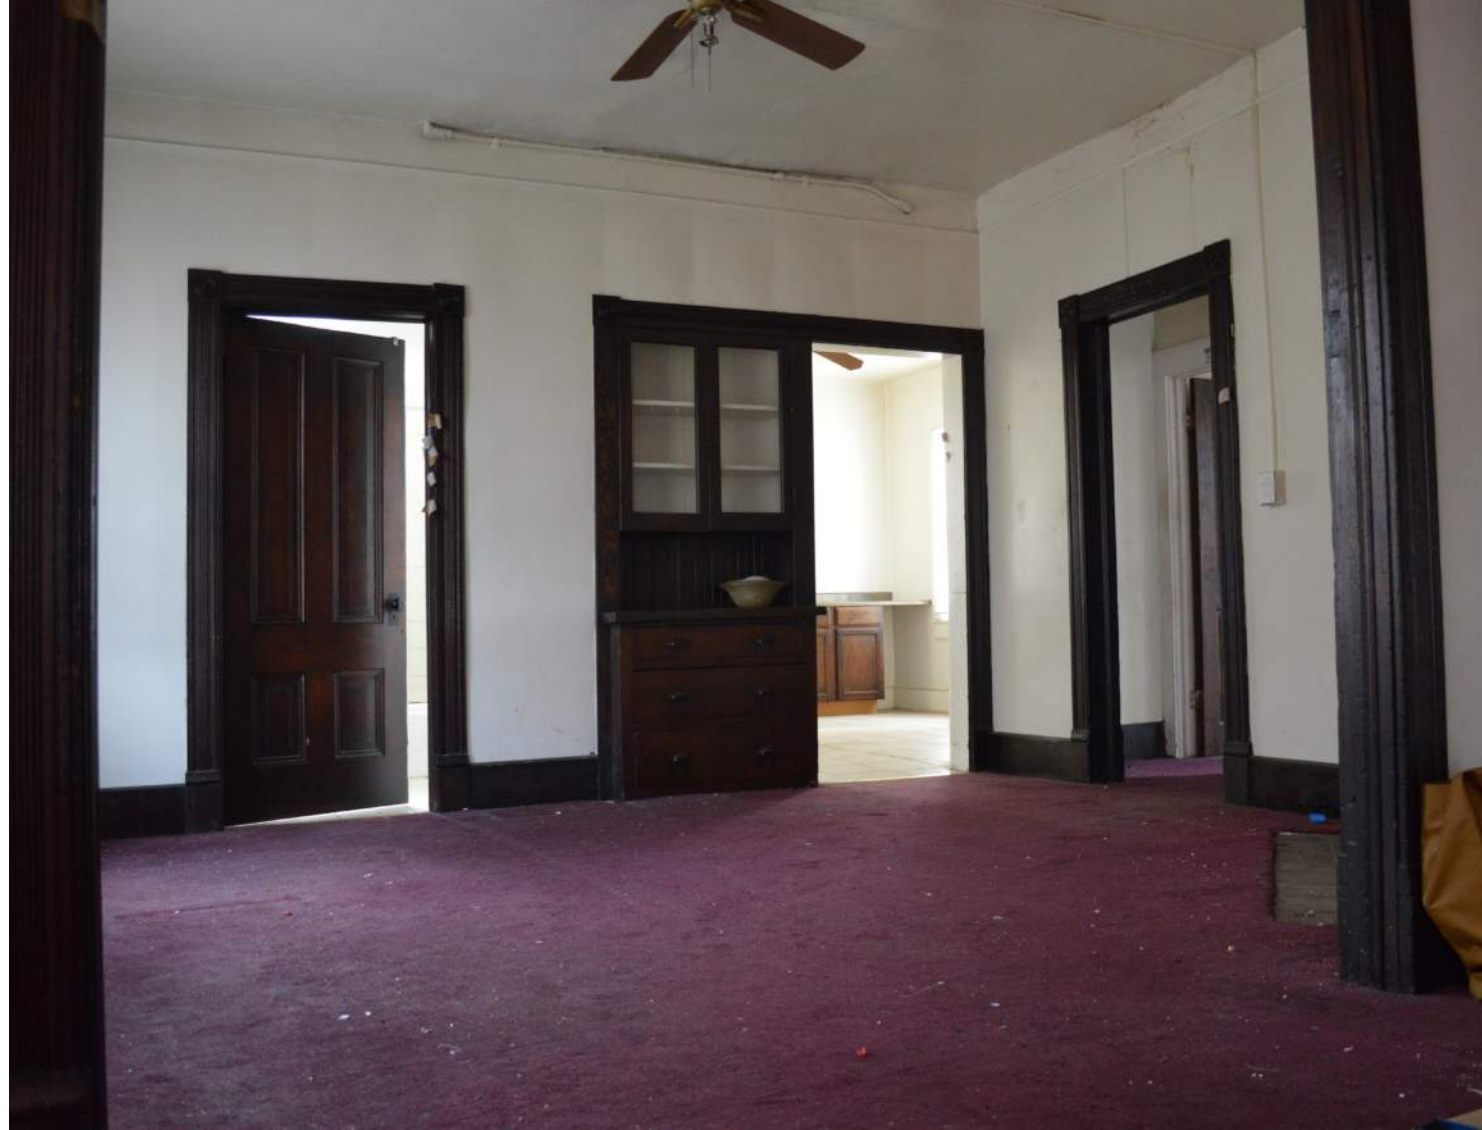
Cabinet and wood detailing in Parsonage dining room, First Floor, View Southeast (existing condition)
Photo: June 2018

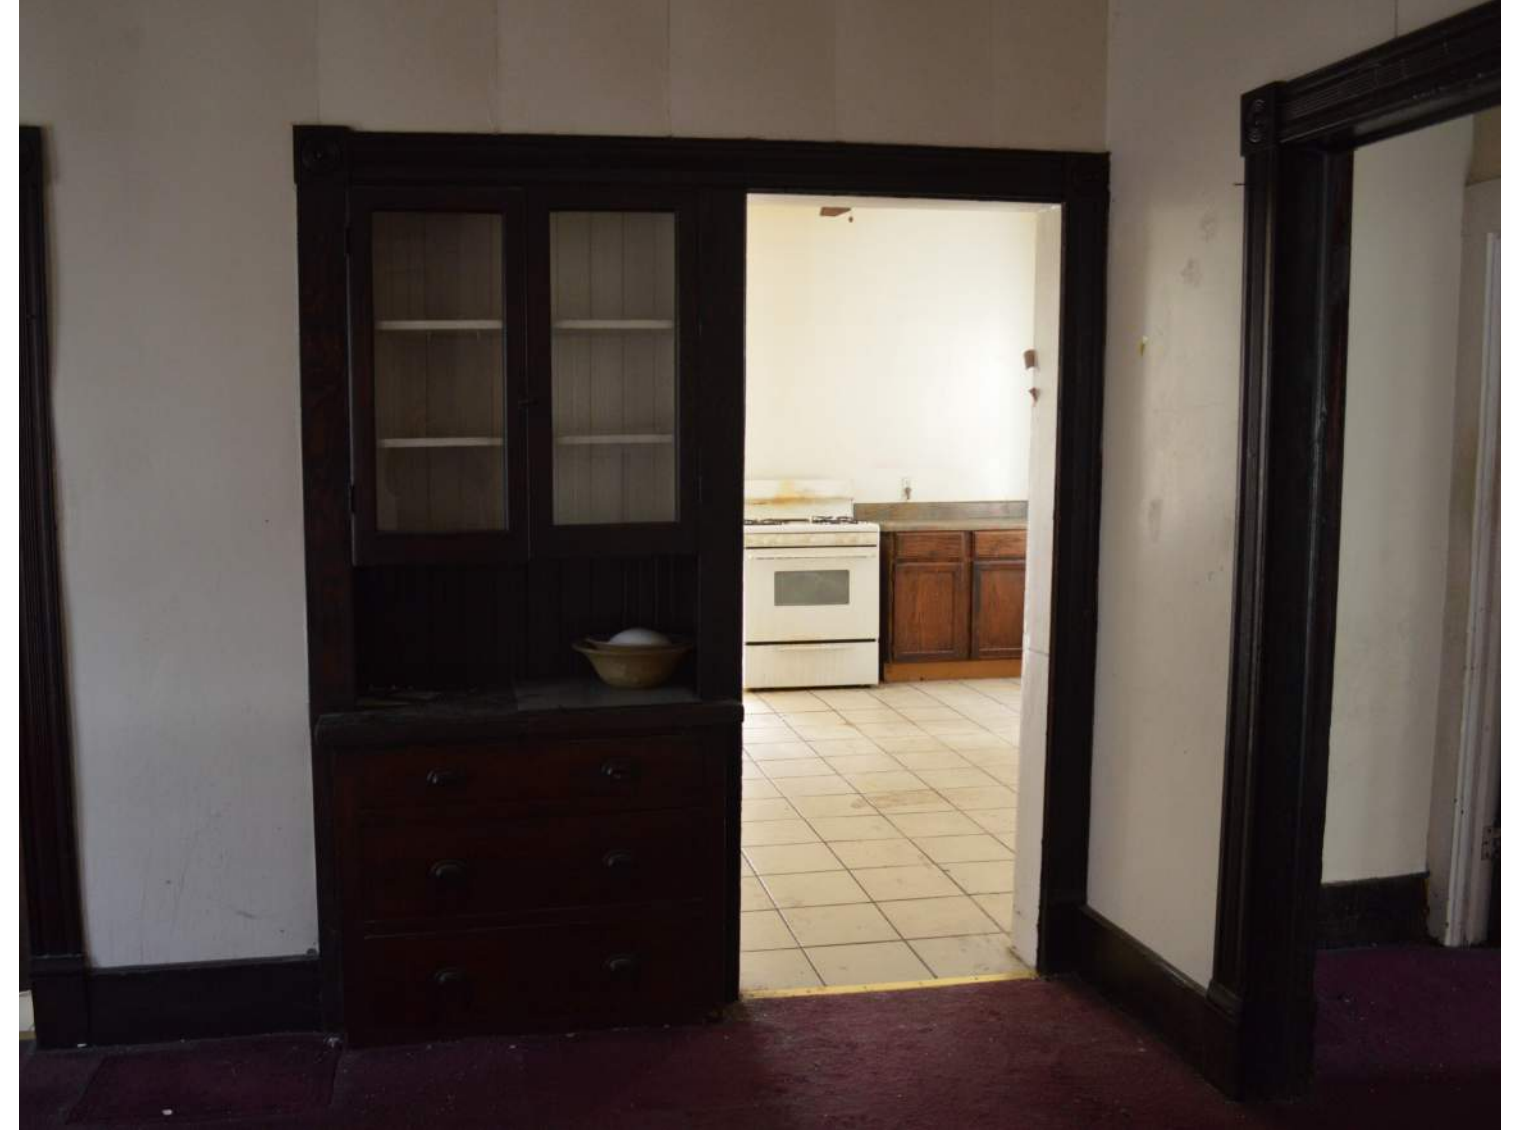
Close-up of original cabinet and wood trim in dining room, First Floor, View East (existing condition)
Photo: June 2018

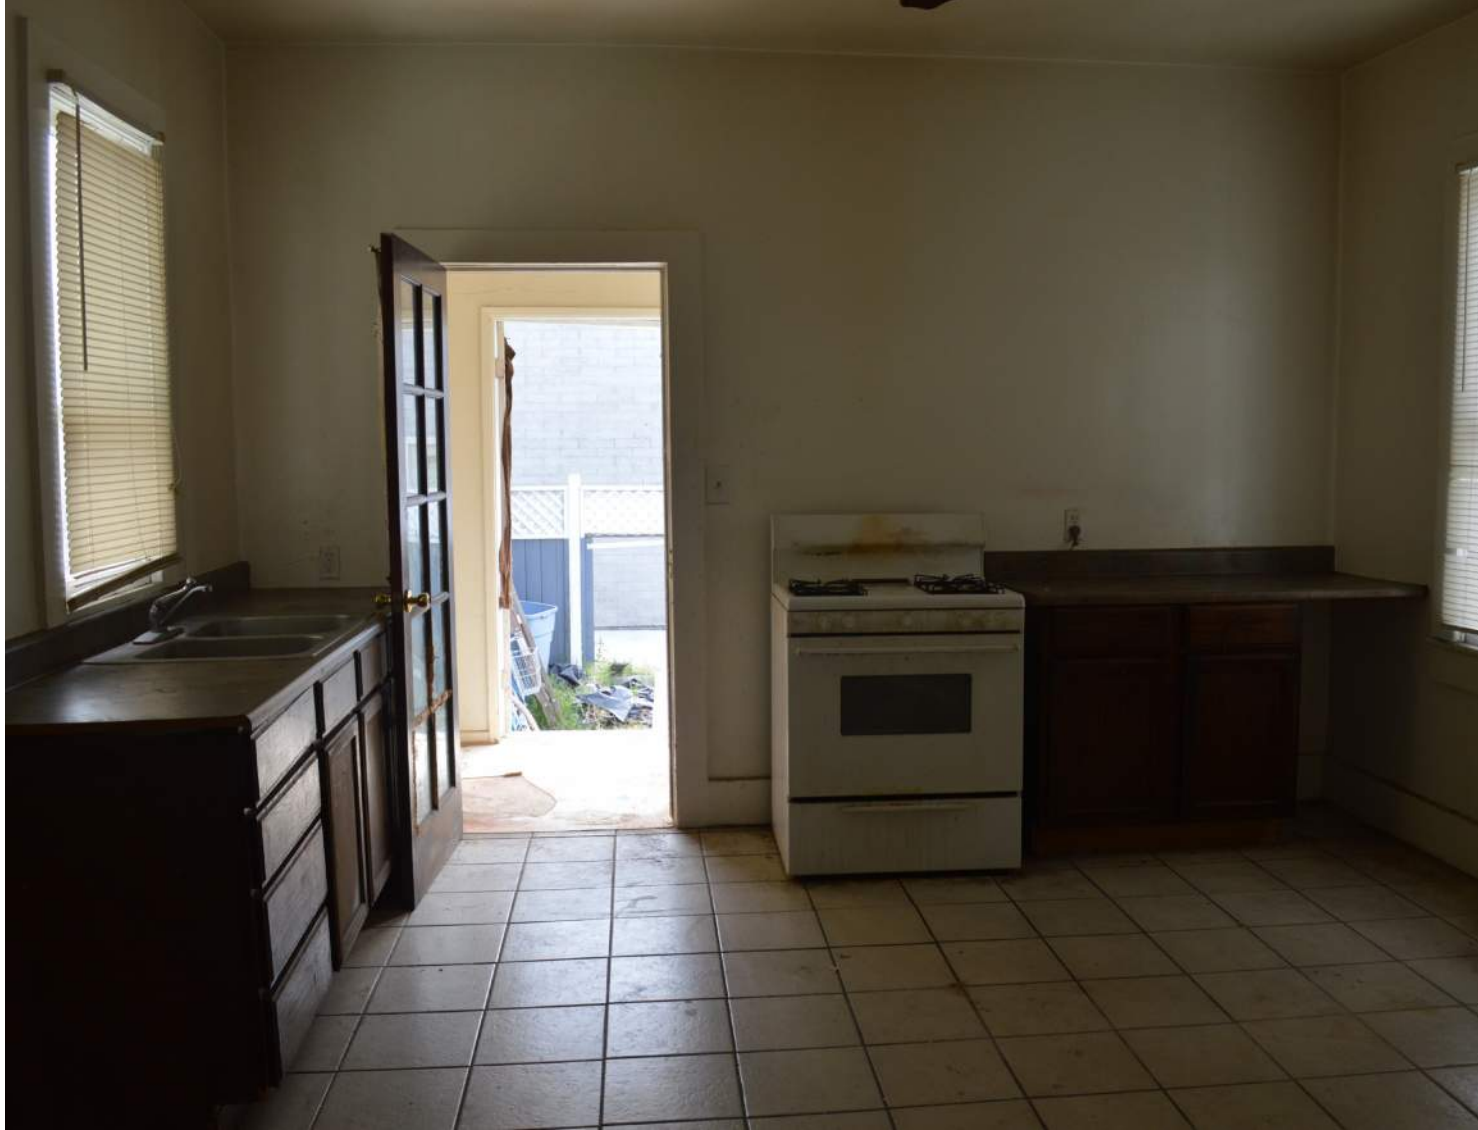
Kitchen area, First Floor, View East (existing condition)
Photo: June 2018

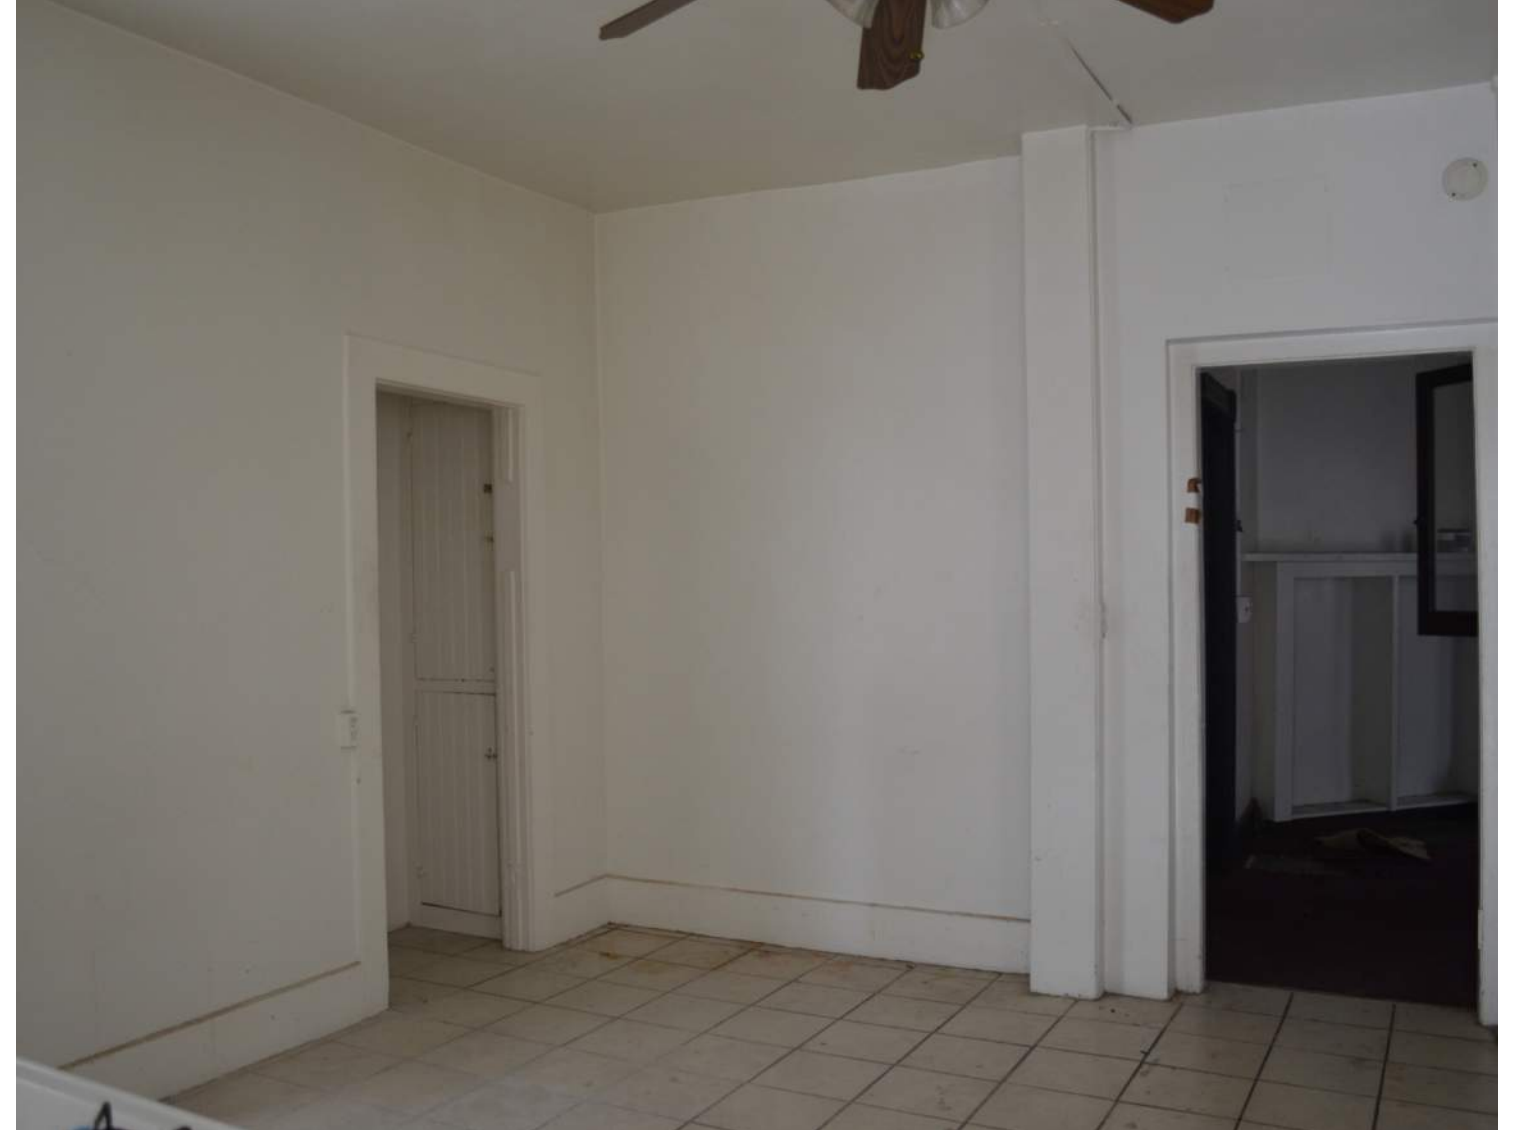
Kitchen, First Floor, View Southwest (existing condition)
Photo: June 2018

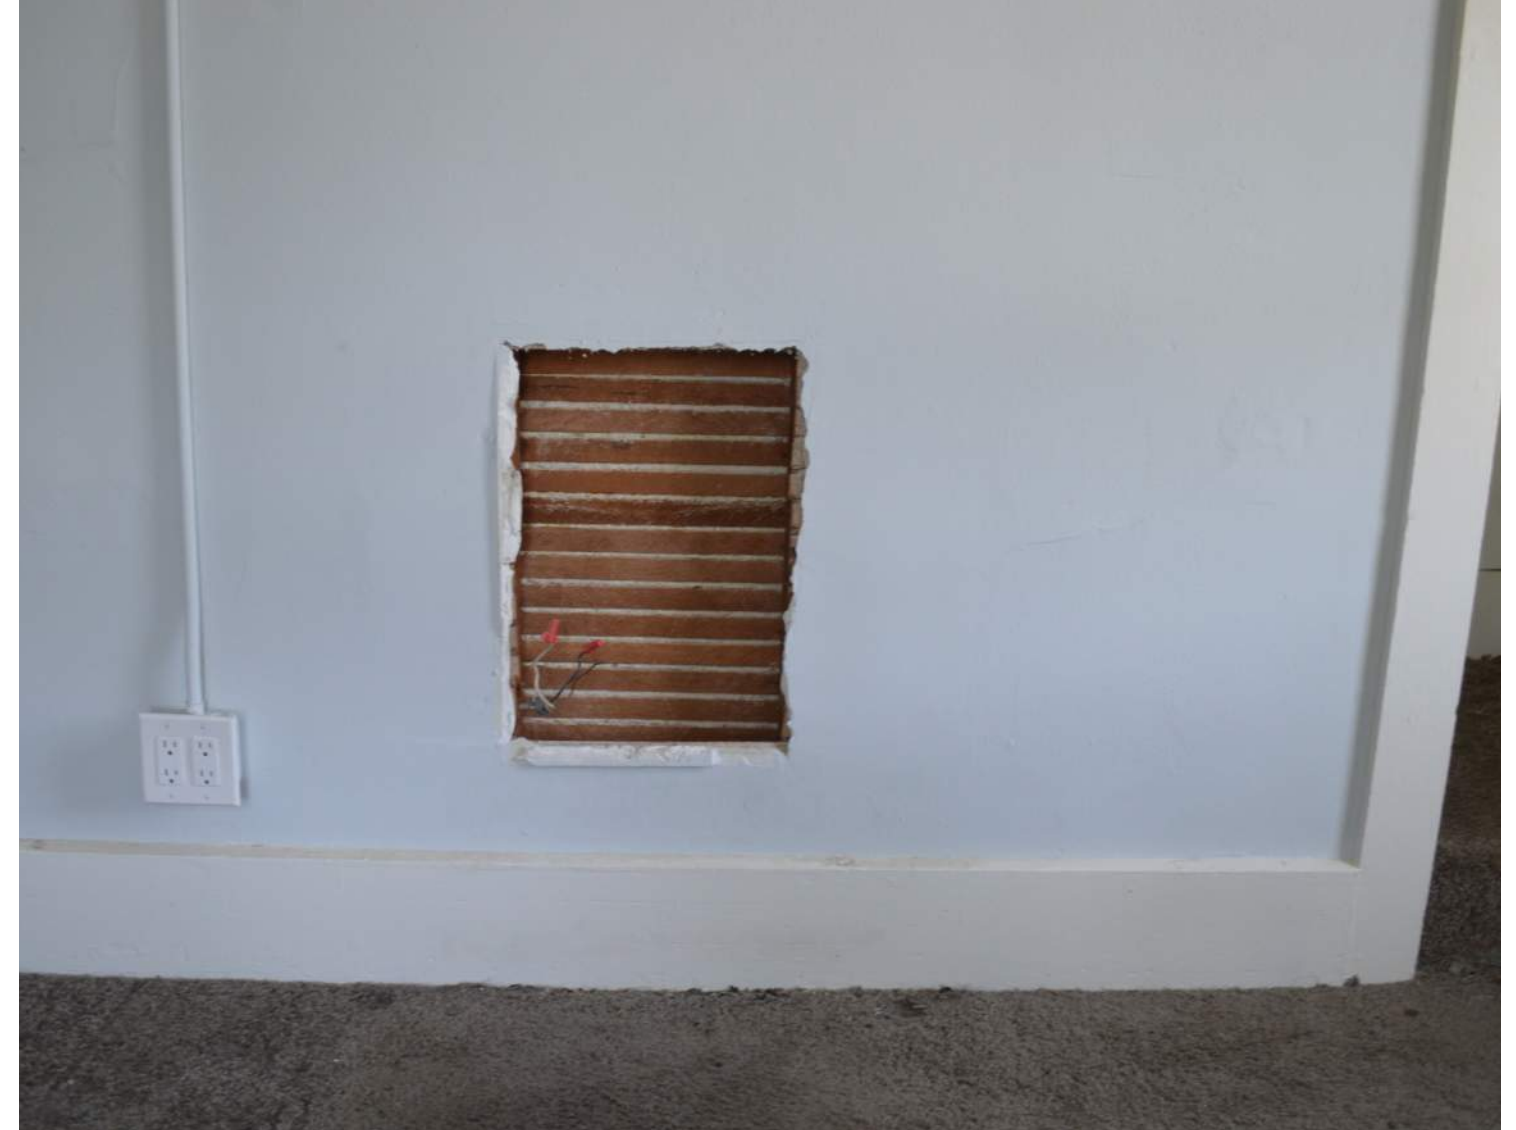
Original construction detail, Second Floor (existing condition)
Photo: June 2018
