REHABILITATION/RESTORATION/MAINTENANCE PLAN

Property Name and Address: The Parsonage, 326 W. 10th Street

City of Long Beach
MILLS ACT PROPERTY TAX INCENTIVE PROGRAM

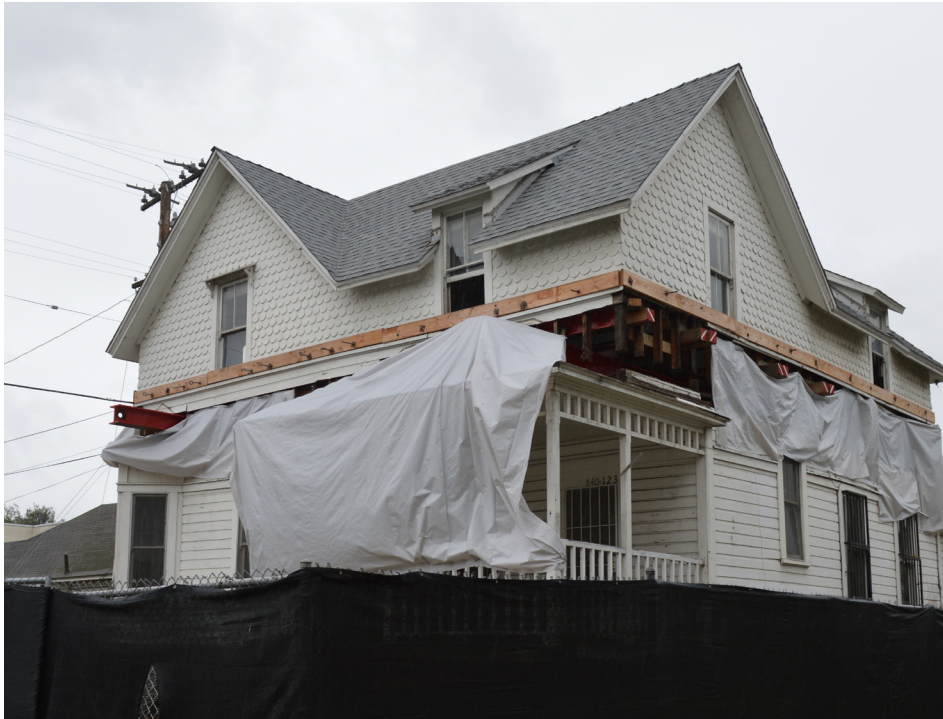
North Elevation, View Southeast (March 21, 2019)

This elevation retains additional character-defining features not listed in the enclosed Rehabilitation Plan including roof gables, bracketed window surrounds, and porch supports and decorative porch detailing. These features will be repaired and restored during 2019, and so work completed will not take place during the applicable work period.

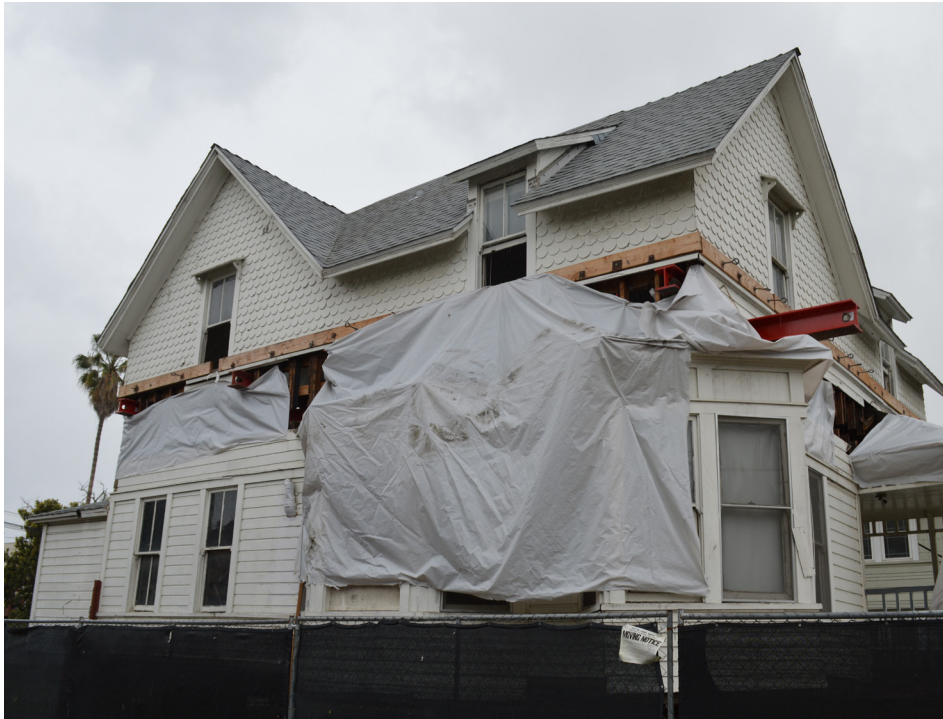
East Elevation, View Southwest (March 21, 2019)

This elevation retains additional character-defining features not listed in the enclosed Rehabilitation Plan including roof gables, bracketed window surrounds, bay windows with individual roof forms, and decorative wood detailing. These features will be repaired and restored during 2019, and so work completed will not take place during the applicable work period.

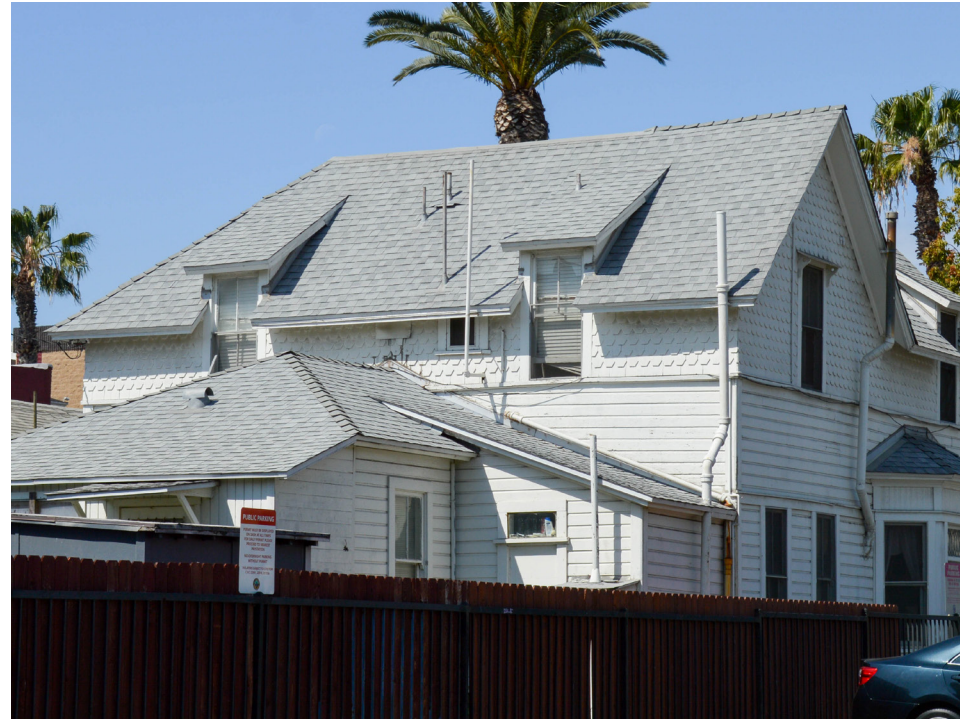
South Elevation, View Northwest (January 9, 2018)

The photograph at left of the building in its present condition documents an opening created through the removal of an addition to the building added after the period of significance, which took place prior to the building's relocation in November 2018. This elevation also retains additional character-defining features not listed in the enclosed Rehabilitation Plan including roof forms and bracketed window surrounds are shown in these photographs. The opening will be filled according to currently-approved plans, and these additional features will be repaired and restored during 2019. As such, they are not included in the Rehabilitation Plan as work completed will not take place during the applicable work period.

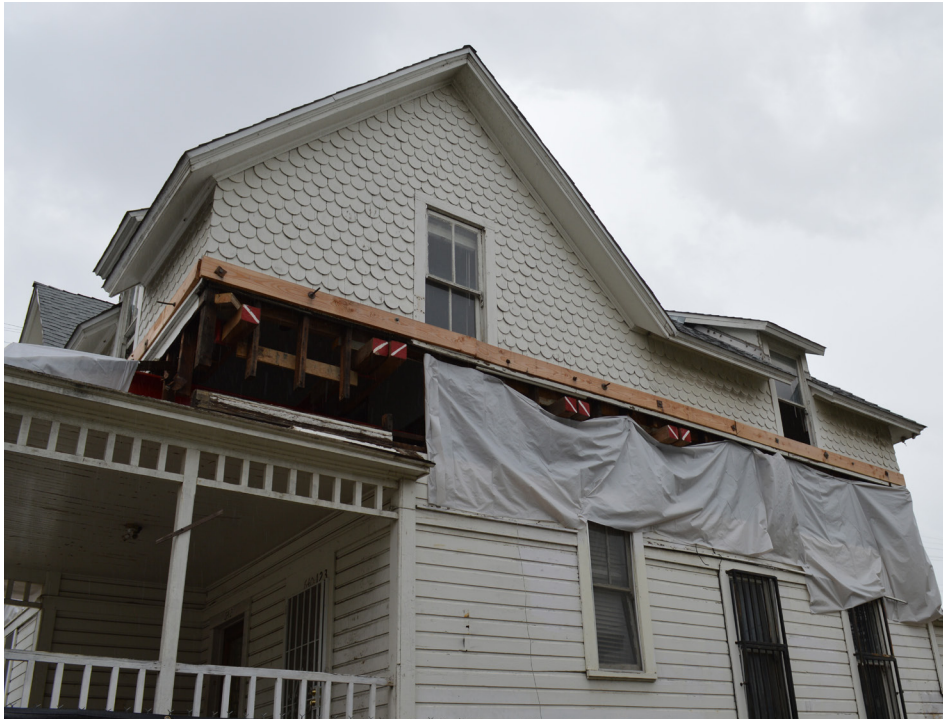
West Elevation, View Southeast (March 21, 2019)

This elevation retains additional character-defining features not listed in the enclosed Rehabilitation Plan including roof gables, bracketed window surrounds, additional wood detailing, and porch supports and decorative porch detailing. These features will be repaired and restored during 2019, and so work completed will not take place during the applicable work period.

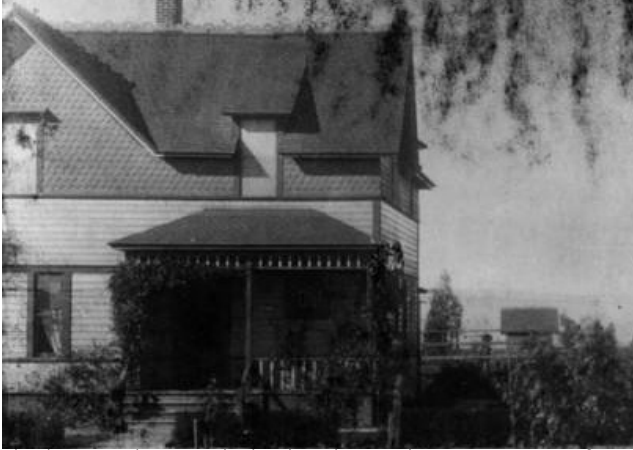
Item No. 5: Exterior Painting in Original Color Scheme Determined by Forensic Paint Analysis

This historic photograph clearly indicates the varying tones of paint colors as well as other features (like front door placement.)

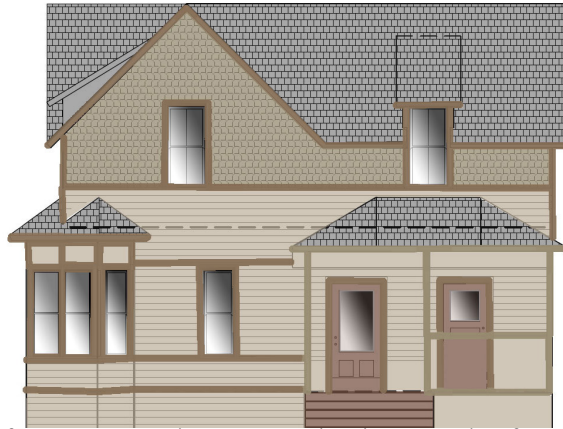
A forensic paint analysis was completed in 2018, identifying the above color palette as original to the building.
