Subject: **Update on Queen Mary Lease Management - REVISED**

# CRITICAL STRUCTURAL REPAIRS STRUCTURAL ANALYSIS: STRESS RESULTS & TANK TOP REPAIR

## QUEEN MARY LONG BEACH, CALIFORNIA

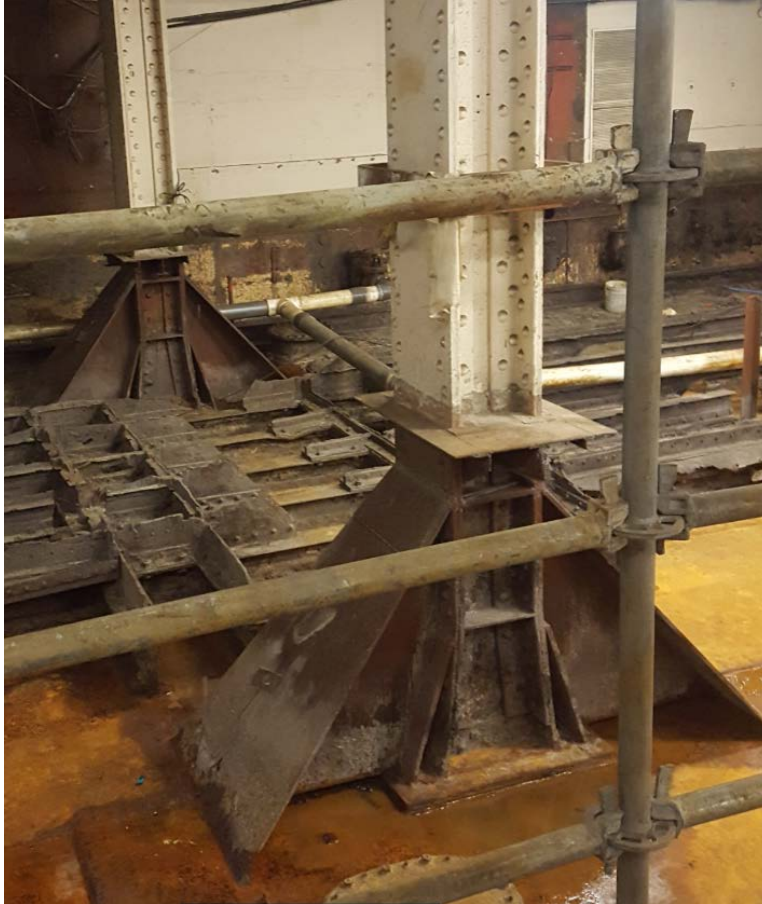
**Figure 11. Photo of pillar supported on tank top**

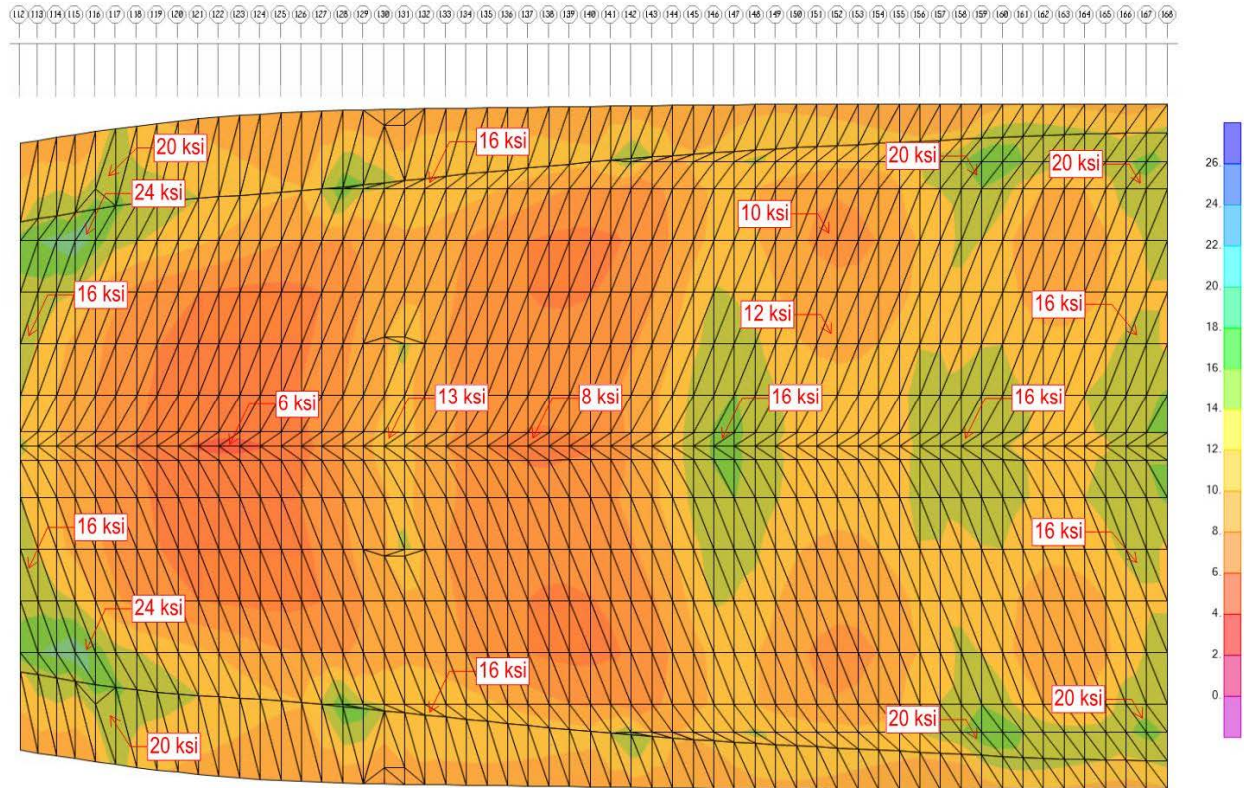
Per existing 1930's drawings, the interior hull tank top plate thickness in the exhibition area varies anywhere from 0.42 to 0.8 inches. The thinnest most common plate thickness was 0.67 inches. To address for possible corrosion, we created an additional FEA model that conservatively uses a reduced plate thickness of 0.25 inches for the entire inner hull. We enveloped our analysis by checking stresses for both inner hull thicknesses. Plate reduction from the thinnest most common plate thickness of 0.67 inches to 0.25 inches increased the von Mises stresses an average of 35%. The highest von Mises stress demand for the interior hull is 23.8 ksi (elements 40556 and 37375; see Table 2, column 13), which is below the allowable stress capacity of 26.1 ksi. Most of the stresses on the inner hull plates are well below this with the average being around 10-12 ksi. See the stress heat maps shown in Figures 1 and 2 below.

**Figure 27. Heat map of the von Mises stresses in the interior hull in the exhibition area (values in the legend are in ksi)  
[plan view]**

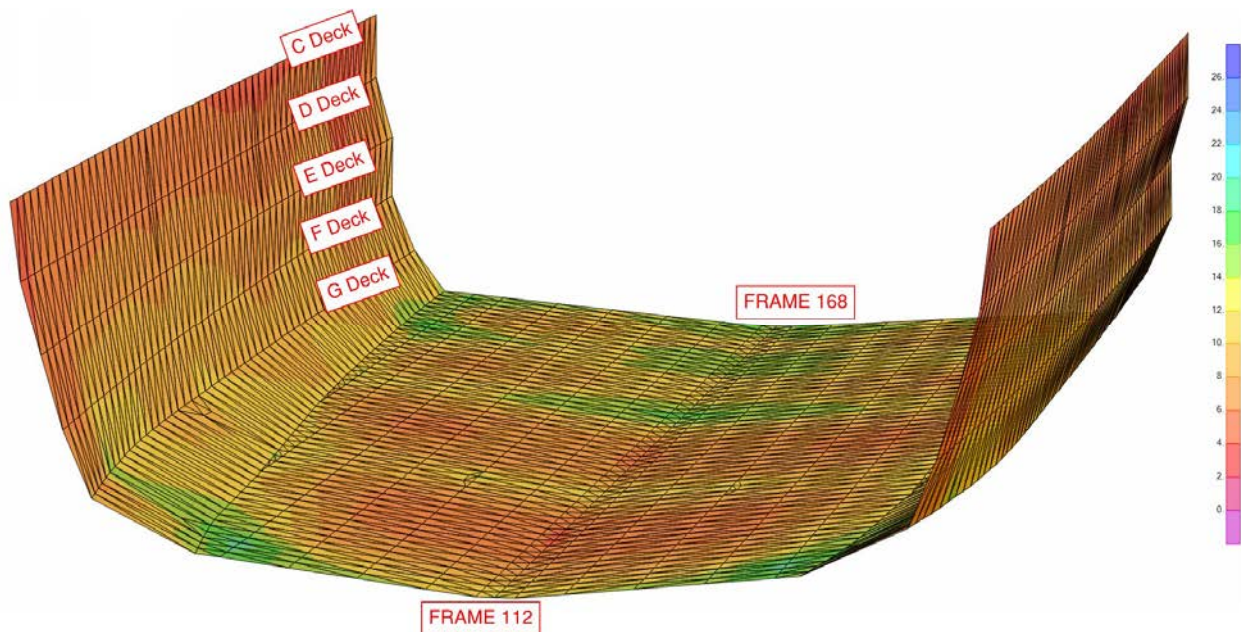
**Figure 28. Heat map of the von Mises stresses in the interior hull in the exhibition area (values in the legend are in ksi)  
[3D view]**

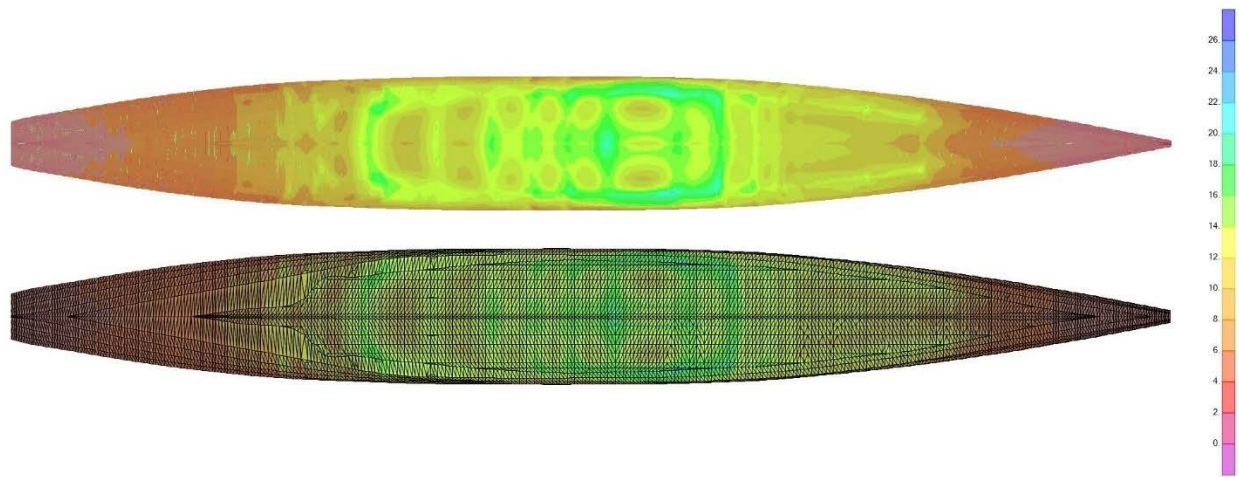
Over the length of the ship, there are no interior hull elements exceeding the allowable stress of 26.1 ksi (see Figure 3). The heat map of the entire inner hulls shows that the higher stress concentrations are generally in the middle of the ship. This is a reasonable result since the deflected shape of the ship is hogging 14 inches.

**Figure 29. Heat map of the von Mises stresses on the entire interior hull  
(values in the legend are in ksi)  
[plan view]**

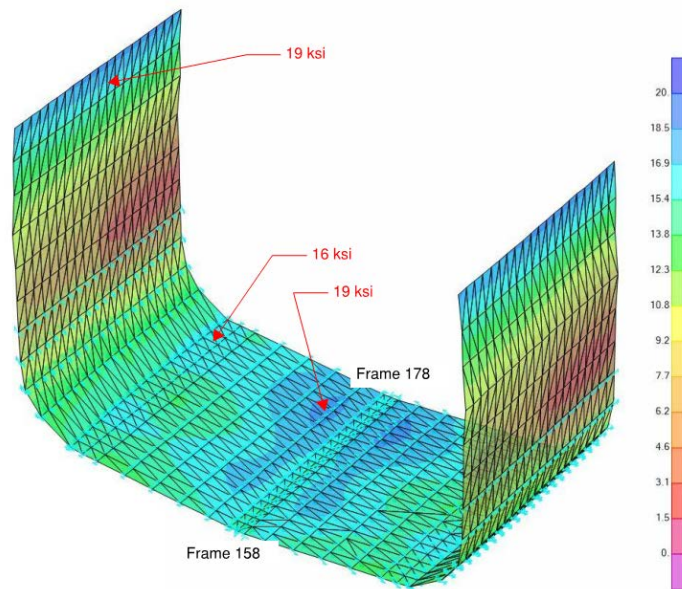
**Figure 35. Von Mises stresses in the exterior hull of the model with 20 ft of water behind bulkhead 112 [Max stress = 19 ksi].**

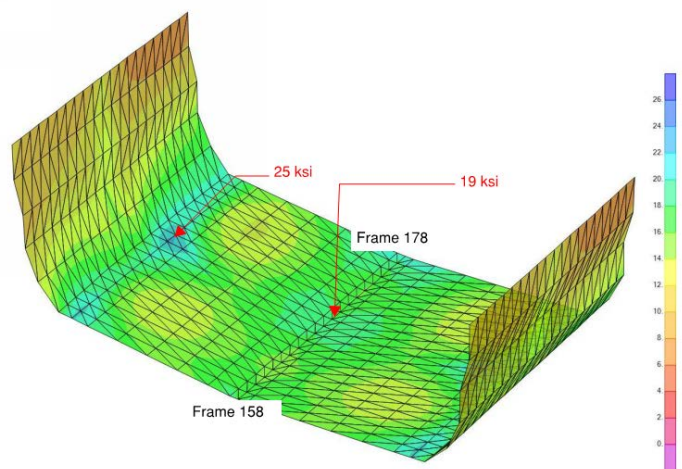
**Figure 36. Von Mises stresses in the interior hull of the model with 20 ft of water behind bulkhead 112 [Max stress = 25 ksi].**

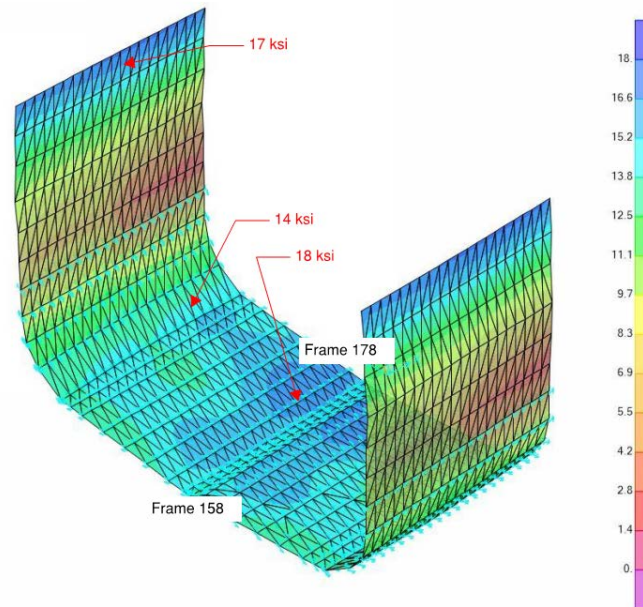
**Figure 37. Von Mises stresses in the exterior hull of the model with uniform water [Max stress = 18 ksi].**

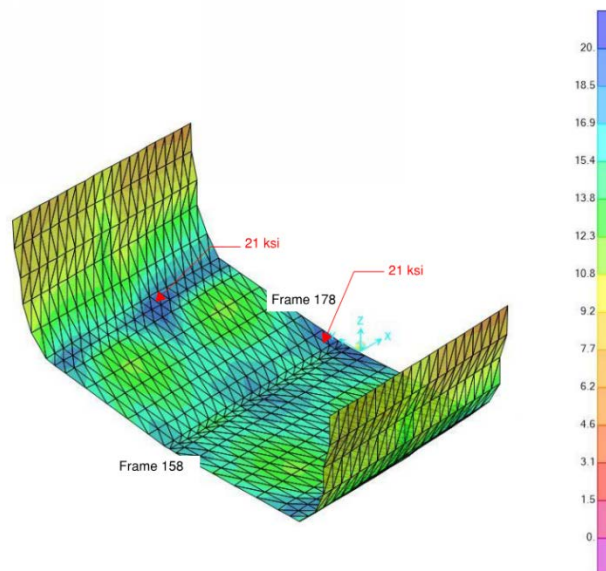
**Figure 38. Von Mises stresses in the interior hull of the model with uniform water [Max stress = 21 ksi].**

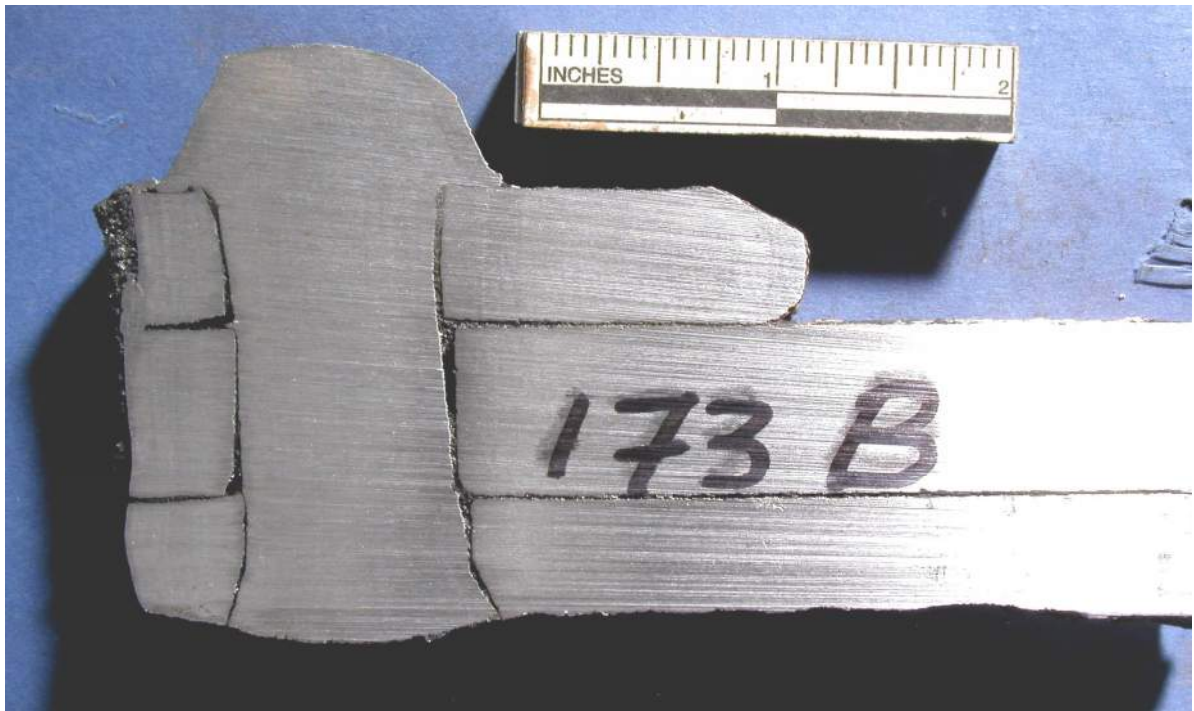
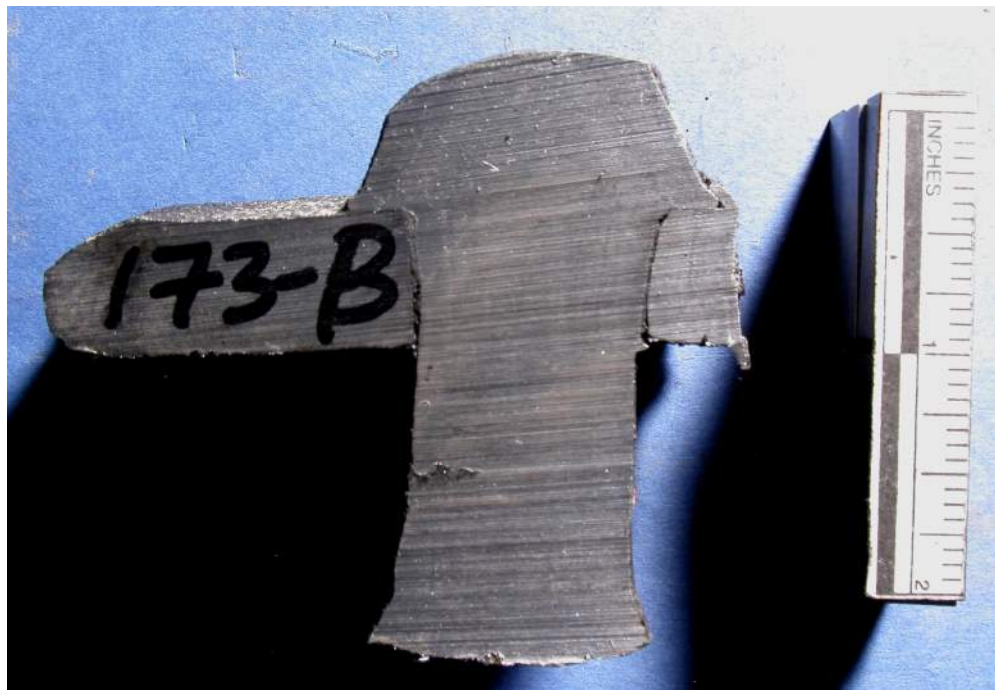
**Rivet From Section 173 - B**

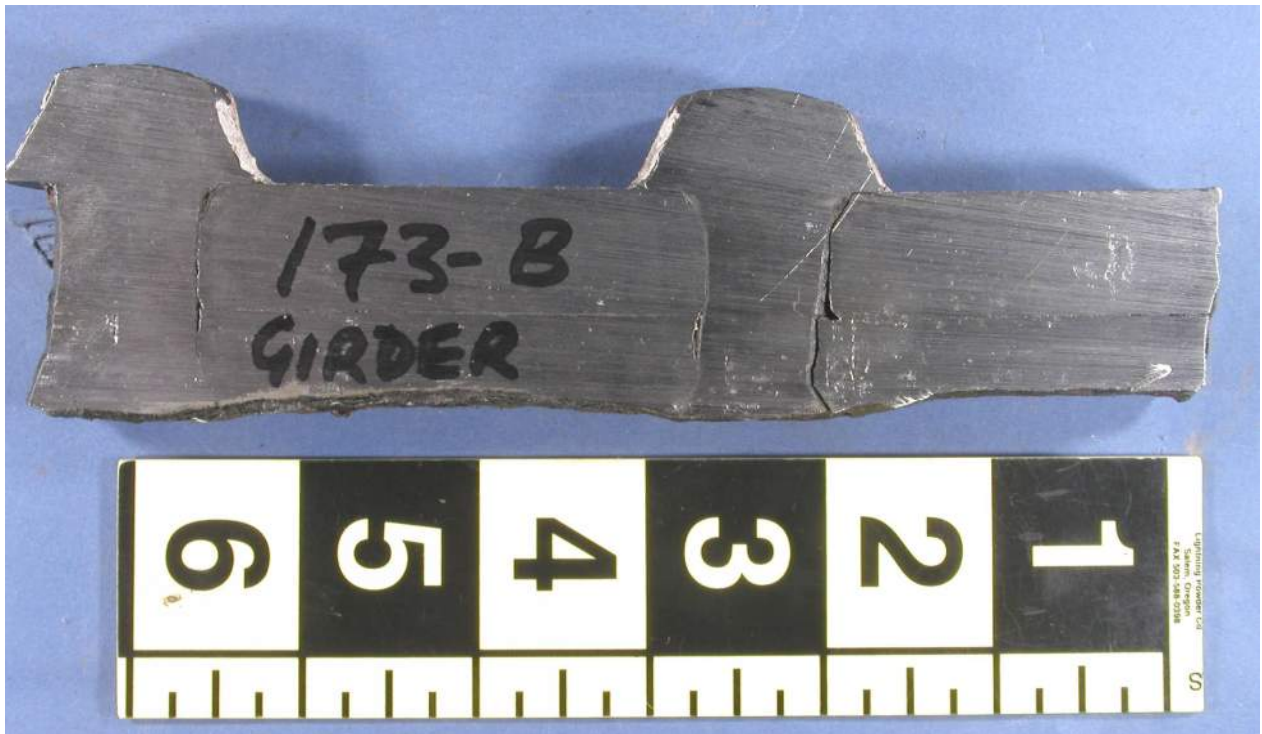
**Rivets From Girder Of Section 173 - B**
