# CITY OF LONG BEACH

HONORABLE MAYOR AND CITY COUNCIL  
City of Long Beach  
California

Authorize the City Manager to proceed with the entitlement phase of the proposed Long-Term Belmont Pool Revitalization Project (Project), and with the installation of a temporary outdoor pool or other interim option. (District 3)

PROPOSED LONG TERM CONCEPT  
**BELMONT PLAZA POOL REPLACEMENT**  
 CITY OF LONG BEACH, CALIFORNIA

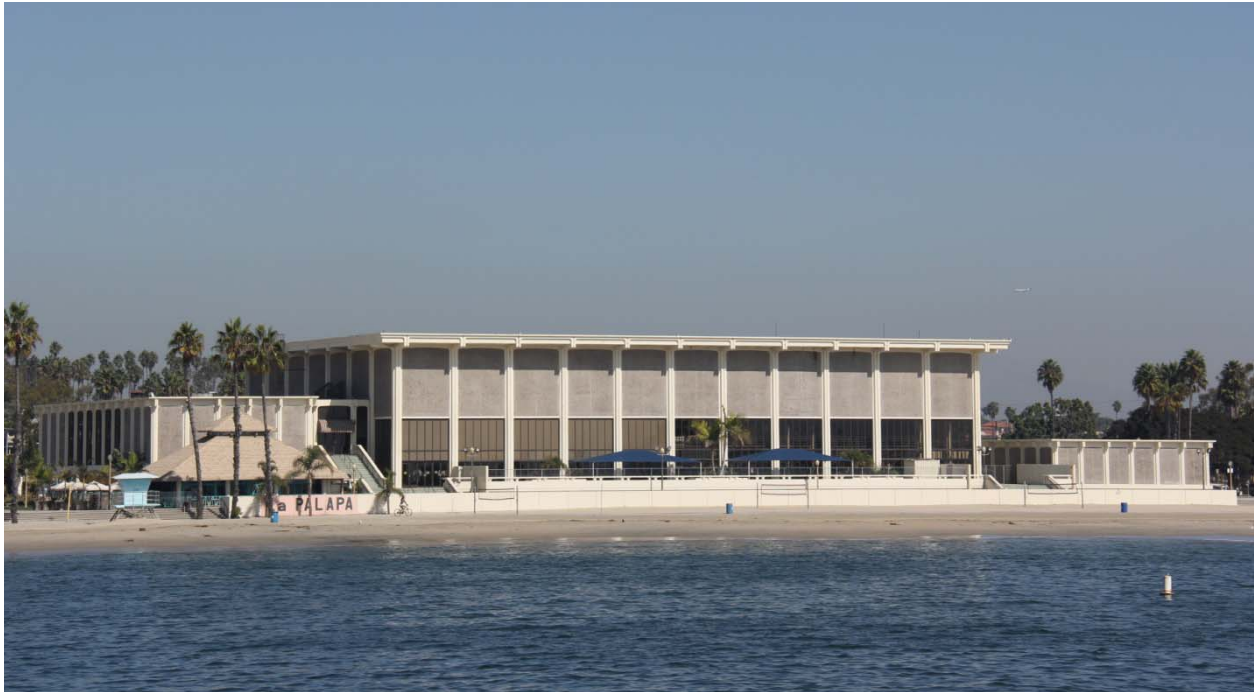
The Natatorium Building has an approximate footprint of 224’x148’. The Natatorium is a very tall, one-story, sloped roof structure with a height that varies between 48’ and 50’ above the floor deck. The structure’s Lateral Force Resisting System consists of a shear wall-frame interactive system with full-height, cast-in-place concrete columns supporting discontinuous 25’-0” high precast concrete shear walls above 23’-0” high glass curtain wall (see Appendix A, Figure 1, 5, 9 and 10).

Figure 1 – Belmont Plaza Olympic Pool Structures, View from South  
[Community Facility to the West (left), Natatorium at Center, Locker Room to the East (right)]

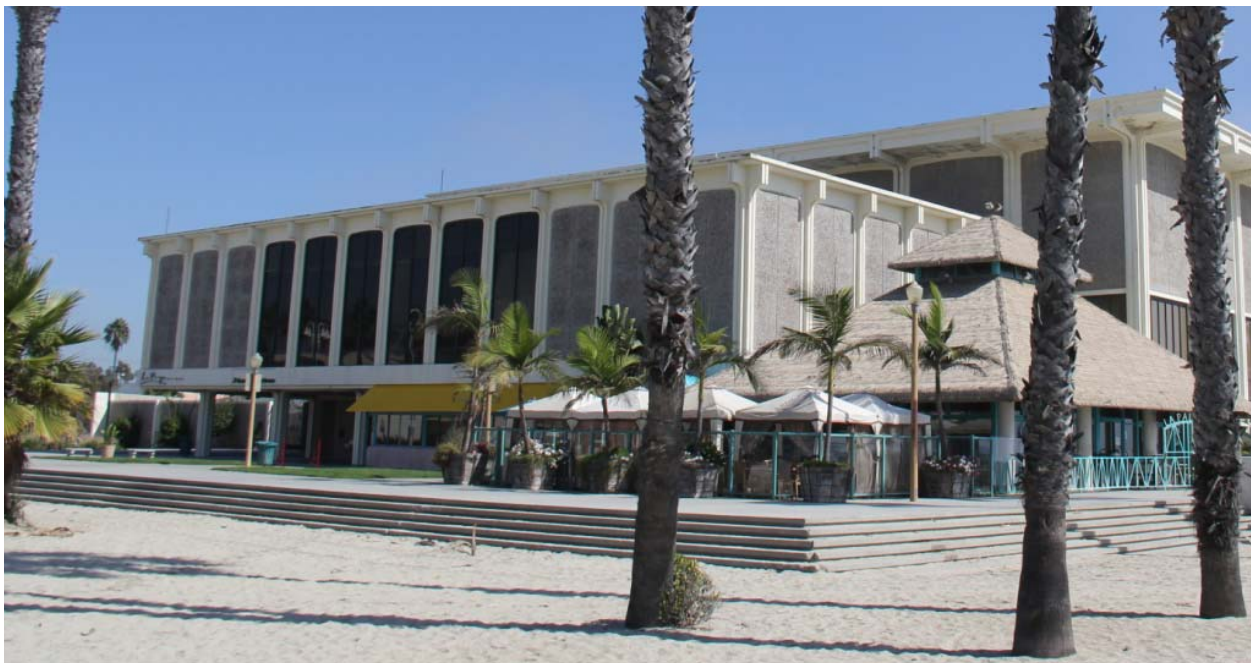
The Private Event Building has an approximate footprint of 127’x78’. The Lateral Force Resisting System of the Private Event Facility consists of perimeter precast concrete shear walls above the 2nd floor, and cast-in-place concrete walls below. The east side of the 2nd floor is mostly open to the Natatorium with only two 10’ wide precast concrete panels located 25’ from the east end. All of the above mentioned walls are not continuous to the foundation, and are supported by cast-in-place overhang concrete beams on the 2nd floor. The 1st floor concrete shear walls are set back 26’-0” and 11’-0” from the 2nd floor on the west side and the north/south direction, respectively. The north exterior ramp and south exterior stair provide access to the 2nd floor (see Appendix A, Figure 2, 3, 6 and 7).

Figure 2 – Community Facility Building, View from Southwest  
[with Natatorium Building in the background]

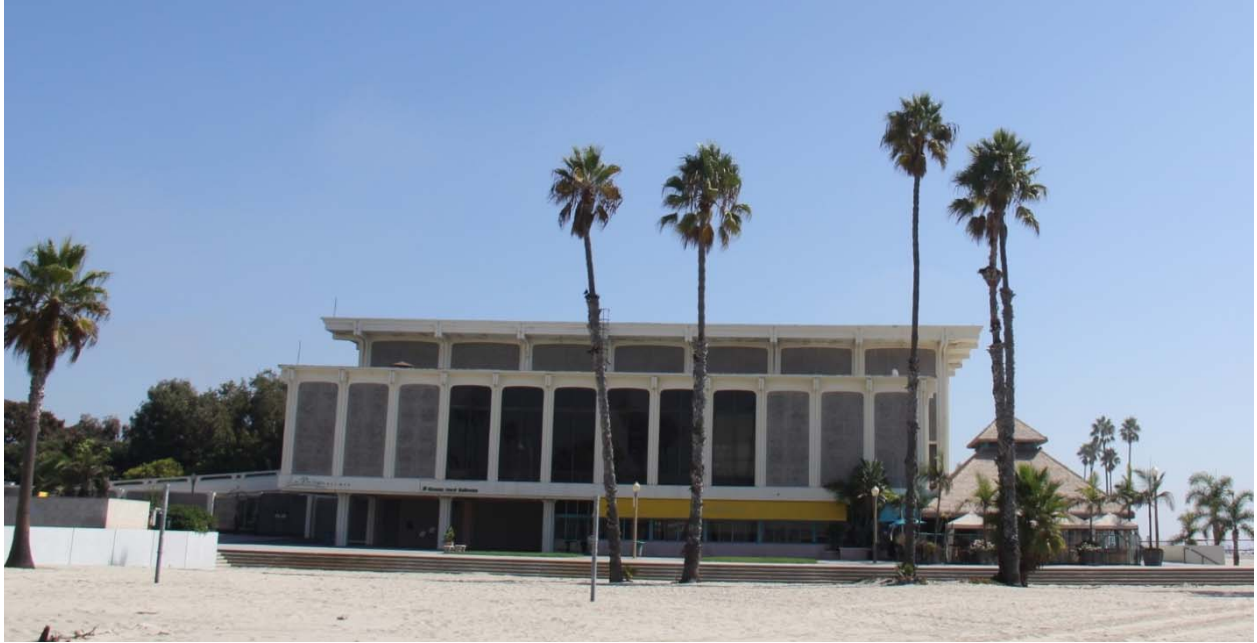
Figure 3 – Community Facility Building, View from West  
[with Natatorium Building in the background]

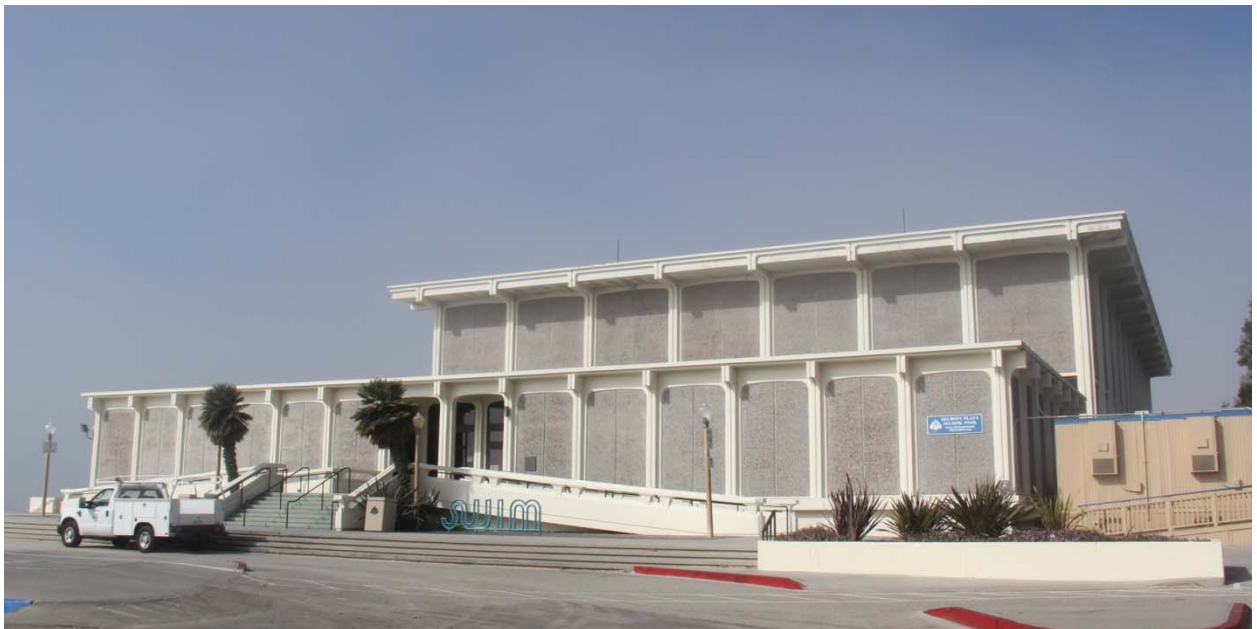
The Locker Building has an approximate footprint of 148’x85’. It is a one-story building similar in construction to the Private Event Building. Its lateral force-resisting system consists of cast-in-place and precast concrete shear walls (see Figure 4, 5 and 9). For its relatively small size, the Locker Building is composed of a relatively large number of shear walls.

Figure 4 –Locker Building, View from Northeast  
[with Natatorium Building in the background]

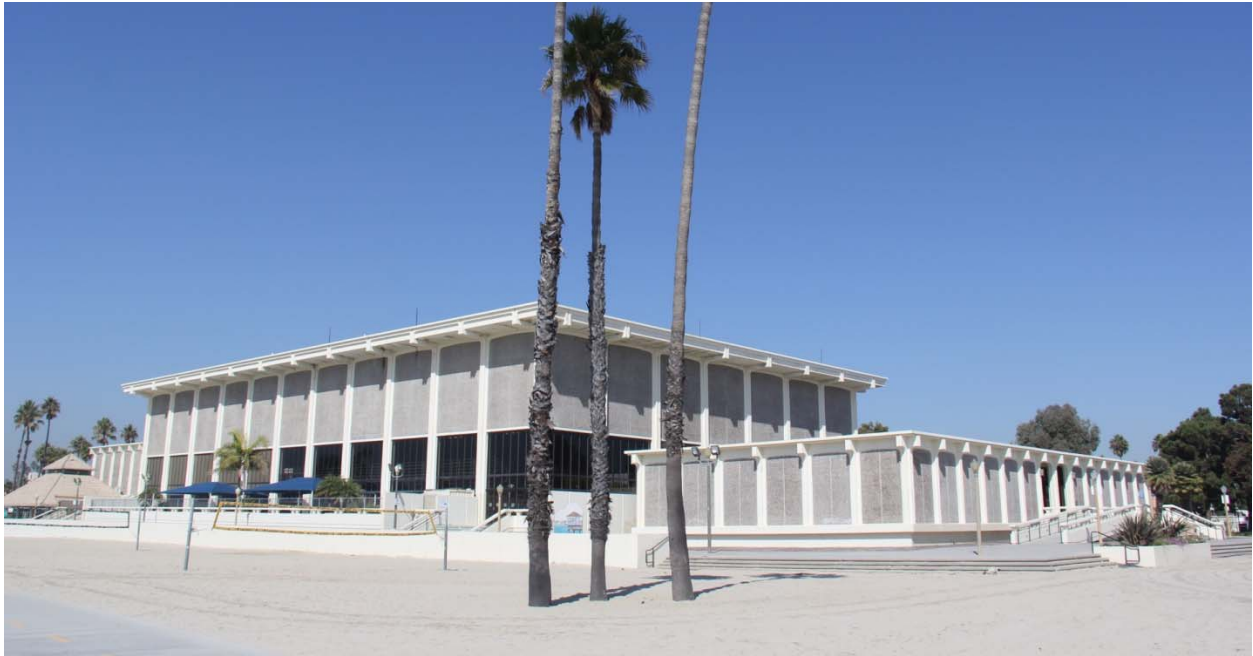
Figure 5 – Locker Building, View from Southeast  
[with Natatorium Building in the background]

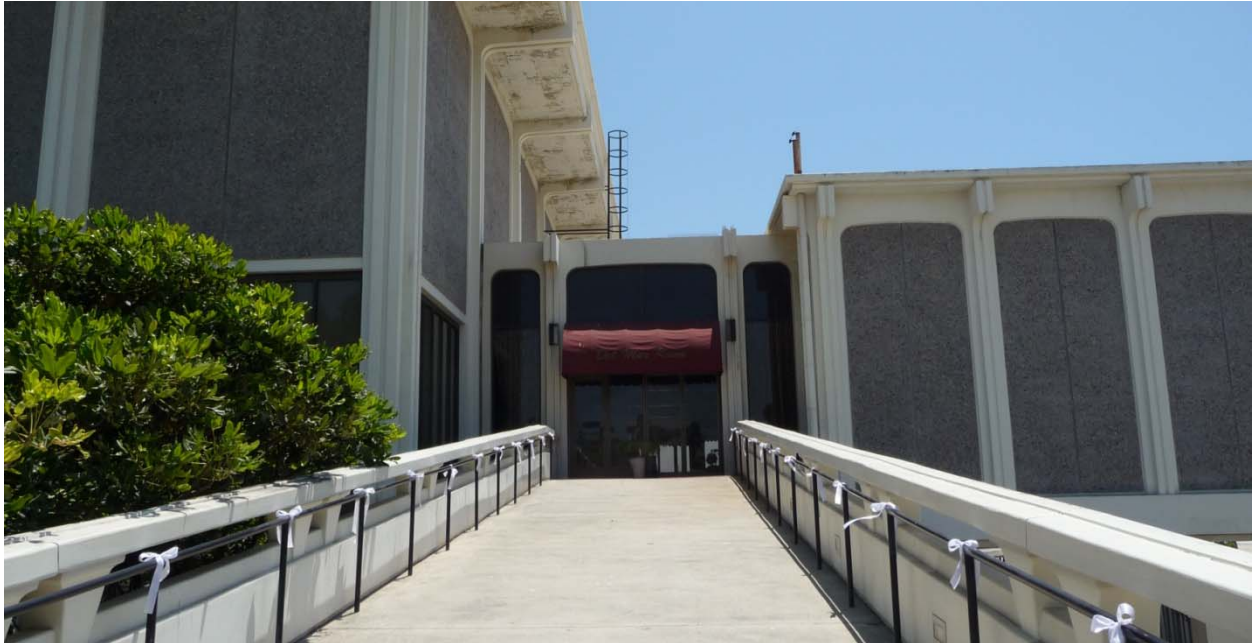
Figure 7 – Ramp at Community Building 2<sup>nd</sup> Floor North Entrance

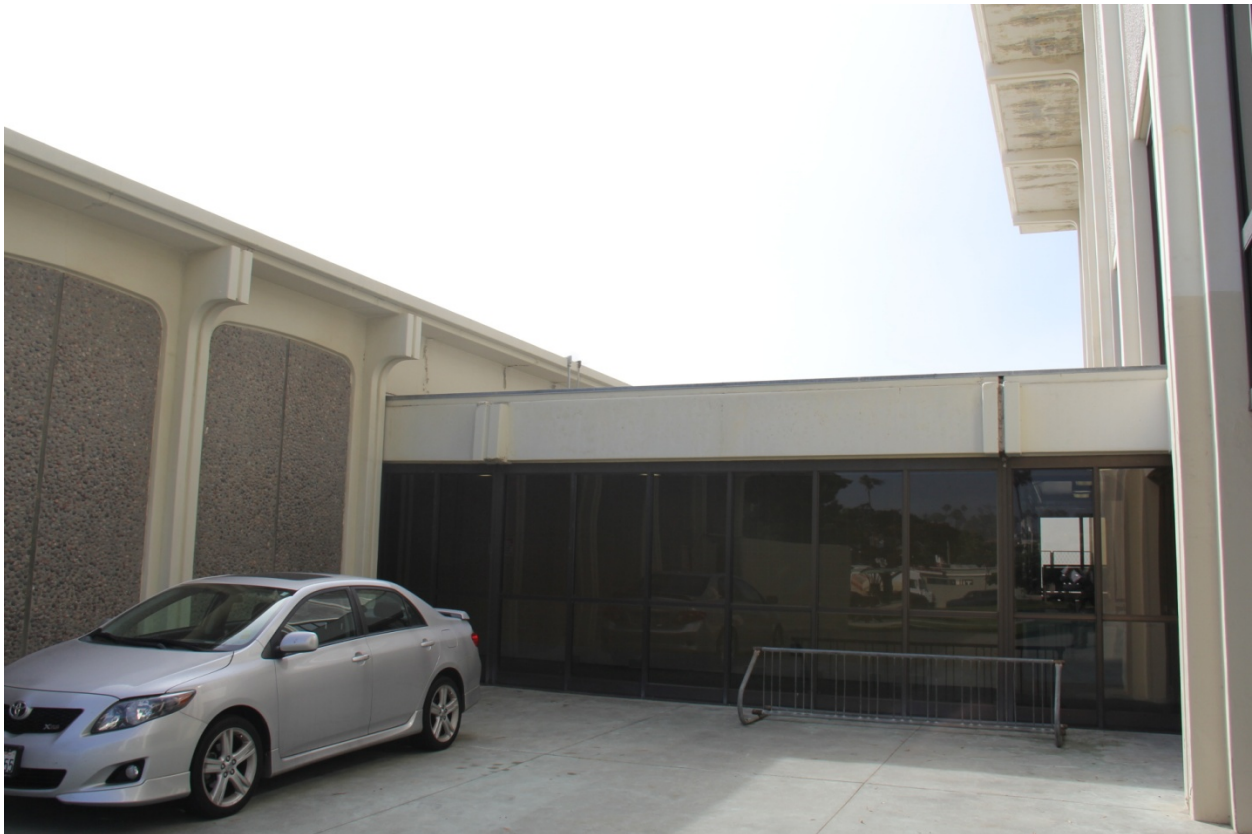
Figure 8 – Locker Building to Natatorium Connection Corridor, North View

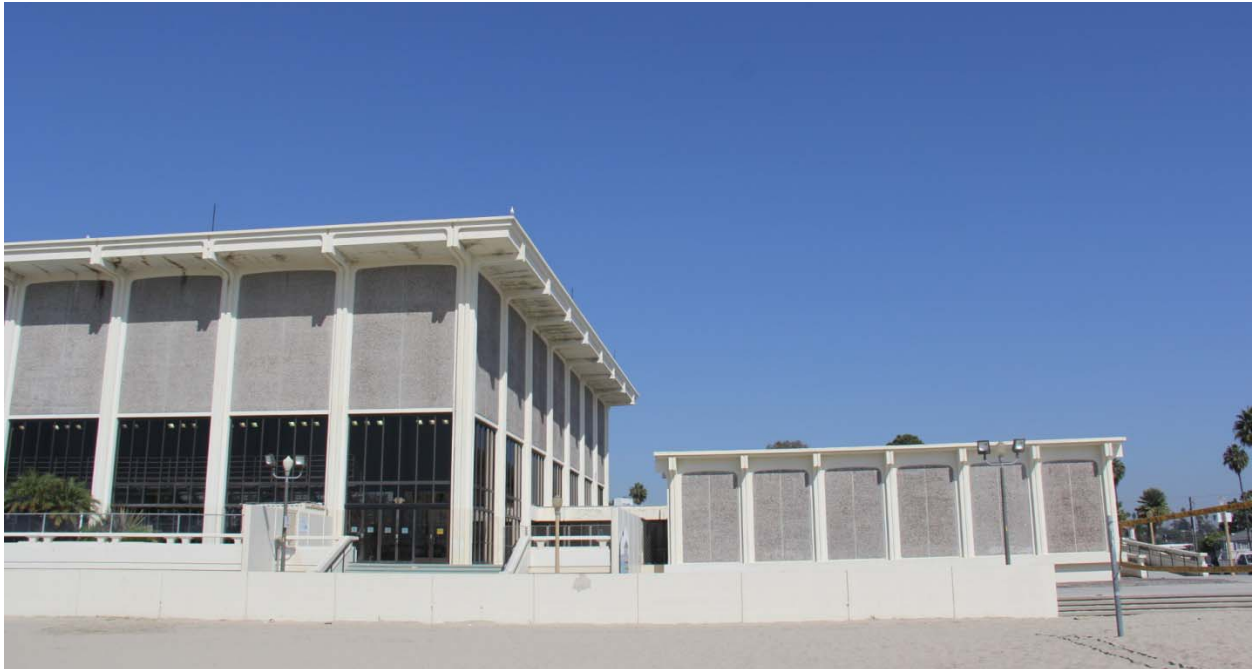
Figure 9 – Locker Building to Natatorium Connection Corridor, South View

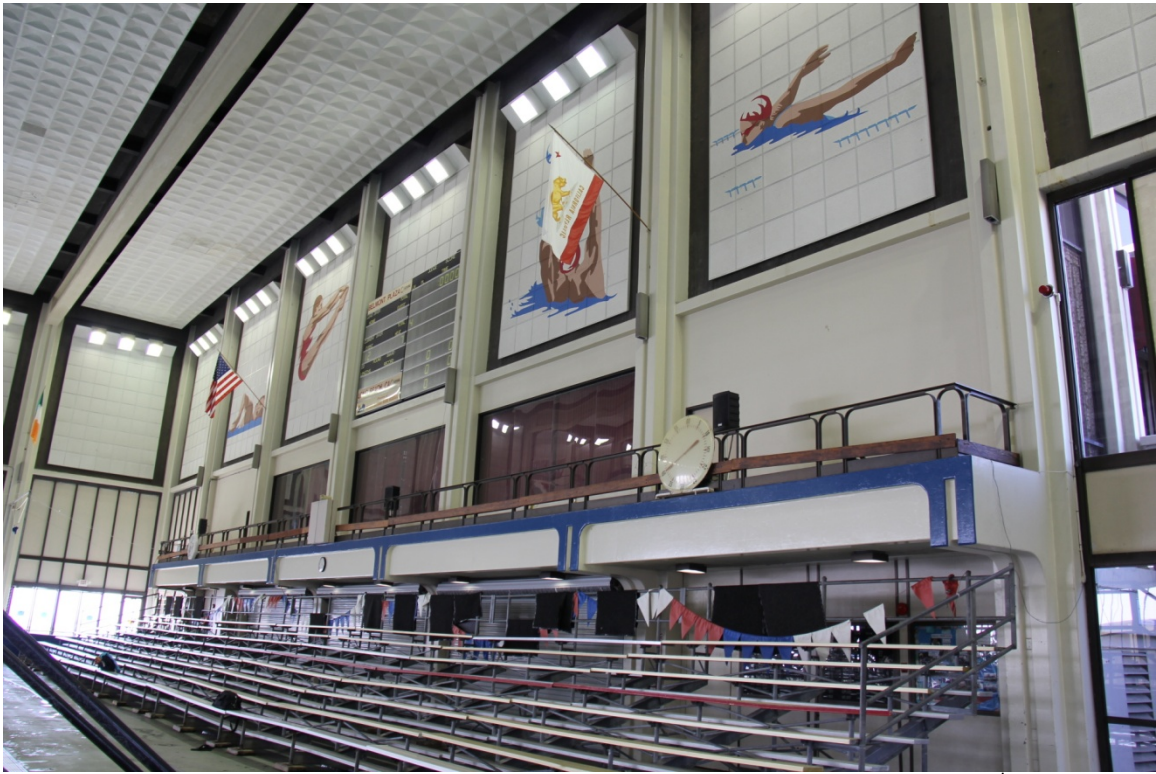
Figure 11 –Natatorium, Balcony at West End (next to Community Building 2<sup>nd</sup> Floor)

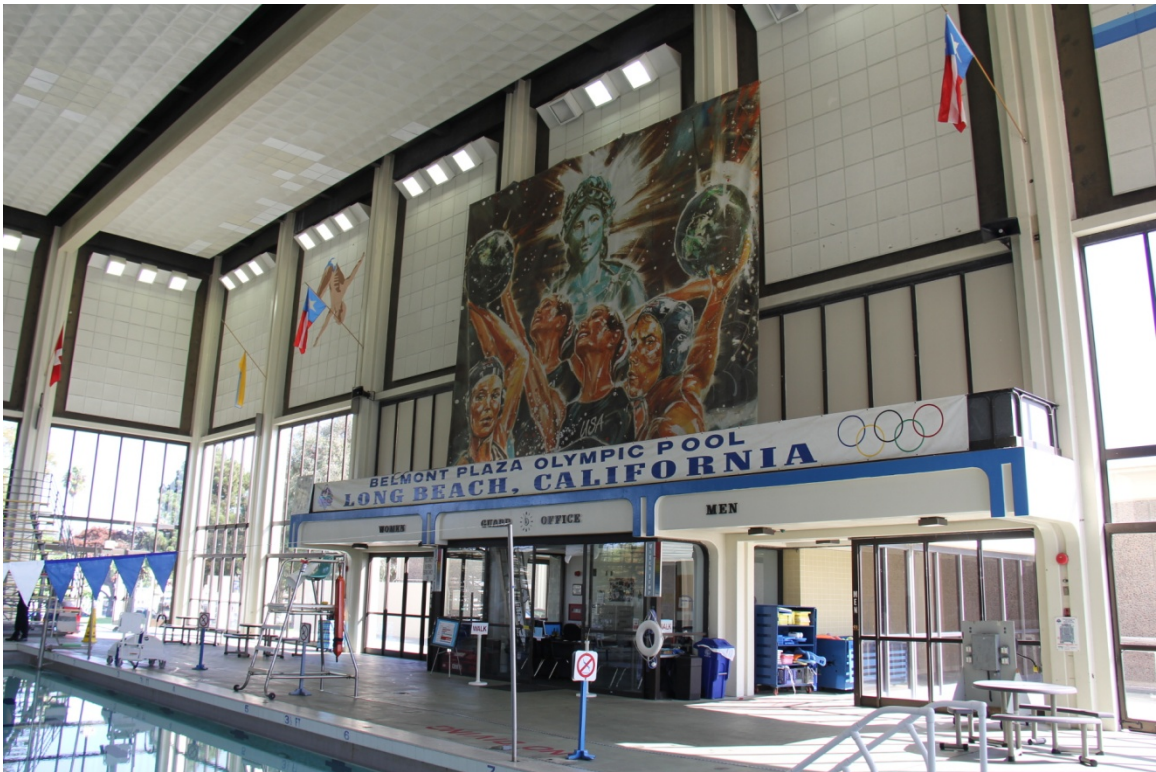
Figure 12 –Natatorium, Balcony/Entrance at East End (next to Locker Corridor)
