Rancho Los Alamitos
Ranch House Seismic Strengthening

RANCH HOUSE SEISMIC UPGRADING

SEISMIC STRENGTHENING OF THE ADOBE, CHIMNEYS, ROOF AND RELATED ITEMS

SCOPE OF WORK

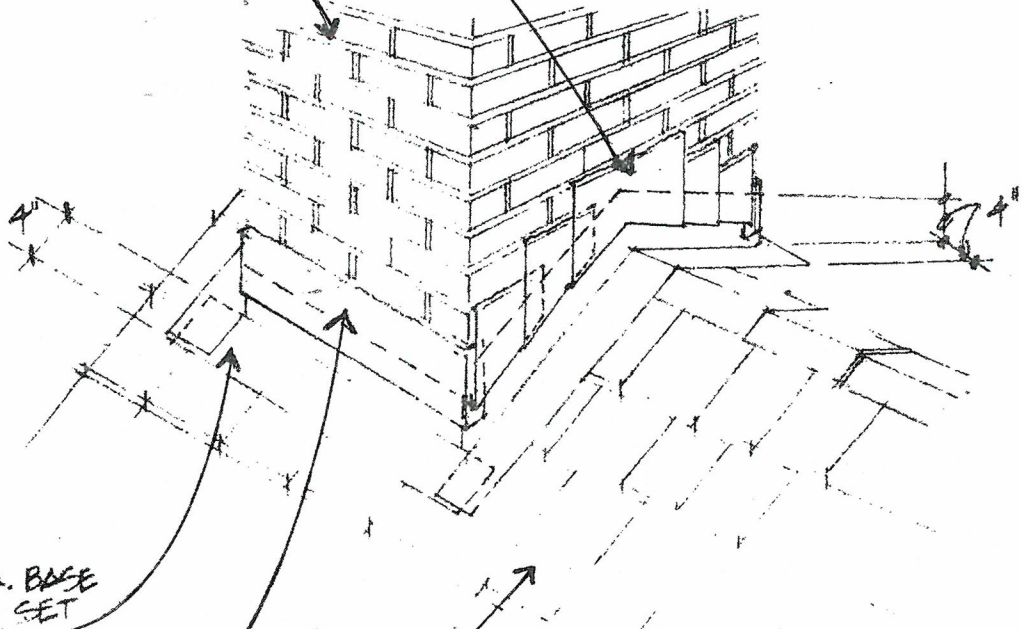
(N) 24 GA. COUNTER
FLASHING SET W/
LEAD WEDGE

INSTALL (N) WD.
SHINGLES AS REQ.

5 CHIMNEY FLASHING AT RIDGE

- Remove and replace all existing roof to wall flashings and counterflashings around brick chimney with new copper flashings. See Flashing Details #1, #2, and #5 in this section.

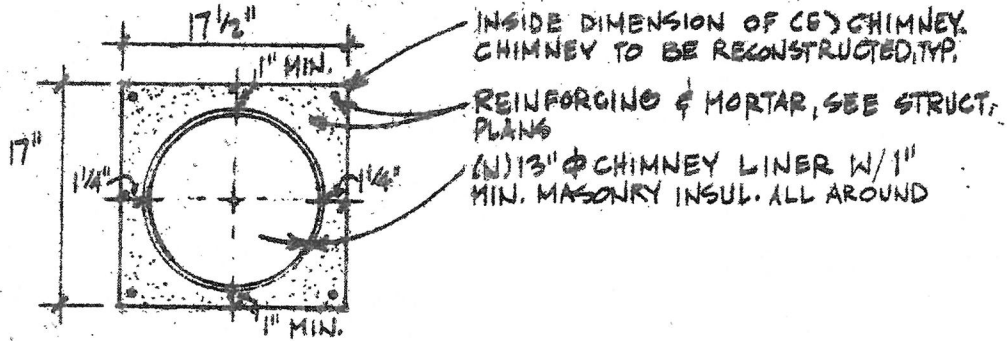
CHIMNEY NO. 1

INSIDE DIMENSION OF (C) CHIMNEY. CHIMNEY TO BE RECONSTRUCTED, TYP.

REINFORCING & MORTAR, SEE STRUCT. PLANS

(N) 13" ϕ CHIMNEY LINER W/ 1" MIN. MASONRY INSUL. ALL AROUND

- Verify interior attic work and roofline work on Chimneys #3, #4 and #5 was completed in Phase One. Verify the Chimney Lining was completed on Chimney #3, see Detail #6 in this section

- Clean existing brick and rout out loose mortar. Repoint all mortar joints.
- After removal of twin stack metal assembly, inspect Chimney flue(s) and determine if they can be made operational. Refer to Chimney Lining Detail #6 in this section. Coordinate options with RLAF.

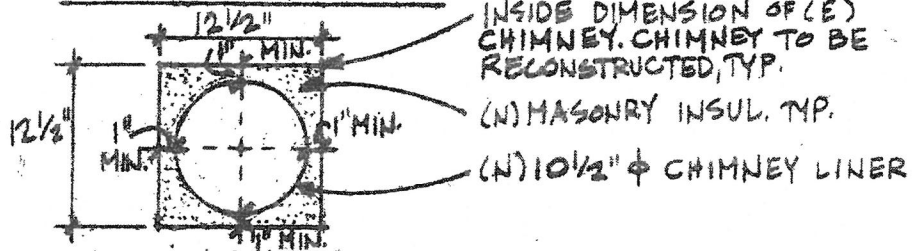
INSIDE DIMENSION OF (C) CHIMNEY. CHIMNEY TO BE RECONSTRUCTED, TYP.

(N) MASONRY INSUL. TYP.
