California Heights

This **DRAFT** section of the Long Beach Historic District Design Guidelines is part of a larger document created as a planning tool for the City's historic districts. The guidelines are intended to provide recommendations, inspiration, and advice as part of an instructive framework that will help guide sensitive changes to historic properties and encourage rehabilitation. By their nature, design guidelines are flexible. As such, outcomes may depend on the resource, the surrounding district, and the goals of the proposed project.

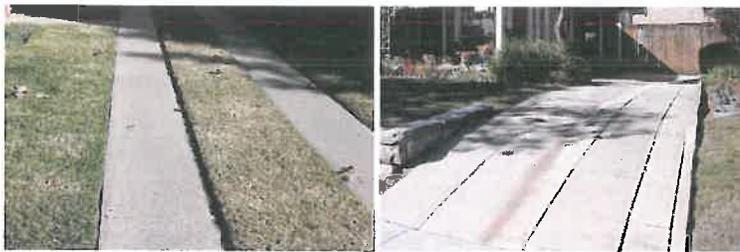
Caption: There is evidence to suggest that many of the driveways in California Heights were once dual-ribbon (left); however, many have been converted to a single concrete slab (right).

Otherwise, a historically compatible slab or dual ribbon driveway with scored joints should be installed. The two strips of a dual ribbon driveway may be separated by grass or loose rock, such as crushed quartz or river rock.

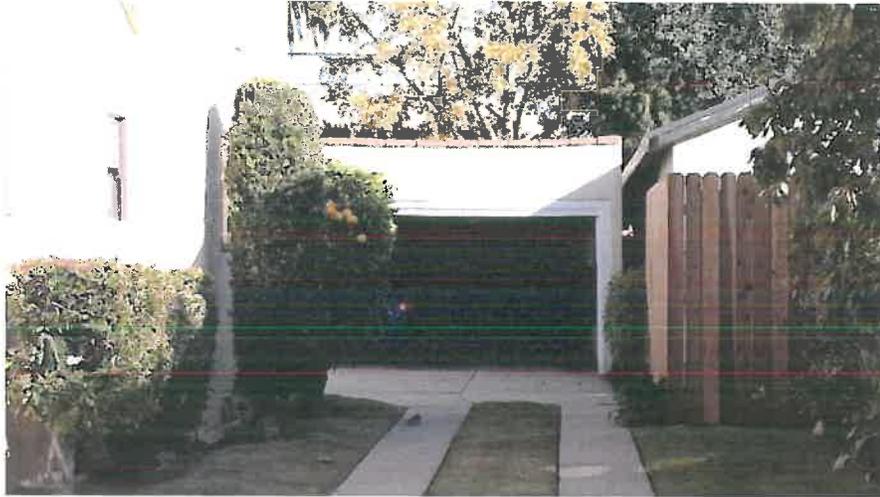
Caption: An existing detached garage in the California Heights Historic District.

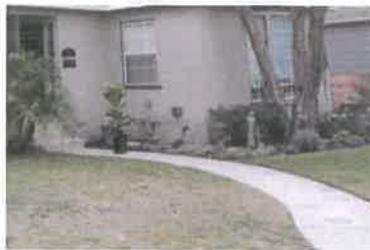
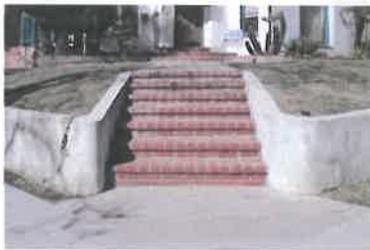
Caption: Walkways in the California Heights Historic District are varied, depending on the style and date of the house, as well as the characteristics of the lot. Some examples of walkways include a straight, concrete walkway (A), a curving concrete walkway (B), and a brick and concrete walkway ending in stairs (C).

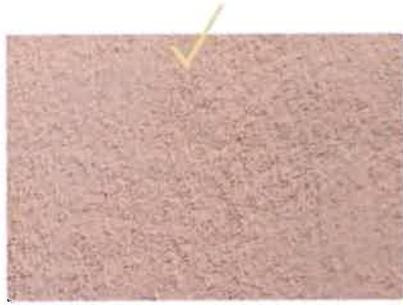
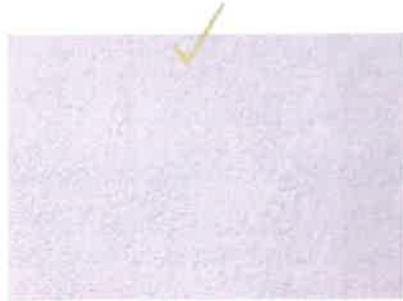
Caption: An appropriate float or dash finish stucco has a slightly rough, sandy texture.

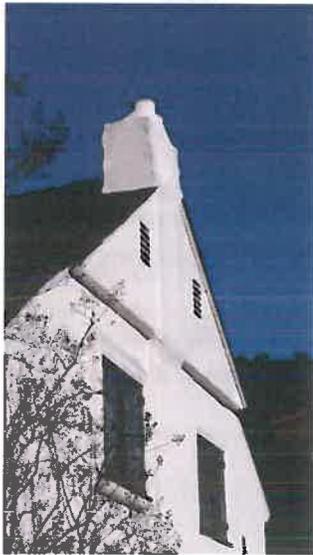
Caption: A chimney on a contributing property in the California Heights Historic District.

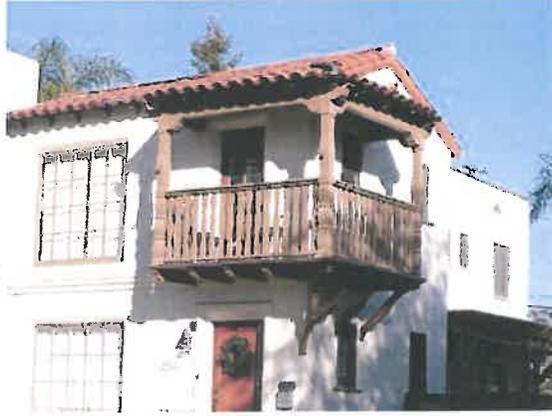
Caption: A balconette on a contributor in the California Heights Historic District.

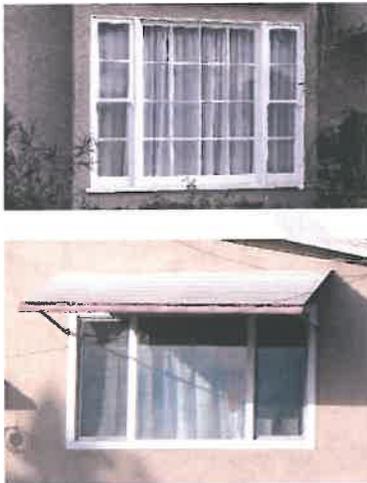
Caption: Historically compatible or original wood windows (top) are always preferable to incompatible replacements, especially horizontal sliding vinyl or aluminum (bottom).

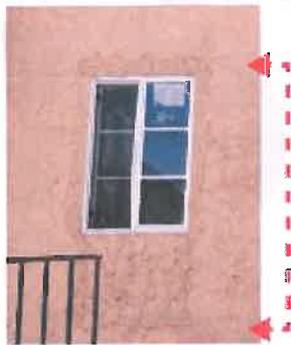
Caption: Changing window openings can leave "scars" on the exterior of a building. Red arrows indicate the original extent of the opening.

The size of a window opening should never be altered to accommodate a new window; rather, the window should be sized to fit the historic window opening.

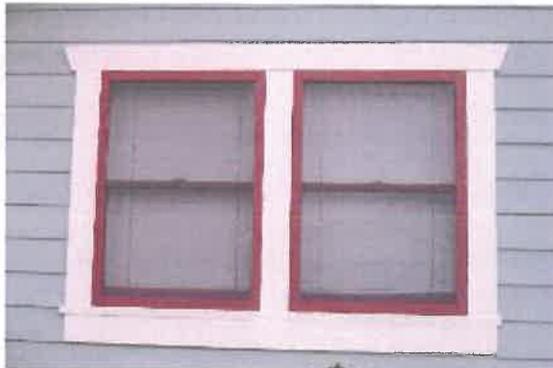
- 5.4.2 *Caption: This compatible window screen is sized to the window and has a narrow wood frame painted to match the building's trim.*

Window screens sized to match the original windows that have narrow, wood frames and are painted to correspond with the building's trim are recommended. The screen itself should be relatively transparent, and should not obscure the window behind it. Retractable screens may also be acceptable. Aluminum-framed screens are discouraged; vinyl-framed screens are not permitted.

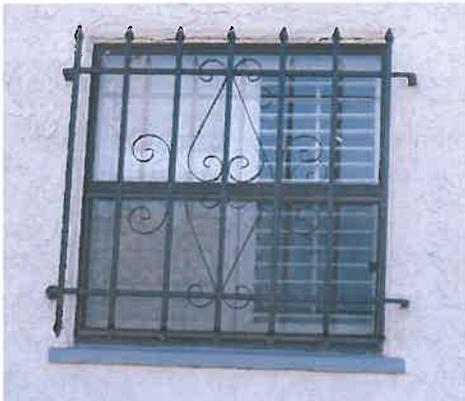
Caption: Security bars are visually obtrusive and incompatible. Other security measures are encouraged.

- 5.5.1 Consider less visually obtrusive security measures such as interior locks, swing-away interior mounted security bars, and wireless security sensors, where feasible. This equipment should be installed carefully so as to avoid damaging historic windows, even from the interior. Damage, especially to wood windows, may leave the window susceptible to deterioration.

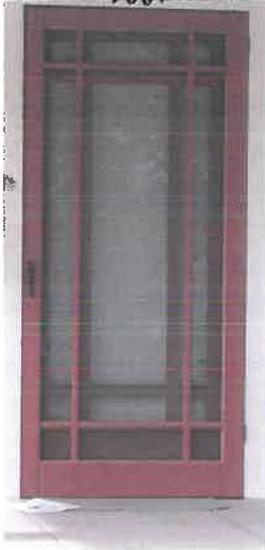
Caption: This is an excellent example of a compatible screen door. The narrow wood frame is stained in a neutral color and the mesh enclosure is transparent enough that it does not obscure the door beneath it.

Installing a **storm door** (glass enclosure) or **screen door** (mesh enclosure) may be acceptable if the feature is sensitively designed and carefully installed. Storm or screen doors that are sized to match the original door, have narrow, wood frames, and are painted to correspond with the building's trim or primary door are recommended. The screen or glass itself should be relatively transparent, and should not obscure the door behind it. Metal-framed screen or storm doors are discouraged. Vinyl-framed screen or storm doors are not permitted.

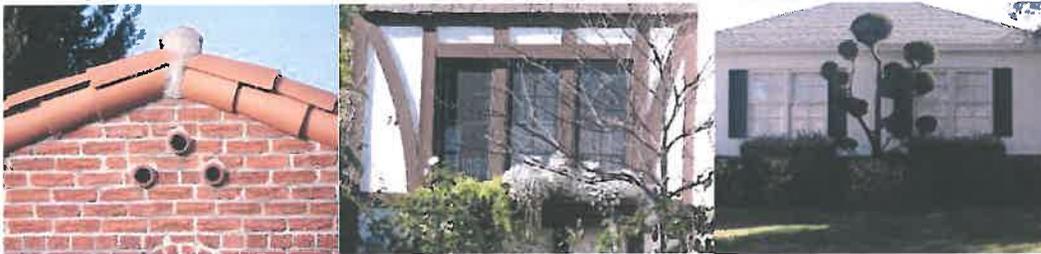
Caption: Existing decorative features in the California Heights Historic District.

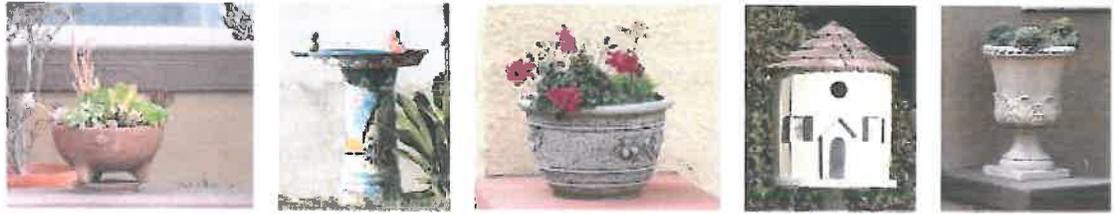
Caption: Carefully installed non-structural decorative features may be added if desired.

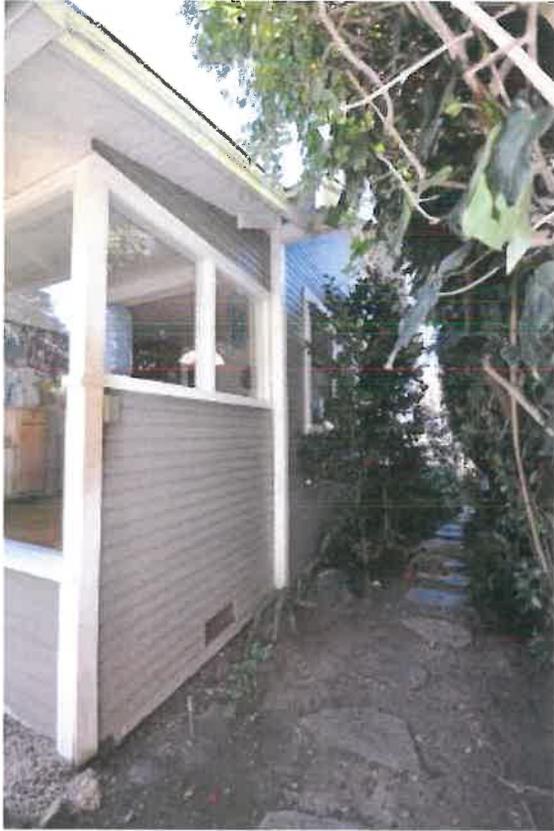
Caption: This compatible addition is differentiated from the main house by fixed single-light windows and a vertical strip of trim.

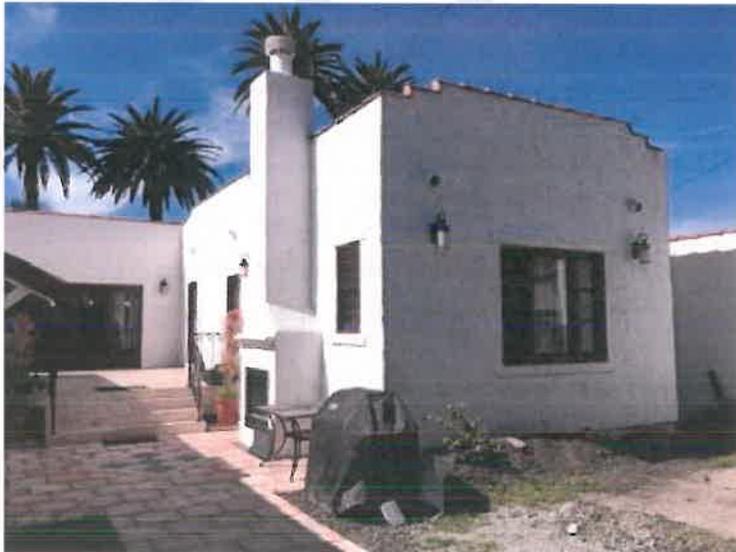
Caption: This compatible addition is differentiated from the main house with a stepped roofline, slightly different yet compatible windows, and slightly differentiated window surrounds.

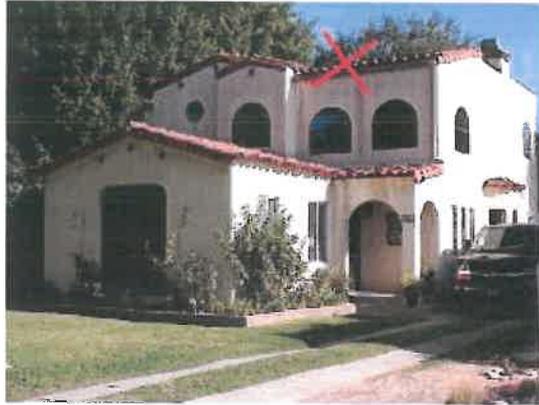
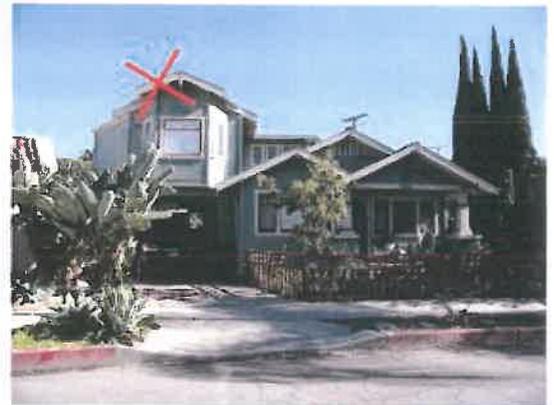
Caption: The additions shown above would not be permitted. They are arranged near the front of the building, making them highly visible from the street and detracting from the original historic home.

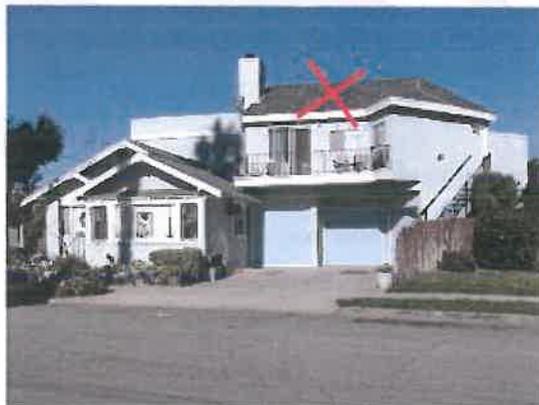
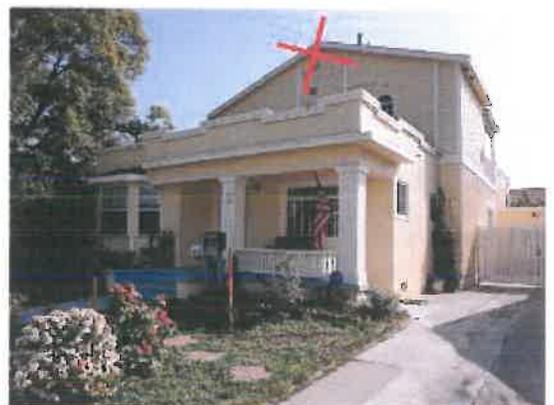
Caption: The additions shown above would not be permitted. They are arranged near the front of the building, and introduce an incompatible roofline that is not in keeping with the original house form.

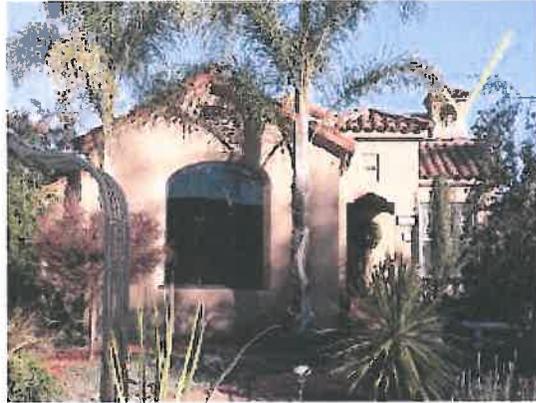
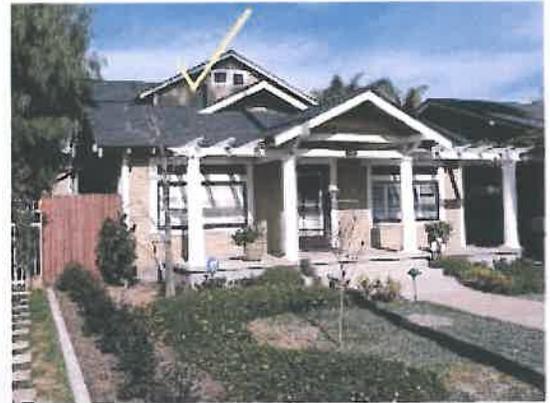
Caption: The additions shown above are acceptable. They are oriented towards the rear of the building and complement the original house form, making them less visible from the street and more compatible.

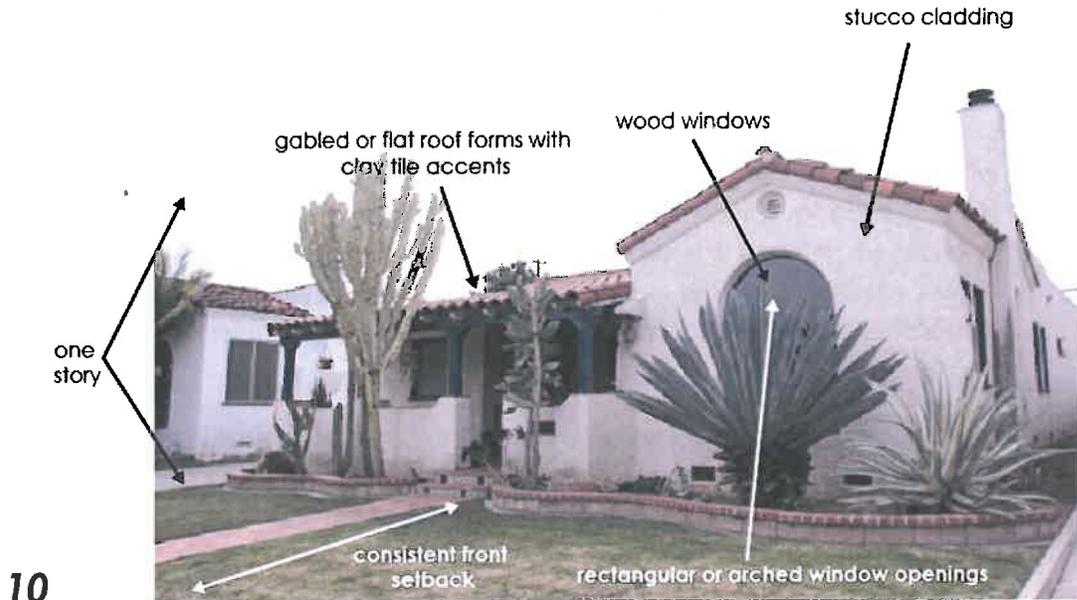
See below for diagrams of features derived from some of the most common styles in the California Heights Historic District.

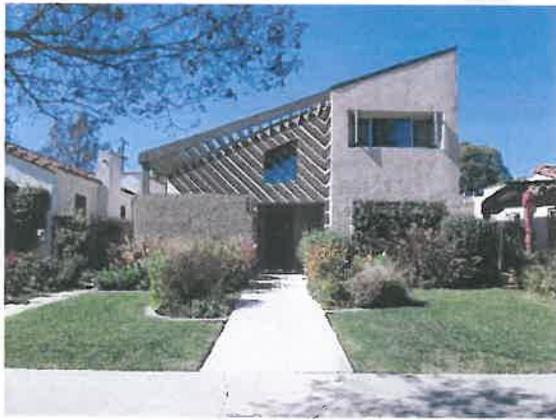
Least compatible: This residence was constructed outside the period of significance and is the least compatible of these examples. It introduces a number of visual elements to the district that are not compatible with the surrounding contributors, including its contemporary massing with a highly visible shed roof, two-story height at the front of the building in a predominantly one-story district, and contemporary design elements including brise-soleils and geometric, non-traditional window shapes. While the design of the building does not draw from any of the contributing buildings surrounding it, it does have a front lawn, setback, and central walkway that help to maintain the visual cohesion of the district.

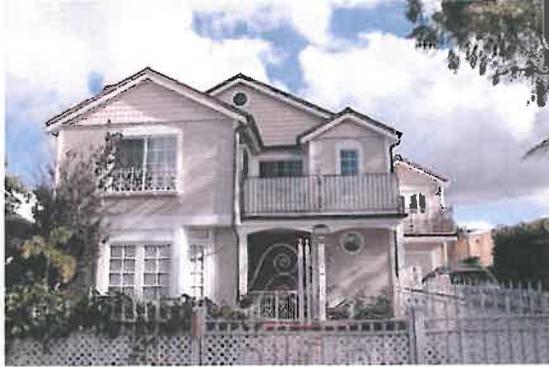
More compatible: This residence was also constructed outside the period of significance. Like the above example, it is two stories in height with its massing oriented towards the front of the building, creating a visual disruption in a district that is predominantly one story in height. However, the design of the building includes more traditional details like horizontal wood cladding and gabled roof forms that help it to blend in more readily with the surrounding contributors and historic character of the district.

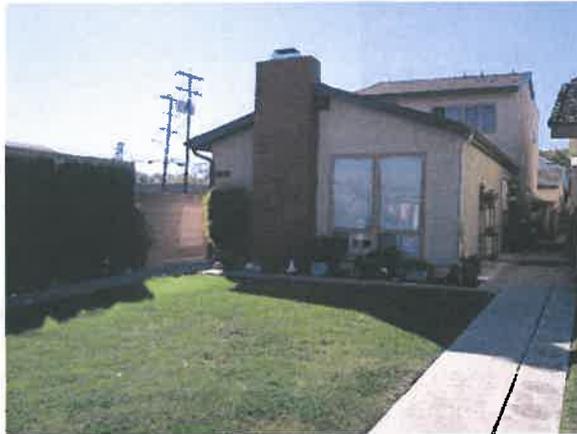
Most compatible: This residence is the most compatible of the three examples. It is two stories in height, but the upper story is oriented towards the rear, making it less visible from the street. The front of the building is one story in height with a gabled roof form and traditional brick chimney. The building is clad in stucco and wood, and the property has a front setback and landscaped yard, helping it to blend in more readily with surrounding contributors and historic character of the district.
