California Heights

This **DRAFT** section of the Long Beach Historic District Design Guidelines is part of a larger document created as a planning tool for the City's historic districts. The guidelines are intended to provide recommendations, inspiration, and advice as part of an instructive framework that will help guide sensitive changes to historic properties and encourage rehabilitation. By their nature, design guidelines are flexible. As such, outcomes may depend on the resource, the surrounding district, and the goals of the proposed project.

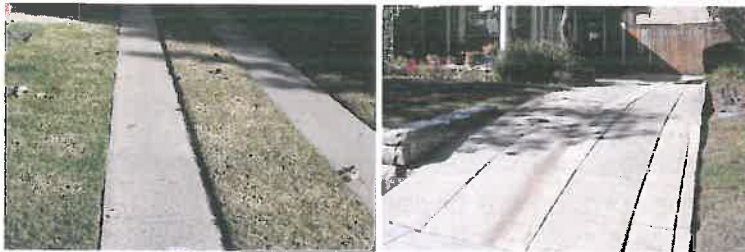
Caption: There is evidence to suggest that the driveways in California Heights were once dual-ribbon (left); however, many have been converted to a single concrete slab (right).

Otherwise, a historically compatible slab or dual ribbon driveway with scored joints should be installed. The two strips of a dual ribbon driveway may be separated by grass or loose rock, such as crushed quartz or river rock.

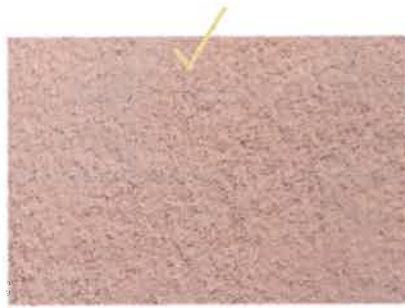
Caption: An appropriate float or dash finish stucco has a slightly rough, sandy texture.

Many properties in the California Heights Historic District are clad in stucco. The majority of the contributing residences retain a historically accurate sand or float stucco finish, while others have been covered with an incompatible, heavily textured stucco. As the existing non-original stucco comes to the end of its useful life, replacement with a more historically appropriate smooth textured stucco finish is encouraged, rather than replicating the existing texture.

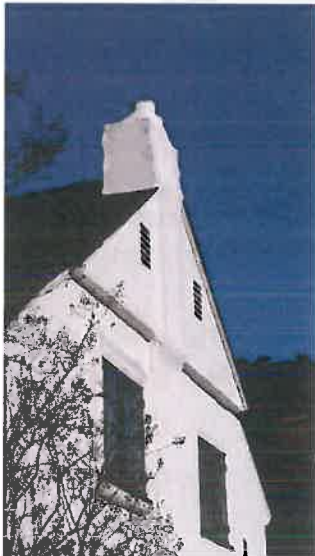
Caption: A chimney on a contributing property in the California Heights Historic District.

Many contributing properties in the California Heights Historic District have original chimneys. The chimneys are made of various materials, but are typically masonry. Some are clad in stucco.

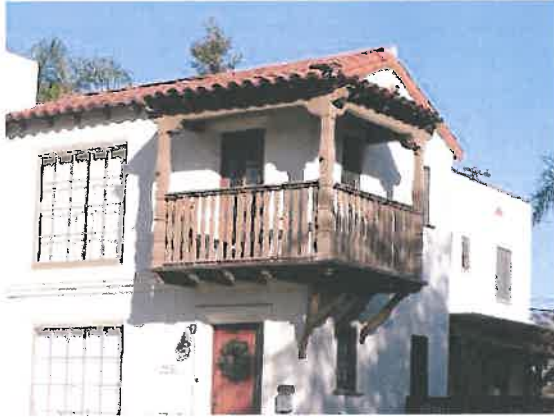
Caption: A balconette on a contributor in the California Heights Historic District.

Similarly, an original **balcony** or **balconette** visible from the public right of way should not be removed or enclosed.

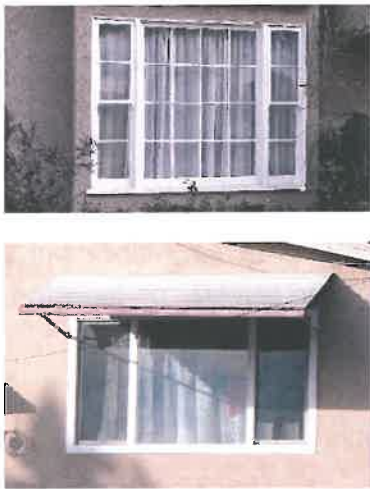
Caption: Historically compatible or original wood windows (top) are always preferable to incompatible replacements, especially horizontal sliding vinyl or aluminum (bottom).

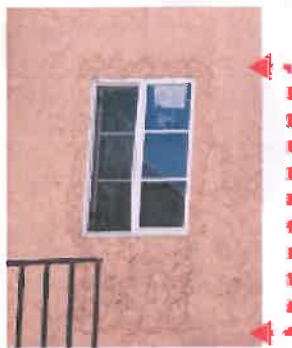
Caption: Changing window openings can leave "scars" on the exterior of a building. Red arrows indicate the original extent of the opening.

The size of a window opening should never be altered to accommodate a new window; rather, the window should be sized to fit the historic window opening.

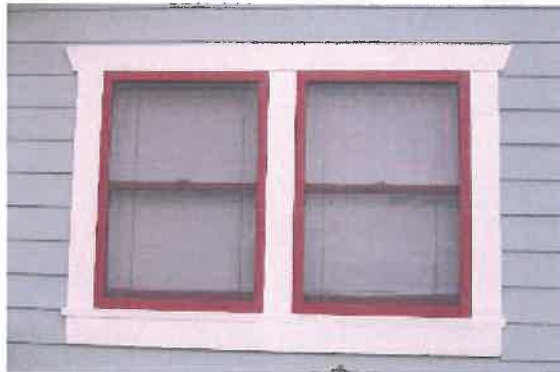
Caption: This compatible window screen is sized to the window and has a narrow wood frame painted to match the building's trim.

Window screens sized to match the original windows that have narrow, wood frames and are painted to correspond with the building's trim are recommended. The screen itself should be relatively transparent, and should not obscure the window behind it. Retractable screens may also be acceptable. Aluminum-framed screens are discouraged; vinyl-framed screens are not permitted.

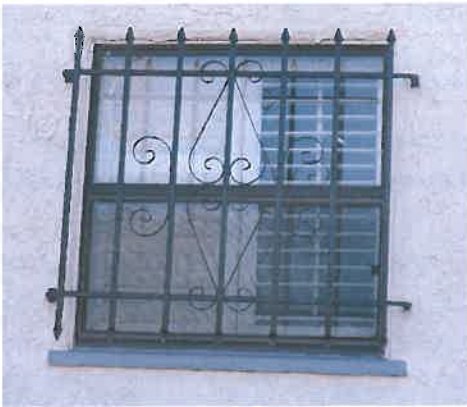
Caption: Security bars are visually obtrusive and incompatible. Other security measures are encouraged.

Consider less visually obtrusive security measures such as interior locks, swing-away interior mounted security bars, and wireless security sensors, where feasible. This equipment should be installed carefully so as to avoid damaging historic windows, even from the interior. Damage, especially to wood windows, may leave the window susceptible to deterioration.

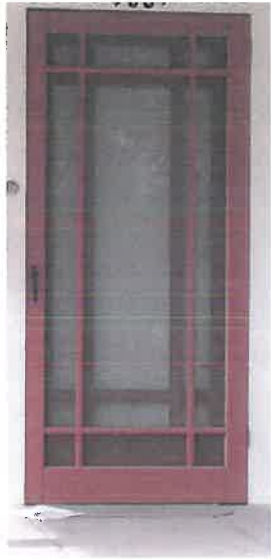
Caption: This is an excellent example of a compatible screen door. The narrow wood frame is stained in a neutral color and the mesh enclosure is transparent enough that it does not obscure the door beneath it.

Installing a **storm door** (glass enclosure) or **screen door** (mesh enclosure) may be acceptable if the feature is sensitively designed and carefully installed. Storm or screen doors that are sized to match the original door, have narrow, wood frames, and are painted to correspond with the building's trim or primary door are recommended. The screen or glass itself should be relatively transparent, and should not obscure the door behind it. Metal-framed screen or storm doors are discouraged. Vinyl-framed screen or storm doors are not permitted.

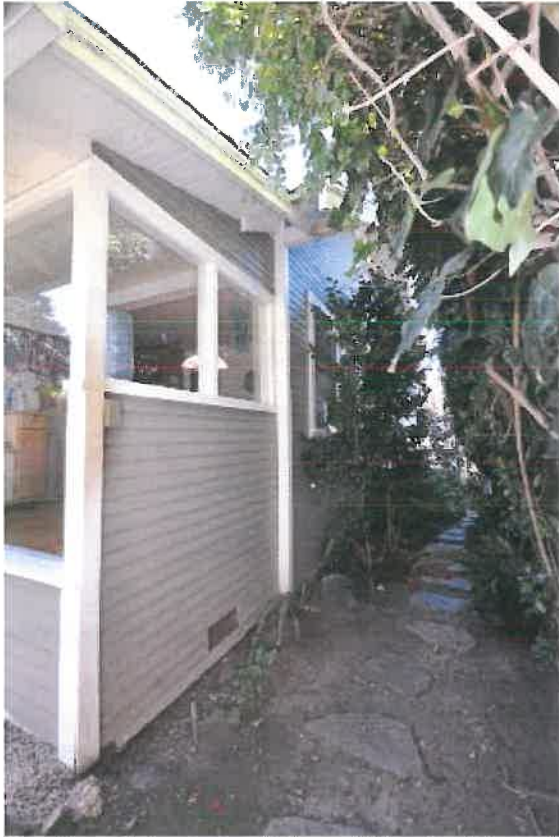
Caption: This compatible addition is differentiated from the main house by fixed single-light windows and a vertical strip of trim.

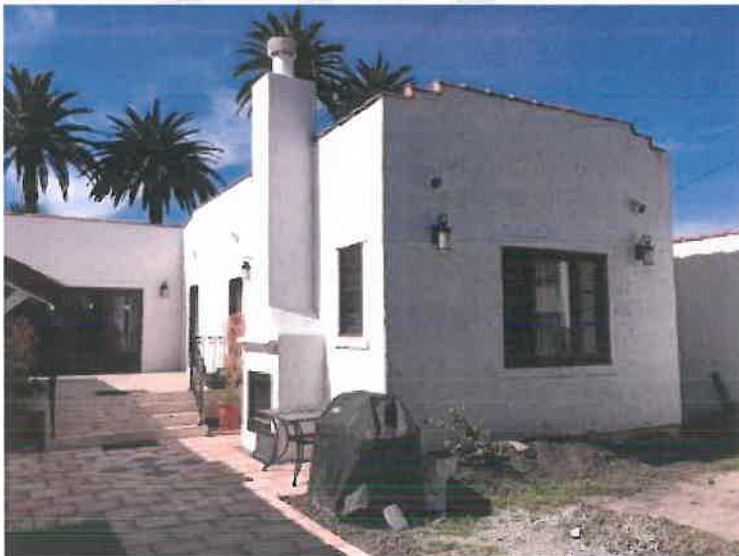
Caption: This compatible addition is differentiated from the main house with a stepped roofline, slightly different yet compatible windows, and slightly differentiated window surrounds.

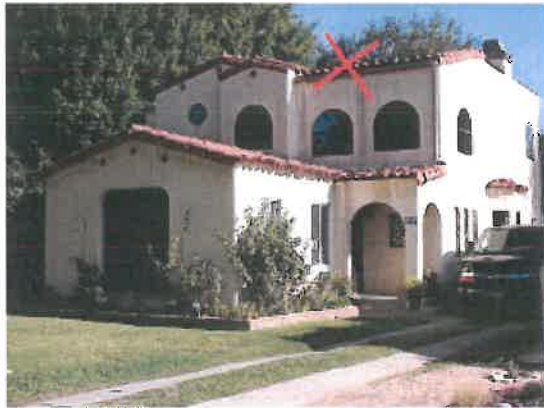
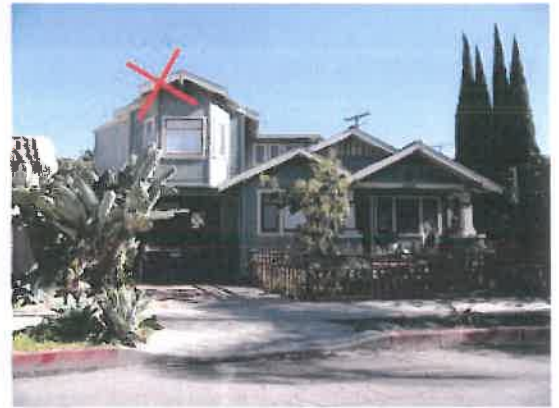
Caption: The additions shown above would not be permitted. They are arranged near the front of the building, making them highly visible from the street and detracting from the original historic home.

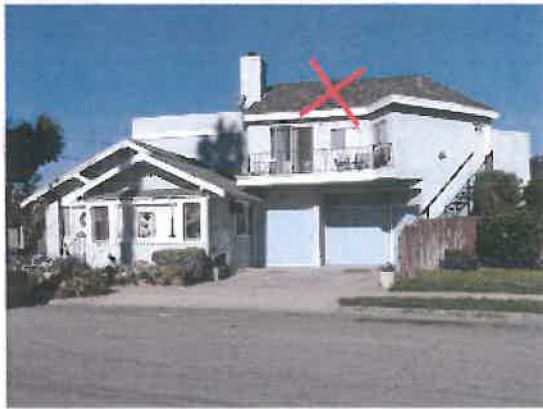
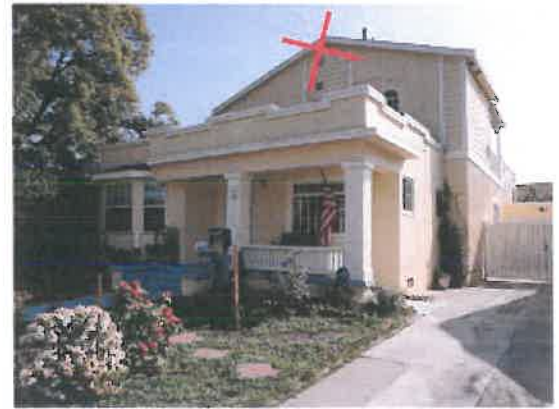
Caption: The additions shown above would not be permitted. They are arranged near the front of the building, and introduce an incompatible roofline that is not in keeping with the original house form.

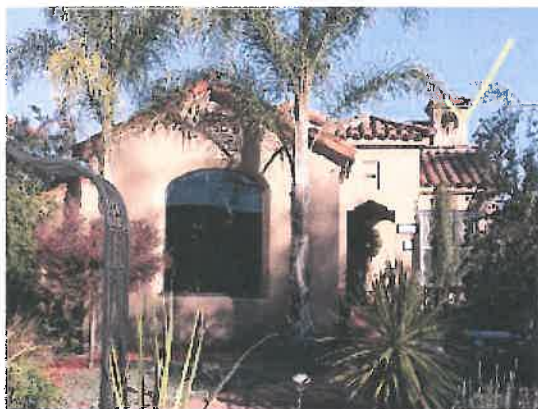
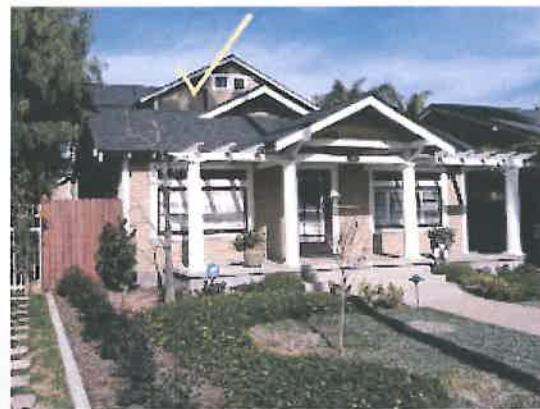
Caption: The additions shown above are acceptable. They are oriented towards the rear of the building and complement the original house form, making them less visible from the street and more compatible.

Rear additions should be designed to be compatible with the historic building, but avoid exactly duplicating the original building materials and detailing so that the addition is not mistaken for an original part of the residence in the future. Duplicating the features of the original building can create what is called a false sense of history, (i.e. it could be difficult, even for professionals, to visually determine which portion of the residence is original) .

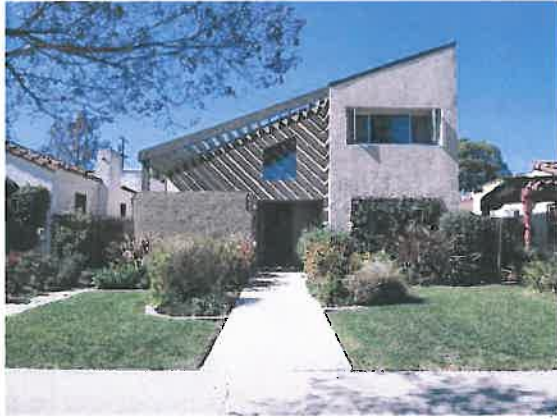
Least compatible (3759-61 Lewis Ave): This residence was constructed outside the period of significance and is the least compatible of these examples. It introduces a number of visual elements to the district that are not compatible with the surrounding contributors, including its contemporary massing with a highly visible shed roof, two-story height at the front of the building in a predominantly one-story district, and contemporary design elements including brise-soleils and geometric, non-traditional window shapes. While the design of the building does not draw from any of the contributing buildings surrounding it, it does have a front lawn, setback, and central walkway that help to maintain the visual cohesion of the district.

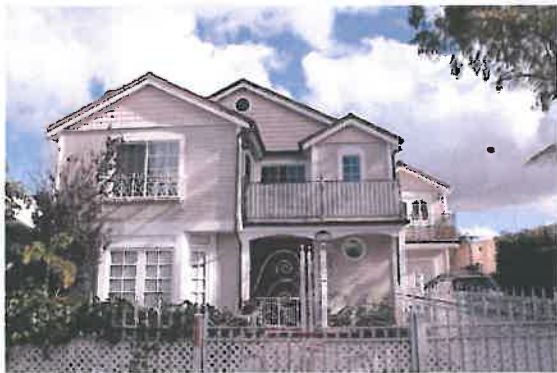
More compatible (3558-60 Falcon Ave): This residence was also constructed outside the period of significance. Like the above example, it is two stories in height with its massing oriented towards the front of the building, creating a visual disruption in a district that is predominantly one story in height. However, the design of the building includes more traditional details like horizontal wood cladding and gabled roof forms that help it to blend in more readily with the surrounding contributors and historic character of the district.

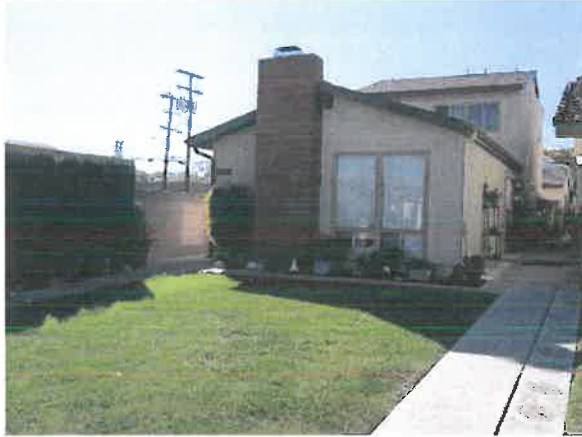
Most compatible (3439 Cerritos Avenue): This residence is the most compatible of the three examples. It is two stories in height, but the upper story is oriented towards the rear, making it less visible from the street. The front of the building is one story in height with a gabled roof form and traditional brick chimney. The building is clad in stucco and wood, and the property has a front setback and landscaped yard, helping it to blend in more readily with surrounding contributors and historic character of the district.
