City of Long Beach
MILLS ACT PROPERTY TAX INCENTIVE PROGRAM

REHABILITATION/RESTORATION/MAINTENANCE PLAN

Property Name and Address: 805 Maine Ave, Long Beach, CA 90813

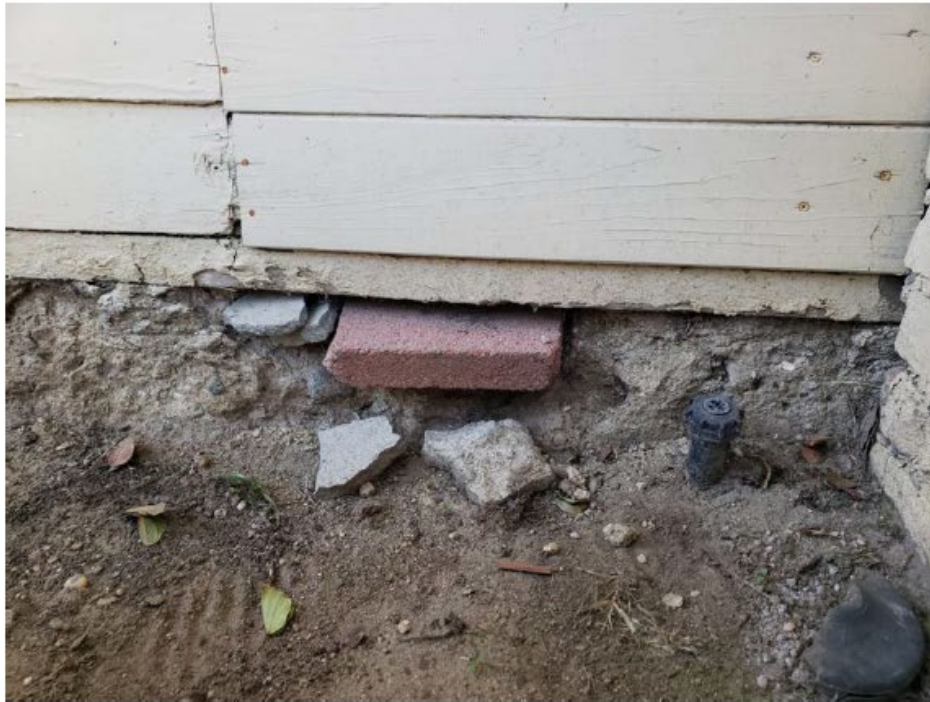
1) 815 Maine Ave Foundation Replacement (year 2020) Priority: MAXIMUM

Bricks used to fill gaping holes in footings

Item No.: 1)	Detailed description of work:
Building Feature: 815 Foundation Replacement. Directly visible from the street/sidewalk.	Please see detailed rehabilitation report in Appendix. Deteriorated foundation resulting in critically poor condition and priority consideration for repair. Wherever possible, local vendors will be used in the repair of the foundation. Bids will be requested from multiple vendors and local vendors will be given priority during the selection process.
Completion Year: 20 20	
Plan to Use Long Beach Vendors For Materials/Labor: <input checked="" type="checkbox"/> Yes (If Yes, specify/list) <input type="checkbox"/> No	Specify/list: TBD. Vendor selection to be completed upon Mills Act qualification and will be based on best value.

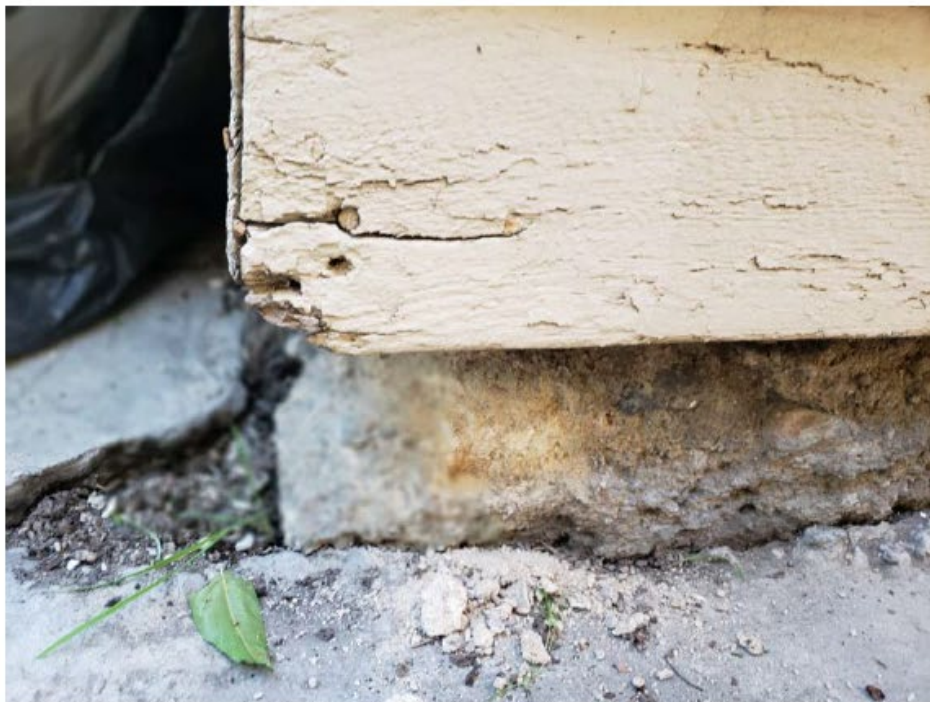
Disintegrating footings

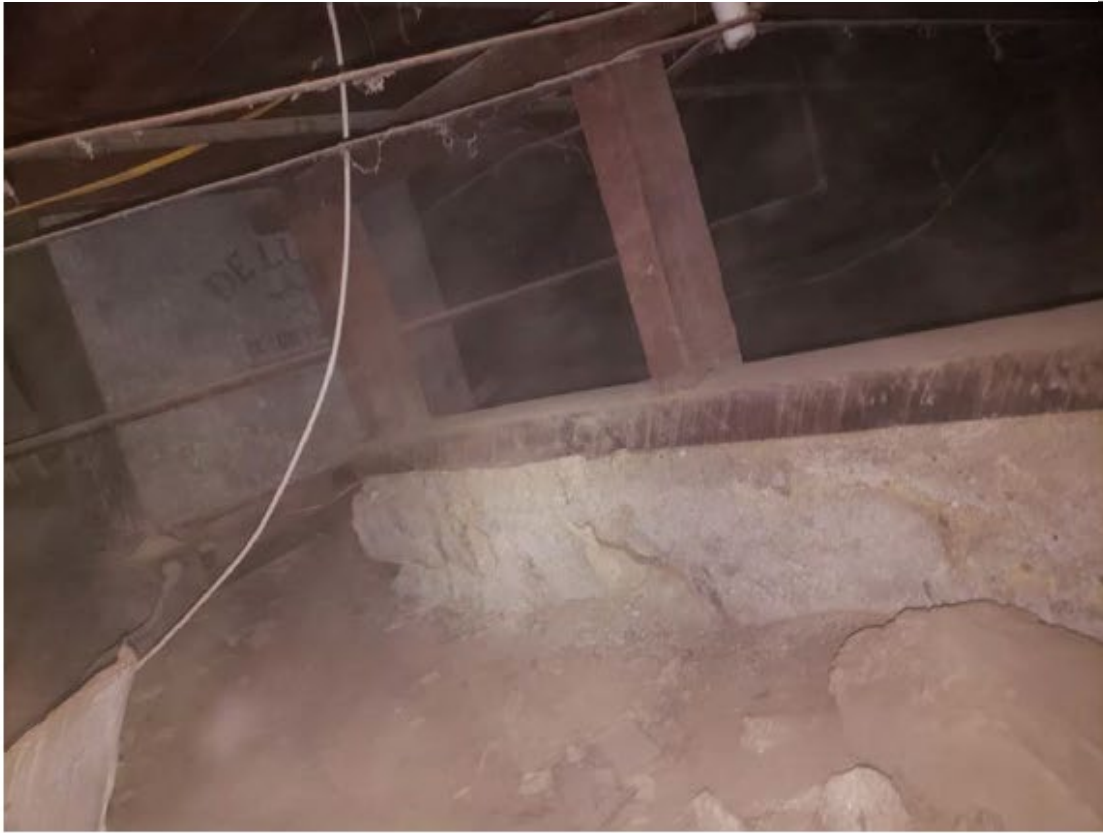
1. 815 Maine Ave Foundation Replacement (year 2020) Priority: MAXIMUM

Disintegrating footings

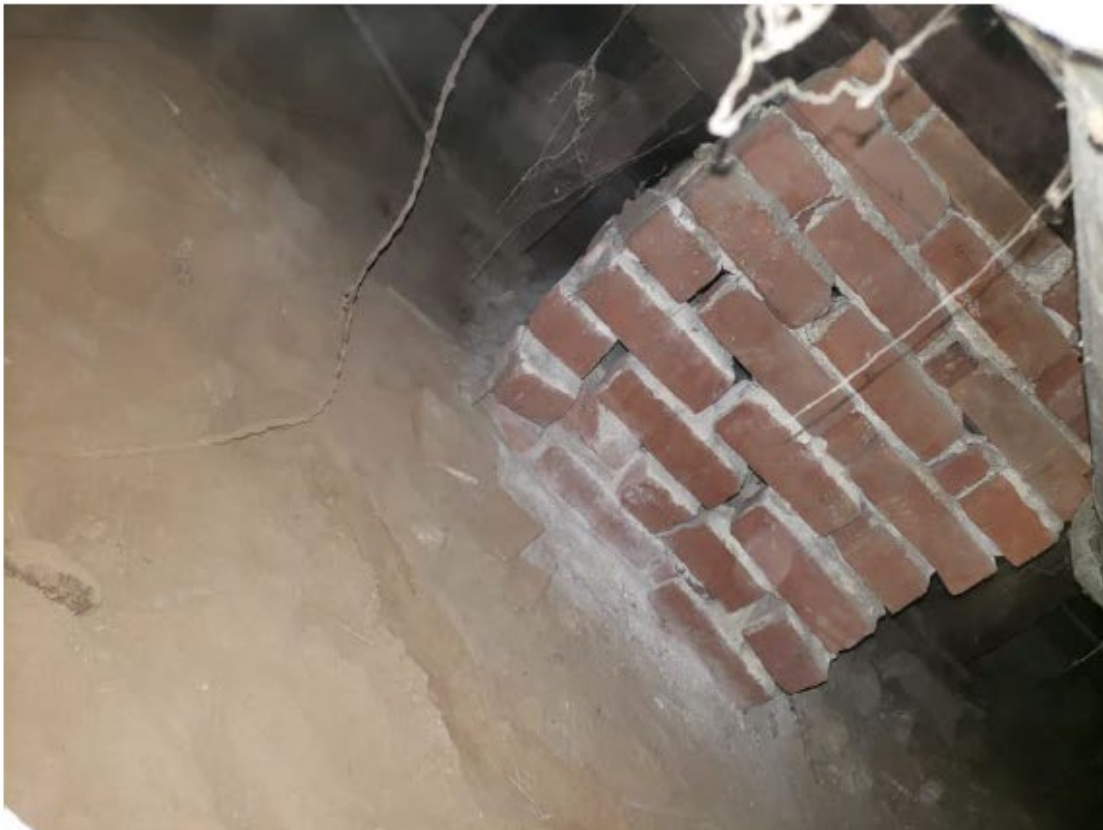
Brick footings that are completely separating

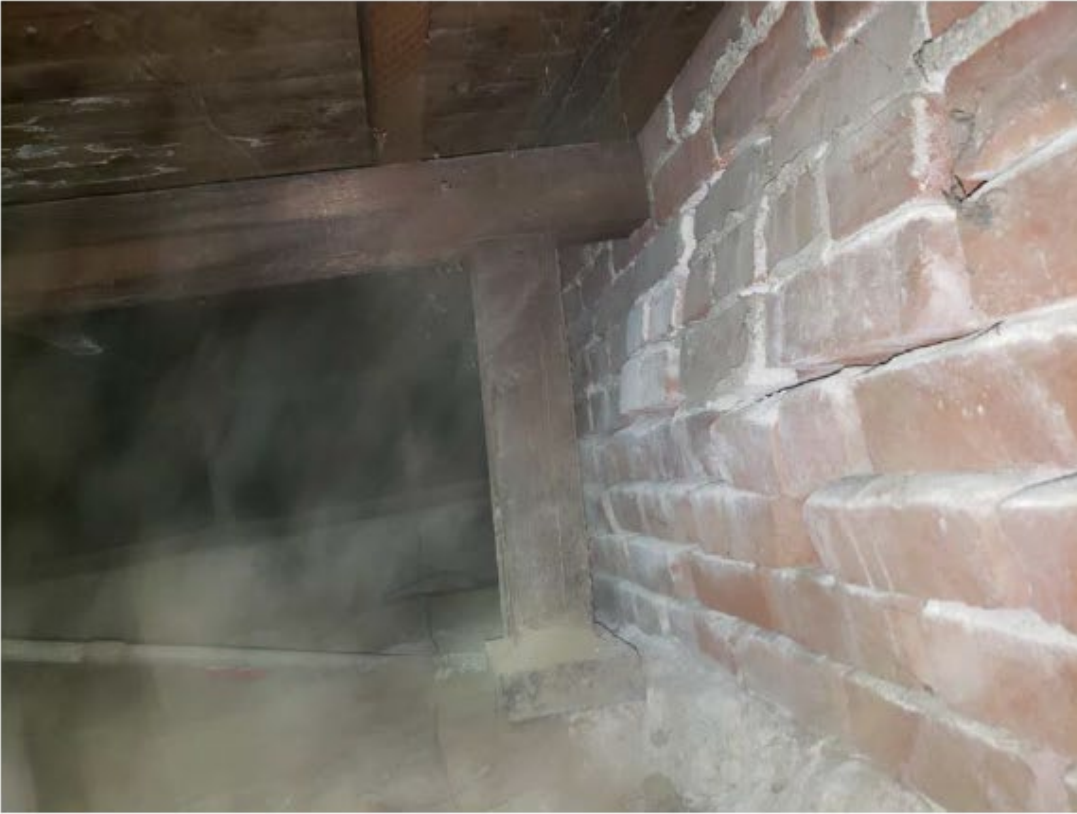
1. 815 Maine Ave Foundation Replacement (year 2020) Priority: MAXIMUM

Brick footings starting to buckle from weight and improper support

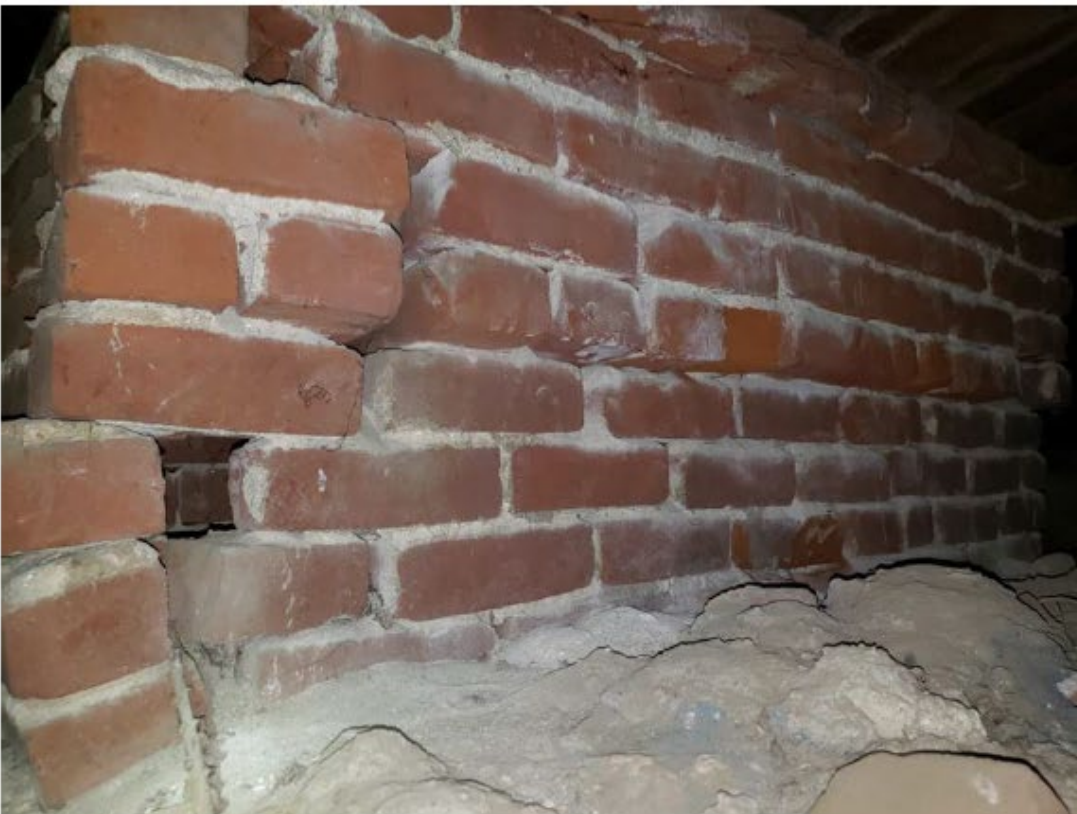
Brick footings falling apart

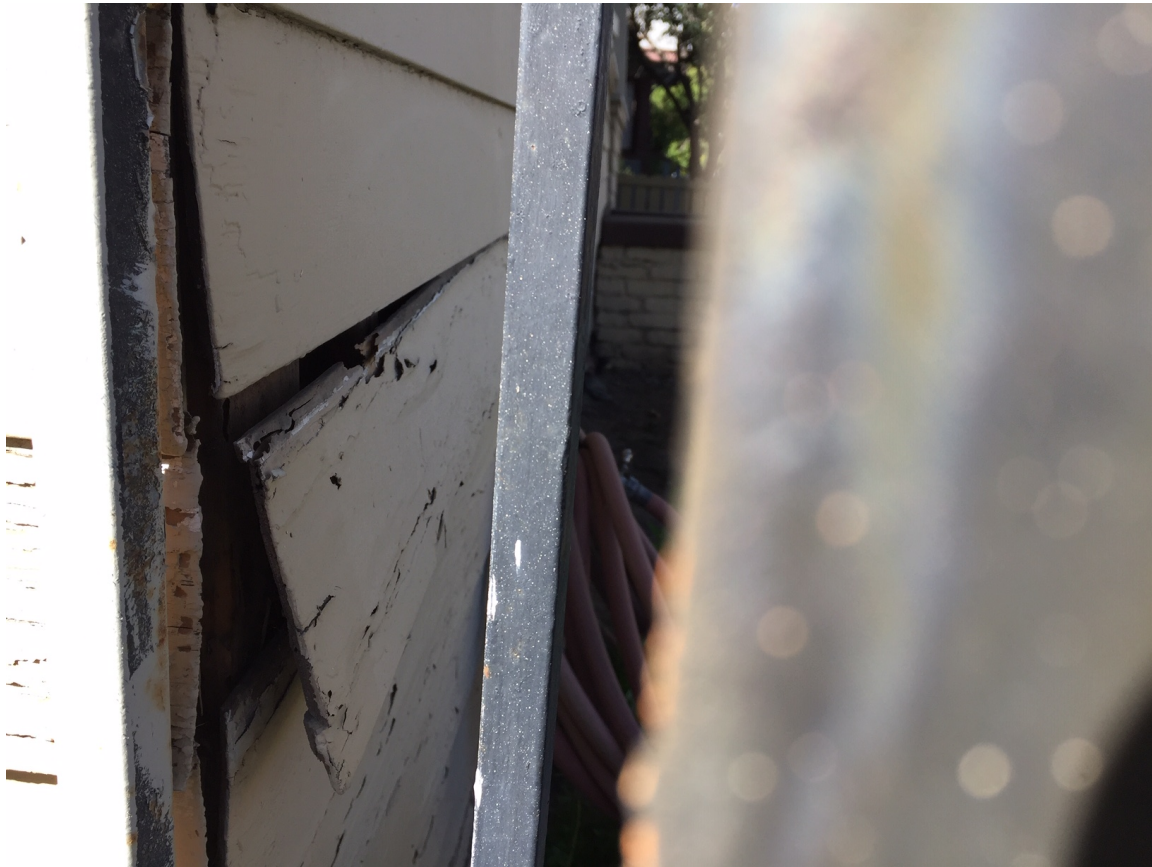
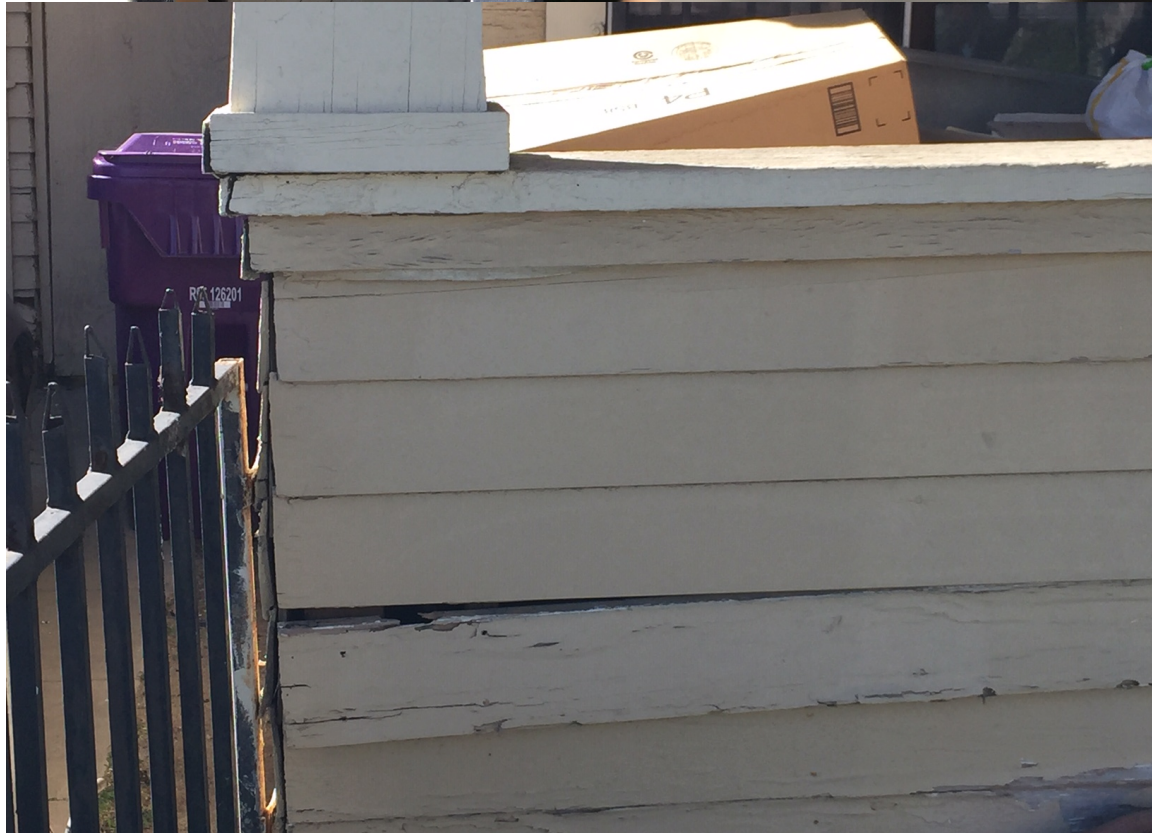
2) 815 Maine Ave Front Porch Repair (year 2021) Priority: High

The front porch is severely damaged and needs significant repair.

Item No.: 2)	Detailed description of work:
Building Feature: 815 Maine Ave Front Porch Repair. Directly visible from the street/sidewalk.	Front porch has settled, is cracking and needs to be repaired. Front porch needs to be rebuilt after the foundation is repaired. It is currently cracking and the wood paneling is popping out as a result of the pressure. Wherever possible, local vendors will be used in the repair of the foundation. Bids will be requested from multiple vendors and local vendors will be given priority. I would like to complete this in 2020 but budget constraints may require this in '21.
Completion Year: 20 21	
Plan to Use Long Beach Vendors For Materials/Labor: <input checked="" type="checkbox"/> Yes (If Yes, specify/list) <input type="checkbox"/> No	Specify/list: TBD. Vendor selection to be completed upon Mills Act qualification and will be based on best value.

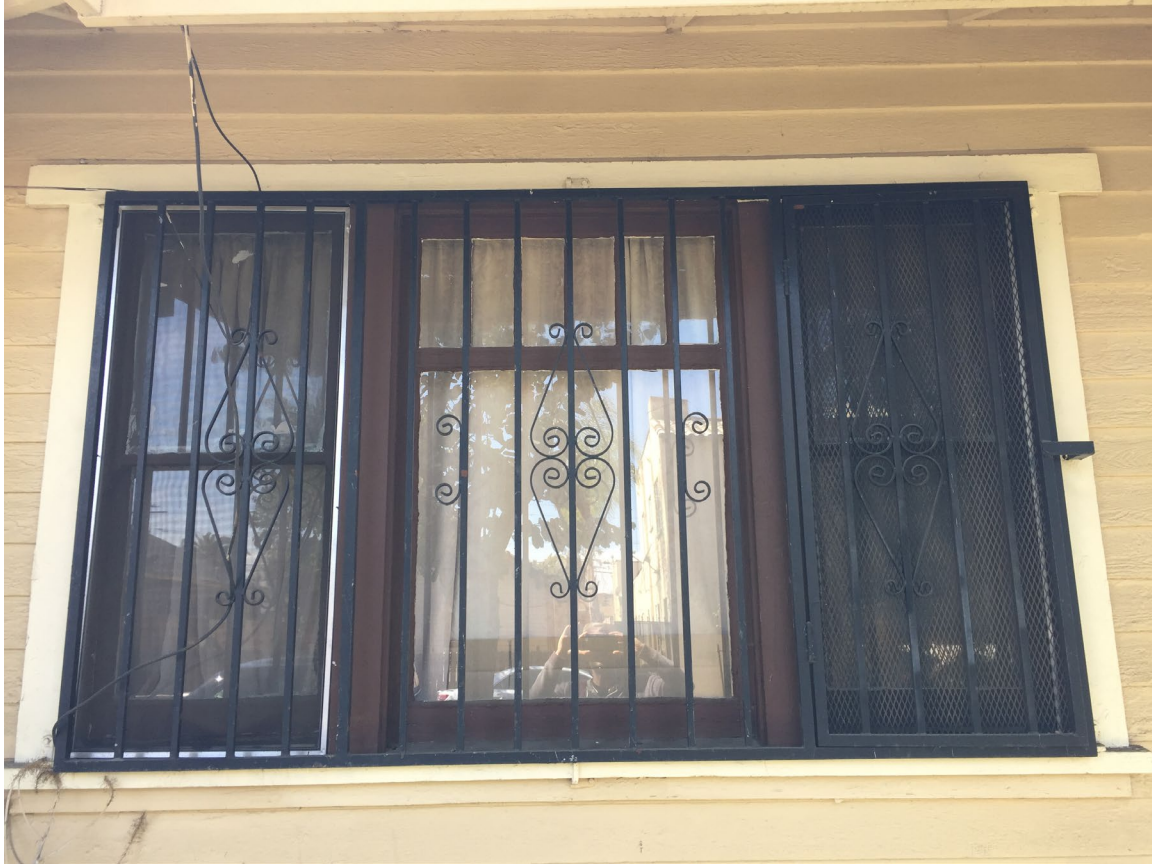
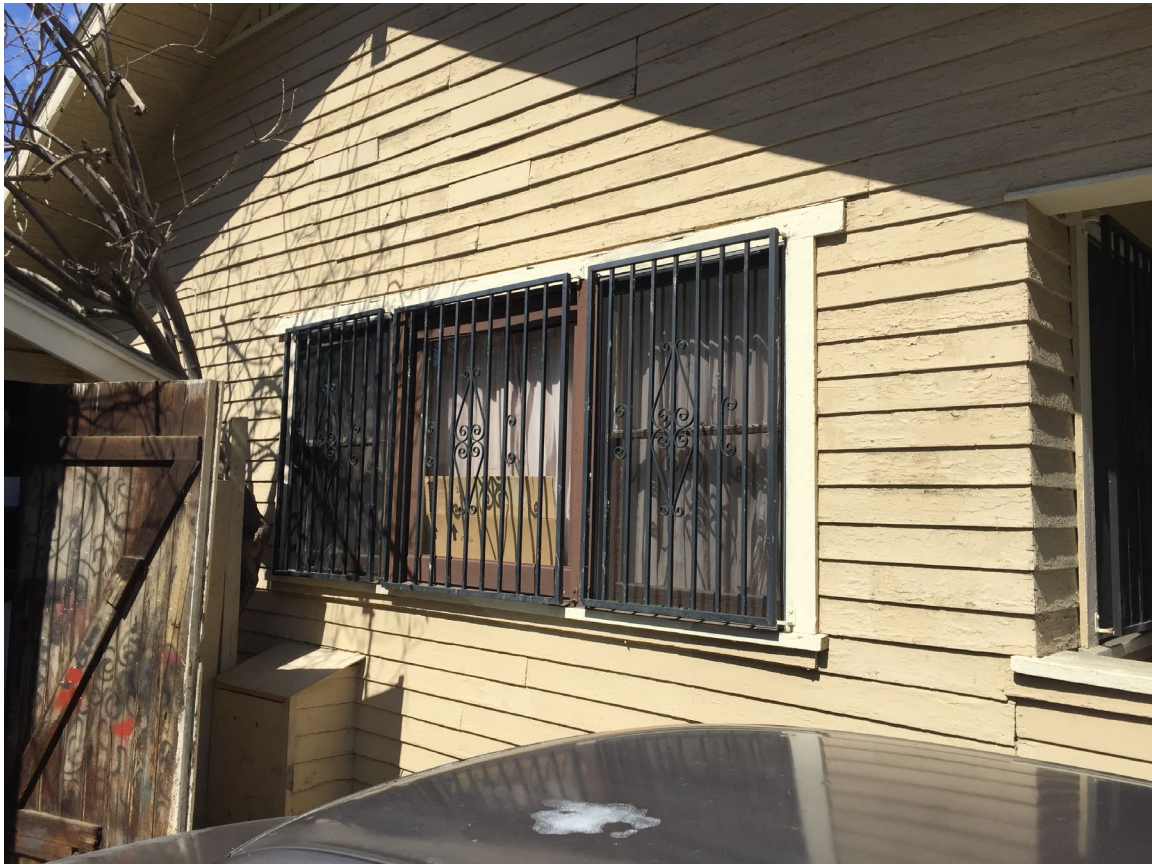
4. 815 window frame/window repair (year 2022) Priority: High

Item No.: 4)	Detailed description of work:
Building Feature: 815 Window frame/window repair. Directly visible from the street/sidewalk.	Windows and frames facing south need to be completely removed and refurbished/replaced as a result of the house shifting. Temporary wood was nailed on during a recent storm because the glass completely popped out during strong winds. Wherever possible, local vendors will be used in the repair of the foundation. Bids will be requested from multiple vendors and local vendors will be given priority.
Completion Year: 20 22	
Plan to Use Long Beach Vendors For Materials/Labor: <input checked="" type="checkbox"/> Yes (If Yes, specify/list) <input type="checkbox"/> No	Specify/list: TBD. Vendor selection to be completed upon Mills Act qualification and will be based on best value.

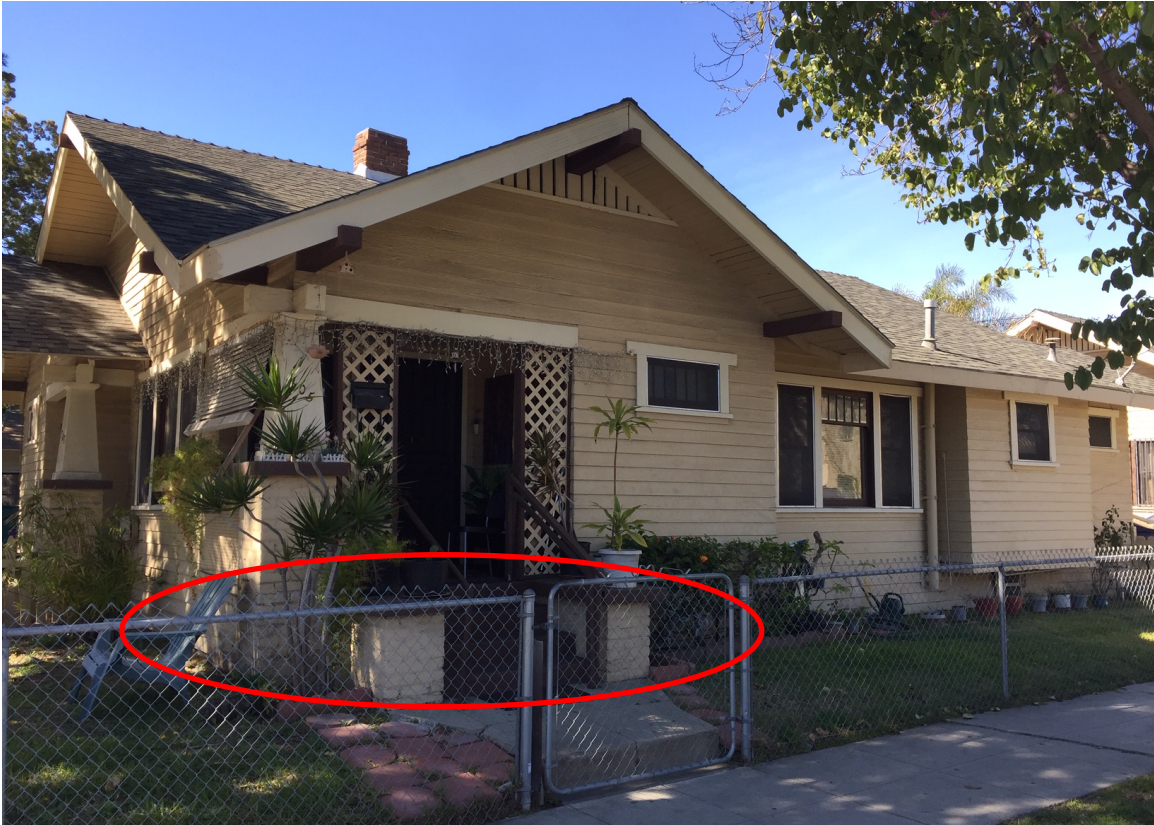
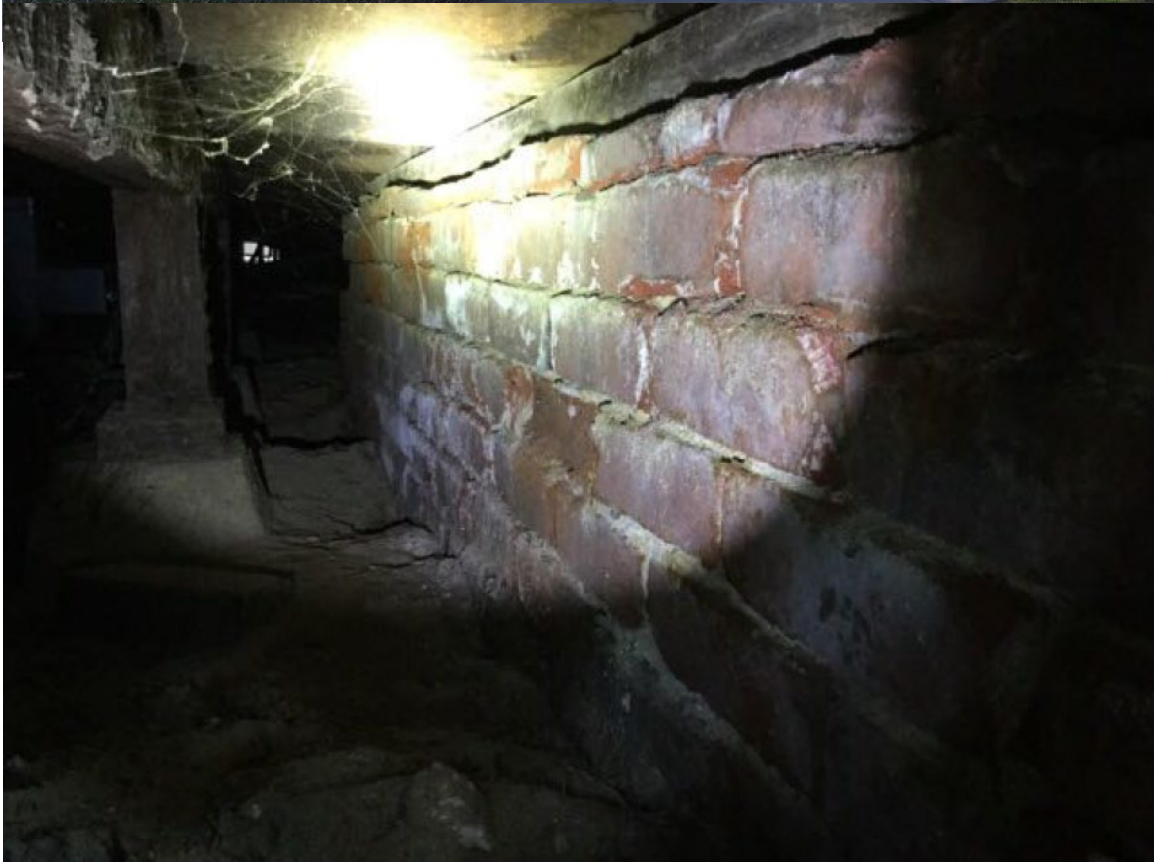
5) 805 front porch repair (year 2023) Priority: High

Item No.: 5)	Detailed description of work:
Building Feature: 805 Front porch repair. Directly visible from the street/sidewalk.	Front porch made out of brick is cracking and crumbling and showing signs of structural deterioration. Front porch needs to be rebuilt as a result of structural settling. Wherever possible, local vendors will be used in the repair of the foundation. Bids will be requested from multiple vendors and local vendors will be given priority.
Completion Year: 20 23	
Plan to Use Long Beach Vendors For Materials/Labor: <input checked="" type="checkbox"/> Yes (If Yes, specify/list) <input type="checkbox"/> No	Specify/list: TBD. Vendor selection to be completed upon Mills Act qualification and will be based on best value.
