**DRAFT
ARCHITECTURAL BUDGET COST MODEL
OF**

**5870-5874 ATLANTIC AVENUE
LONG BEACH, CALIFORNIA**

**THE CITY OF LONG BEACH
REDEVELOPMENT AGENCY**

**File No. 110018
April 2010**

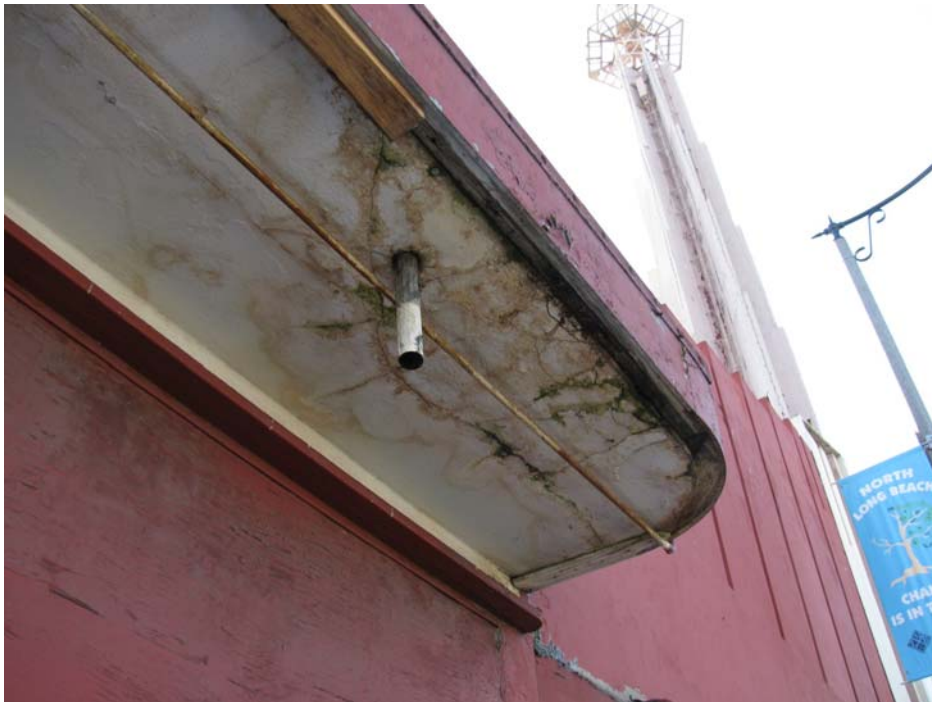
8

8. Detail of eyebrow at furniture store.

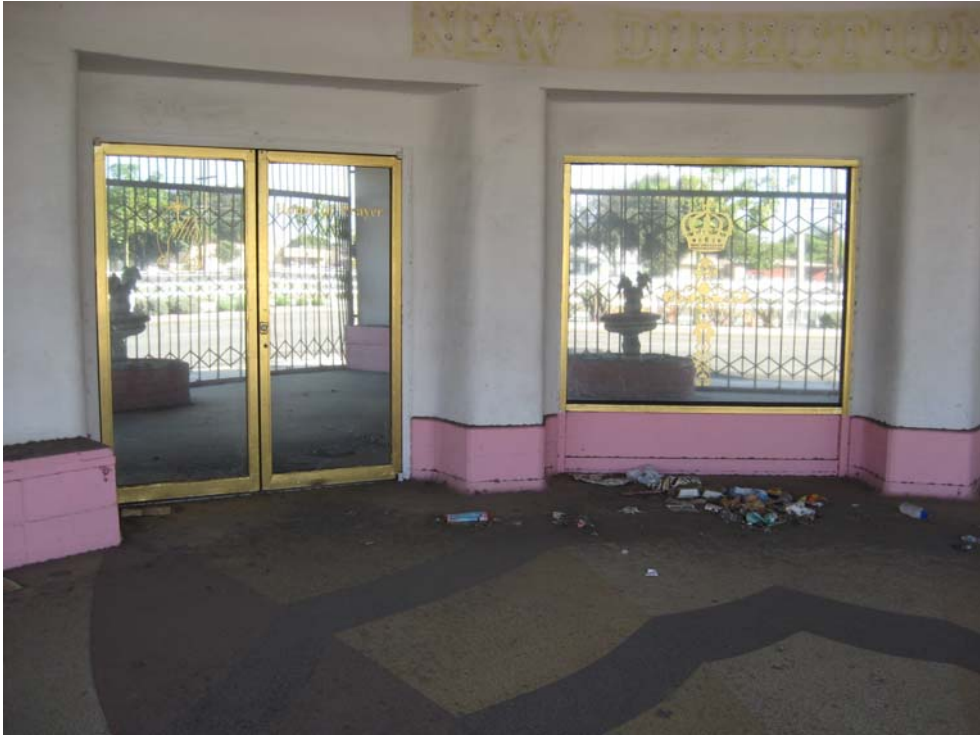
7

7. Entrance to the former church space.

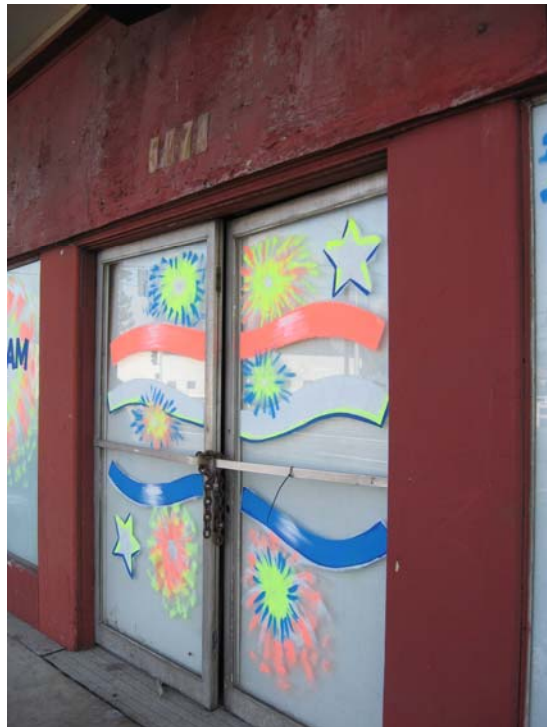
8

Signage is missing at the two accessible parking stalls and one of the two stalls should be designated as van accessible. At the entrance there is metal fence that slides on a permanent rail that is affixed to the sidewalk. This rail prevents a person in a wheelchair from entering the building. This barrier should be removed.

8. Entrance to the furniture store.

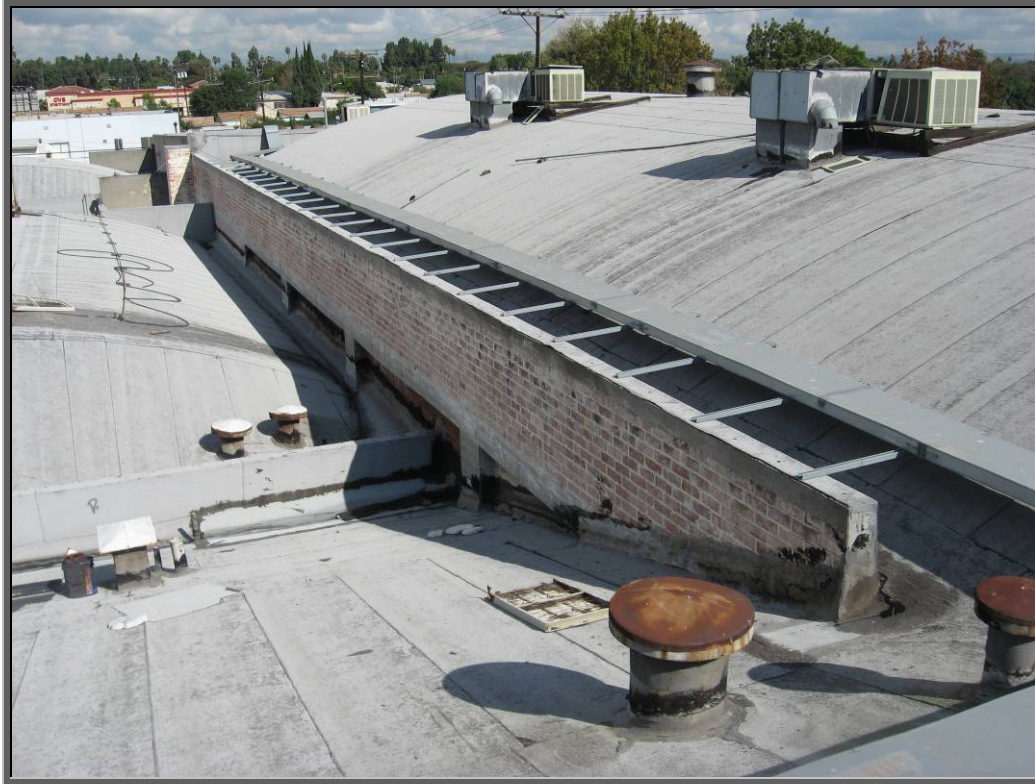
Photo 3: Roof overview.
