PARSONAGE RESIDENCE
640 PACIFIC AVENUE
LONG BEACH, CALIFORNIA 90813

HISTORIC STRUCTURE REPORT

Katie Rispoli Keaotamai
Master of Heritage Conservation
on behalf of
KEAOTAMAI, LLC
July 12, 2018

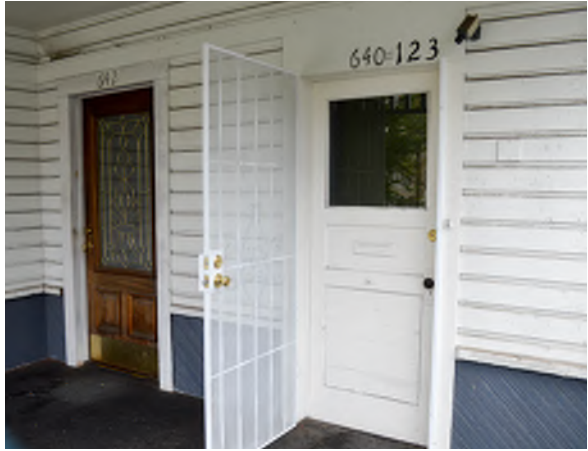
<p>Door Leading to Stairwell (Right,) View Northwest</p>	<p>The door which leads to the stairwell and second story unit is likely original to the building. The hardware on this door matches hardware from the period of historic significance identified throughout the interior of the building. In addition, period hardware and weathering on the door indicate its age.</p>	<p>Relocation Preparation</p> <p>Reassembly</p> <p>Rehabilitation</p>	<p>The door will be removed prior to relocation and safely brought to the future site. Both doors will be removed and their openings framed prior to relocation. Following relocation, the original door should be reinstalled in the leftmost door frame, and a fixed, single-lite window installed in the current location of the door as observed in the historic photograph. Hardware of the original door should be removed, and its paint carefully removed under safe conditions. The door will be painted to match its original color as determined by a forensic analysis.</p>	<p>Following the Secretary's Standards for Rehabilitation, damaged wood components of this feature will be repaired rather than replaced when possible. Lost aspects of the feature will not be replaced using conjecture. As a result, the glass within the door will remain single-lite as not to assume a design or texture of original glass. The same approach will be taken for the future window, since these details cannot be seen in the historic photograph.</p>

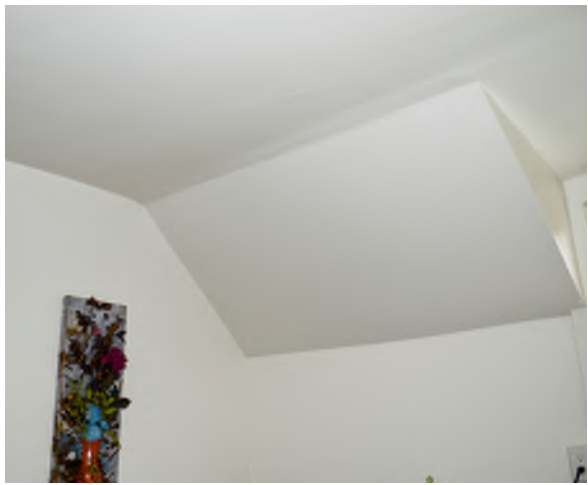
<p>Interior Roof Forms</p> <p>Location:</p> <ul style="list-style-type: none"> All second-story rooms 	<p>Historic Character-Defining Feature</p>

<p>Interior Roof Forms Throughout Second Story</p>	<p>Interior roof forms throughout the second story of the building are a result of the exterior shape of the roof and bracketed window formations. In most occurrences, these forms are steeply pitched, and plaster around them is rounded at the intersection of the form and the ceiling.</p>	<p>Relocation Preparation</p> <p>Rehabilitation</p>	<p>If forms are undisturbed after relocation, it is suggested they be retained. Any remaining lath may be re-plastered, or drywall may be used to re-frame the shapes after relocation. If plaster forms are entirely lost as a result of relocation, they should not be reconstructed in order to provide evidence of the current era and avoid the creation of a false historical narrative.</p>	<p>Following the Secretary's Standards for Rehabilitation, damaged components of this feature will be repaired rather than replaced when possible. When replaced, the new materials will match the original in design, color, and texture. Replaced materials will be painted to match existing.</p>

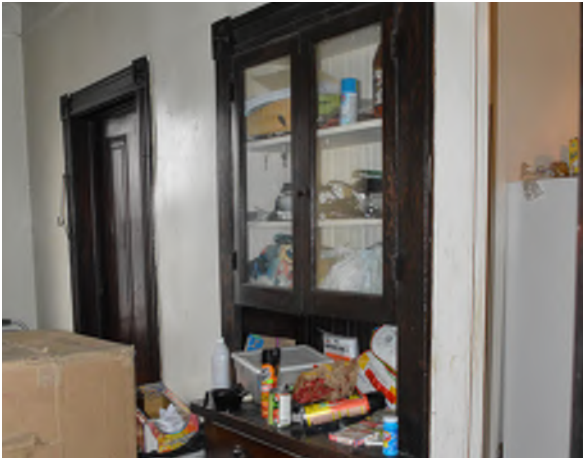
Feature Location	Feature Type	Image	Description	Related Project Component	Treatment Approach	Accordance with Applicable Standards
<p>Built-in China Cabinet</p> <p>Location:</p> <ul style="list-style-type: none"> • First Floor Dining Room 	<p>Historic Character-Defining Feature</p>

<p>Photo Description</p>	<p>A built-in china cabinet is located in the original dining room of the residence on the first story. This china cabinet would have been used to store silverware, linens, and dishes for use by ministers and guests dining at the Parsonage. The cabinet is unpainted wood, with painted 2 inch vertical wood paneling on its interior. The outer edge of the cabinet continues to form the door frame of the door to its right, and is ornamented with dart detailing.</p>	<p>Relocation Preparation</p> <p>Relocation</p> <p>Reassembly</p> <p>Rehabilitation</p>	<p>If cuts must be made near the base of the cabinet in order to prepare the lower portion of the building for relocation, the cabinet must be relocated to preserve its materials. If moving with the building, the cabinet will be wood-framed for protection. If it is removed, it will be appropriately relocated and reinstalled following relocation. It will not be painted. Unpainted wood portions will be stripped of finishing with care not to damage historic fabric. Holes will be filled with wood filler, and wood should be lightly sanded, stained, and sealed to match current stain.</p>	<p>Following the Secretary's Standards for Rehabilitation, any work completed in regards to the cabinet will be completed without the use of abrasive agents or agents which may damage the historic material.</p>

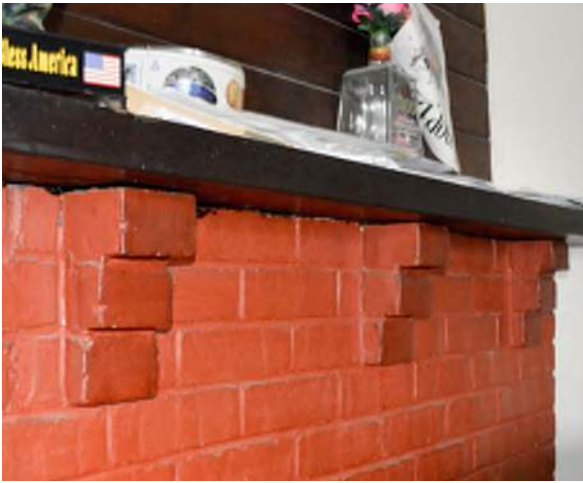
<p>Fireplace</p> <p>Location:</p> <ul style="list-style-type: none"> • First Floor Living Room 	<p>Historic Character-Defining Feature</p>

<p>Fireplace in First Floor Entertaining Area</p>	<p>A brick fireplace is located in the parlor of the residence on the first floor. The fireplace is nonfunctional - its ventilation system was removed in a prior renovation of the building. The fireplace bricks are arranged in horizontal bands. Its opening is square with an angled body of bricks blocking access to the ventilation area. The fireplace has a wood mantle, which is supported by bricks placed vertically into the body of the fireplace, which escalate in their level of protrusion. The fireplace has been painted.</p>	<p>Relocation Preparation</p> <p>Rehabilitation</p>	<p>Relocation of the fireplace will be difficult and will pose a real challenge to the present relocation plan, due to its size and weight. The project proposes to remove the fireplace prior to relocation, and to replace the fireplace at the future site in the rehabilitation process. A new gel fireplace will be used in its place.</p>	<p>The removal and replacement of the fireplace as part of the project is not in accordance with the Secretary's Standards for Rehabilitation. To comply will require the removal of the fireplace prior to relocation, its separate transport or potential deconstruction, and re-installation or reconstruction within the living room at the future site. Undertaking of this action is financially infeasible as part of the proposed project.</p>

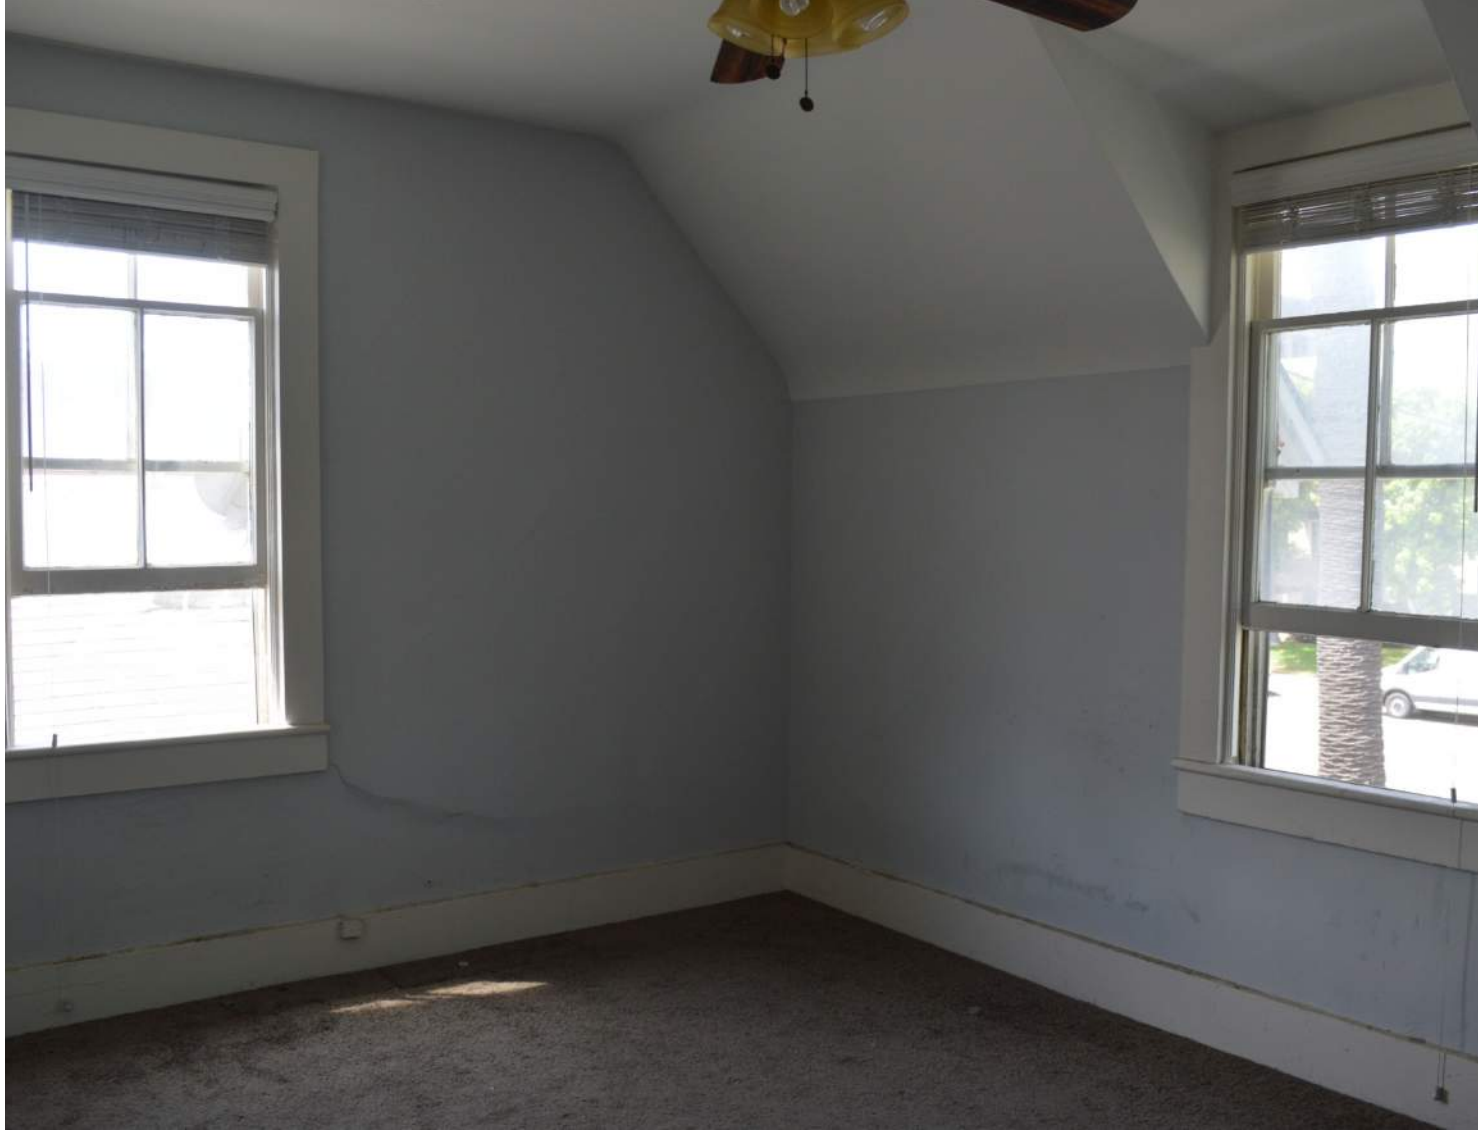
Bedroom, Second Floor, View Southwest (existing condition)
Photo: June 2018
