# CITY OF LONG BEACH

HONORABLE MAYOR AND CITY COUNCIL  
City of Long Beach  
California

Authorize the City Manager to proceed with the entitlement phase of the proposed Long-Term Belmont Pool Revitalization Project (Project), and with the installation of a temporary outdoor pool or other interim option. (District 3)

PROPOSED LONG TERM CONCEPT  
**BELMONT PLAZA POOL REPLACEMENT**  
 CITY OF LONG BEACH, CALIFORNIA

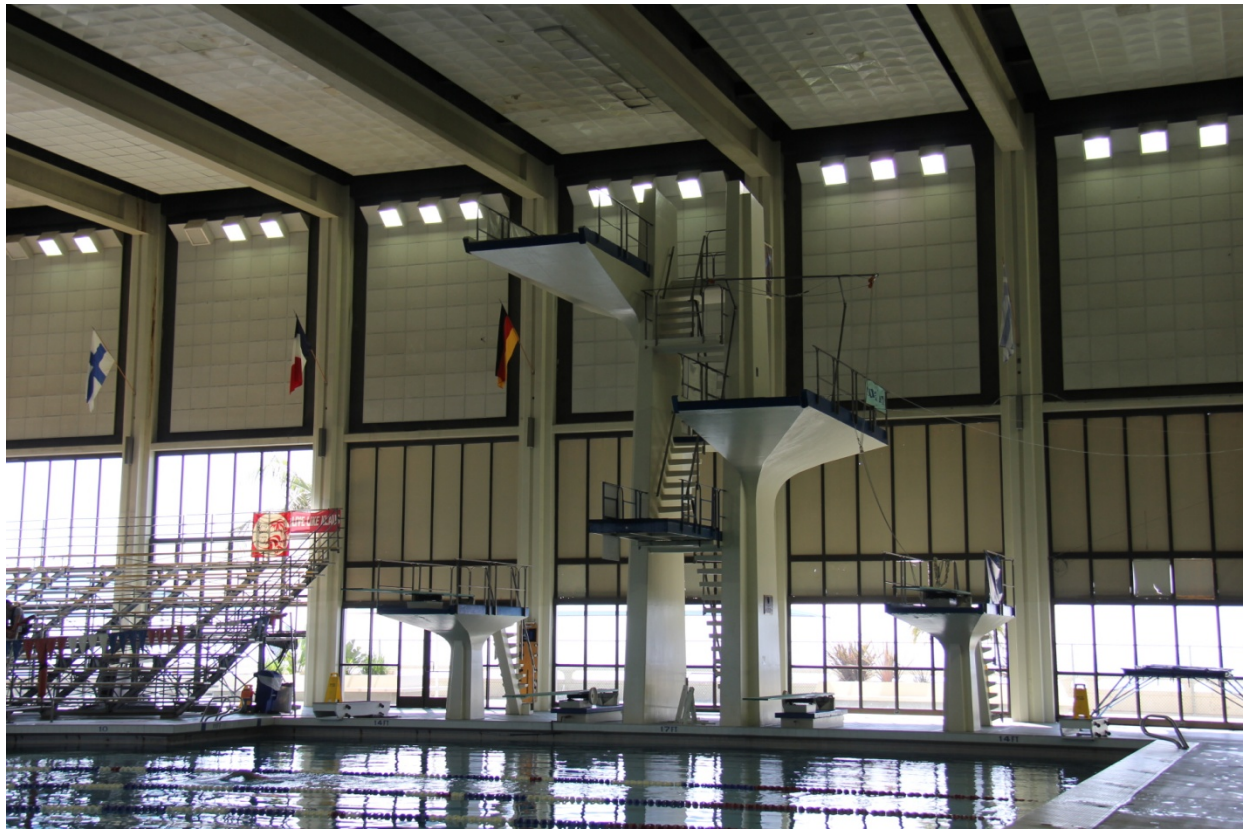
Figure 13 –Natatorium, Diving Platforms
